2007 ADS STORMWATER WORKSHOP

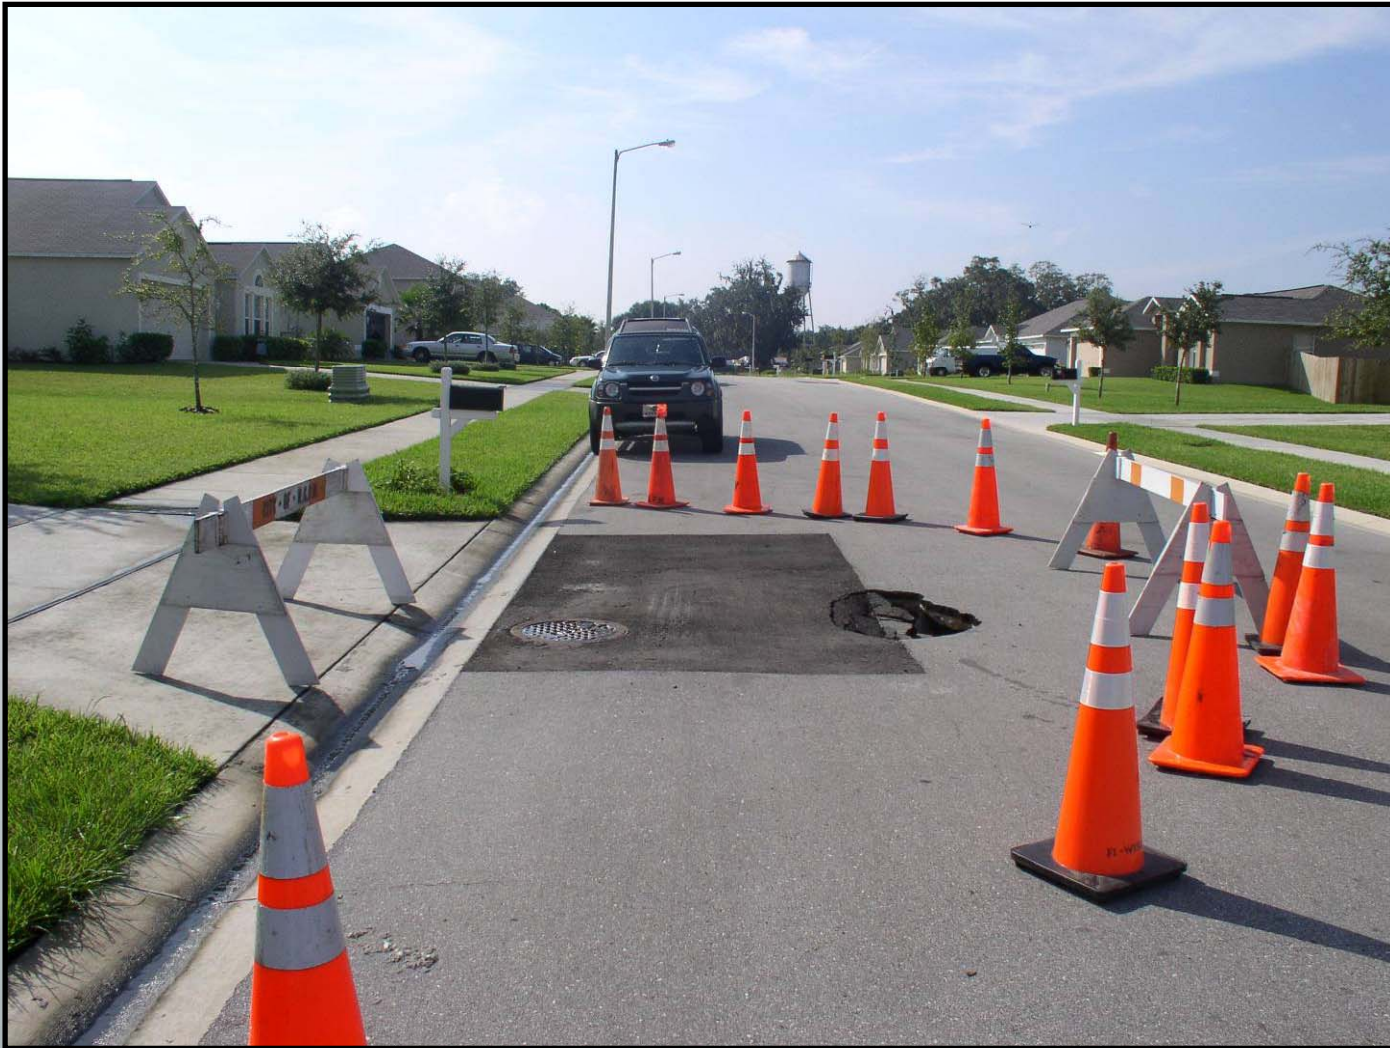
Sand flowing into leaking manhole leading to loss of soil and "sinkhole"

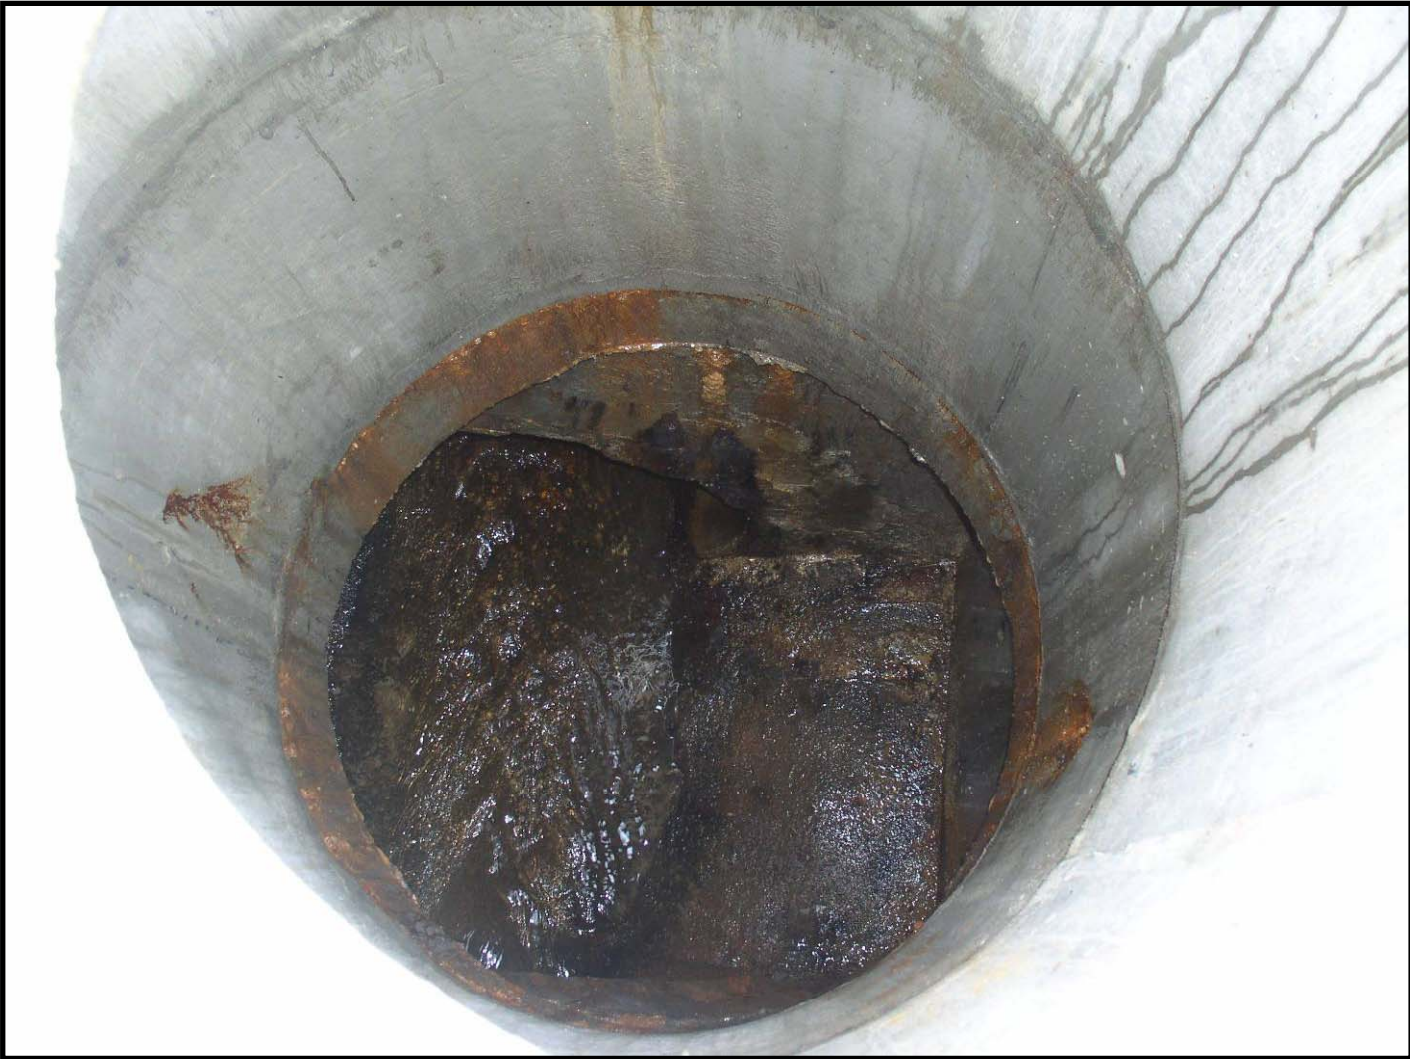
Interior view of leaking manhole

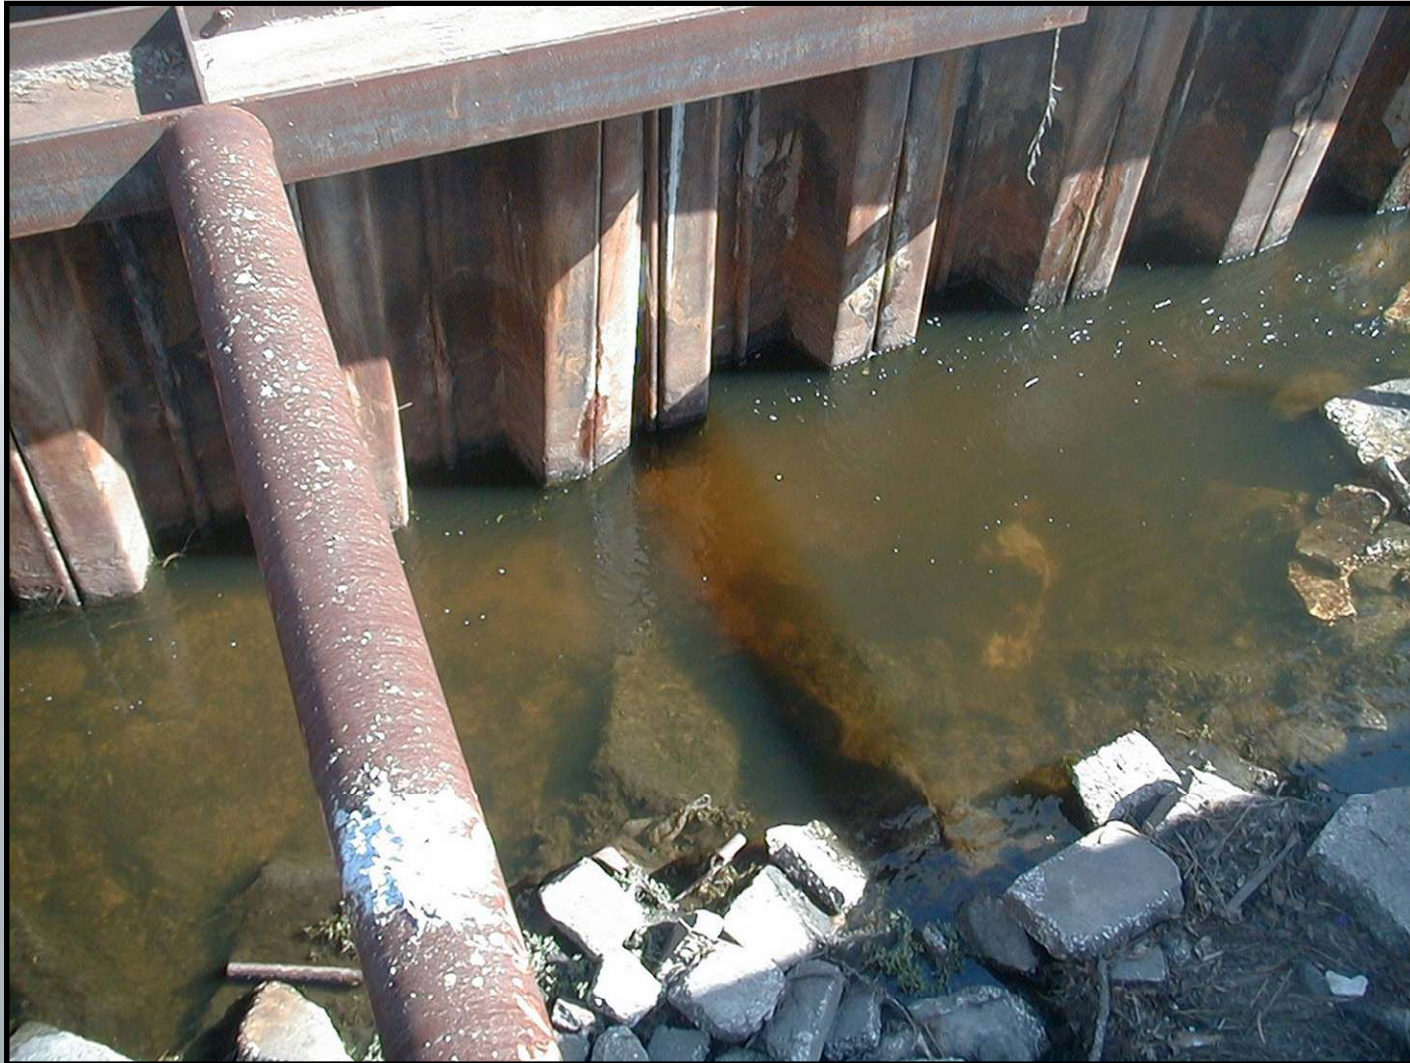
Grout loss directly below angled sheet piles

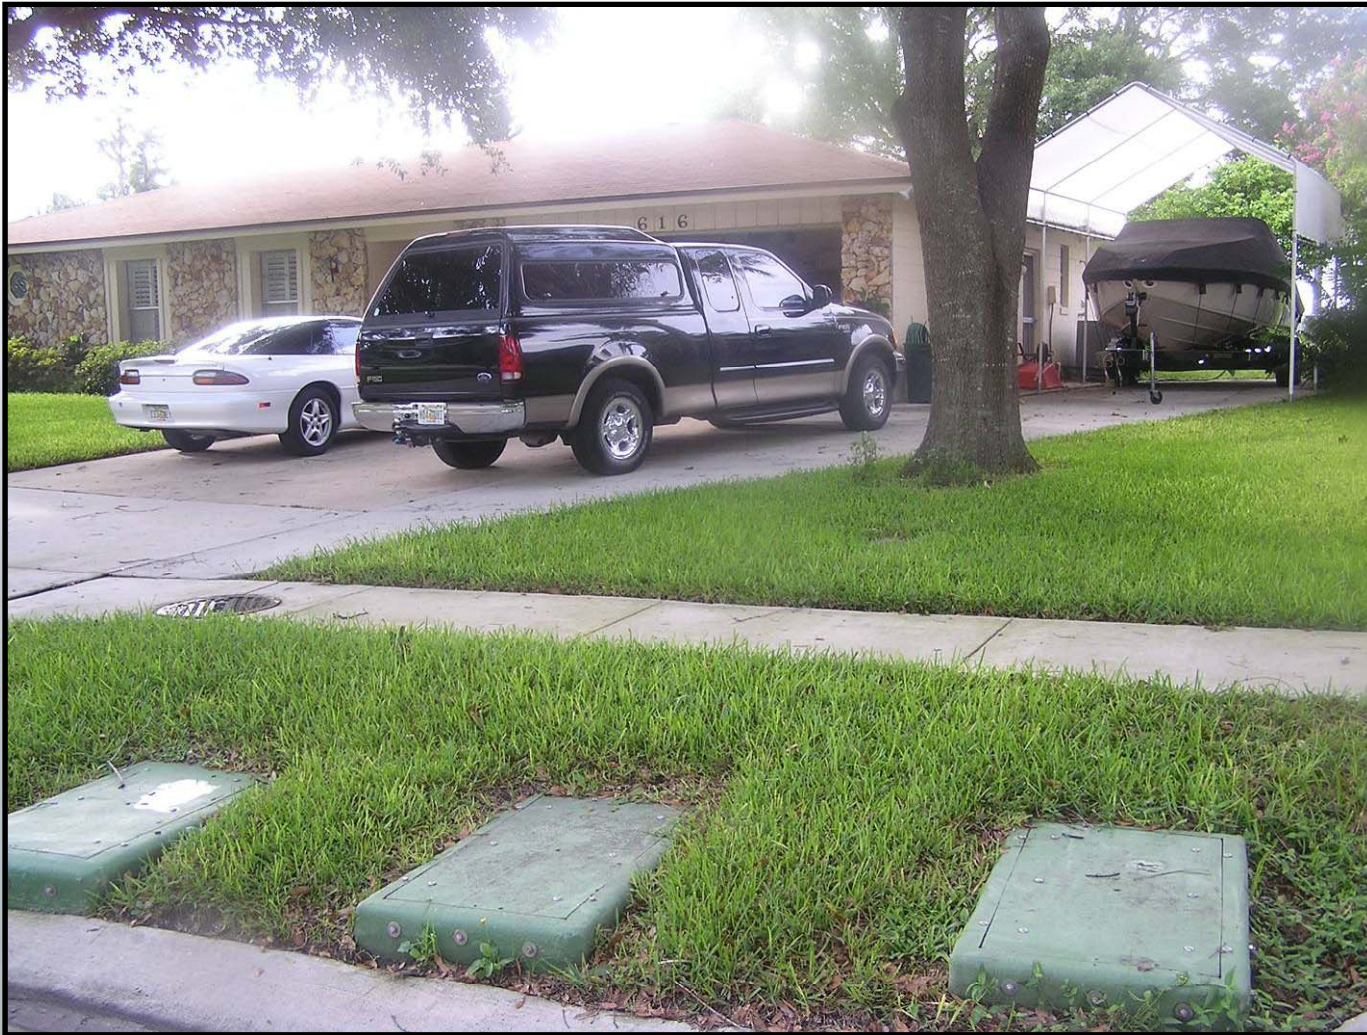
Installed structure in landscape strip

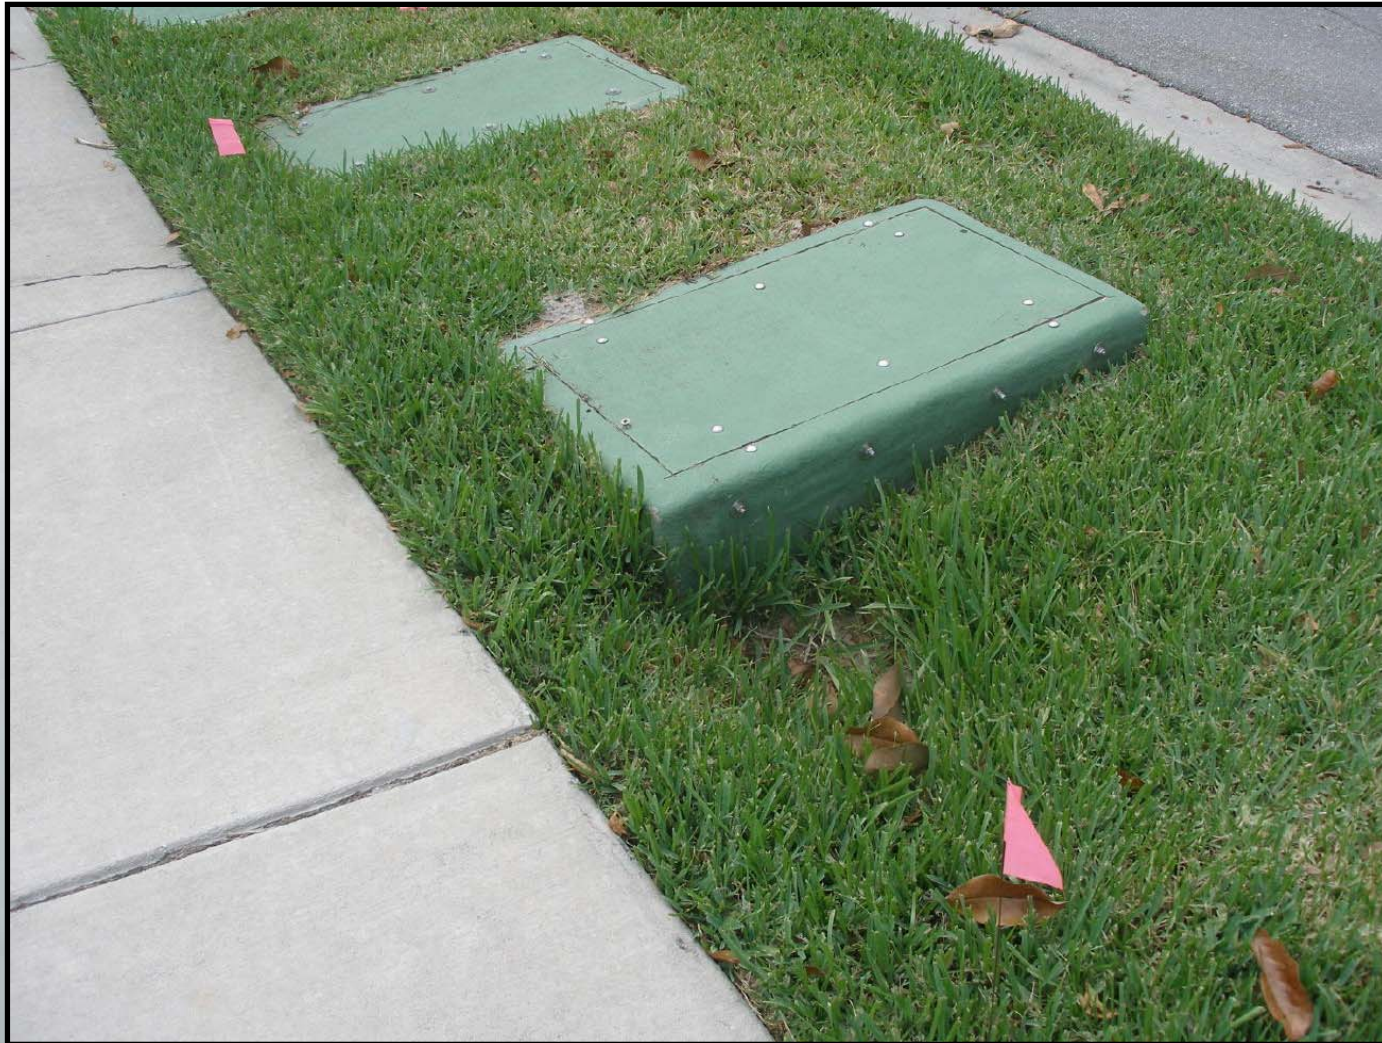
Settlement of soil around structure

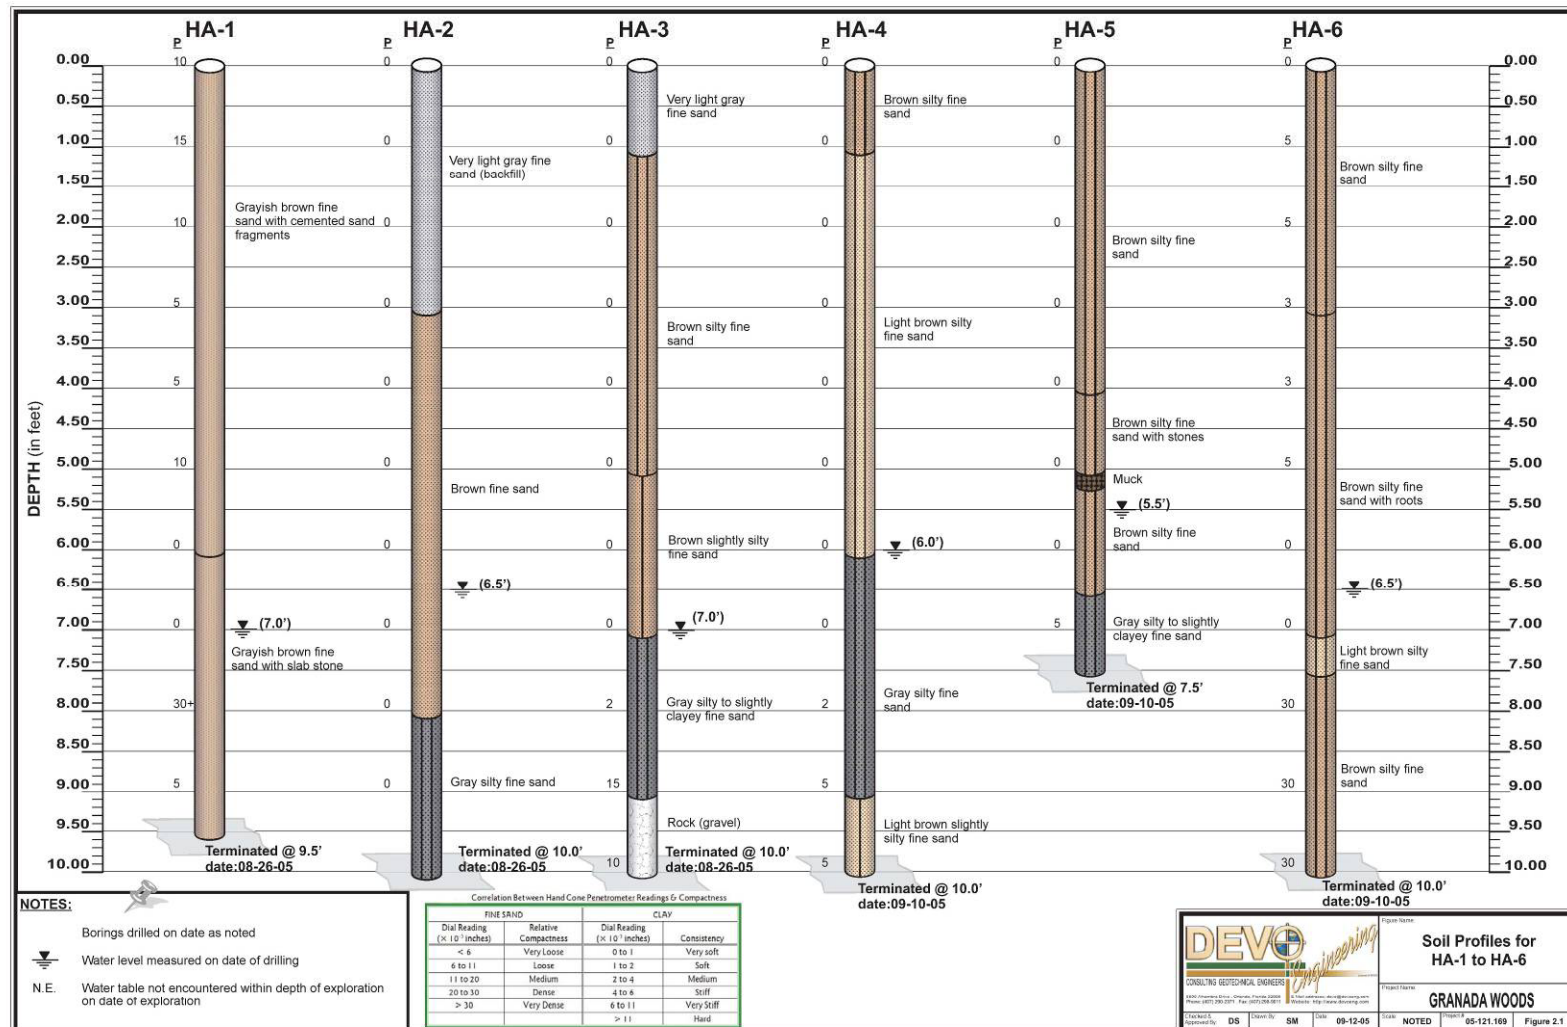
Soil stratigraphy and compactness around structure

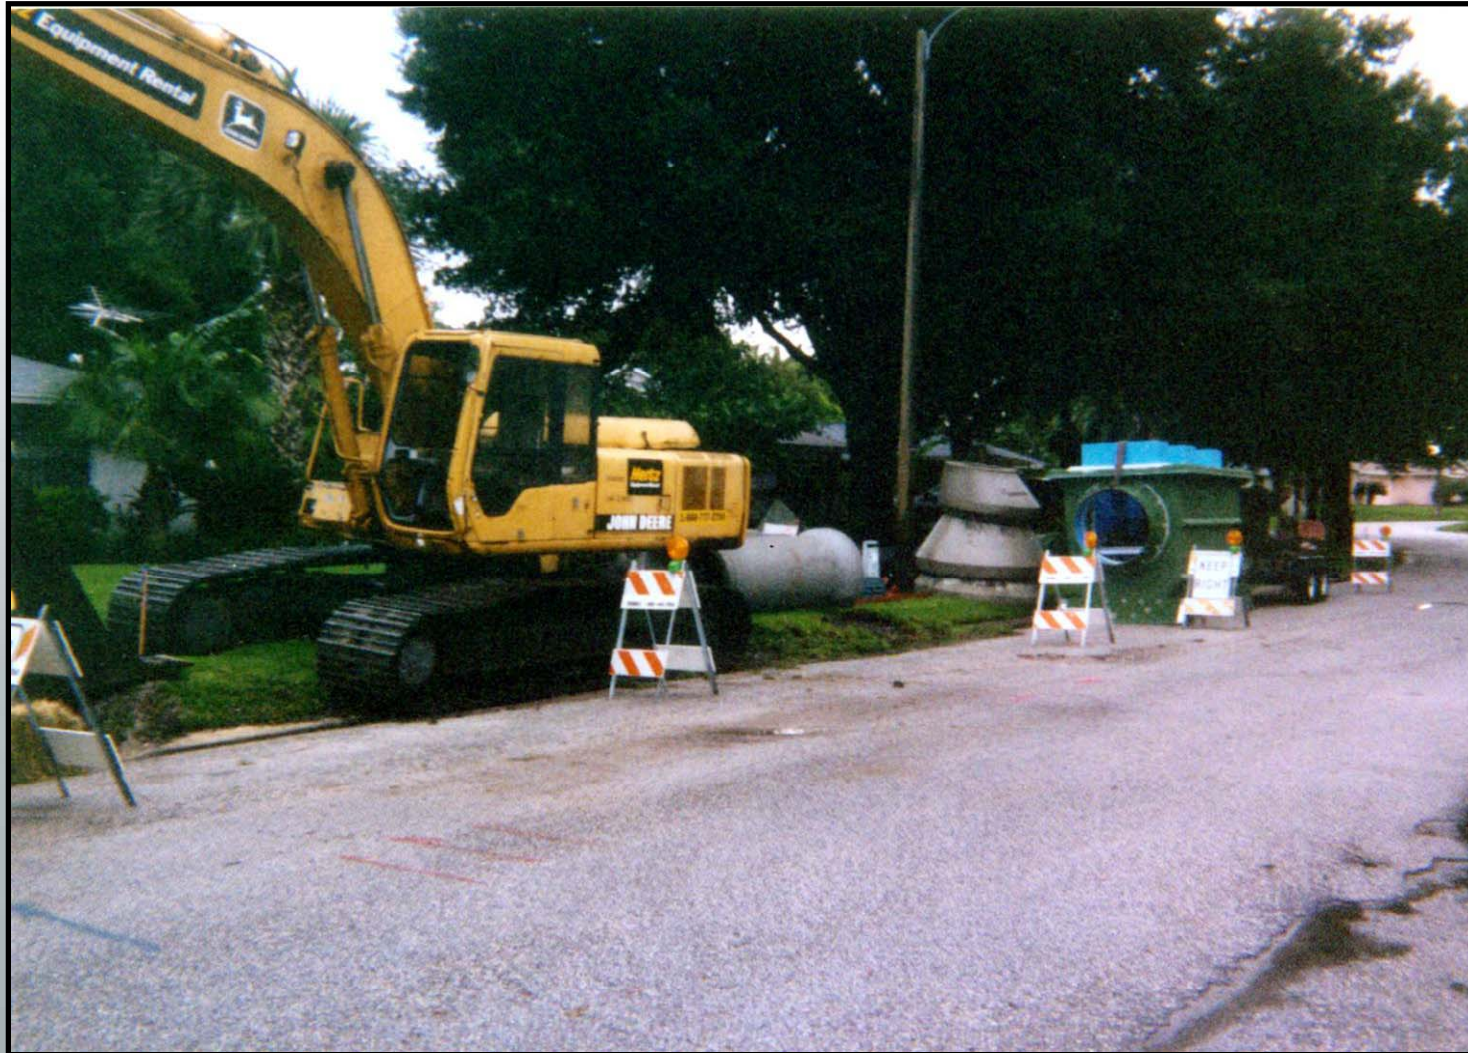
Photos of installation

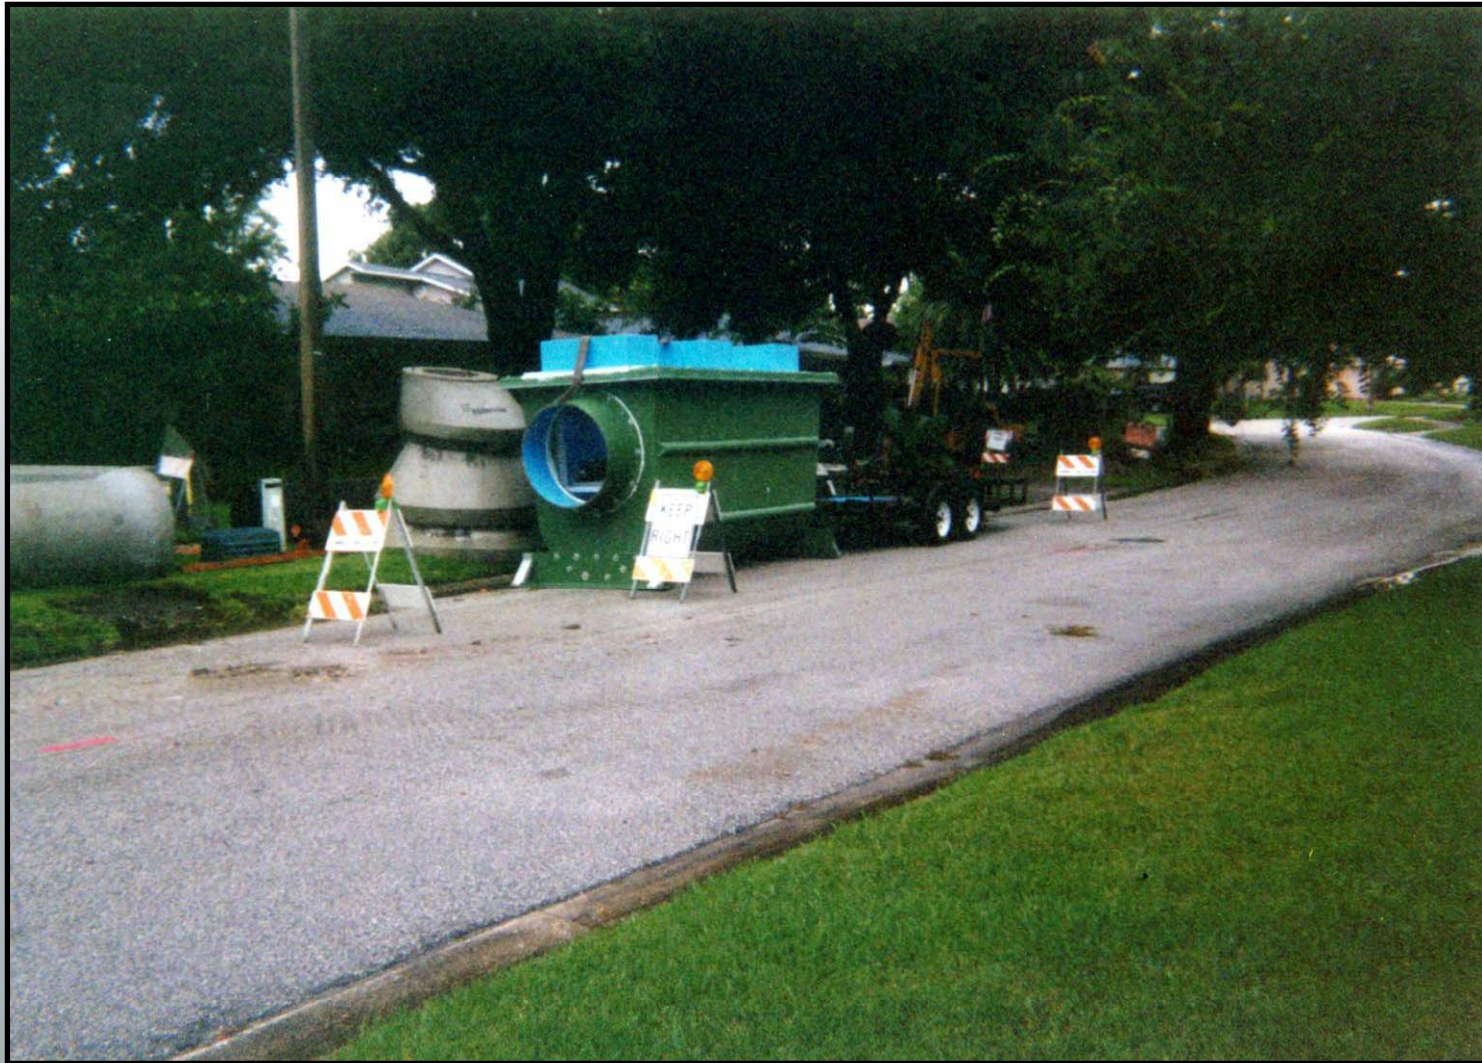
Photos of installation

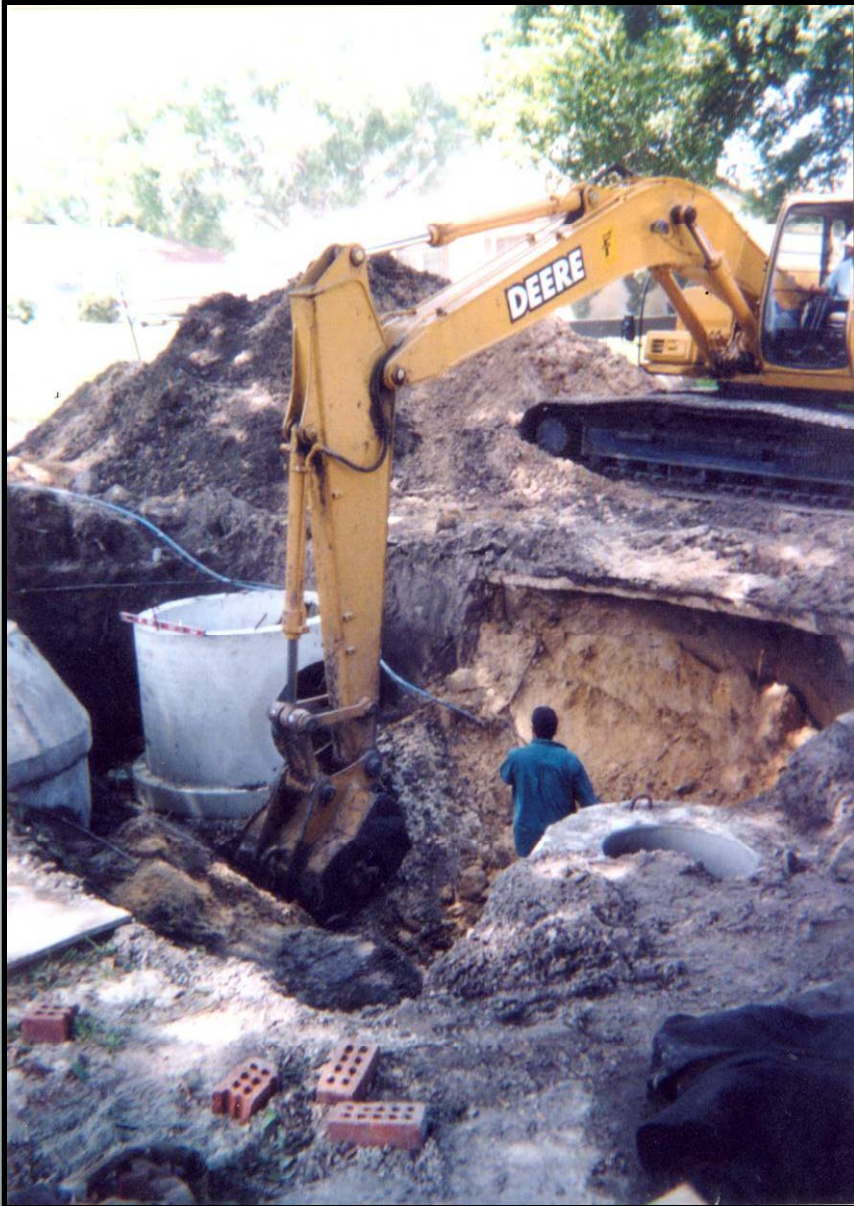
Photos of installation

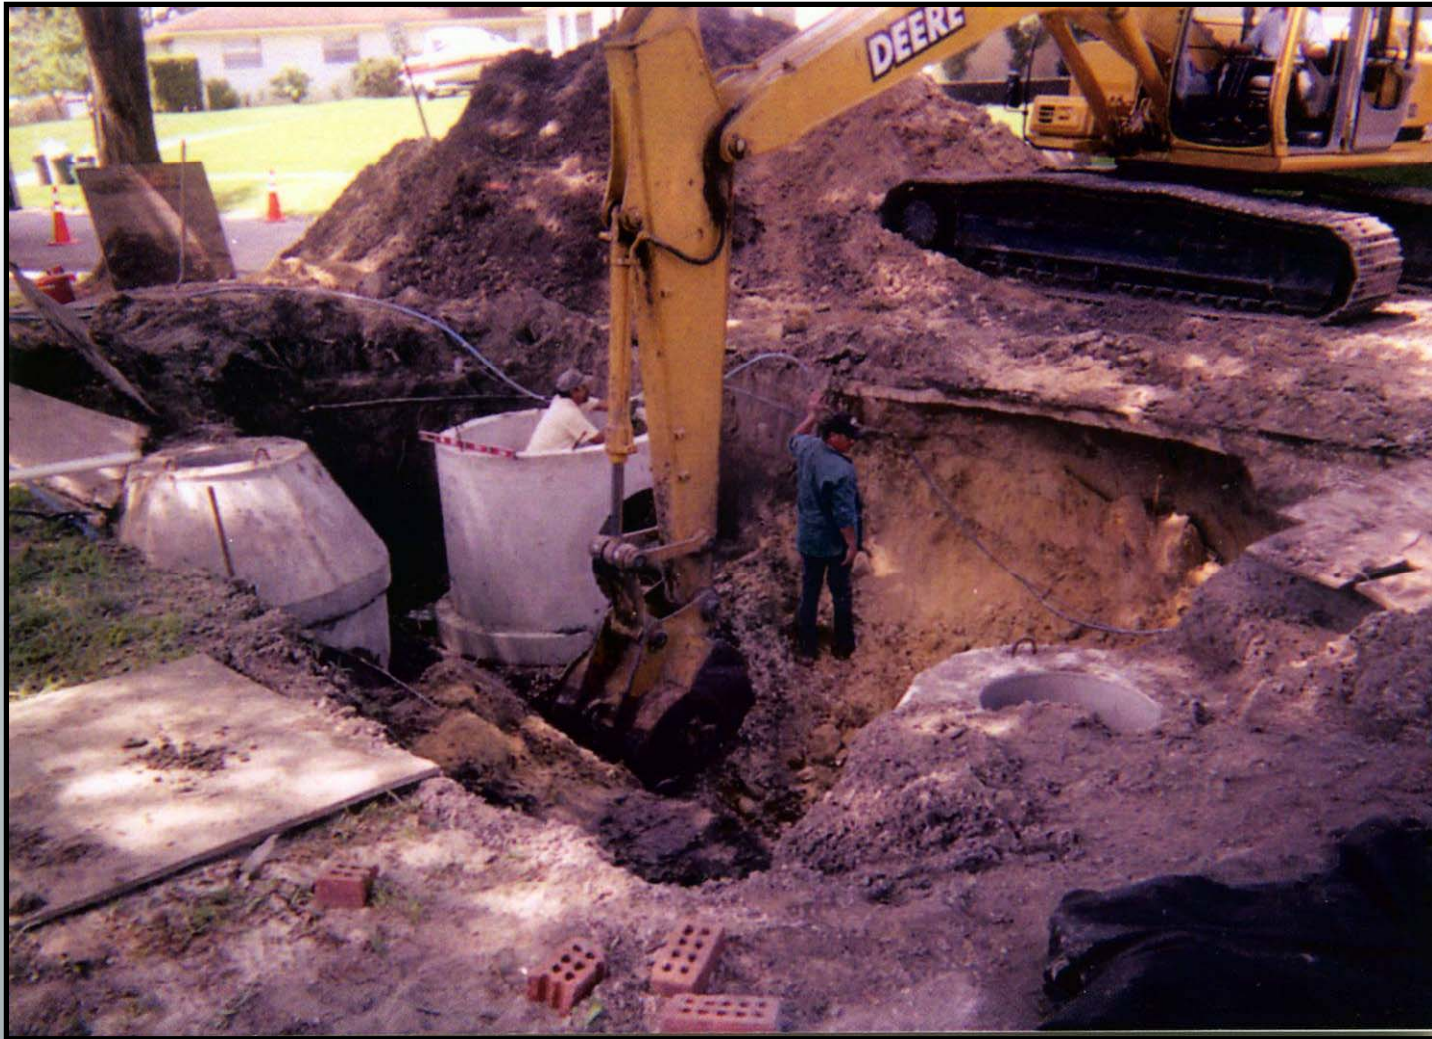
Photos of installation

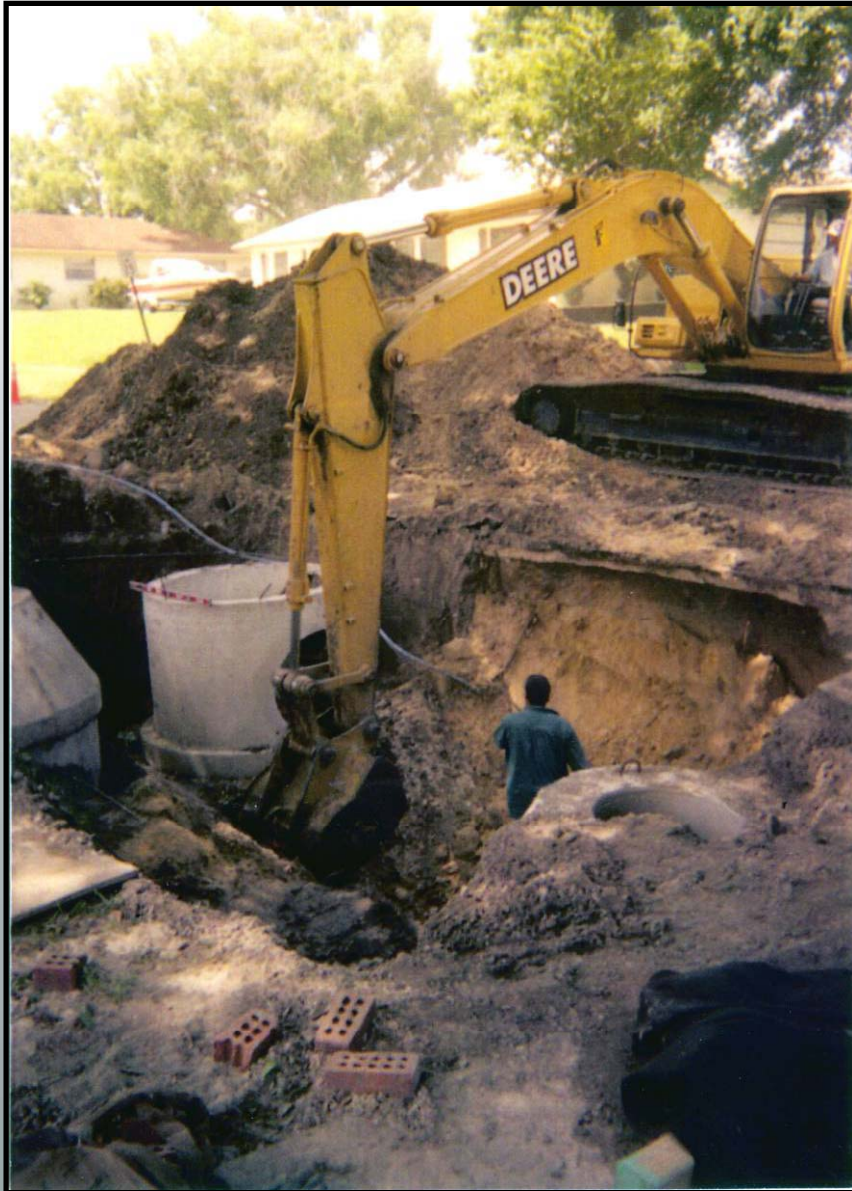
Photos of installation

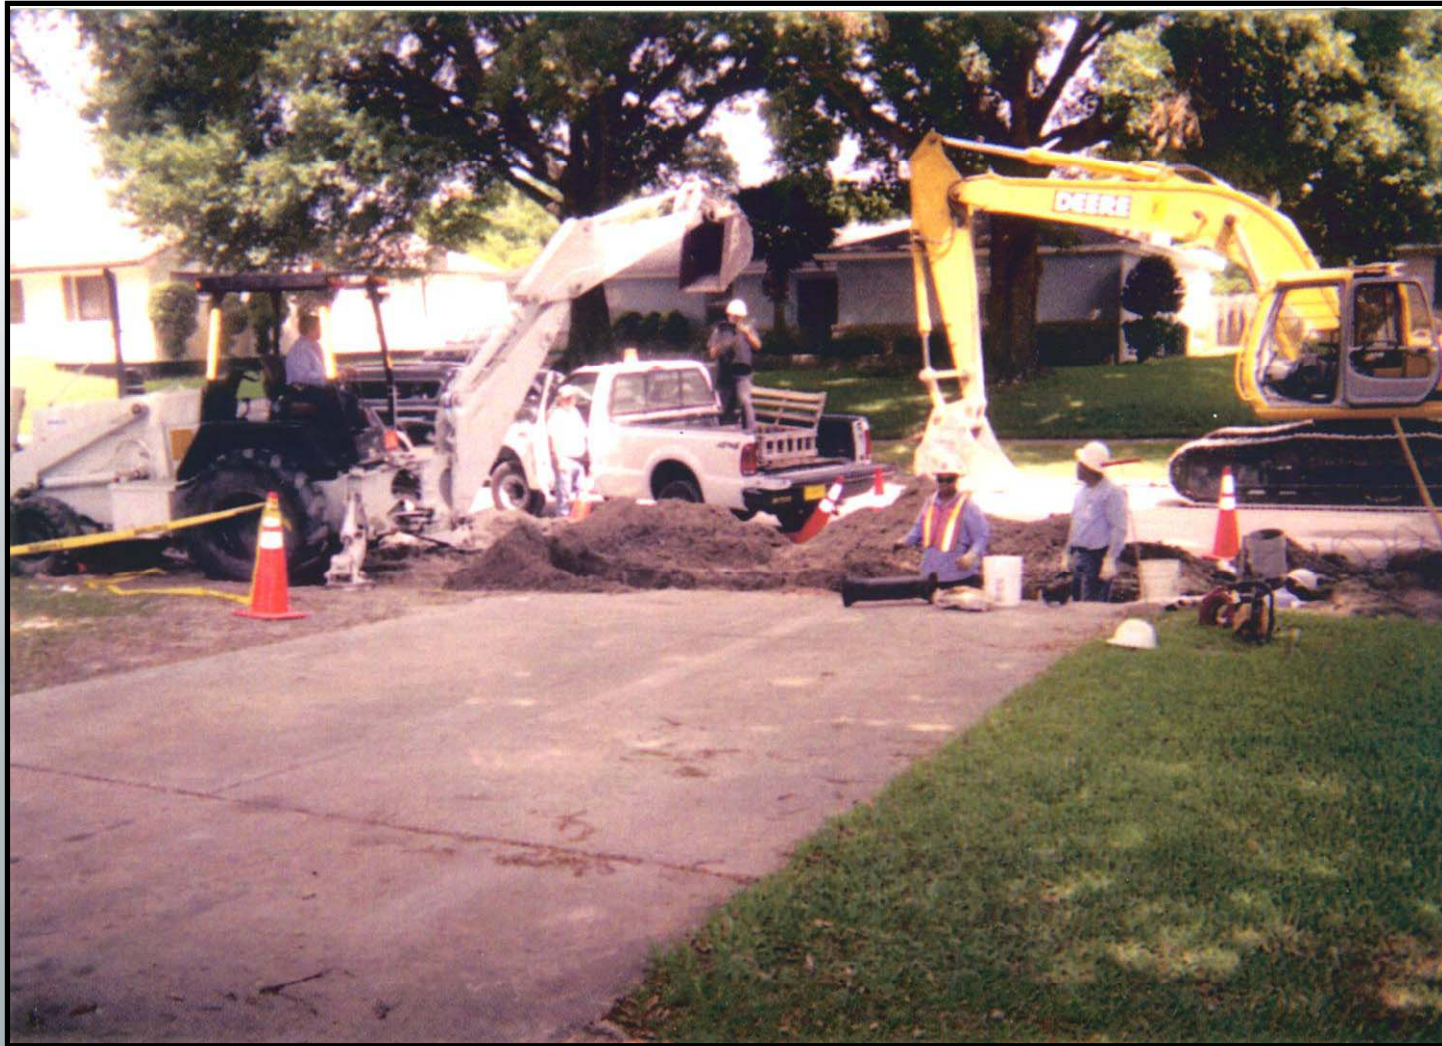
Photos of installation

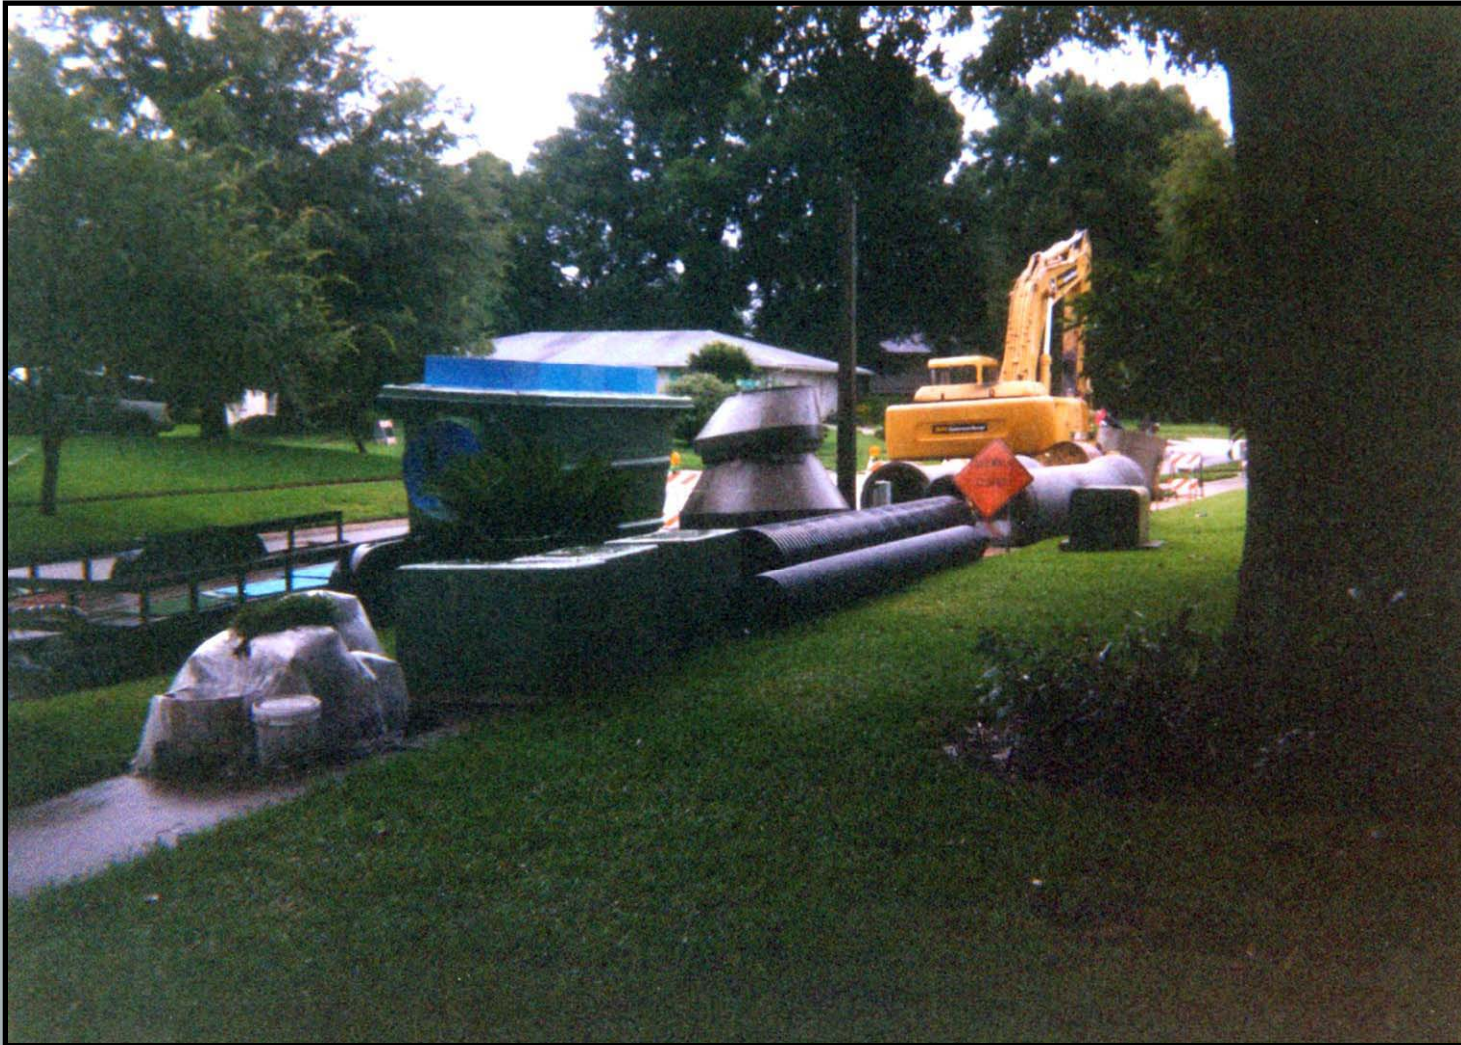
Photos of installation

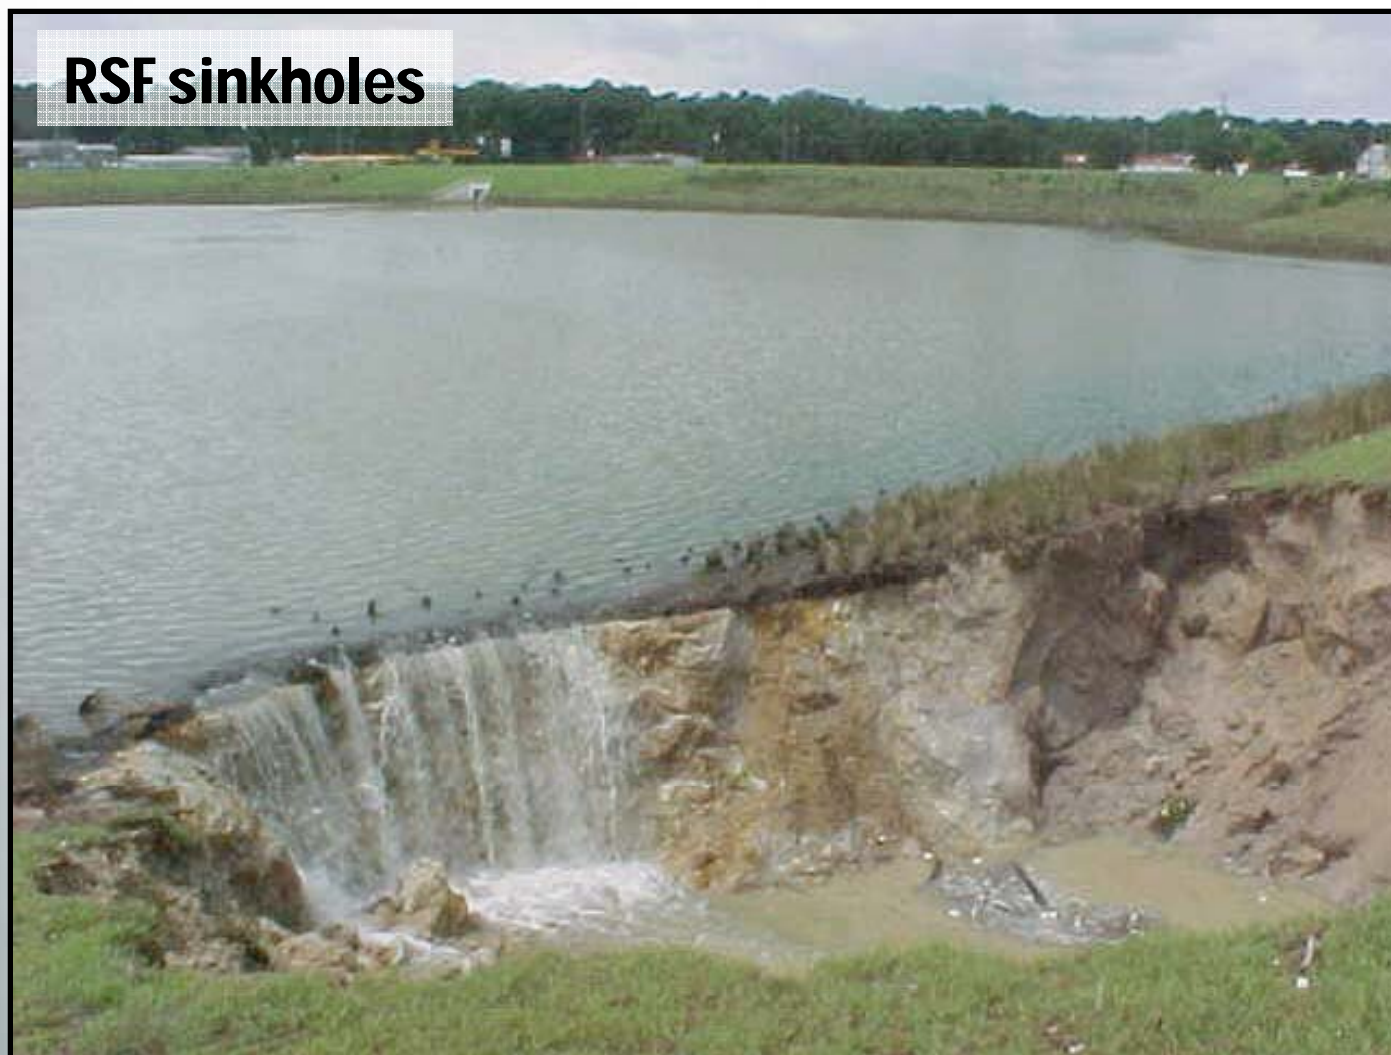
2007 ADS Stormwater Workshop

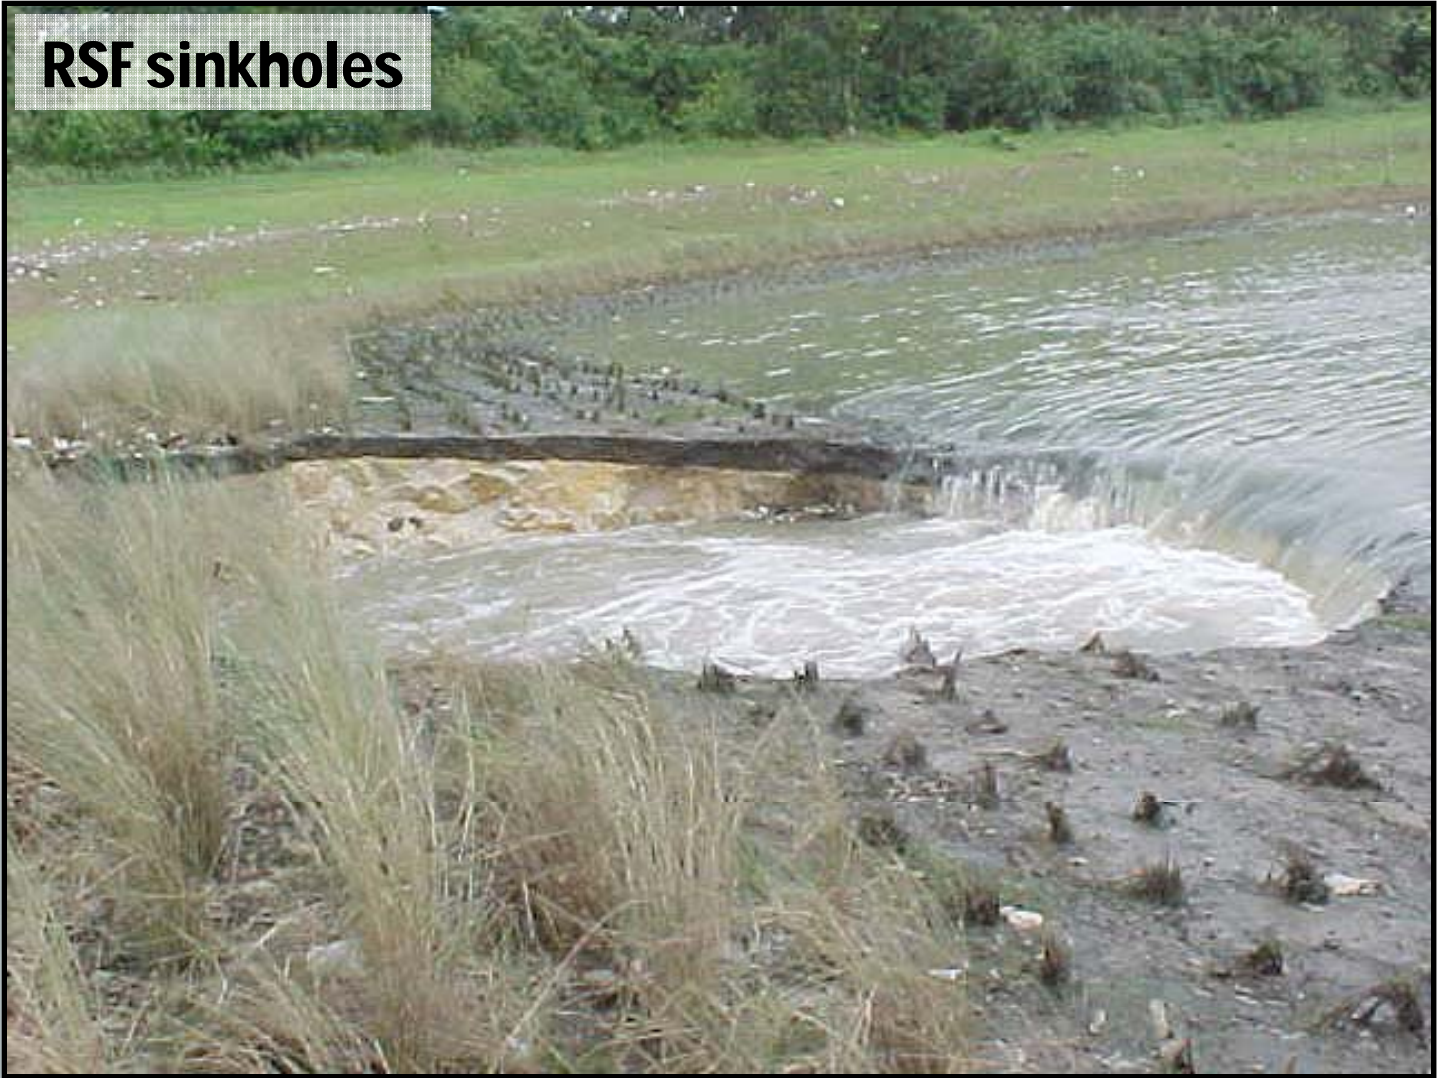
2007 ADS Stormwater Workshop

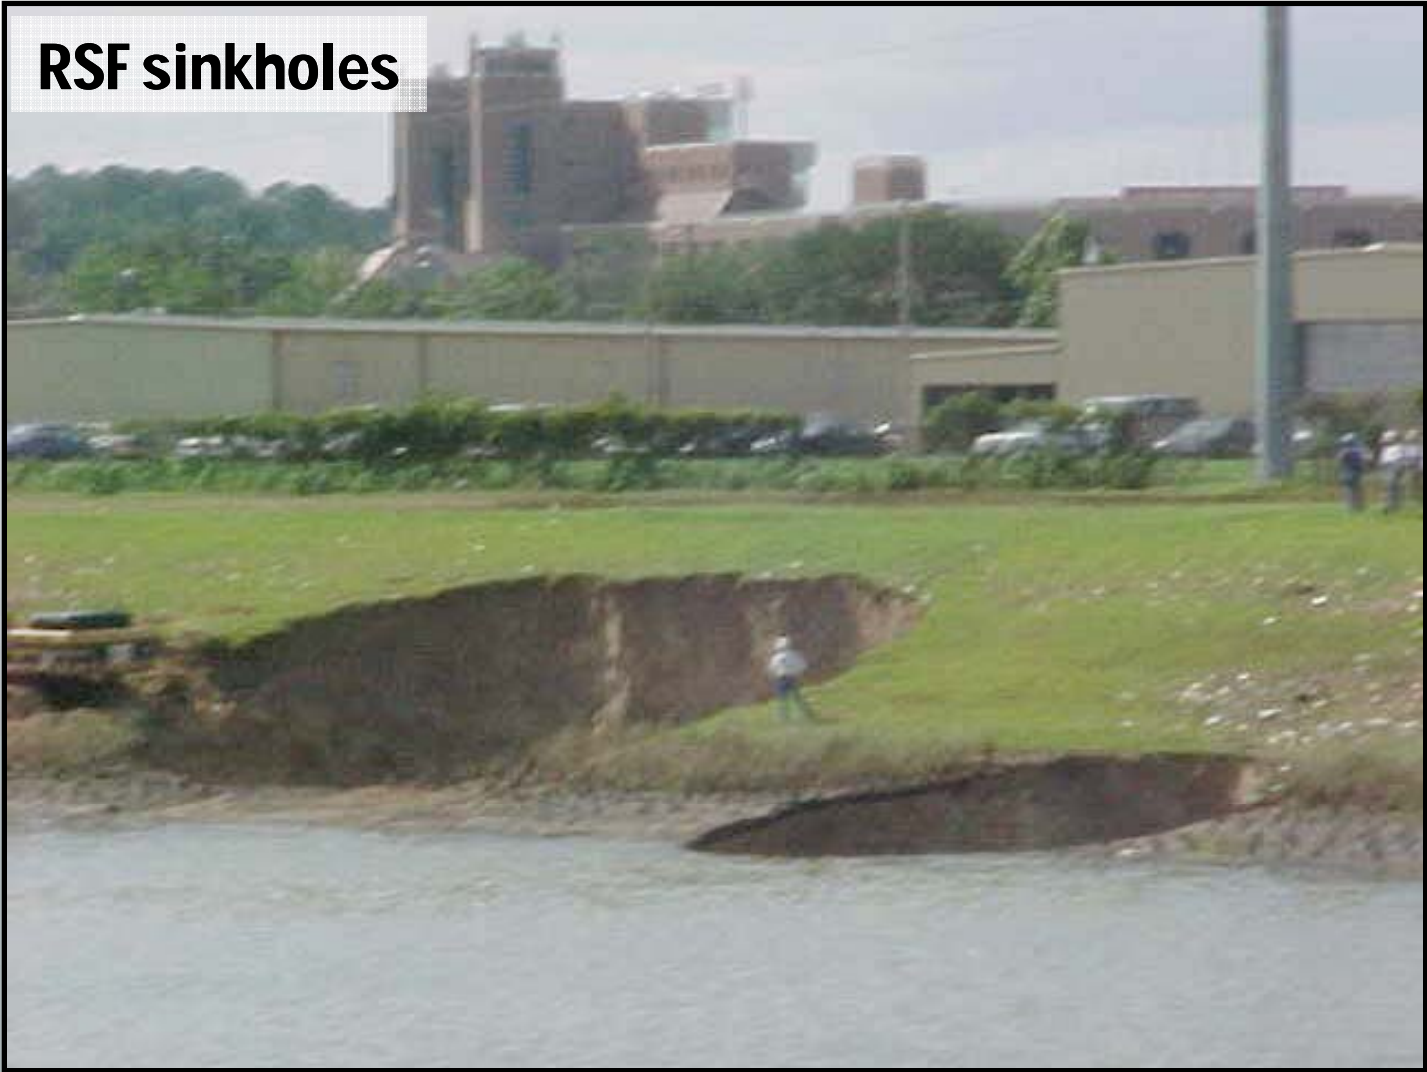
2007 ADS Stormwater Workshop
