2007 ADS STORMWATER WORKSHOP

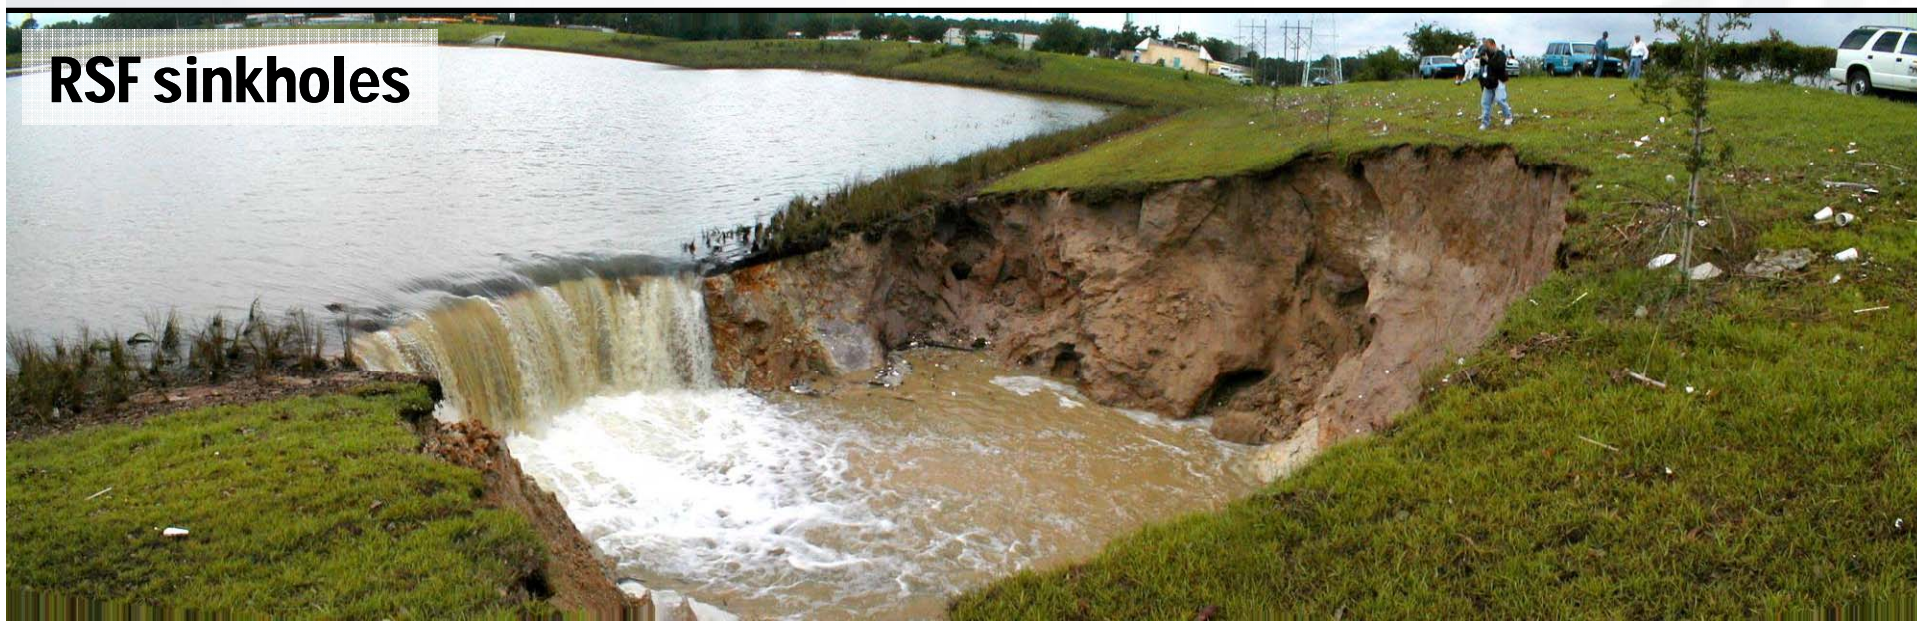
2007 ADS Stormwater Workshop

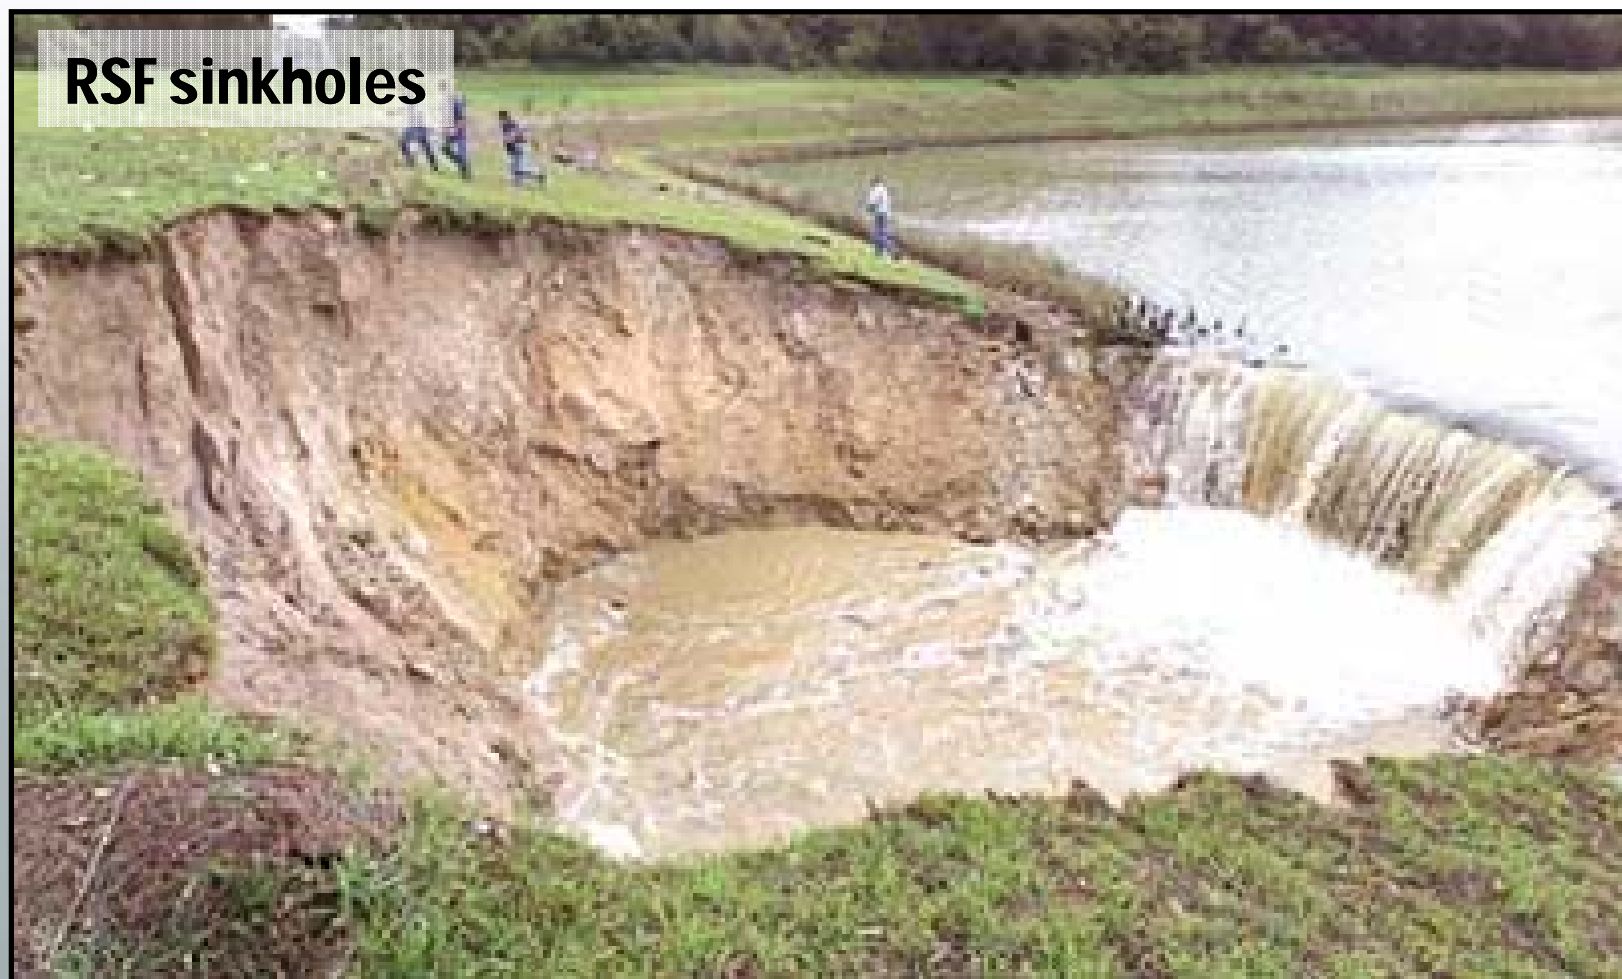
2007 ADS Stormwater Workshop

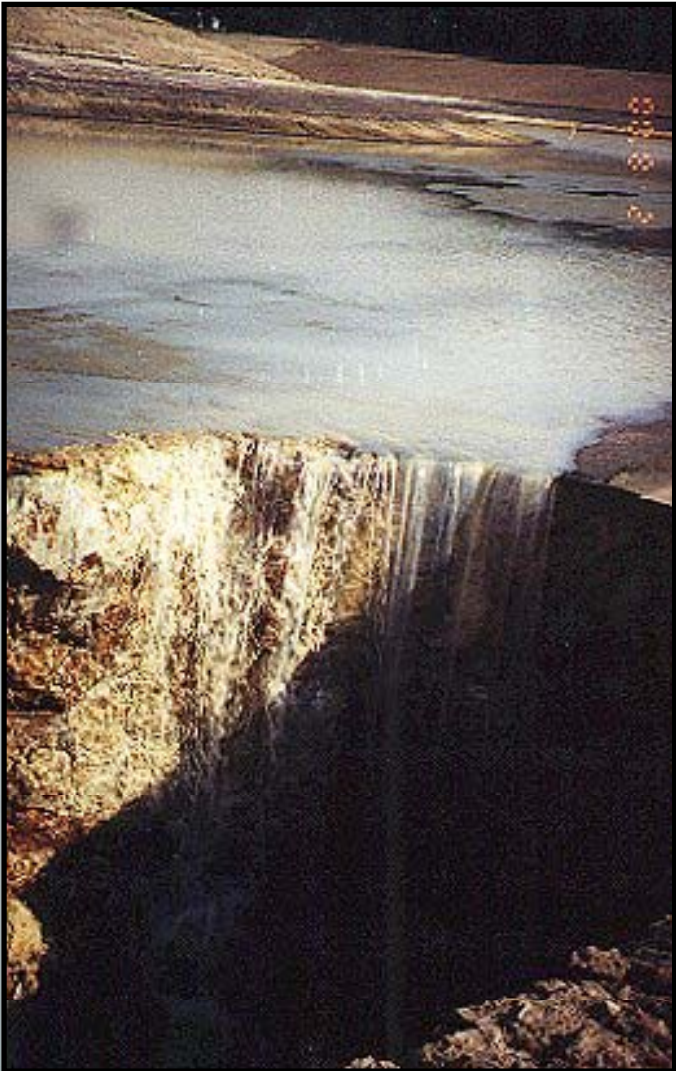
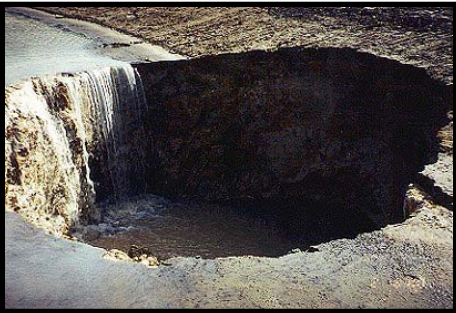
2007 ADS Stormwater Workshop

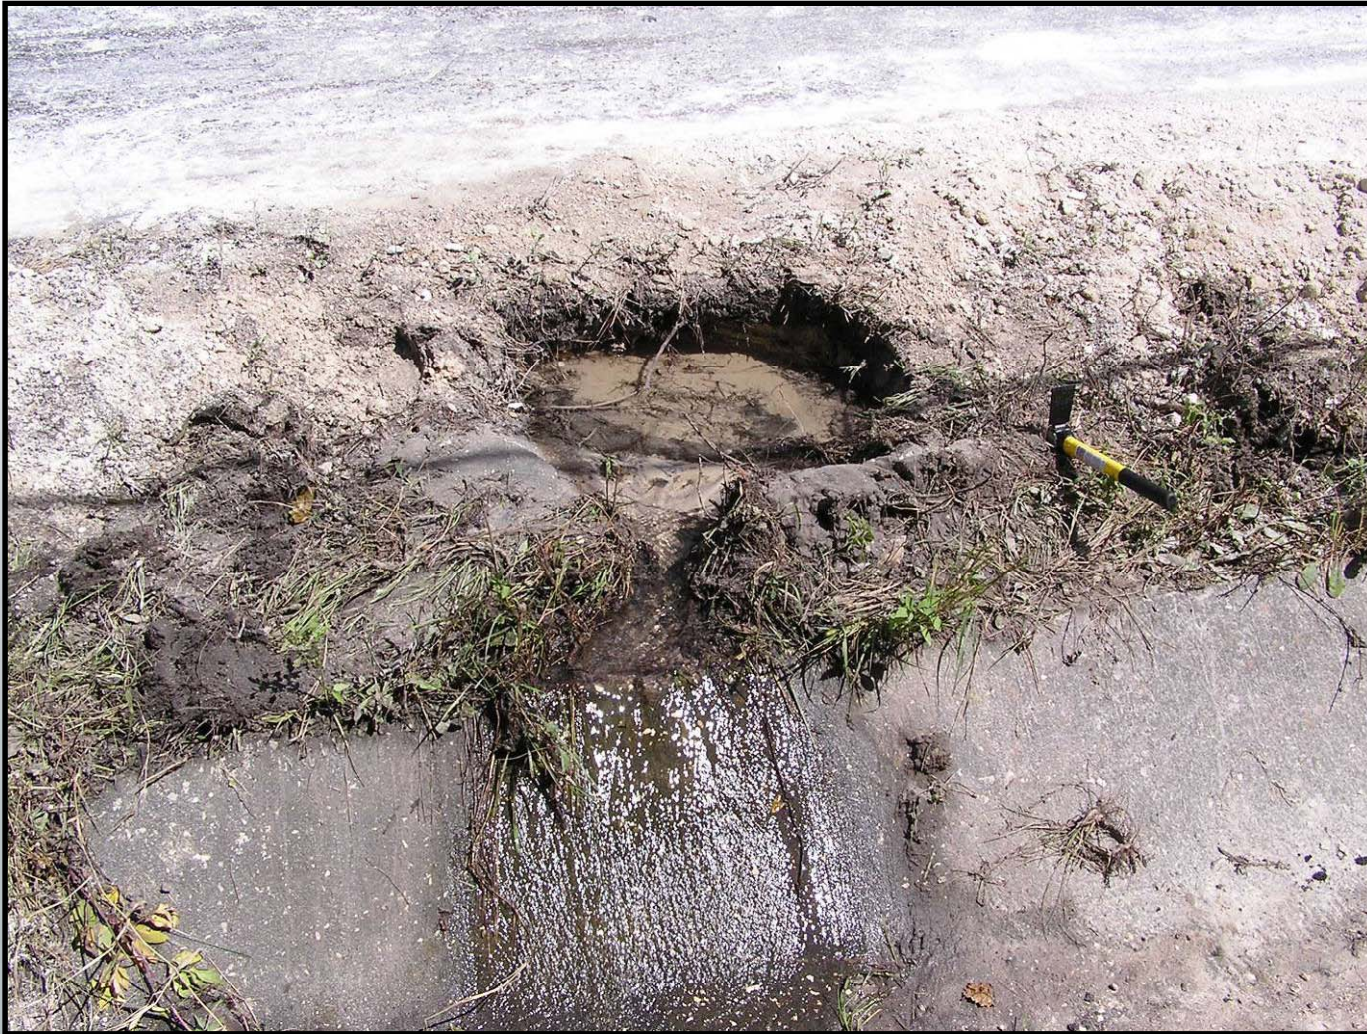
Seepage from Wolf Branch Road Subgrade, Just South of Cumulative Drainage Confluence Point

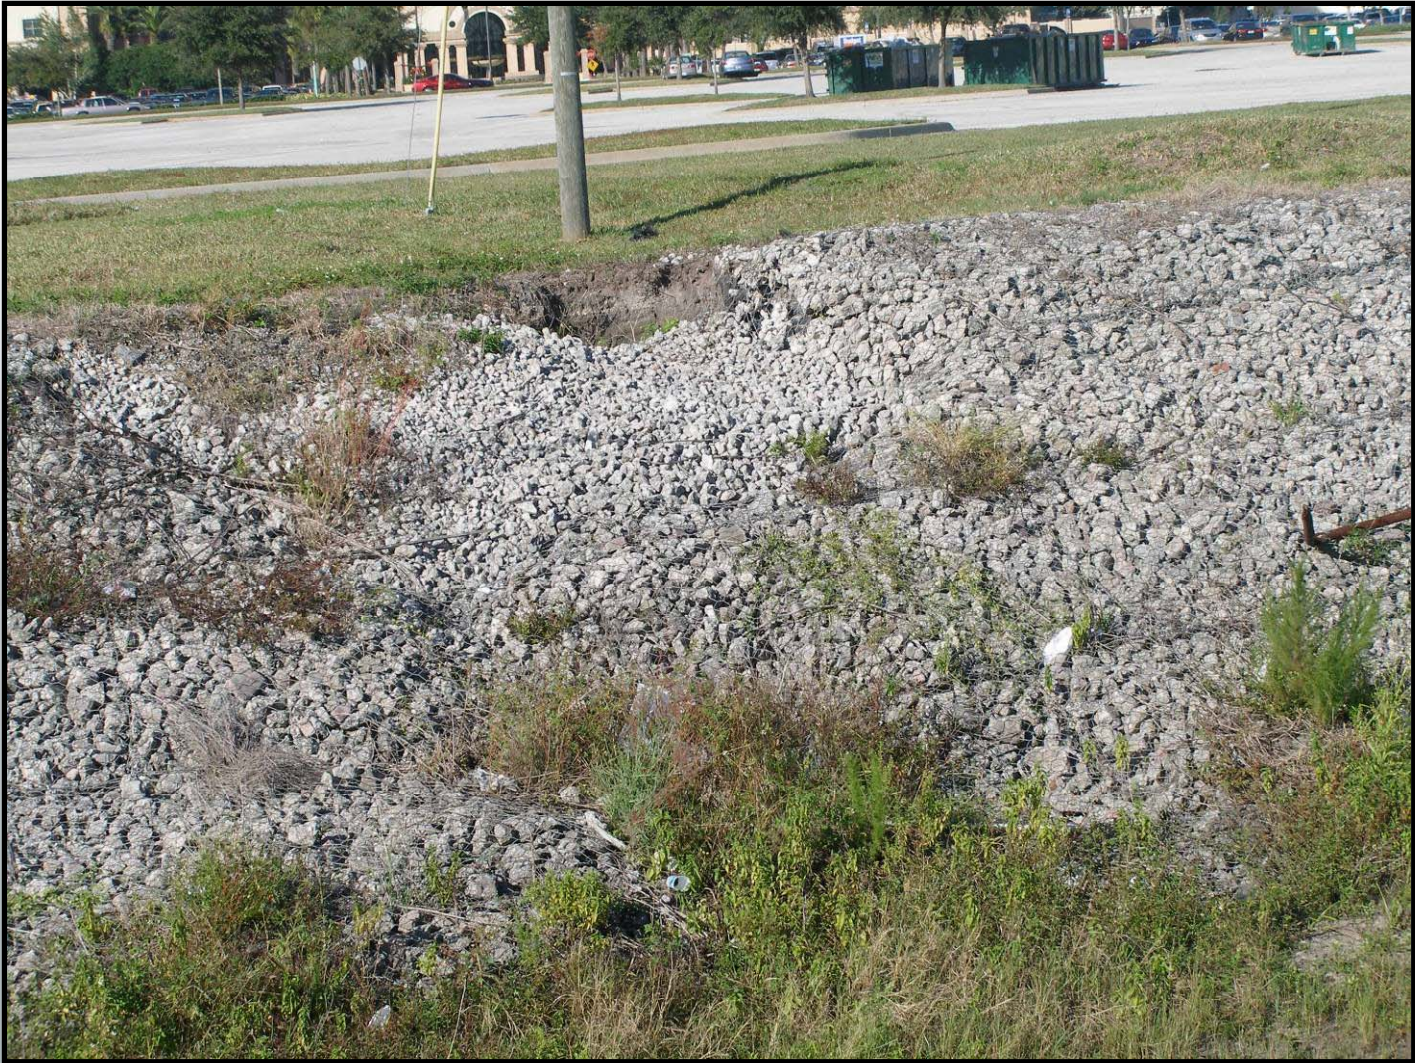
No anchorage of reno mattress on steep slope

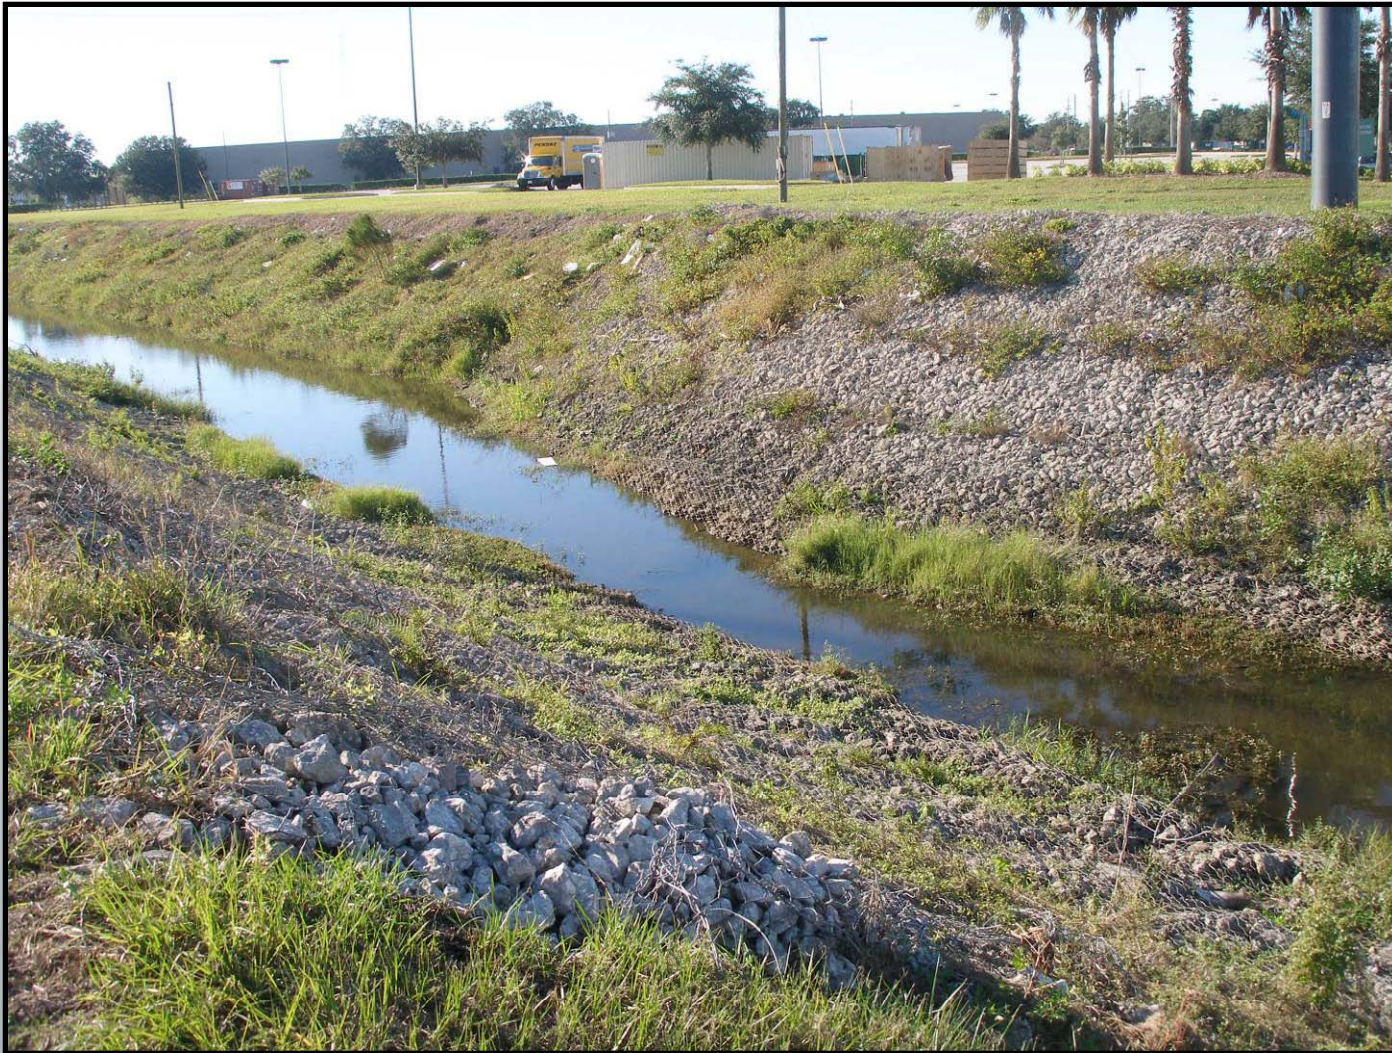
Slippage of reno mattress due to lack of anchorage on steep slope

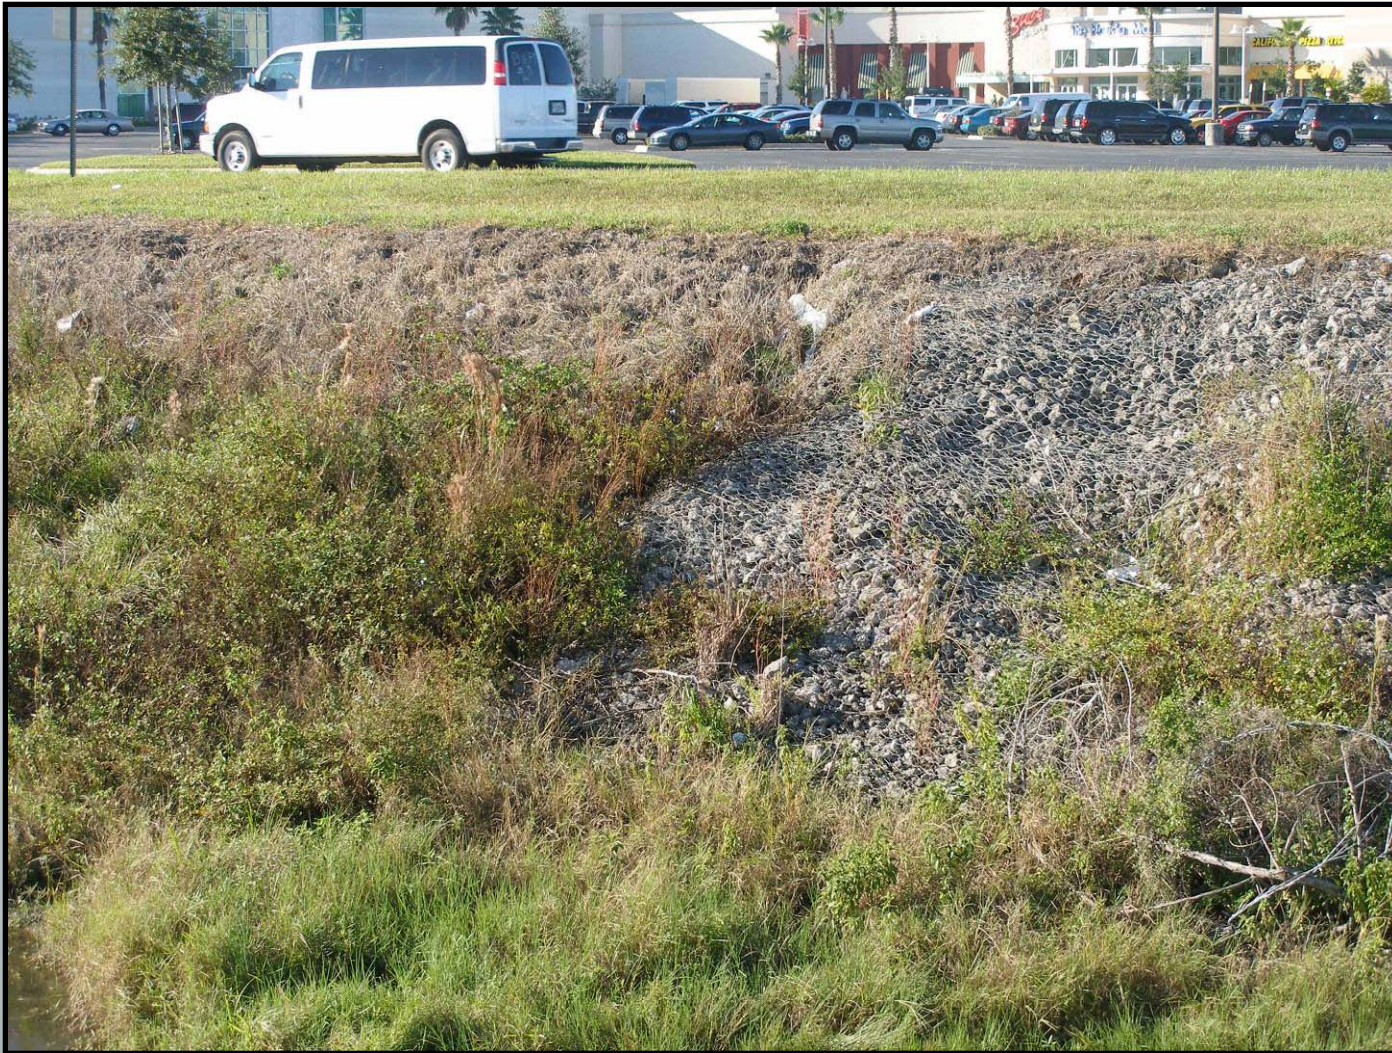
Slippage of reno mattress due to lack of anchorage on steep slope

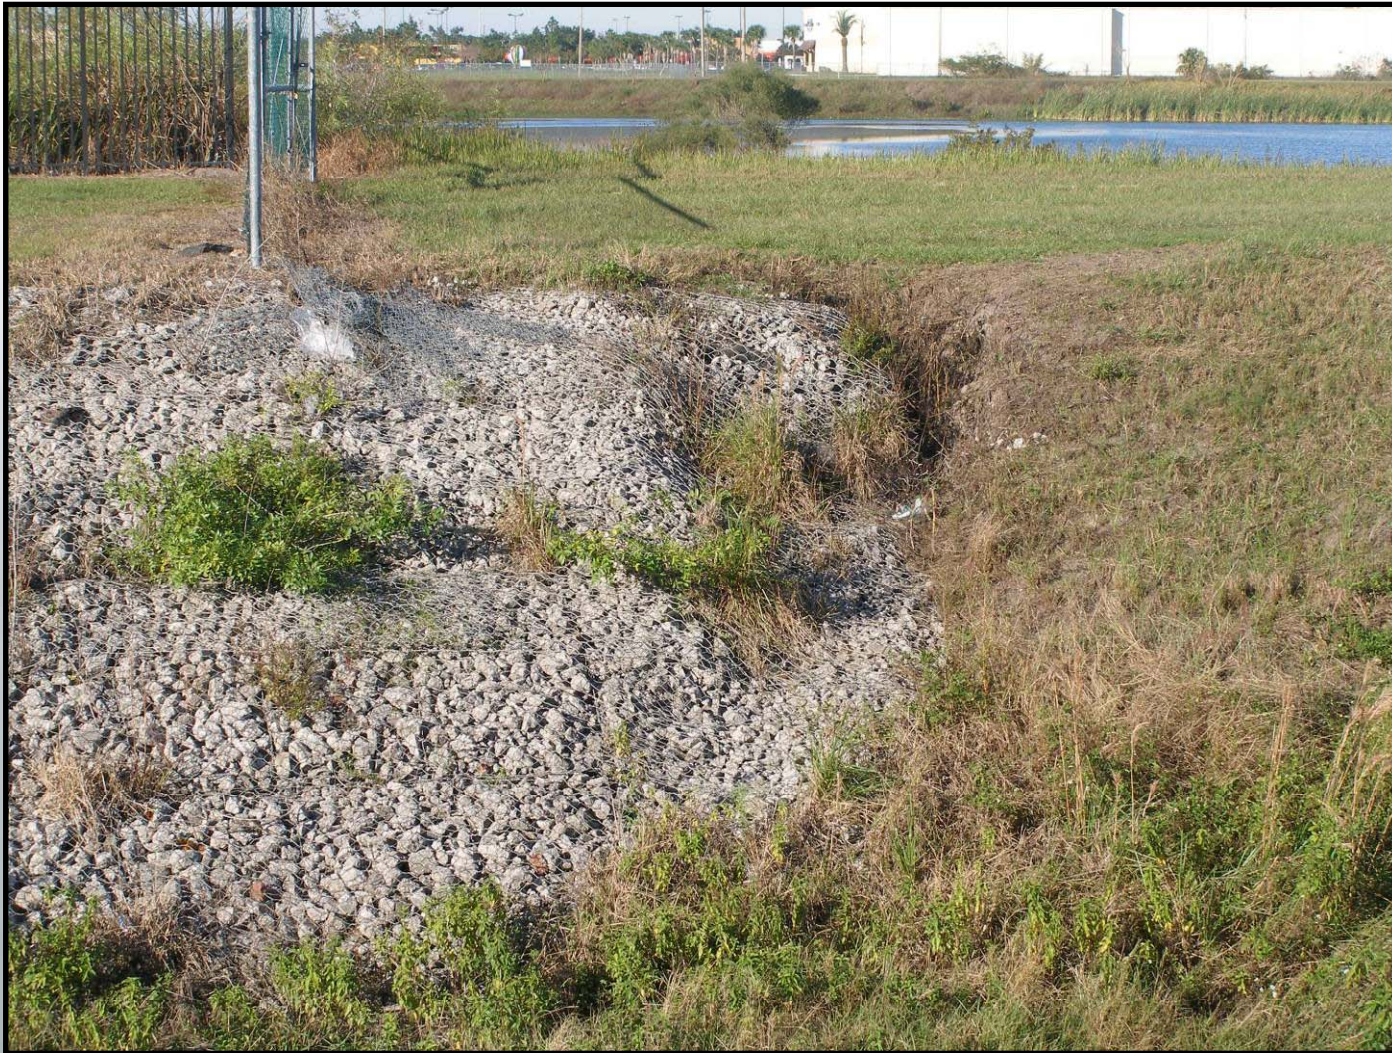
Slippage of reno mattress due to lack of anchorage on steep slope

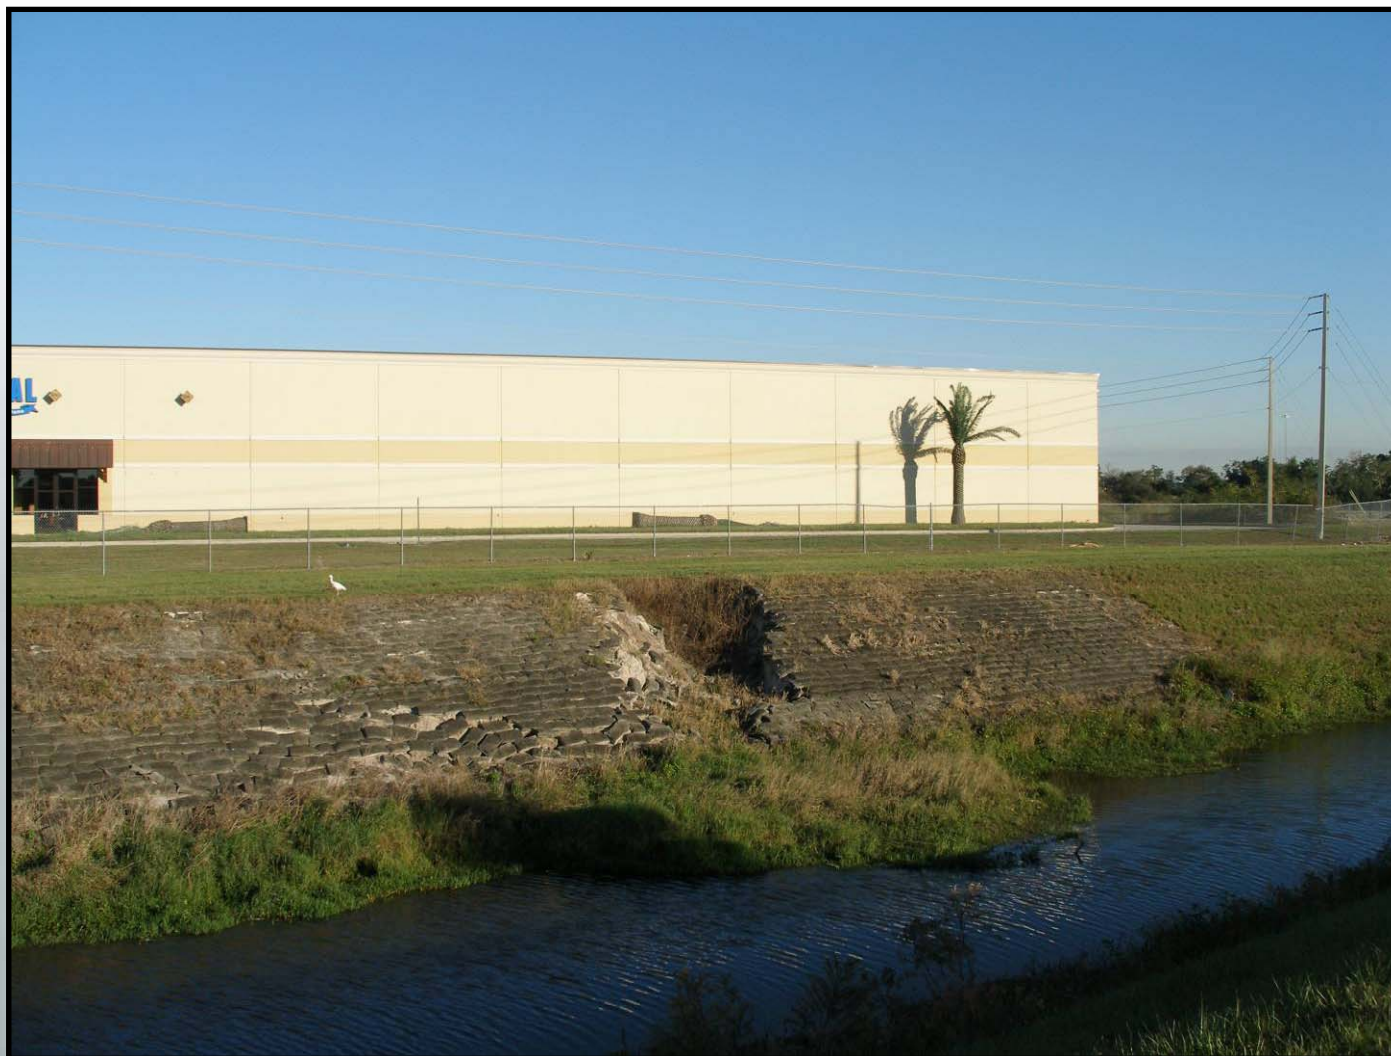
Slope erosion due to runoff

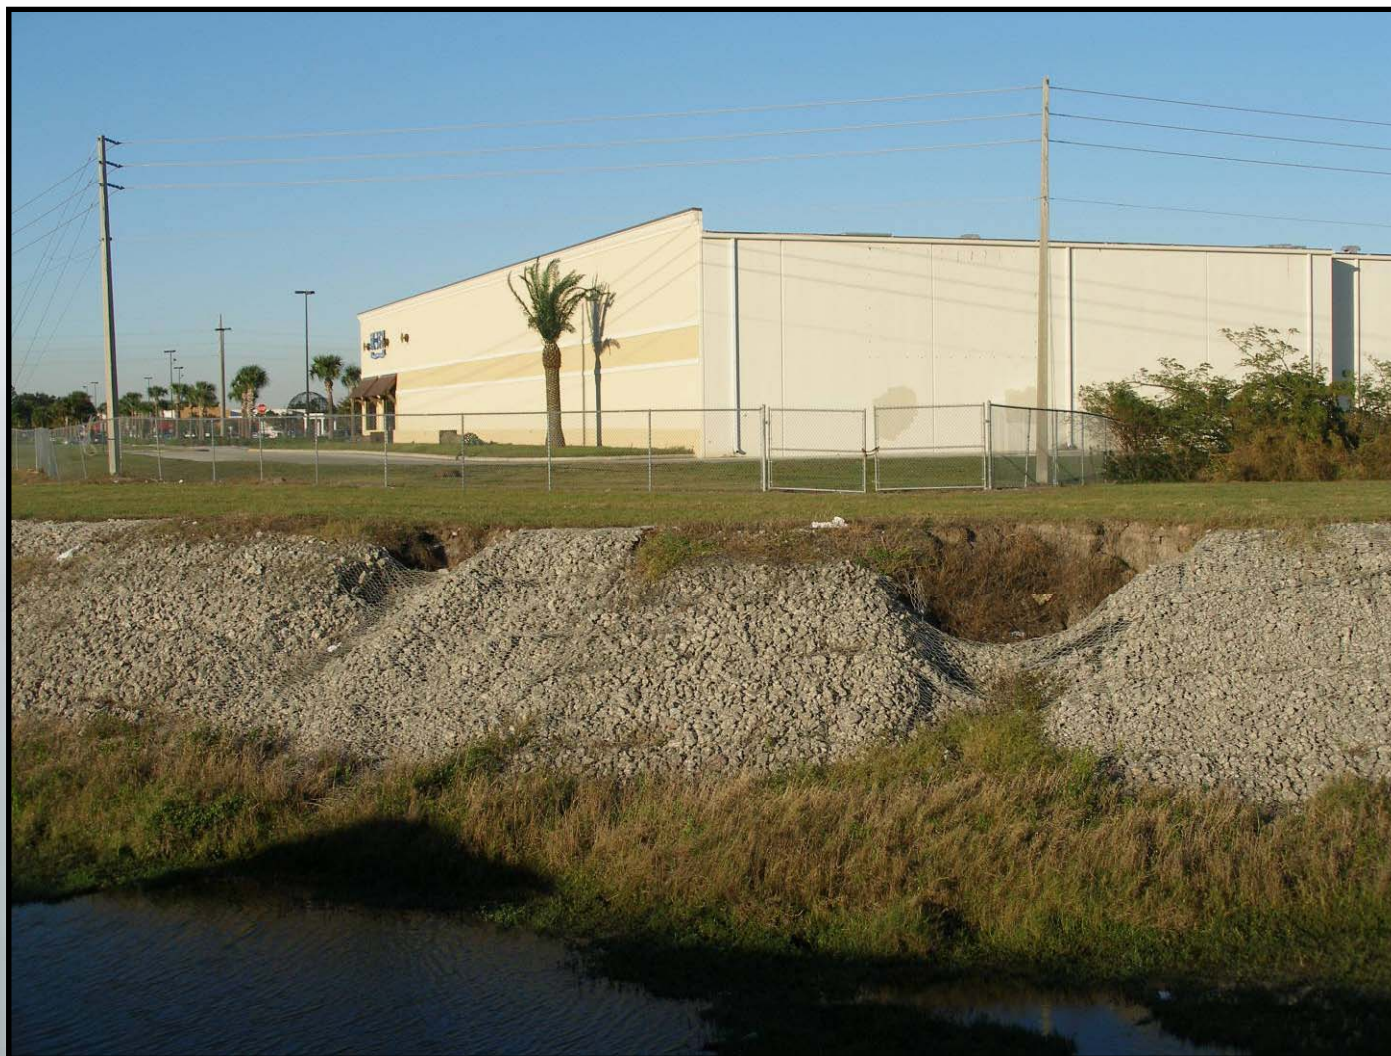
Movement of reno mattress on steep canal slope

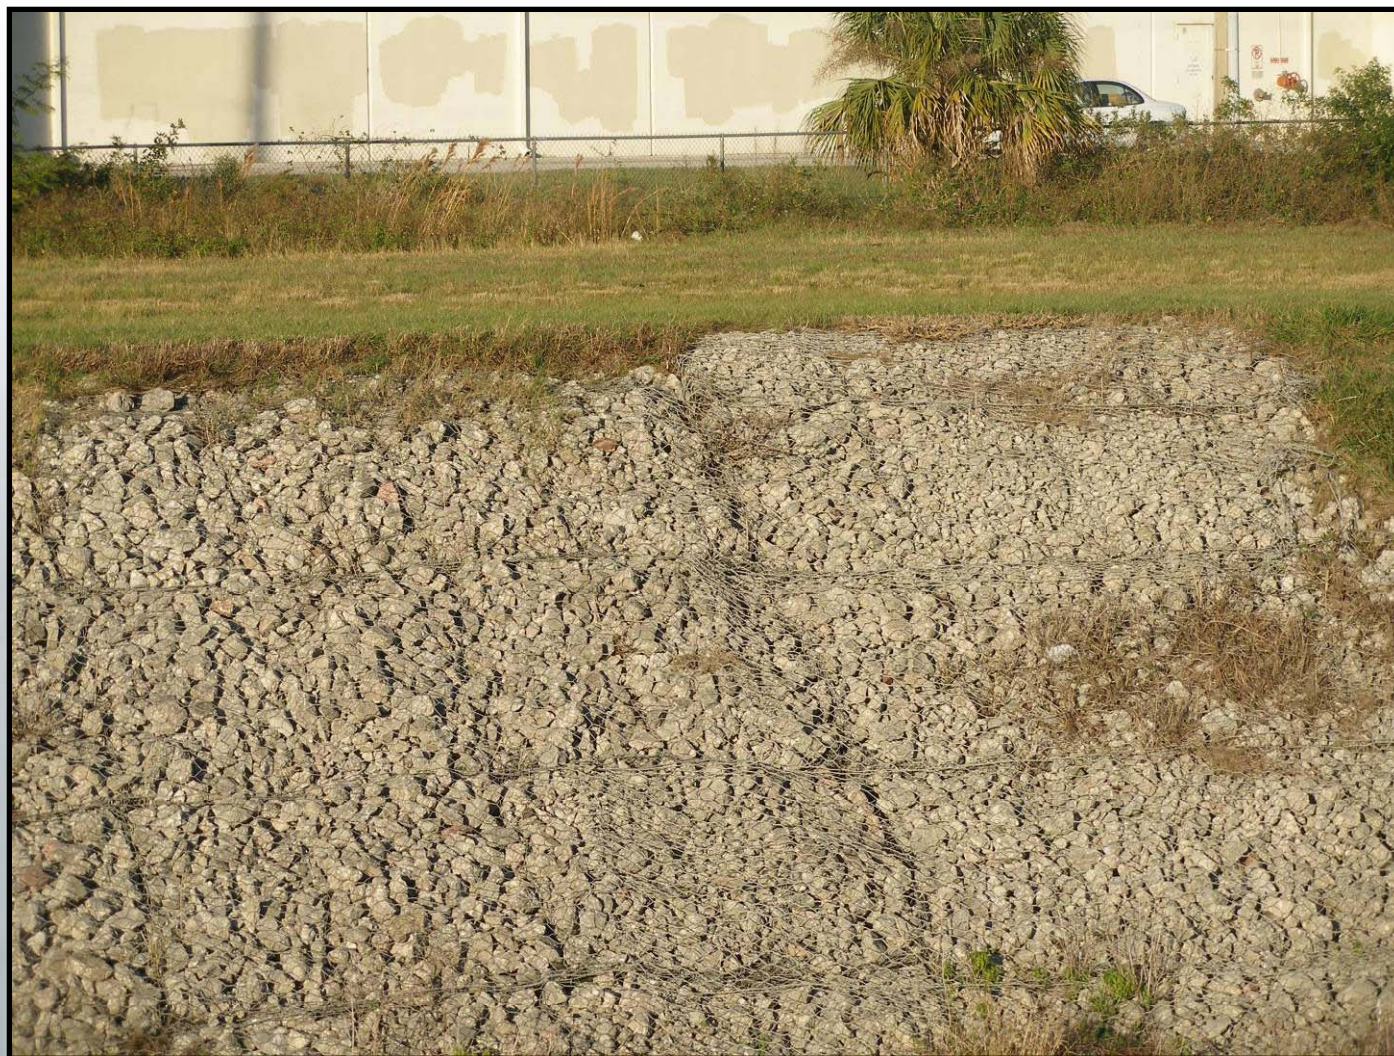
Slipping of reno mattress on steep canal slope

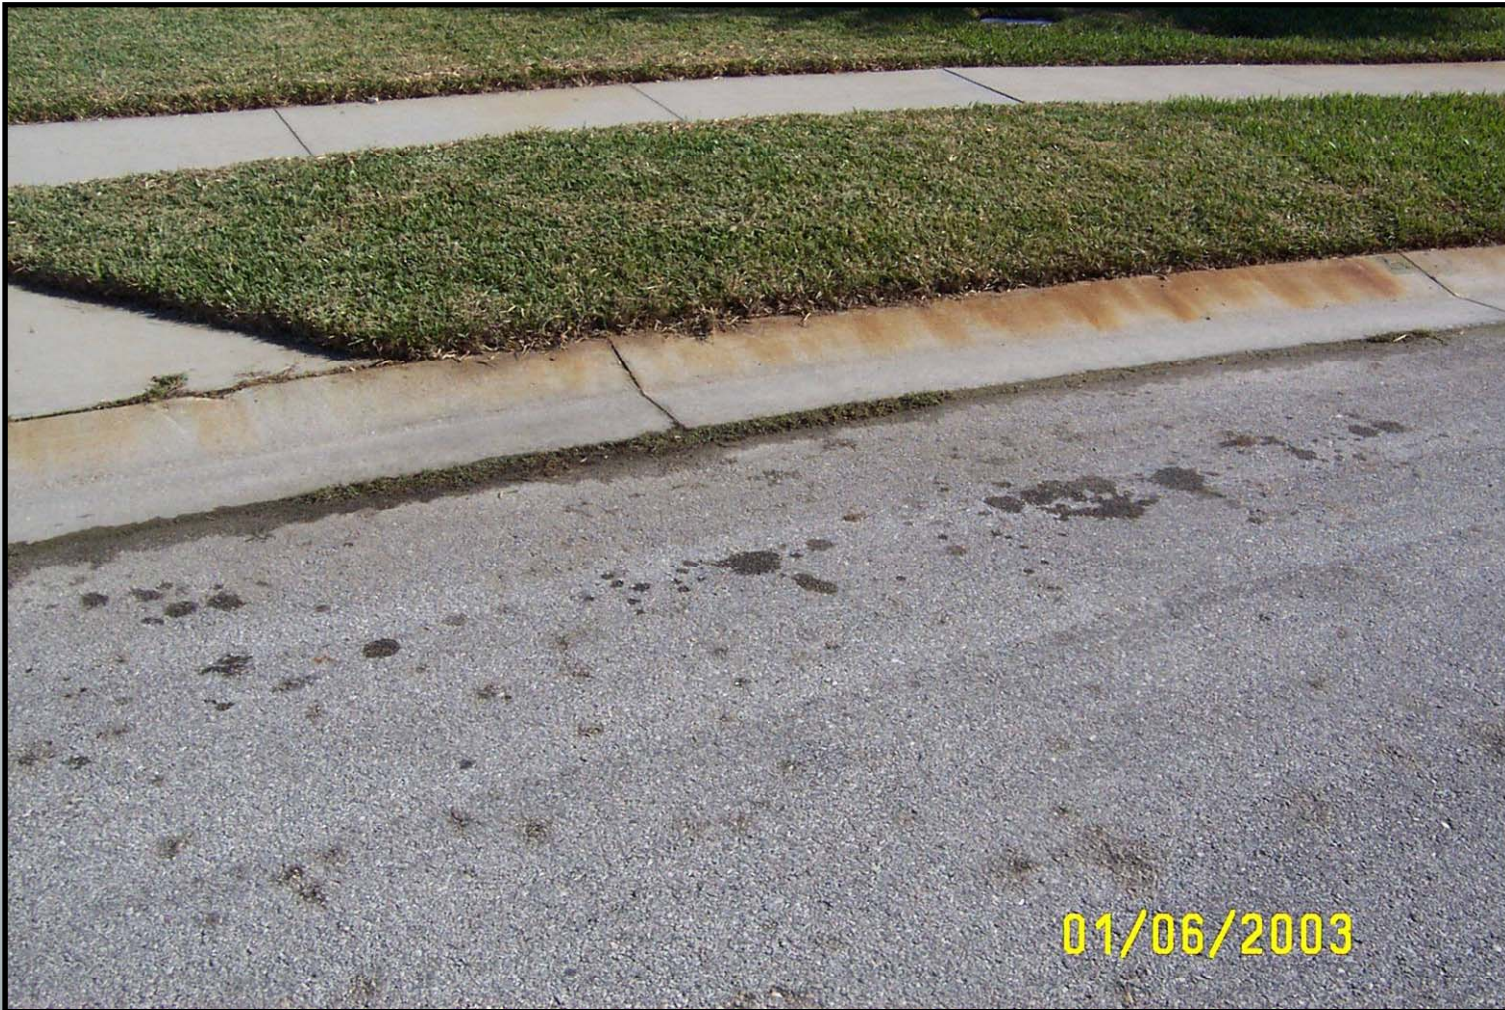
2007 ADS Stormwater Workshop

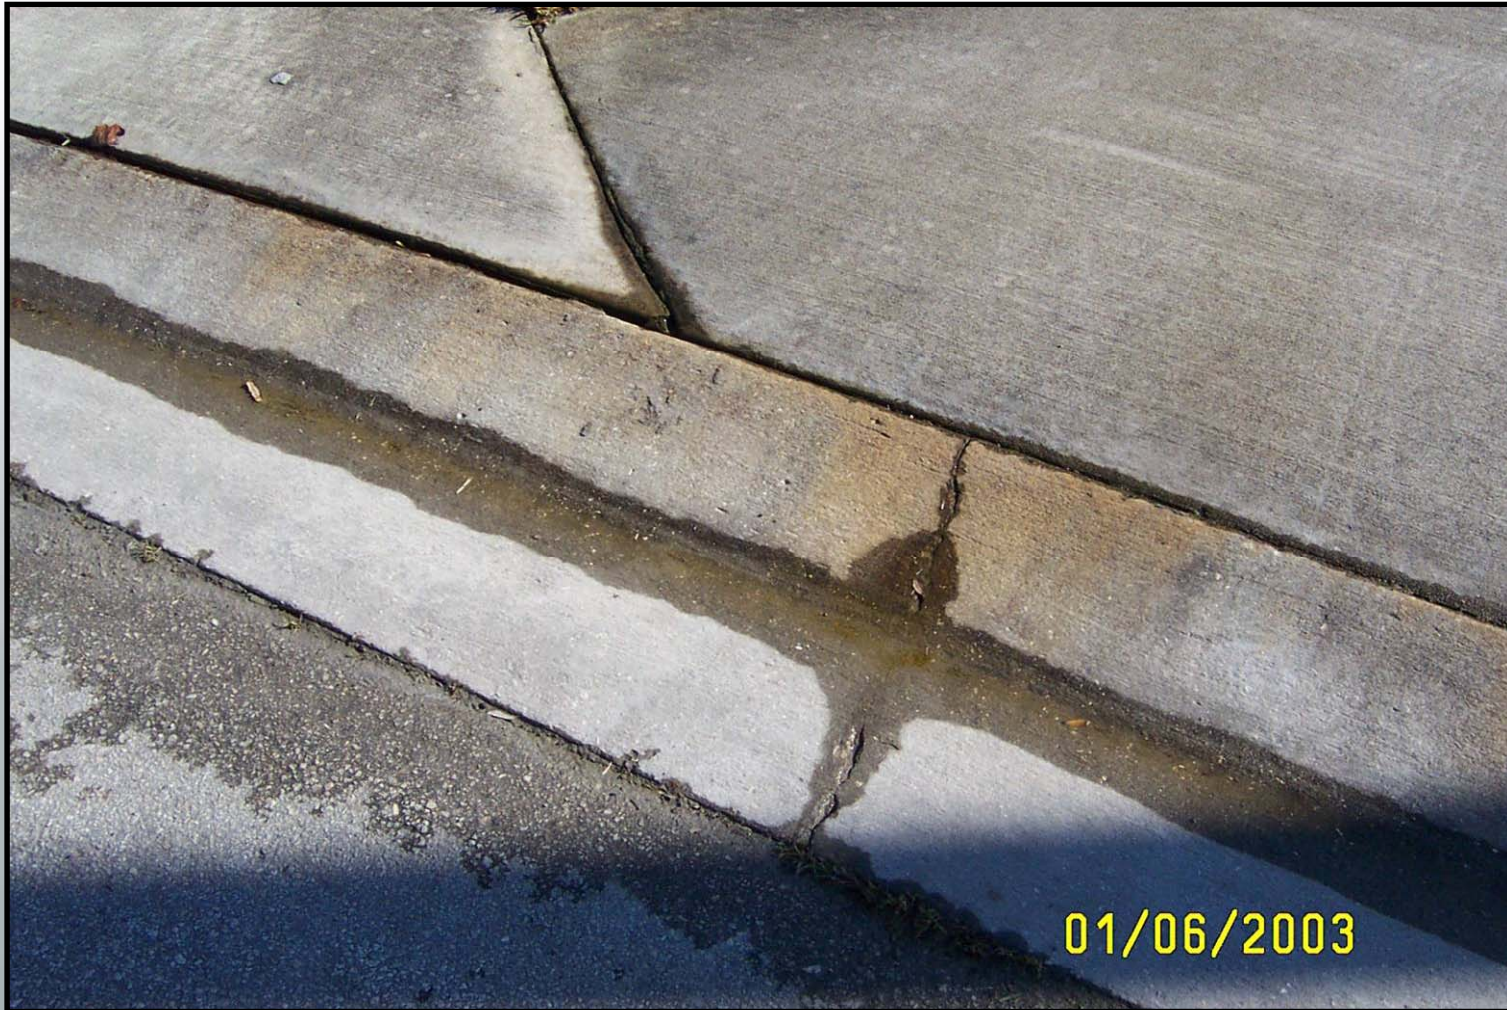
2007 ADS Stormwater Workshop

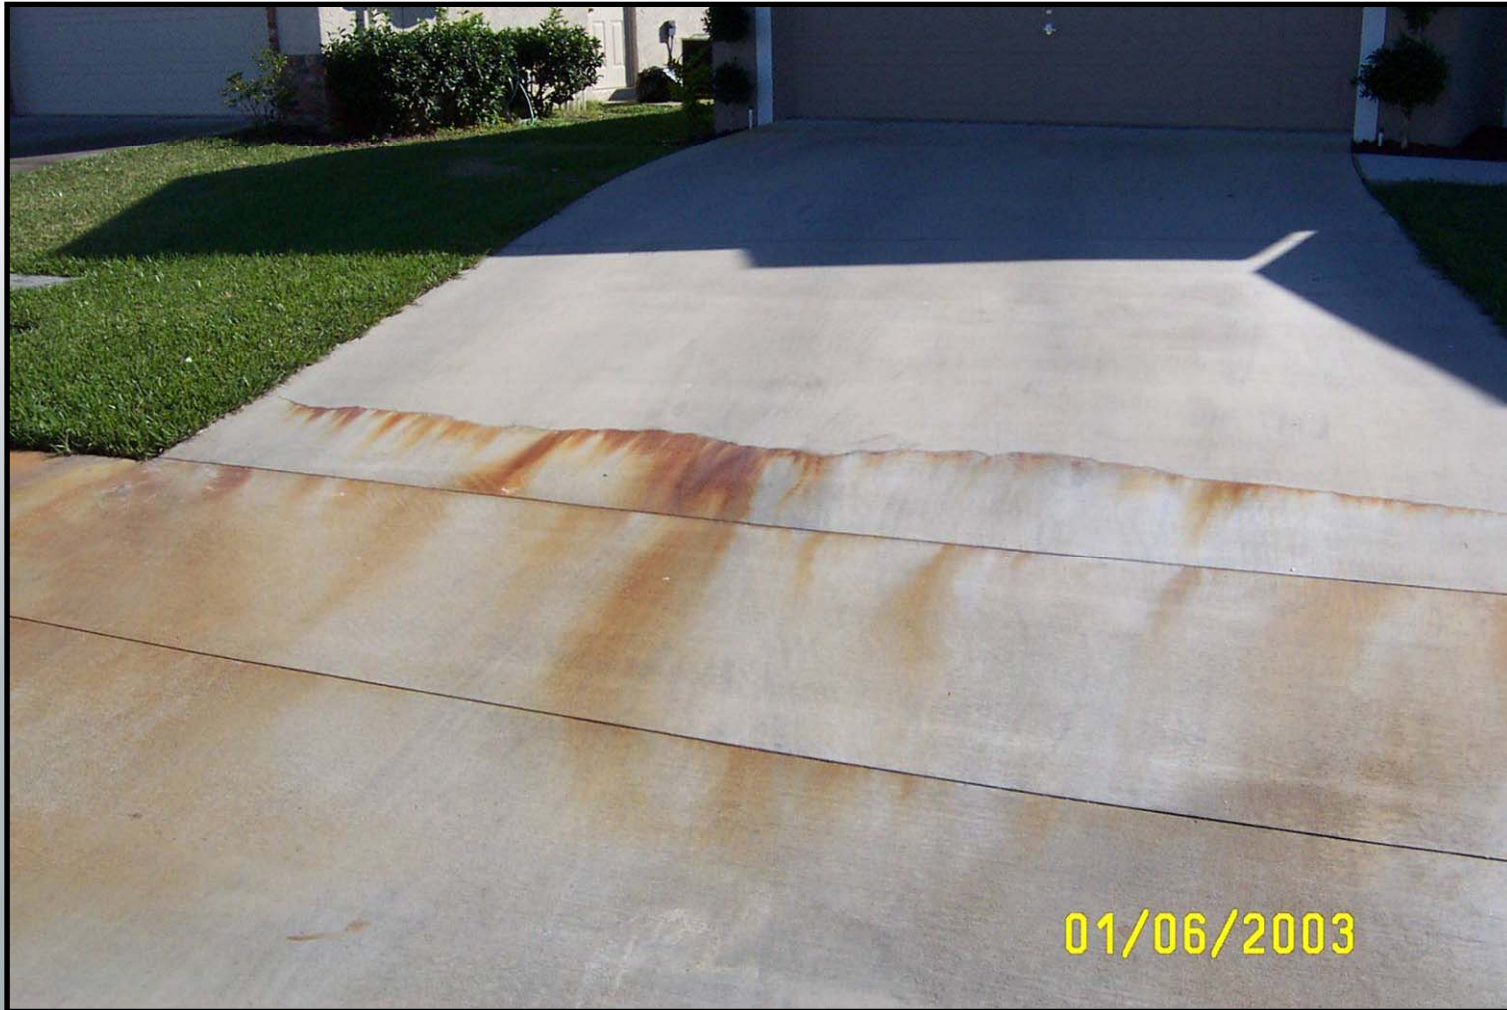
2007 ADS Stormwater Workshop

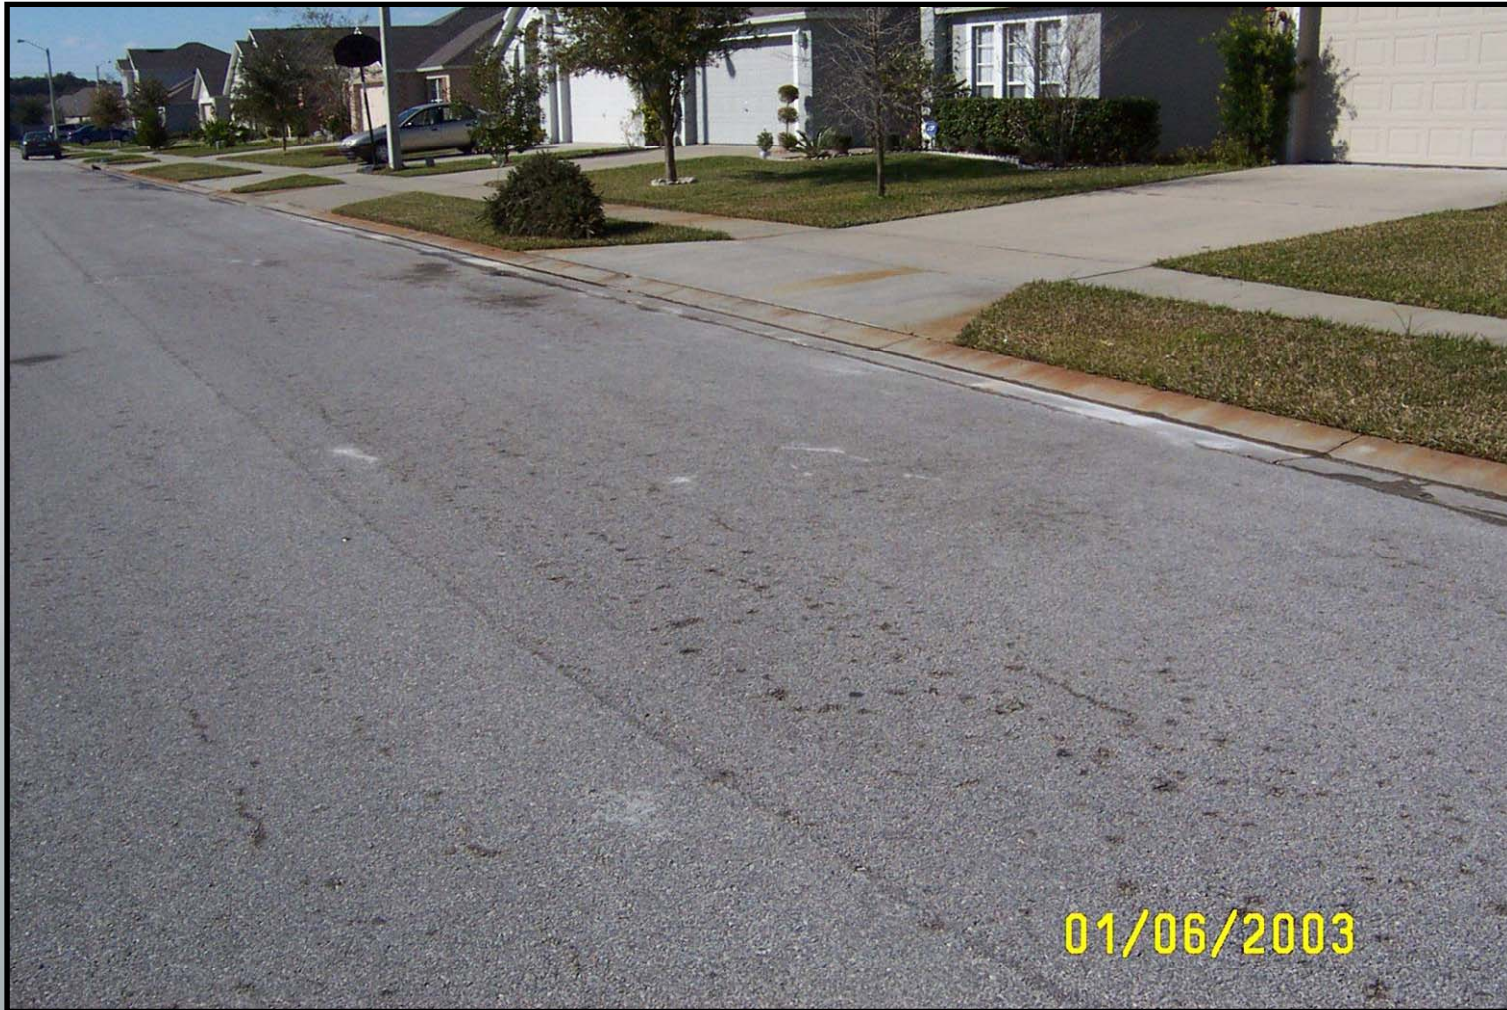
2007 ADS Stormwater Workshop

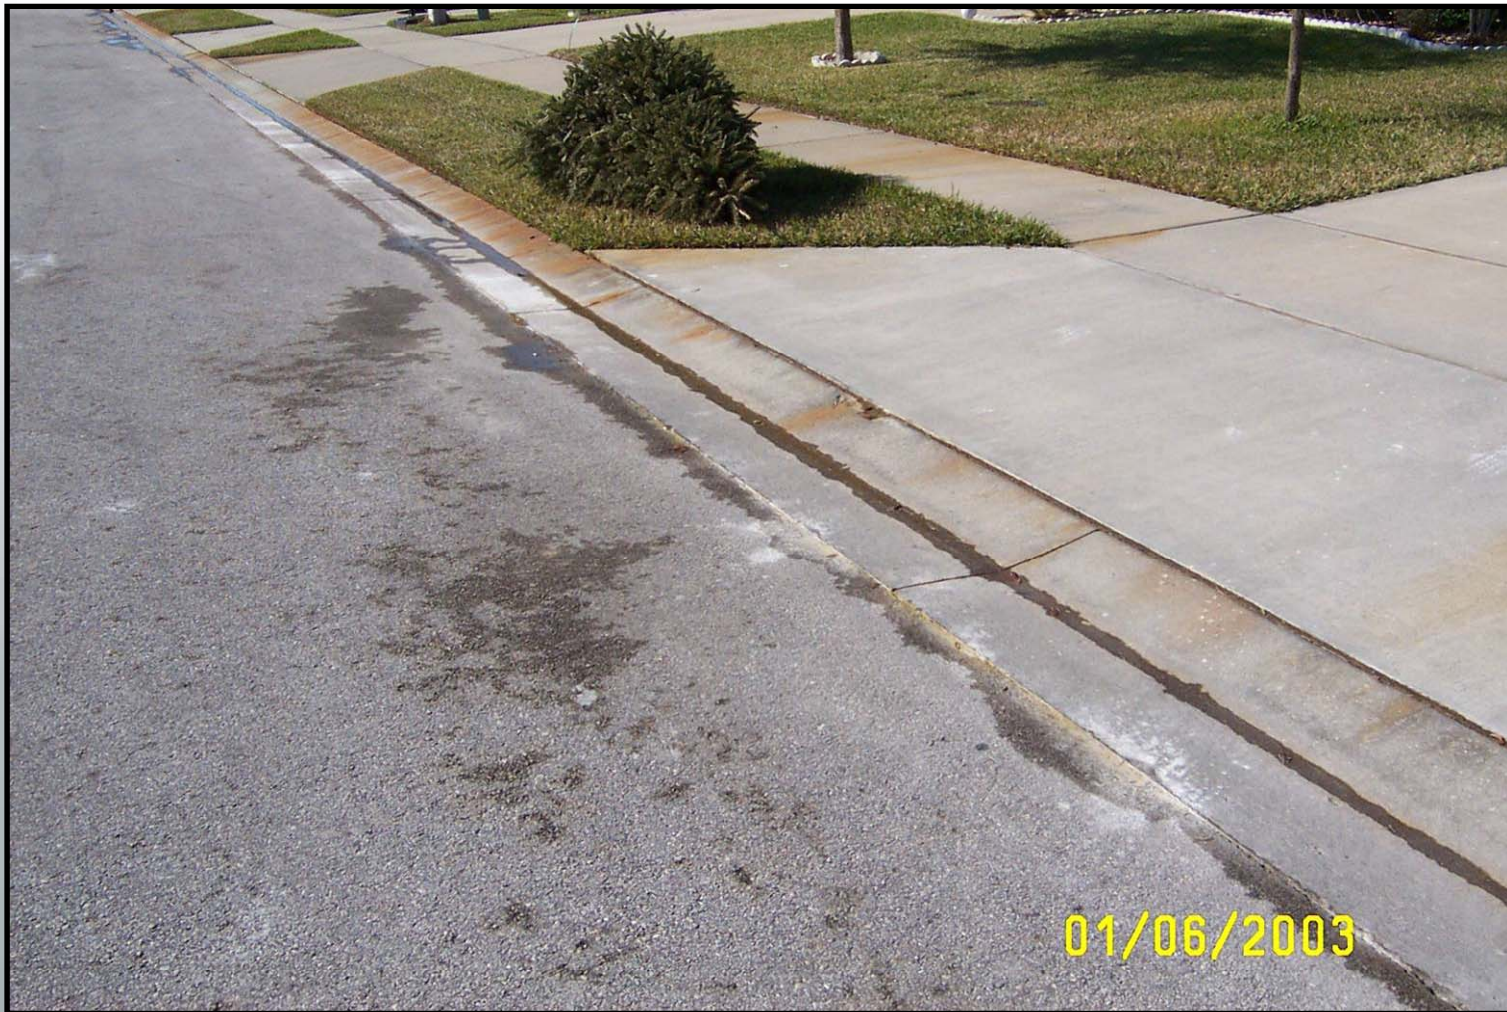
2007 ADS Stormwater Workshop
