2007 ADS STORMWATER WORKSHOP

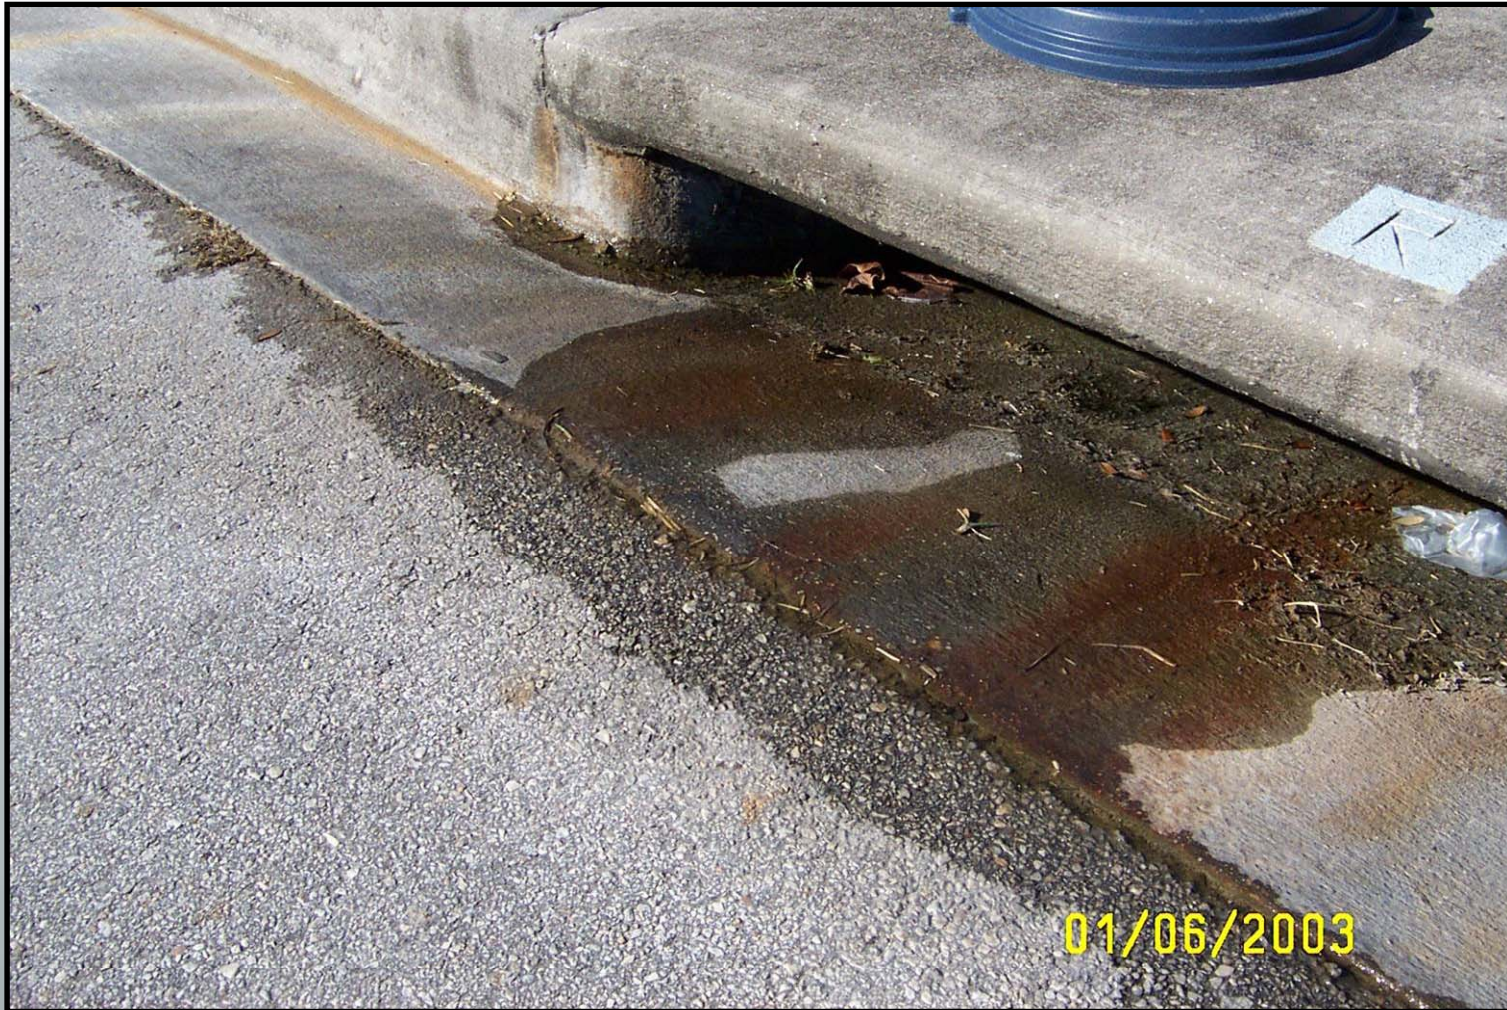
2007 ADS Stormwater Workshop

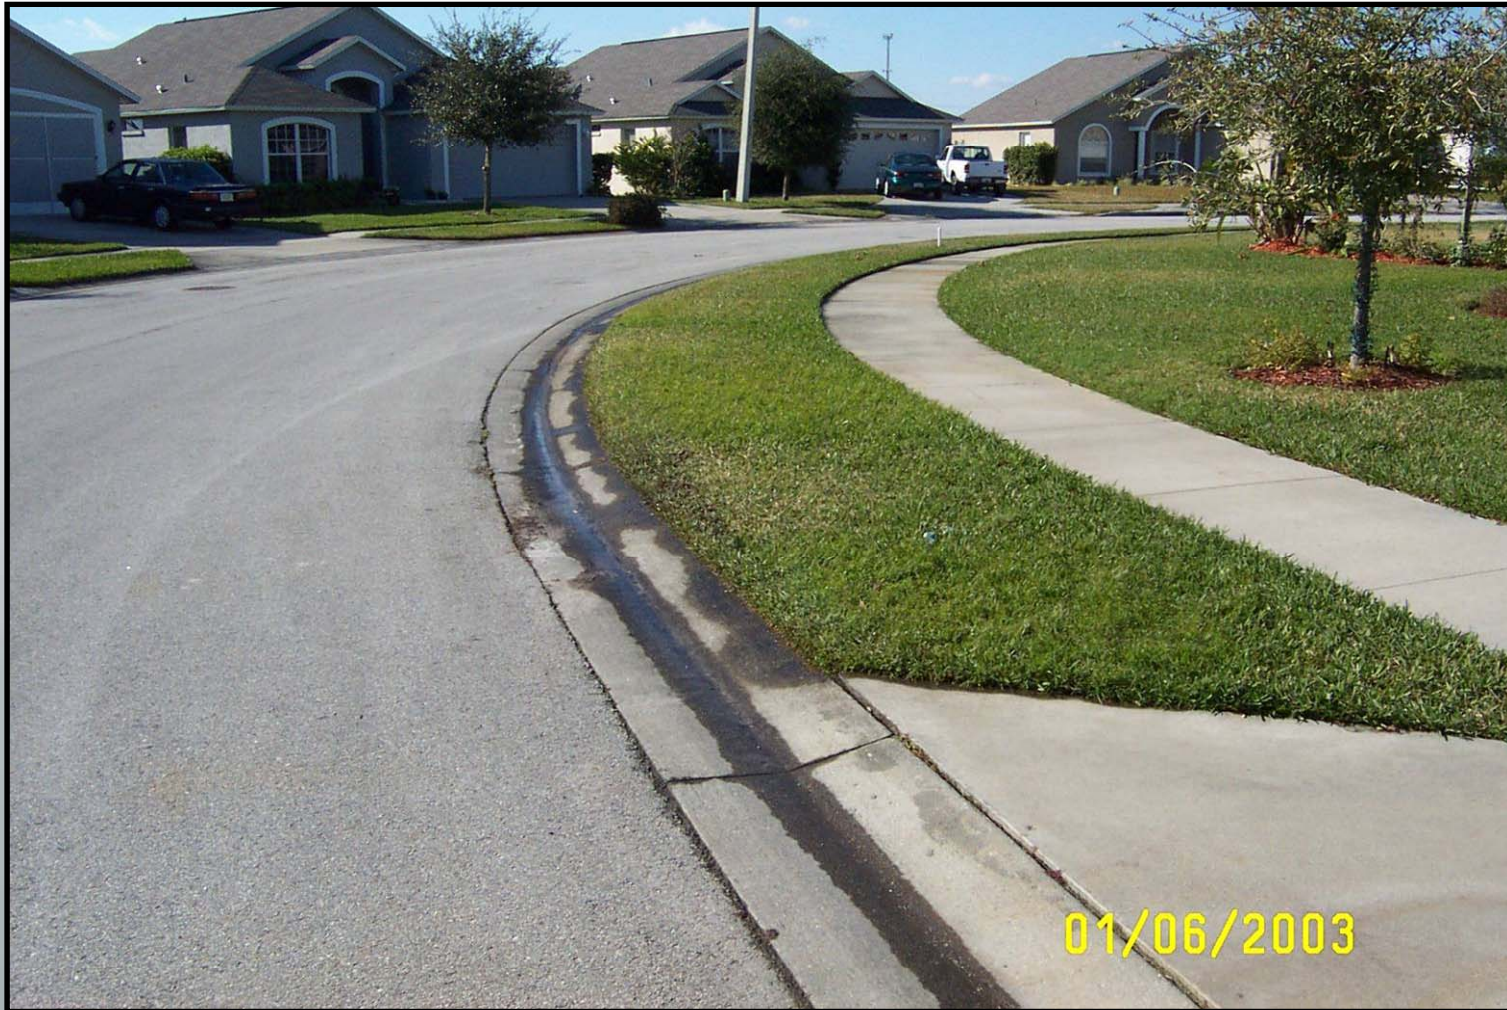
2007 ADS Stormwater Workshop

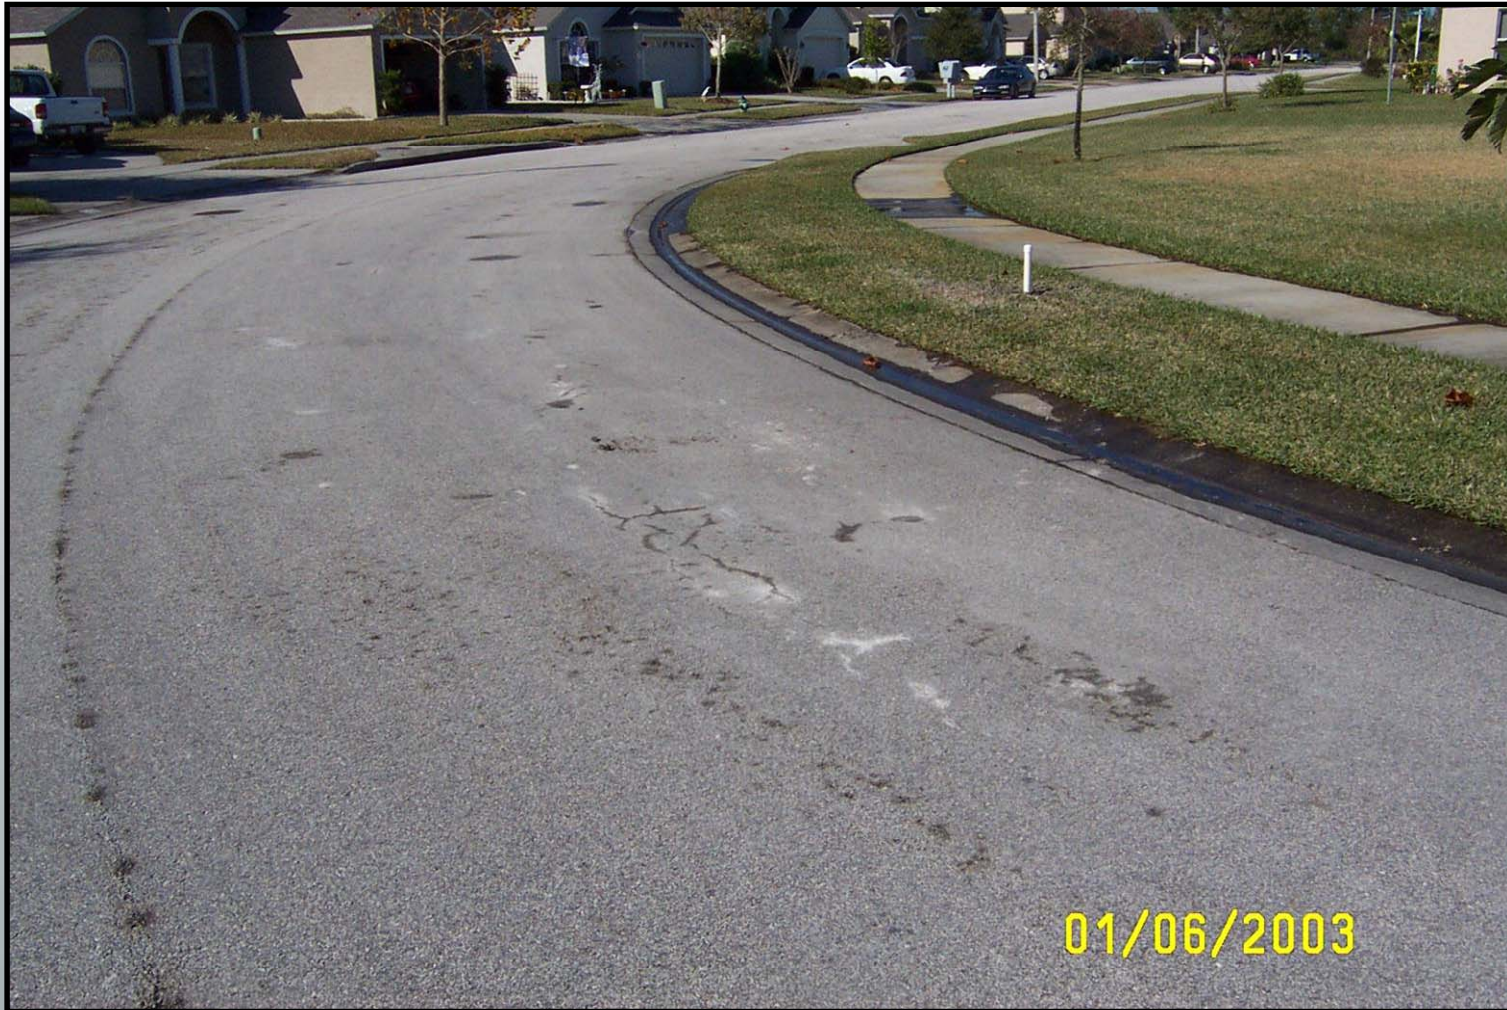
2007 ADS Stormwater Workshop

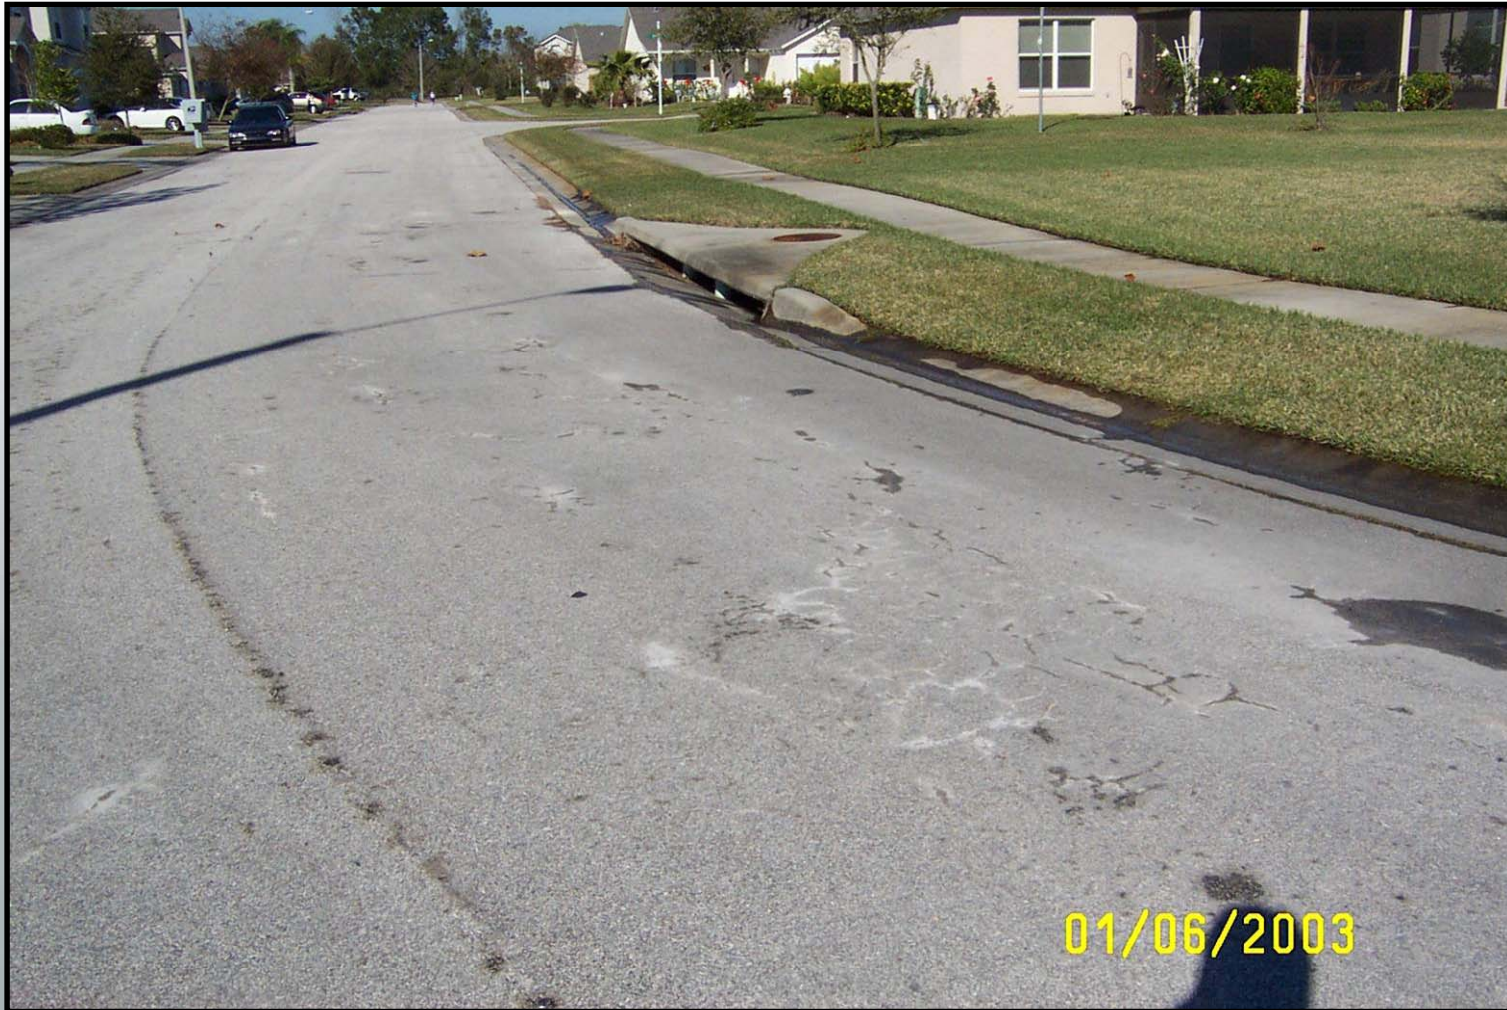
2007 ADS Stormwater Workshop

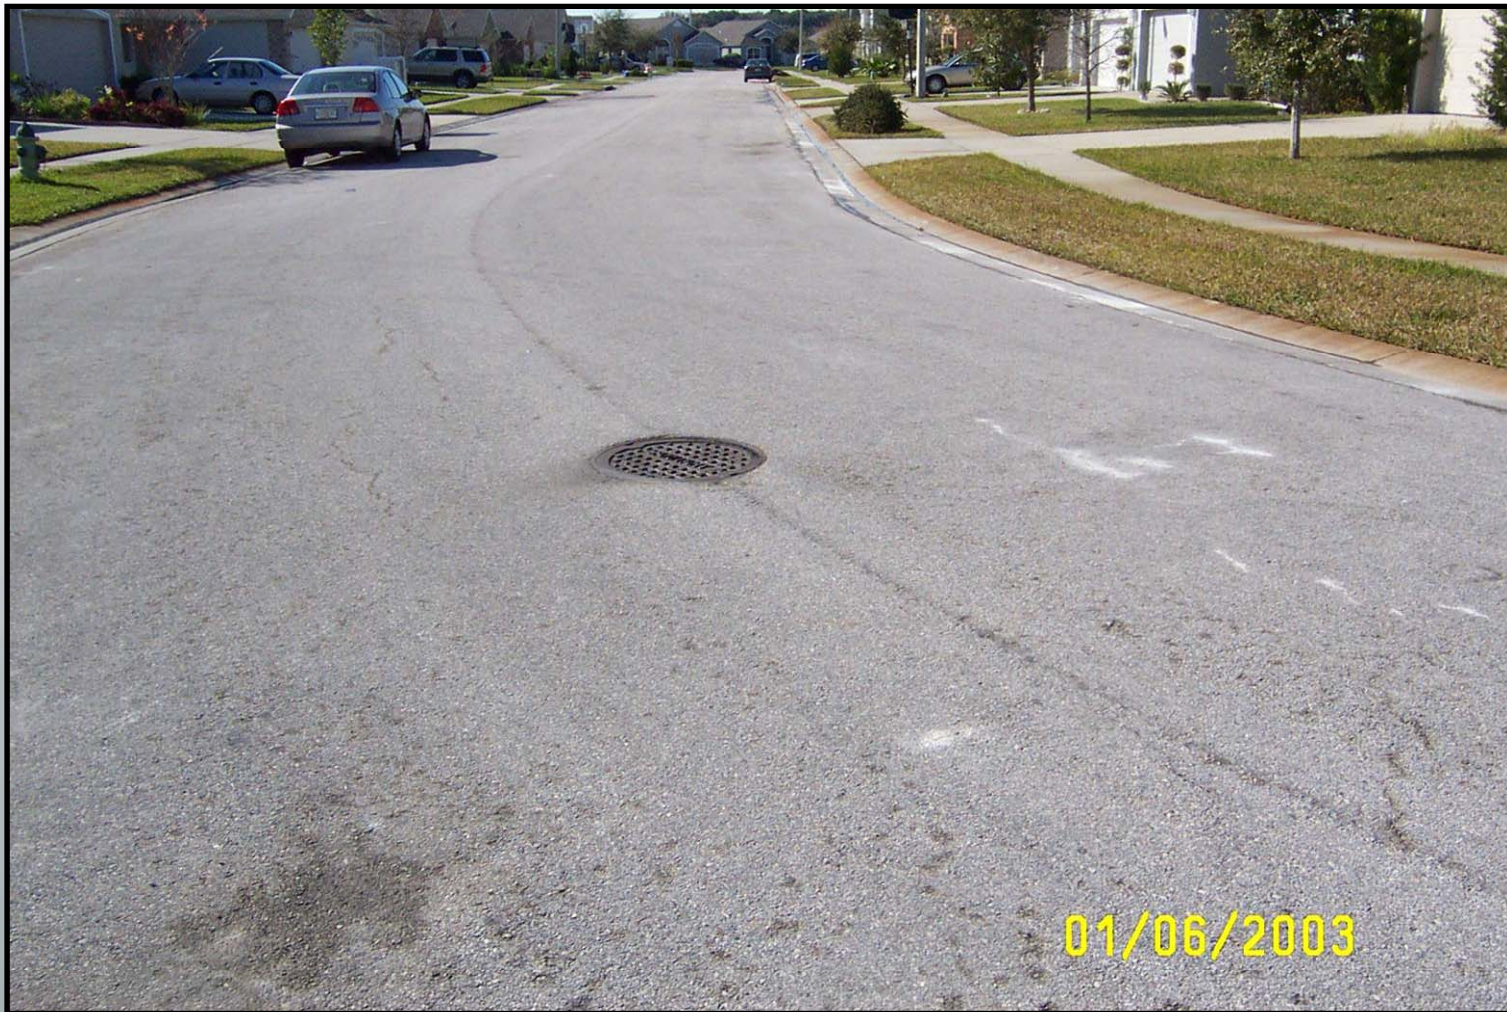
Limerock Pumping From Base

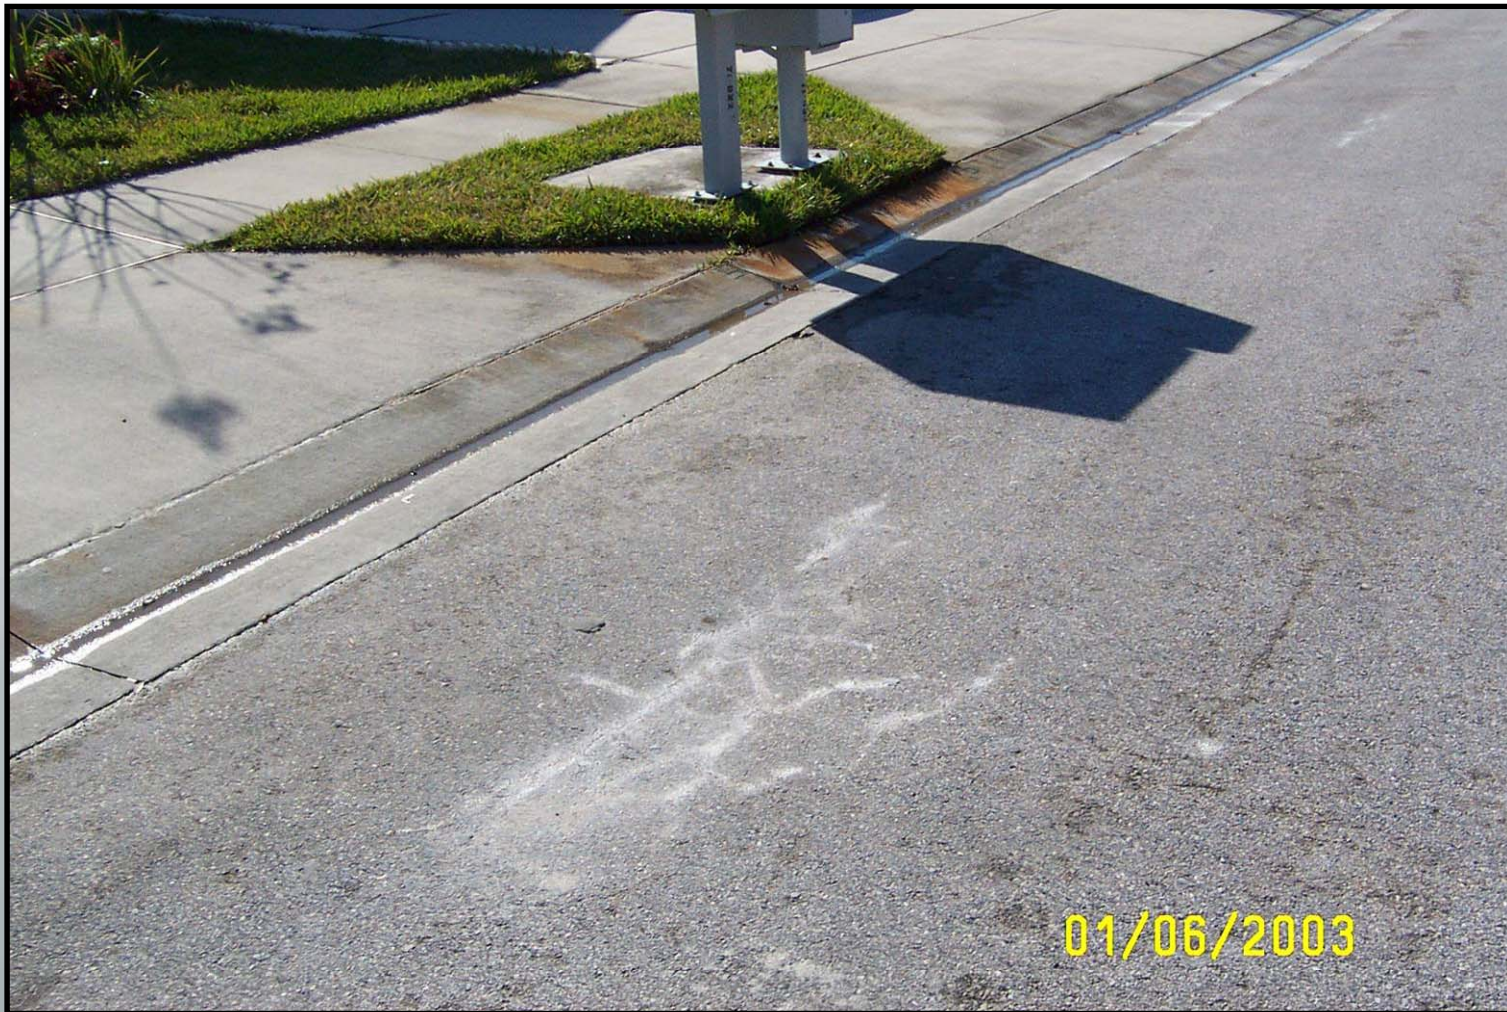
Limerock Pumping From Base

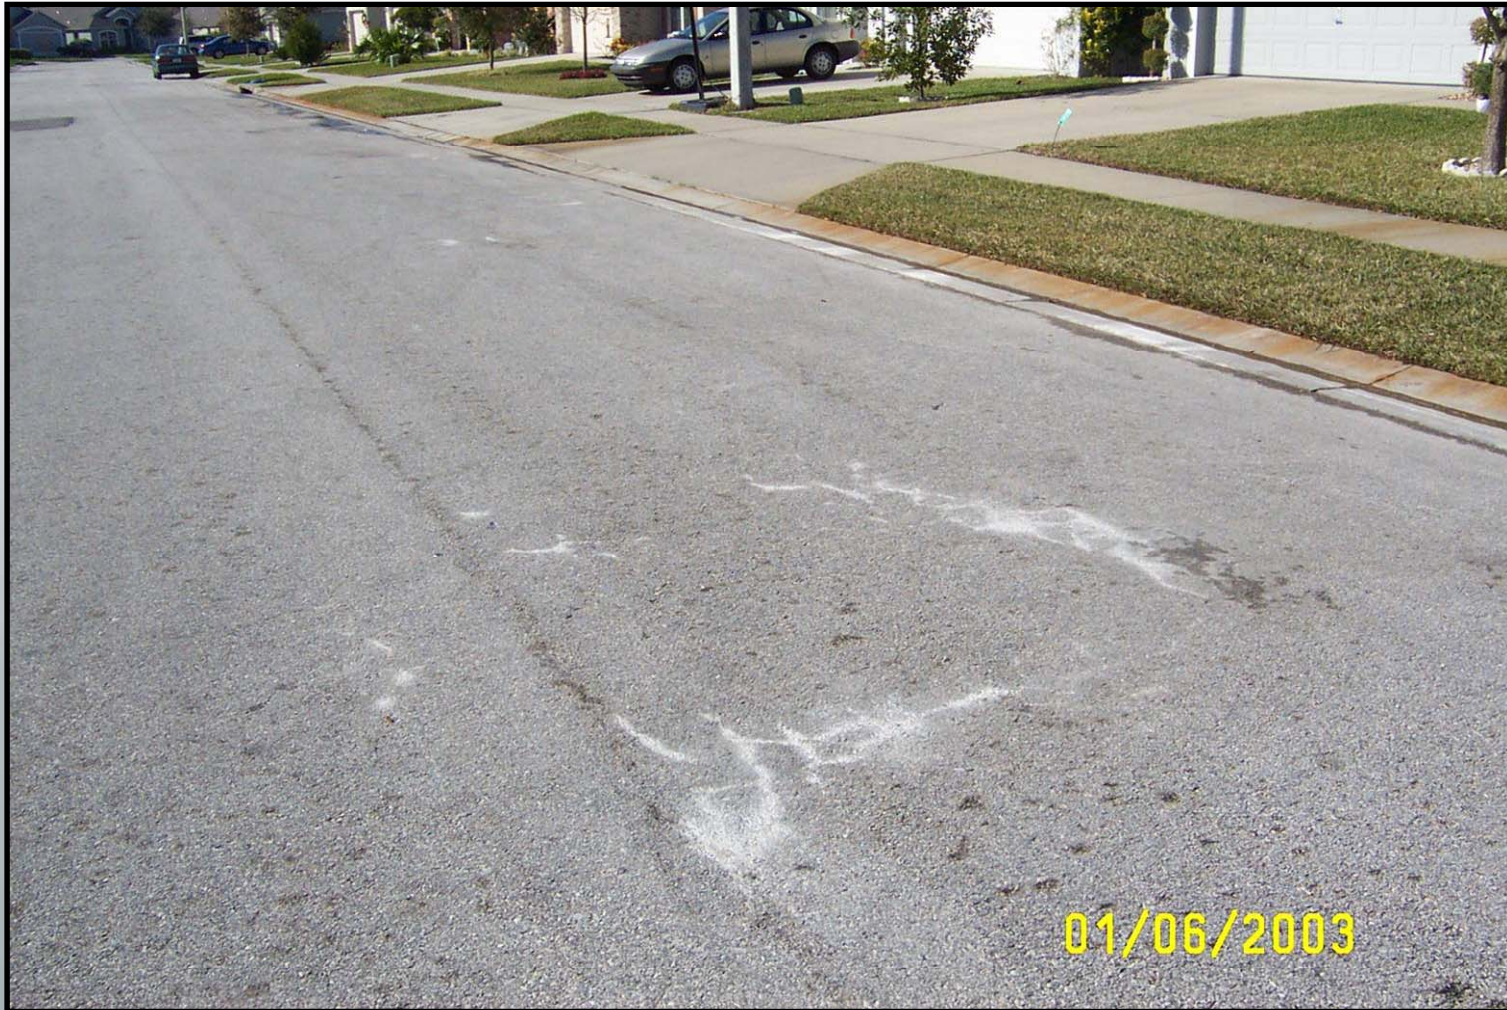
Limerock Pumping From Base

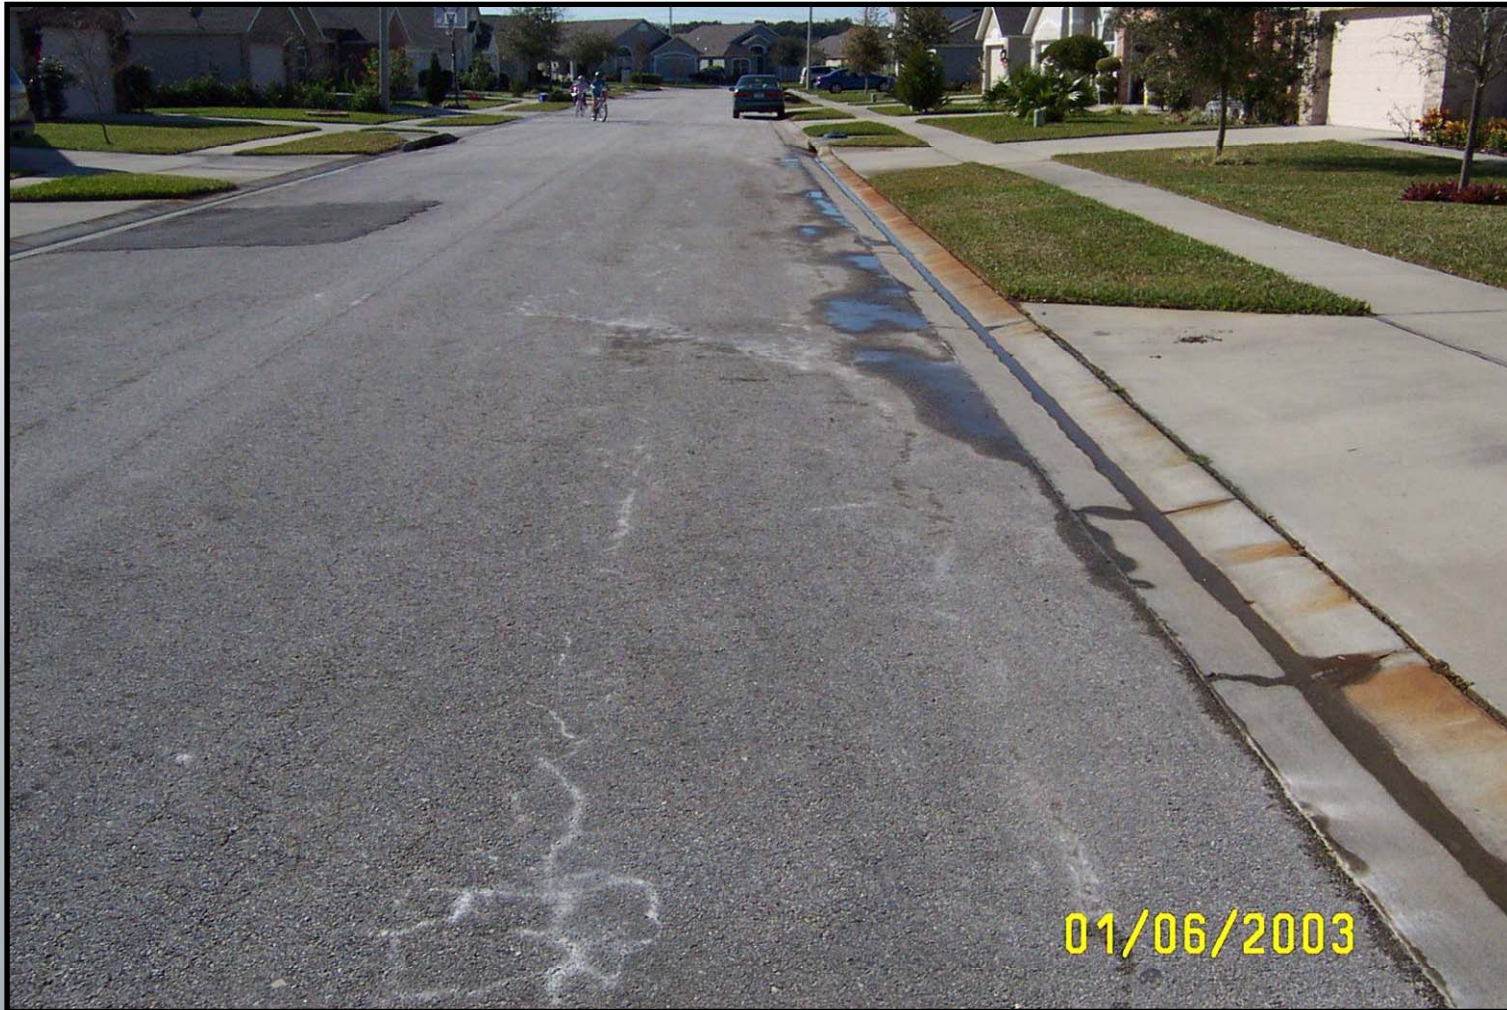
Limerock Pumping From Base

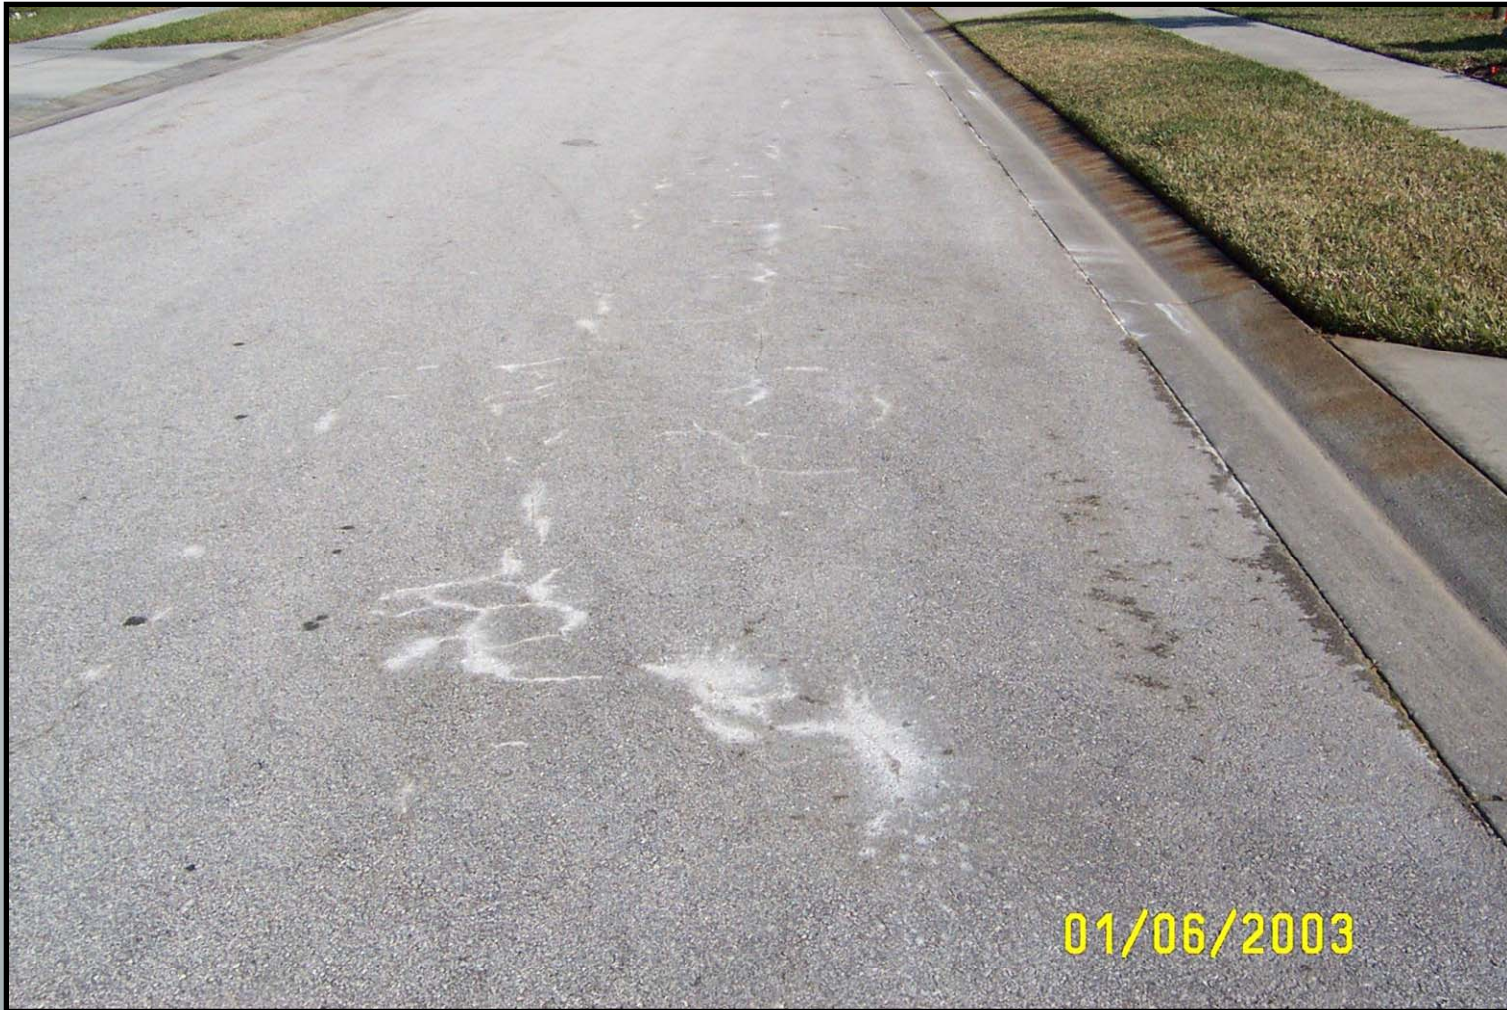
Limerock Pumping From Base

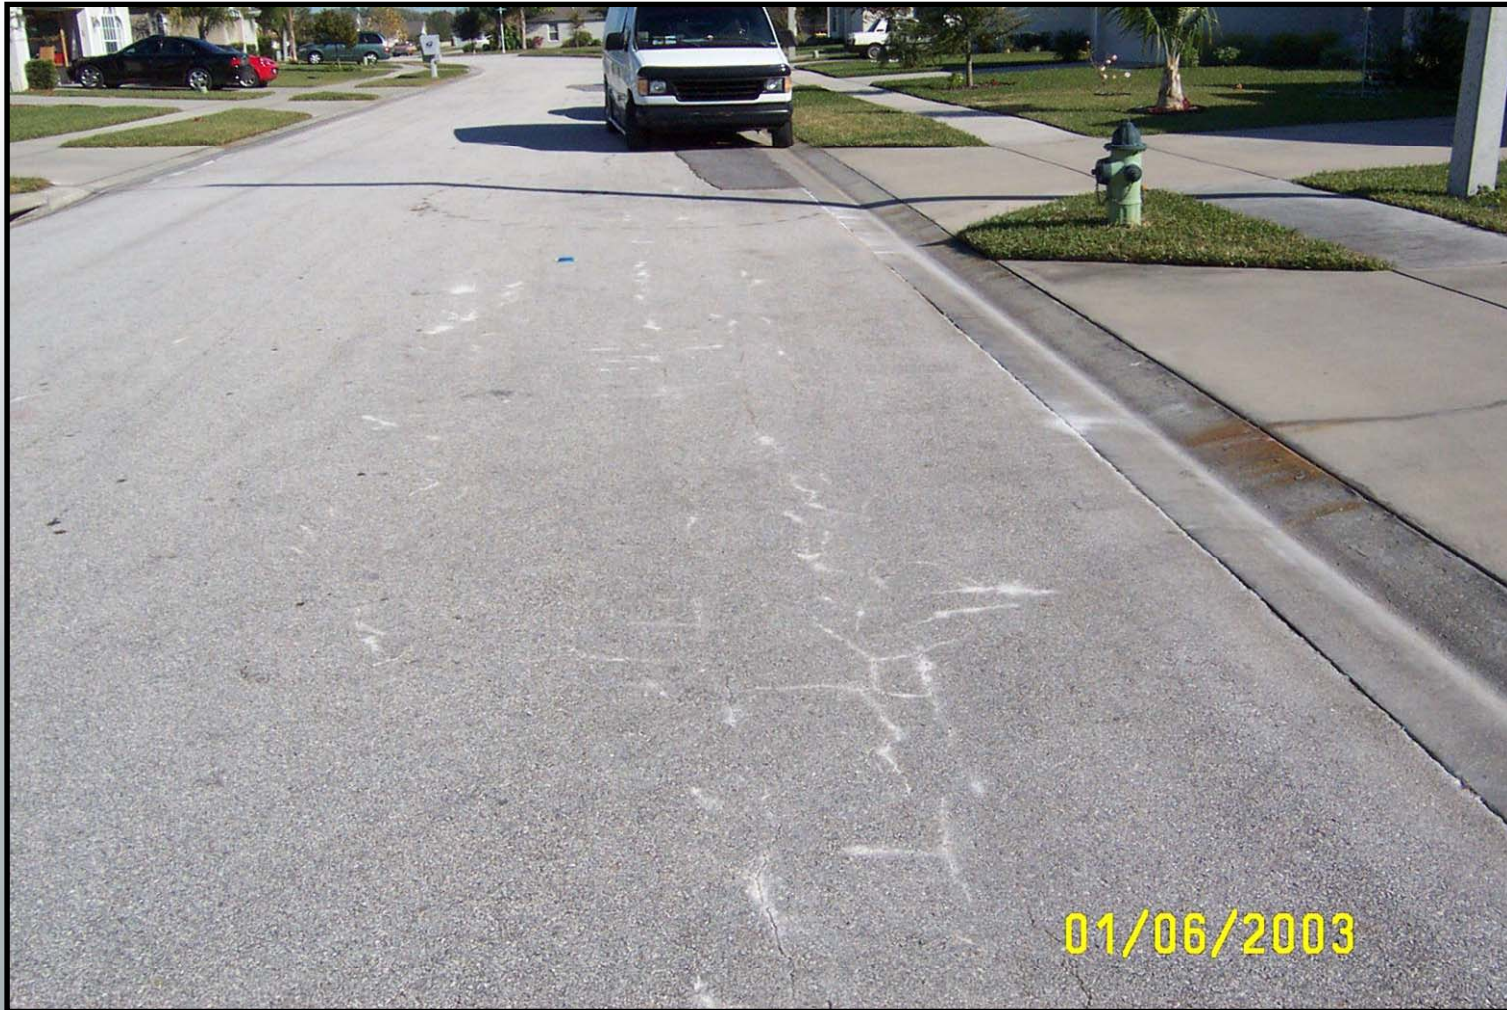
Limerock Pumping From Base

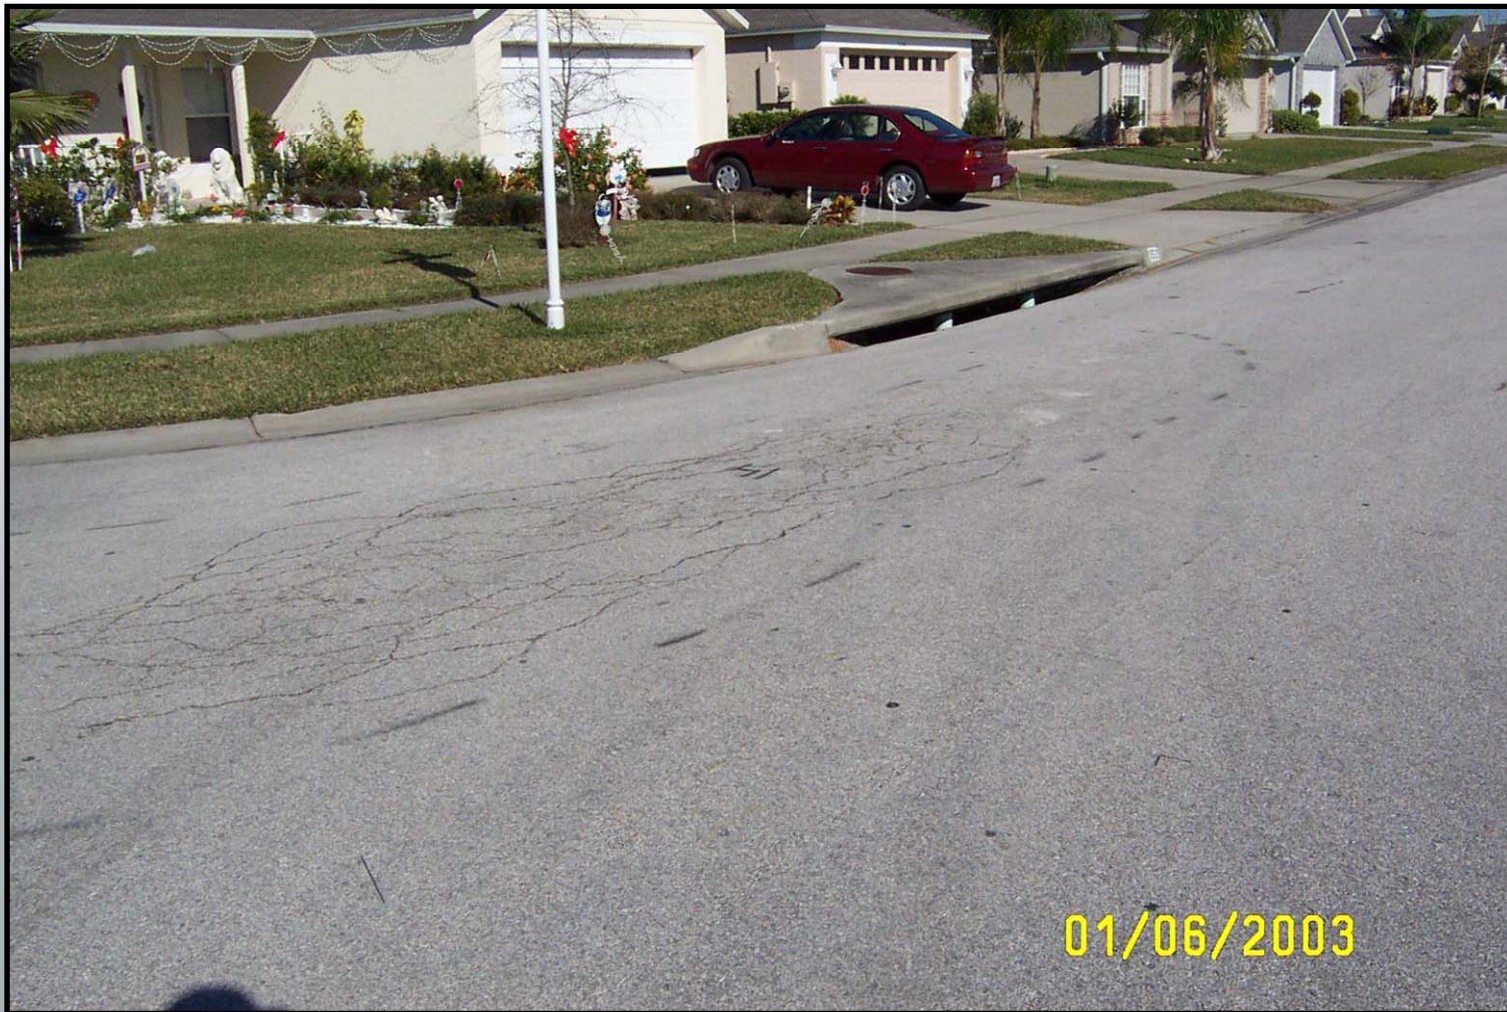
2007 ADS Stormwater Workshop

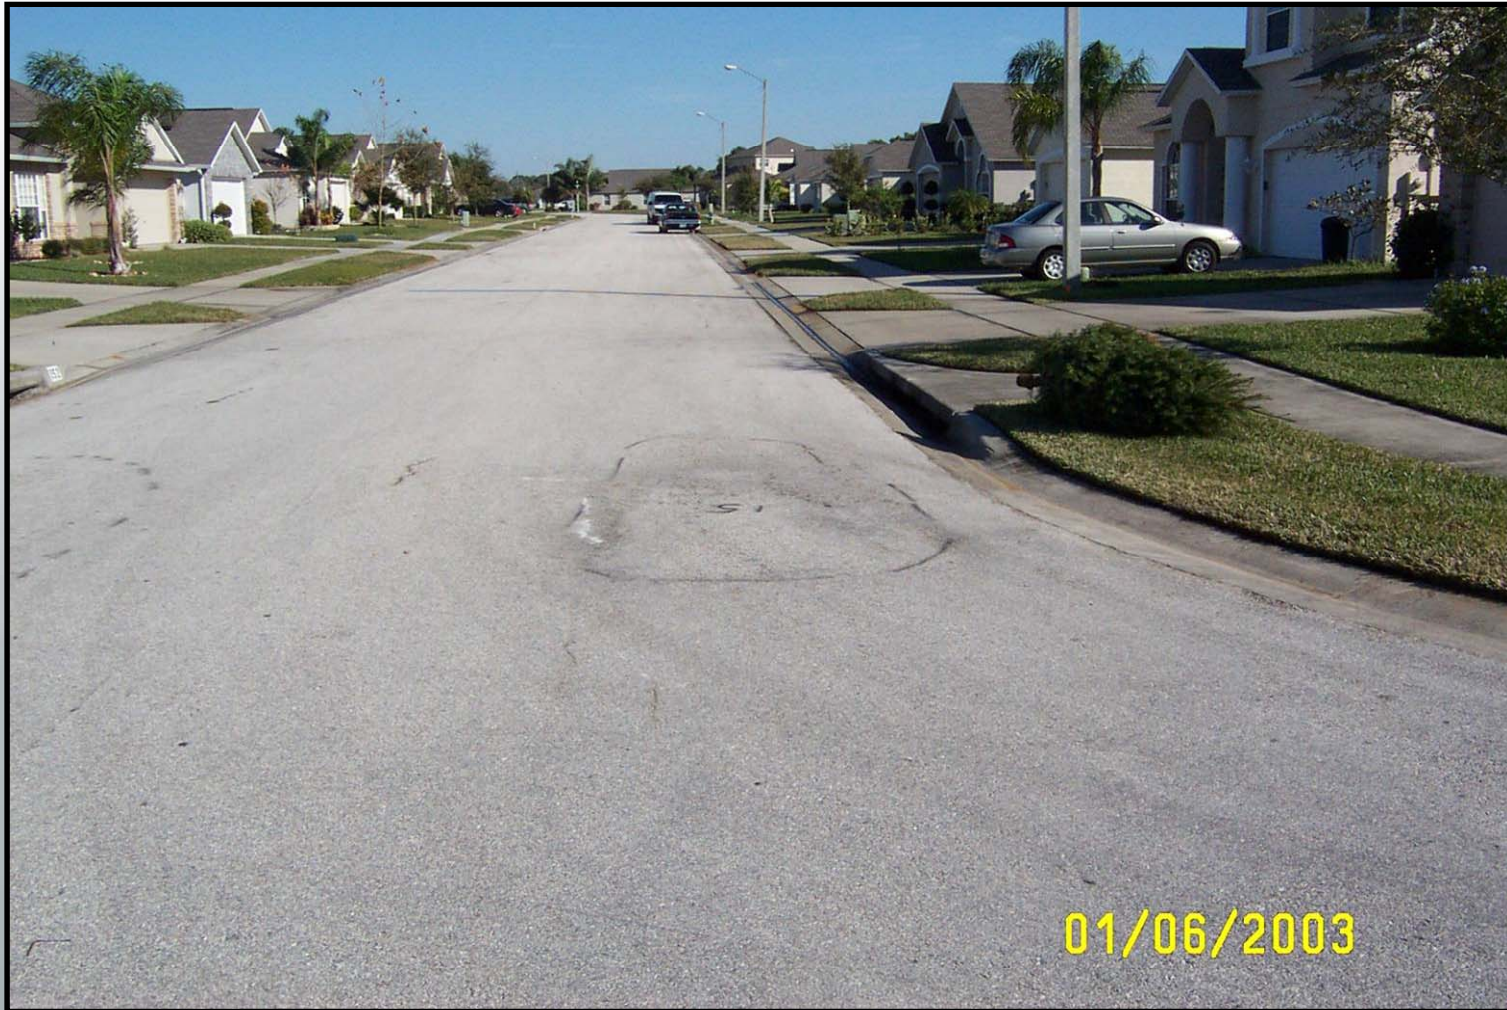
2007 ADS Stormwater Workshop

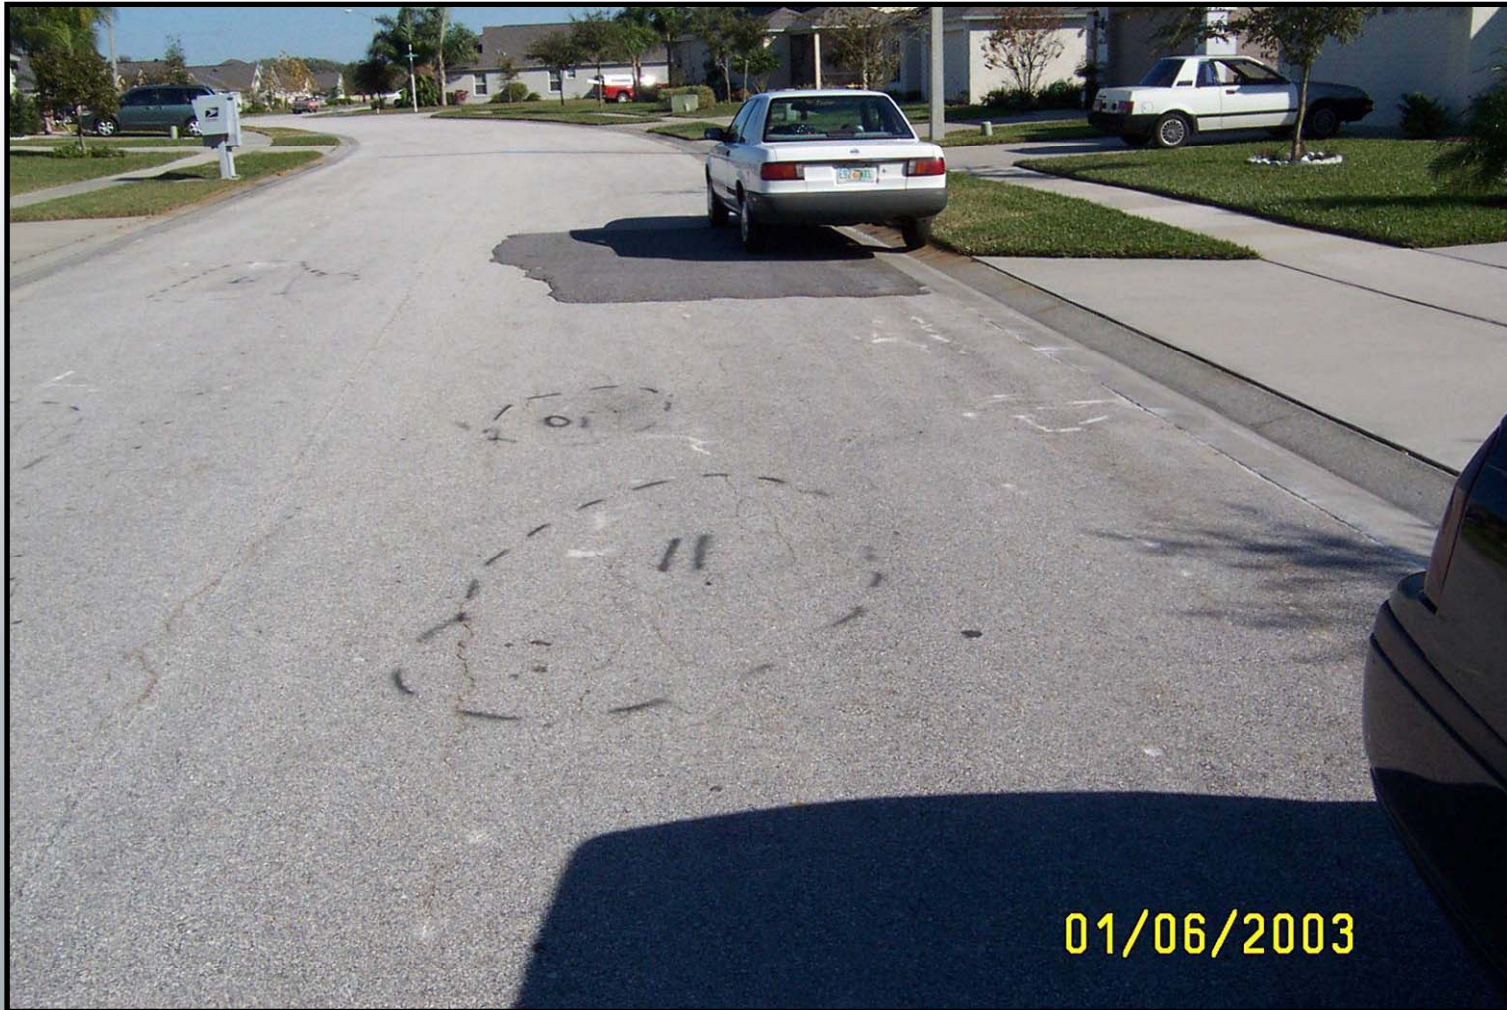
2007 ADS Stormwater Workshop

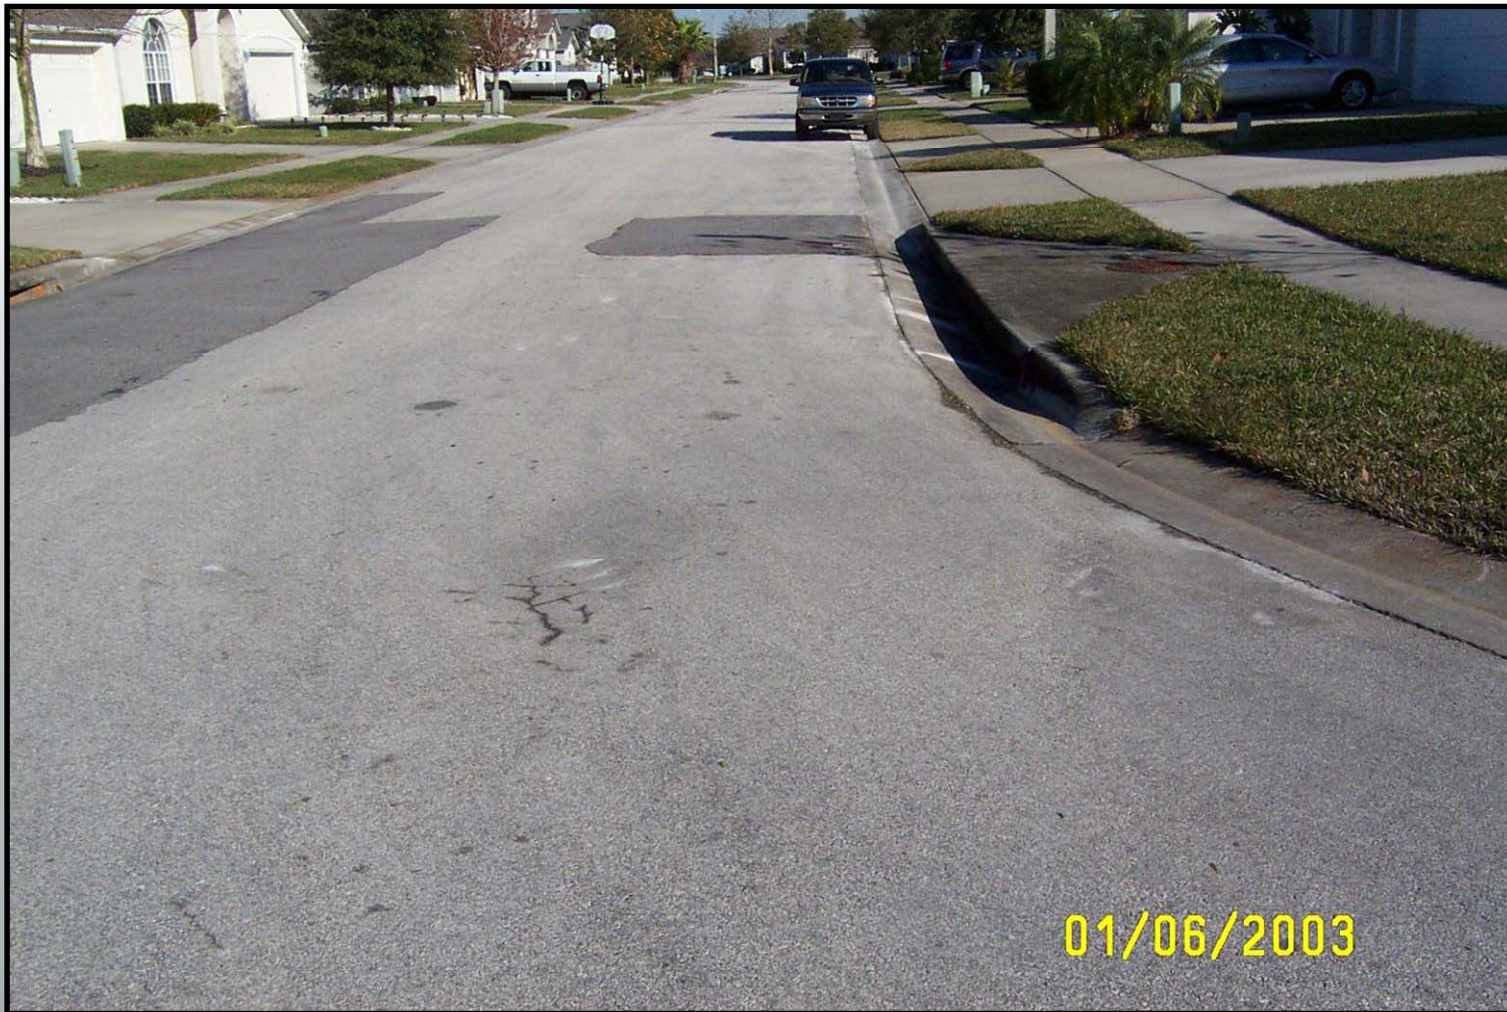
2007 ADS Stormwater Workshop

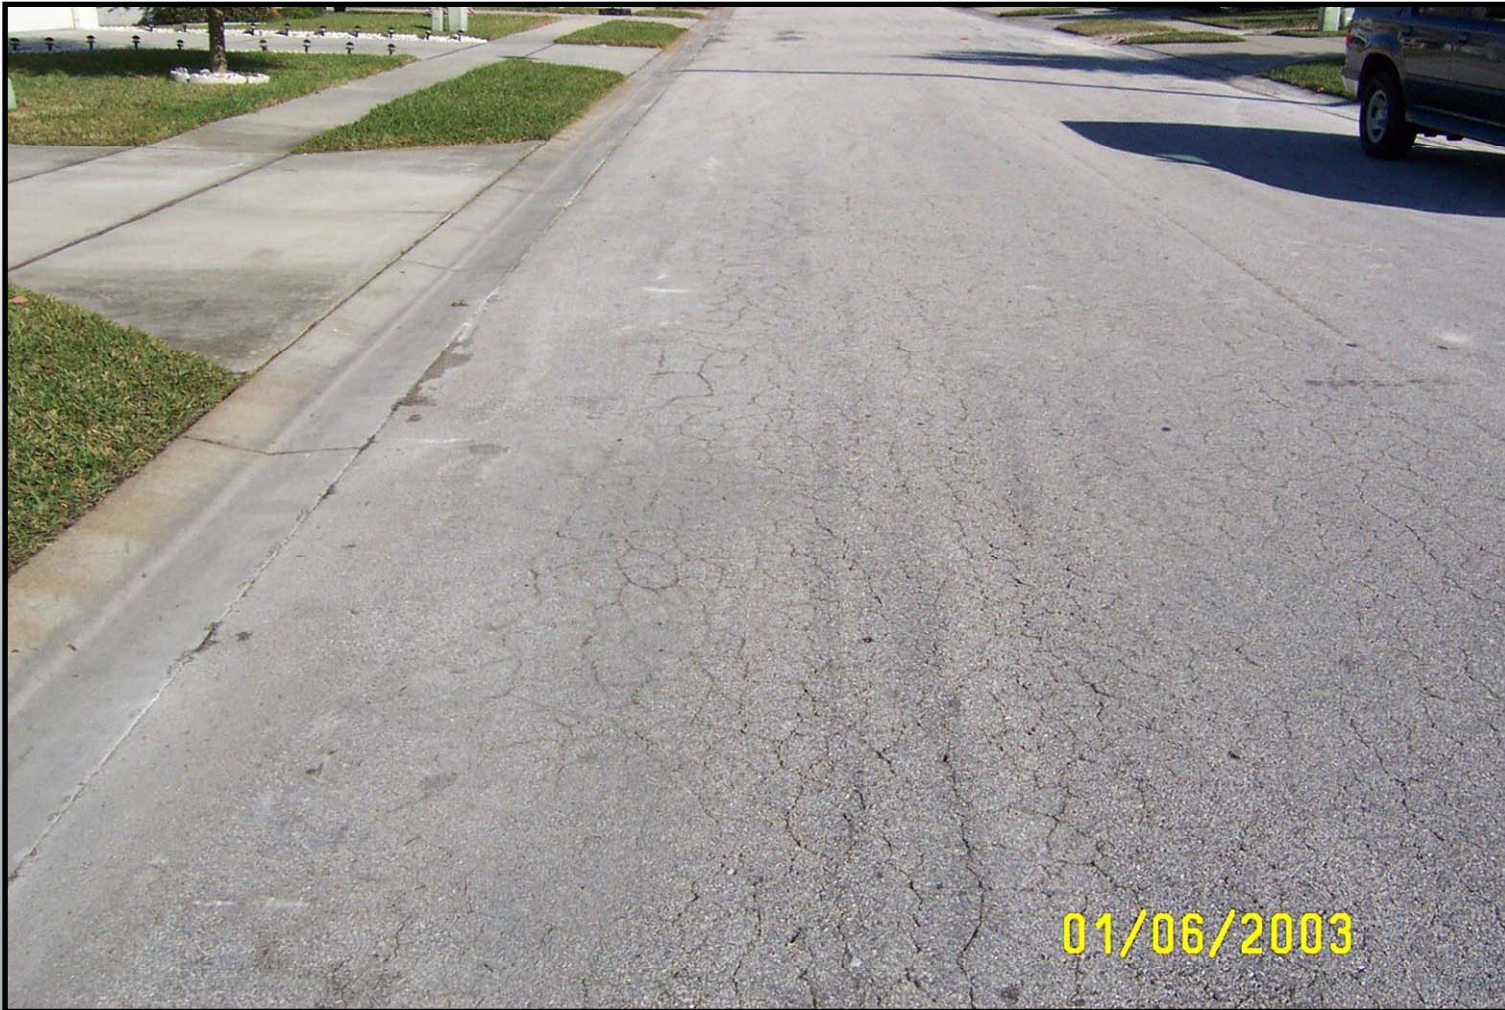
2007 ADS Stormwater Workshop
