2007 ADS STORMWATER WORKSHOP

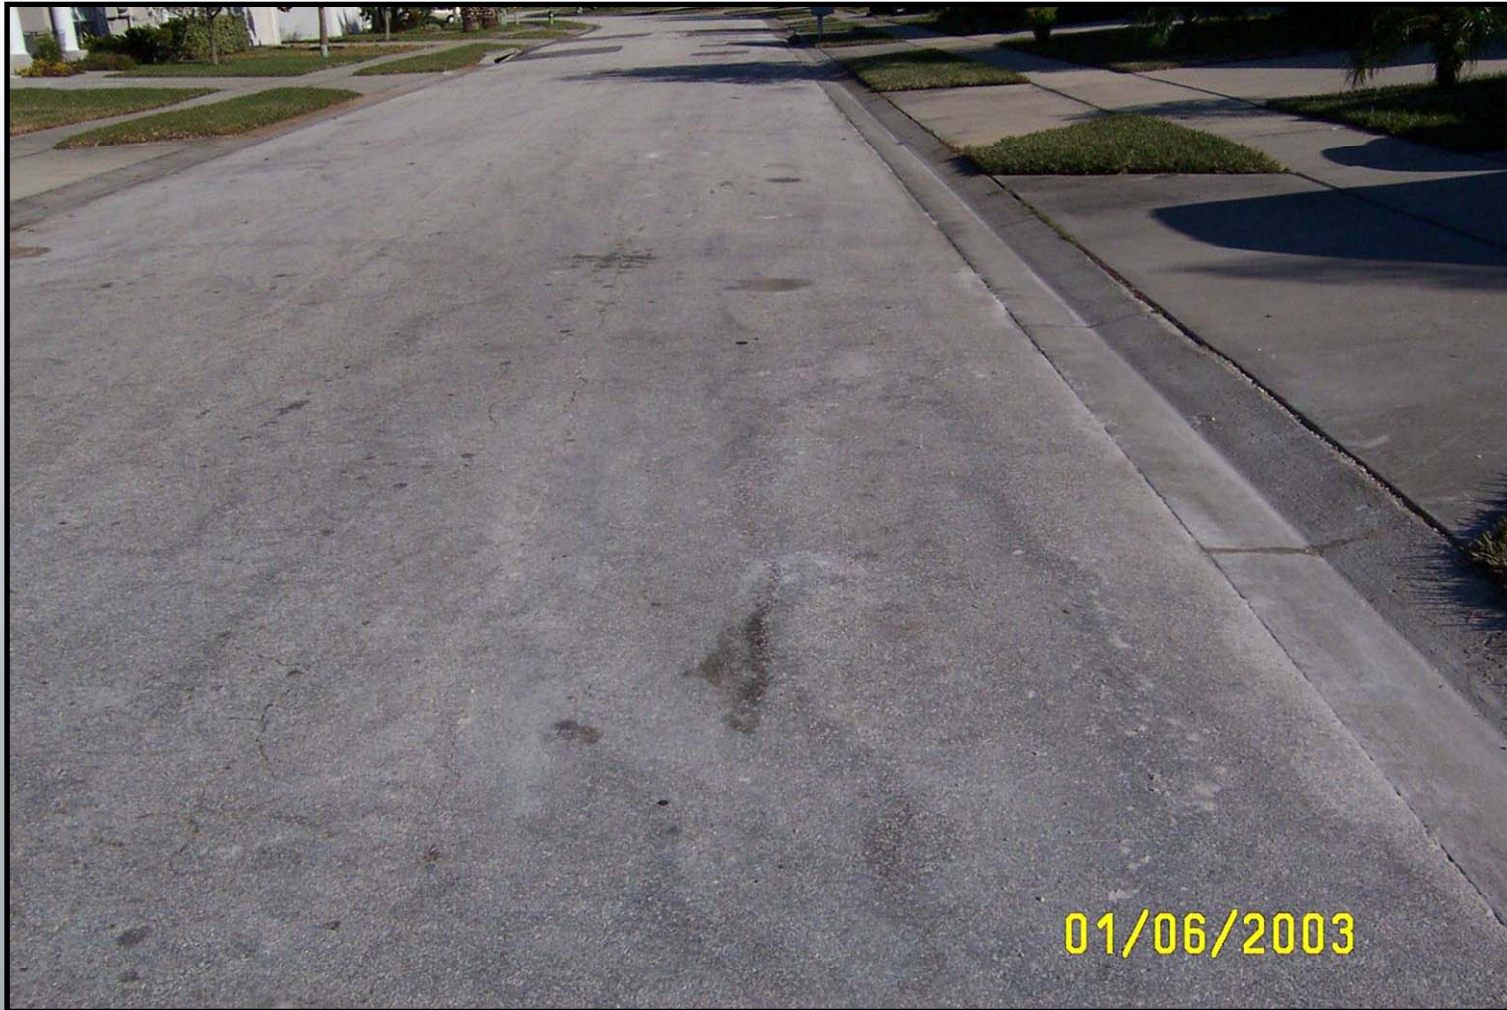
2007 ADS Stormwater Workshop

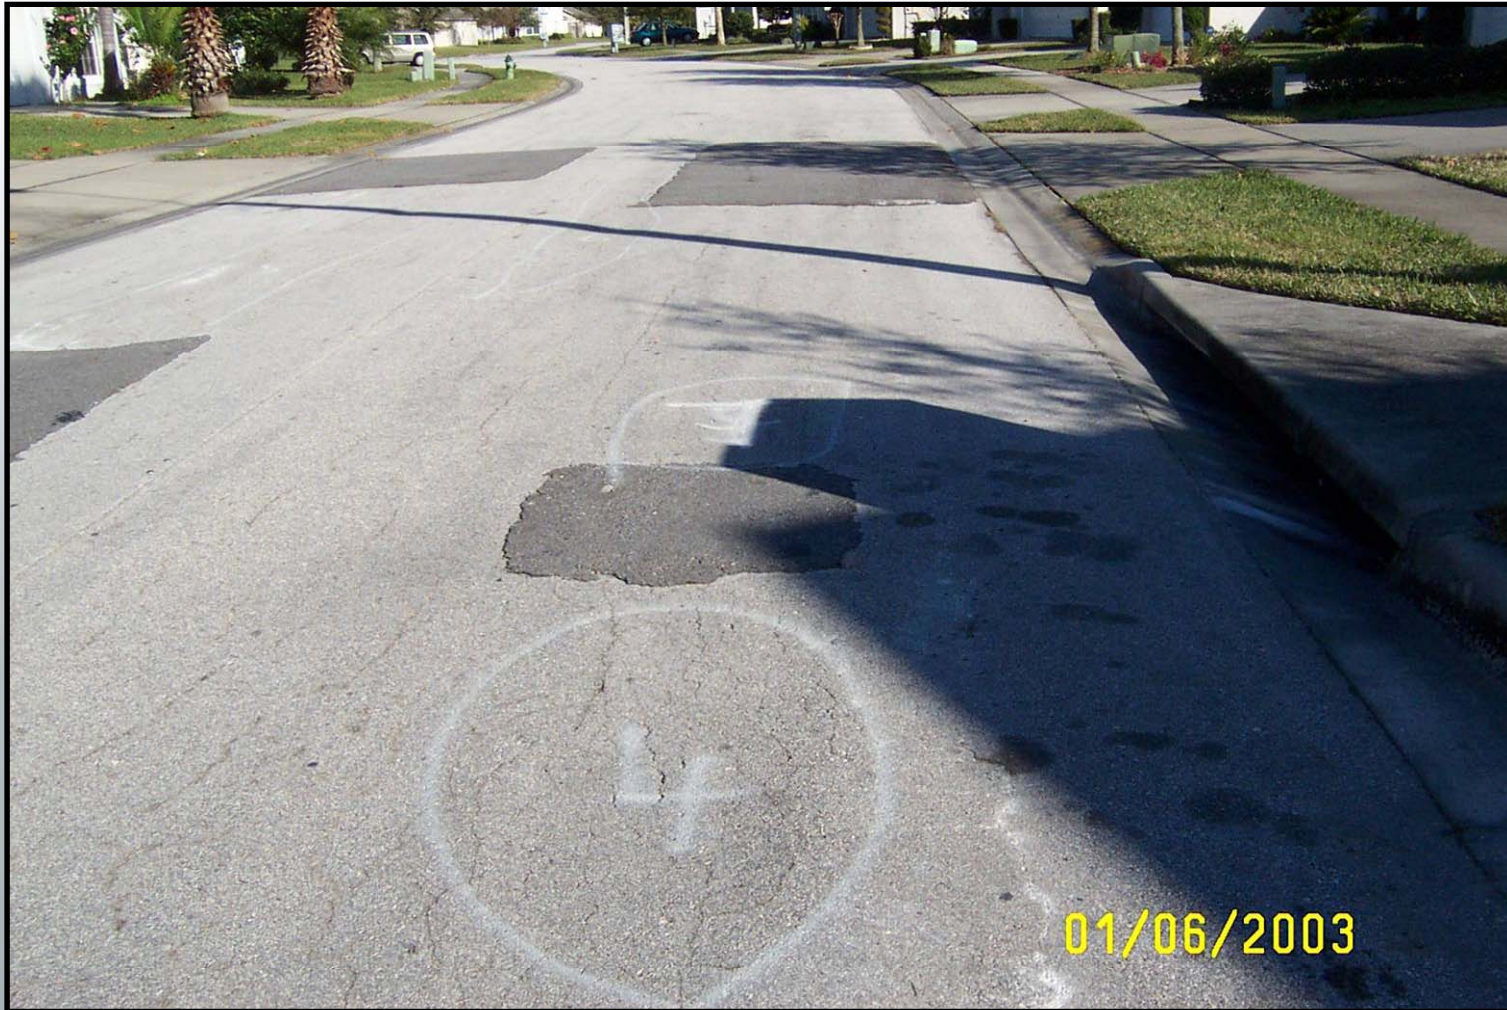
2007 ADS Stormwater Workshop

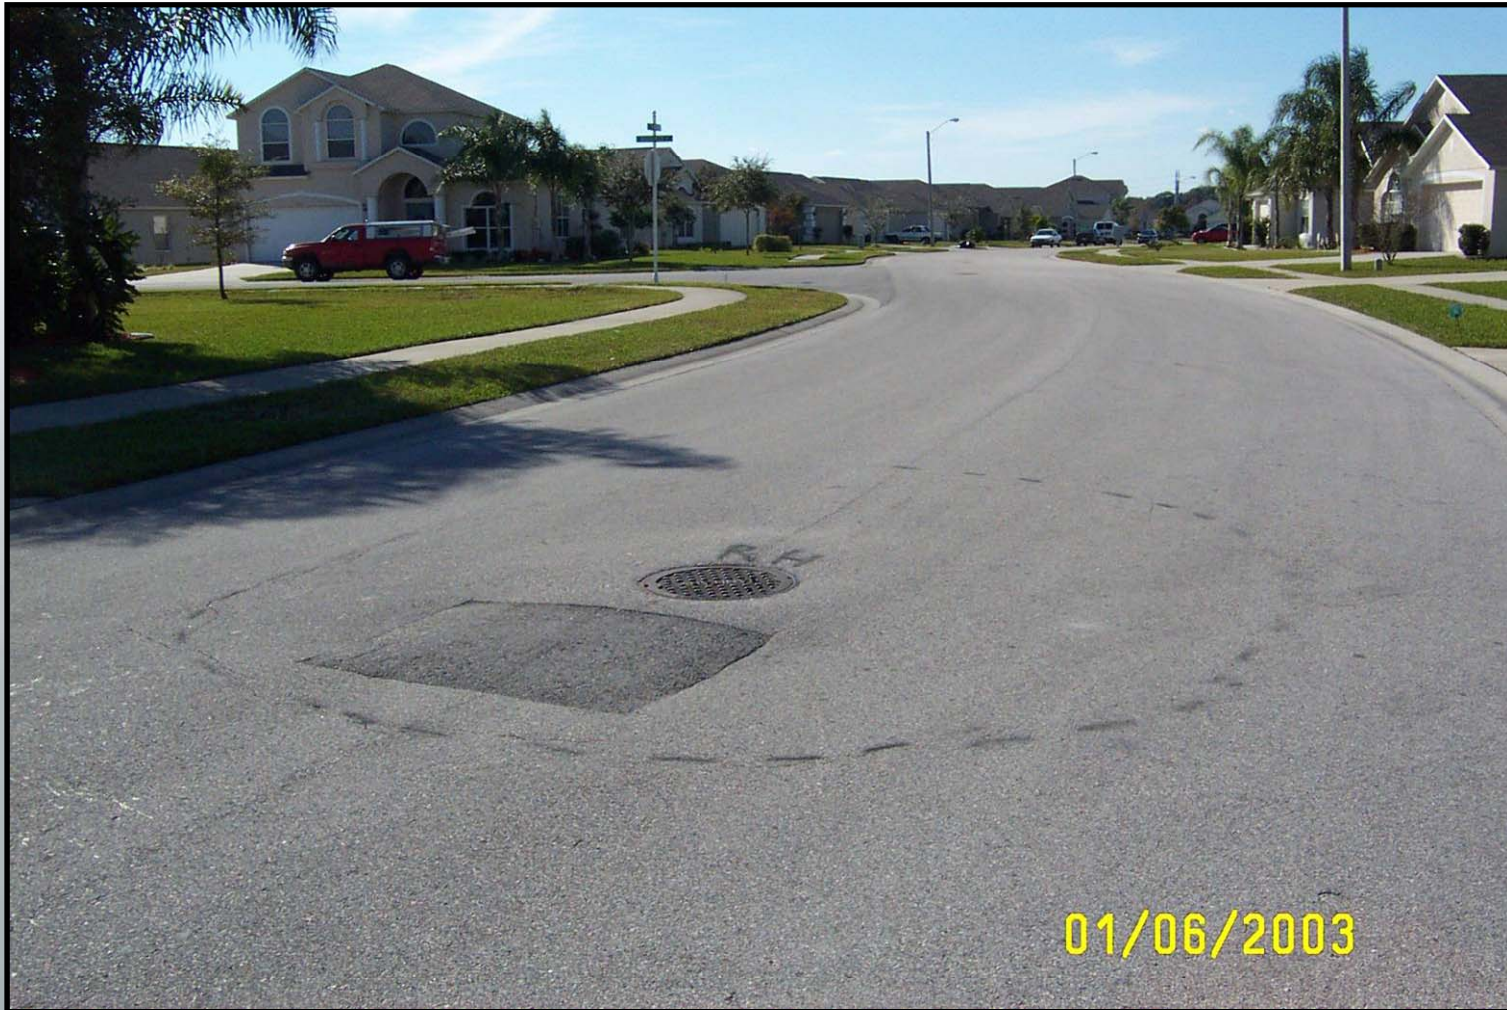
Structure Settlement

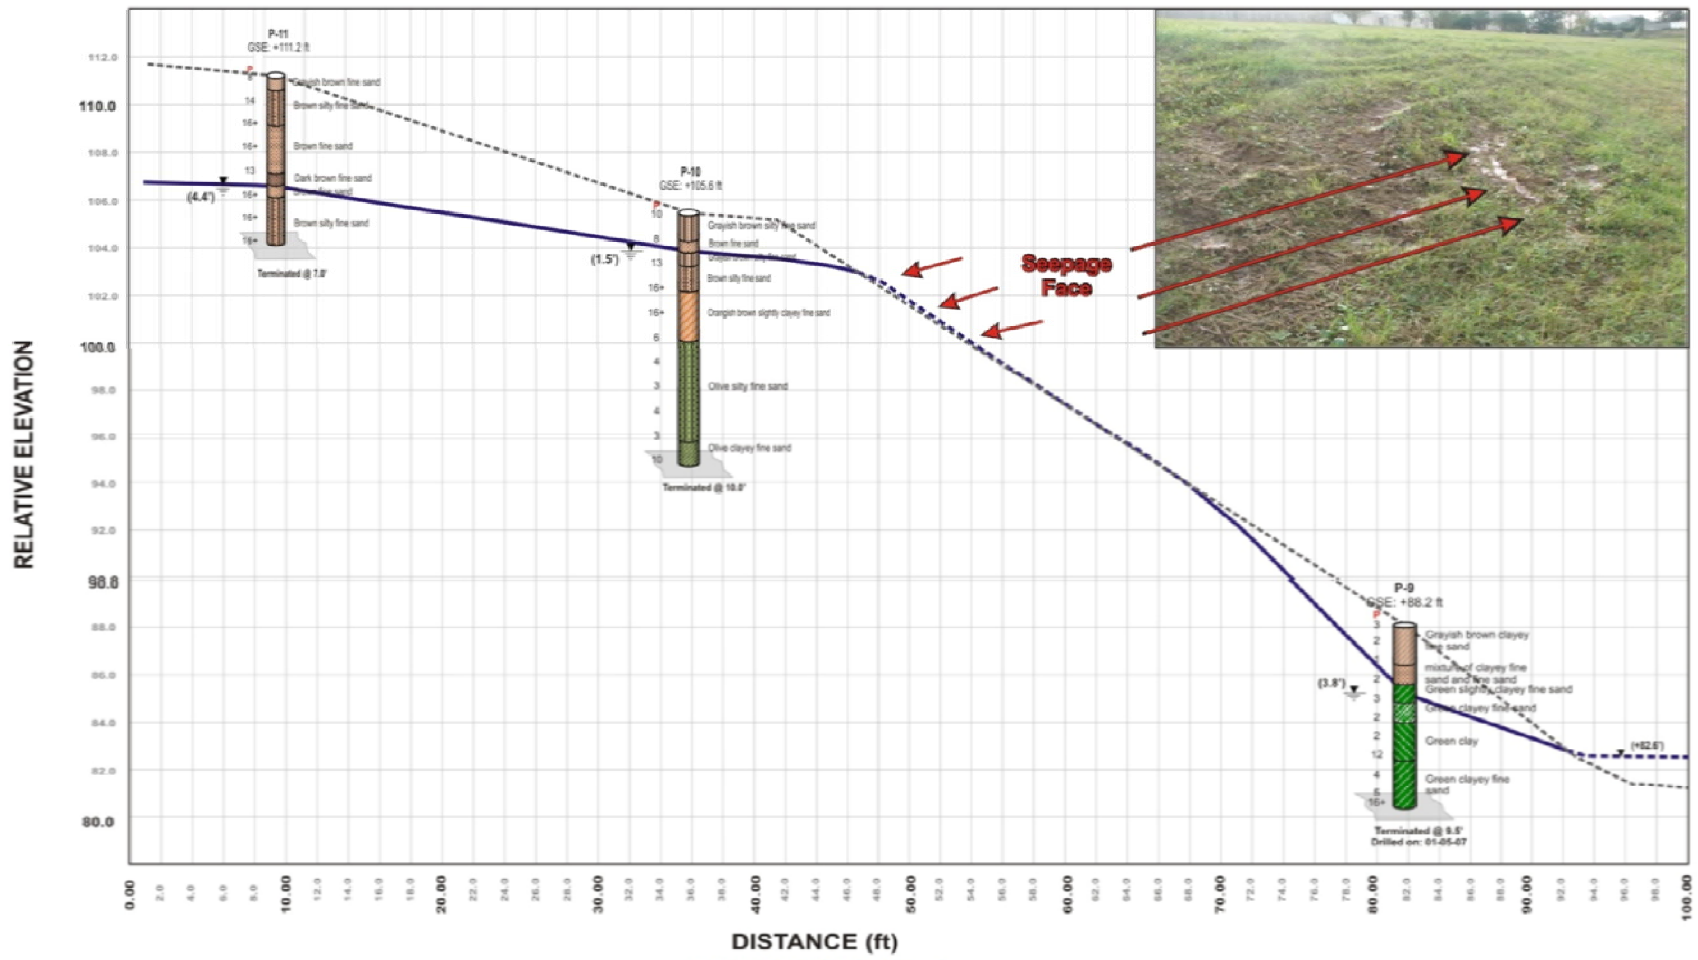
2007 ADS Stormwater Workshop
