**Current Issues in  
Storm Water  
Regulation in Florida**

**29th Annual ASCE-  
EWRI Water Resources  
Seminar**

**Speaker: Devo Seereeram Ph.D., P.E.**

**Topic: Litigation Prone Areas of  
Stormwater Management With  
Illustrated Case Studies**

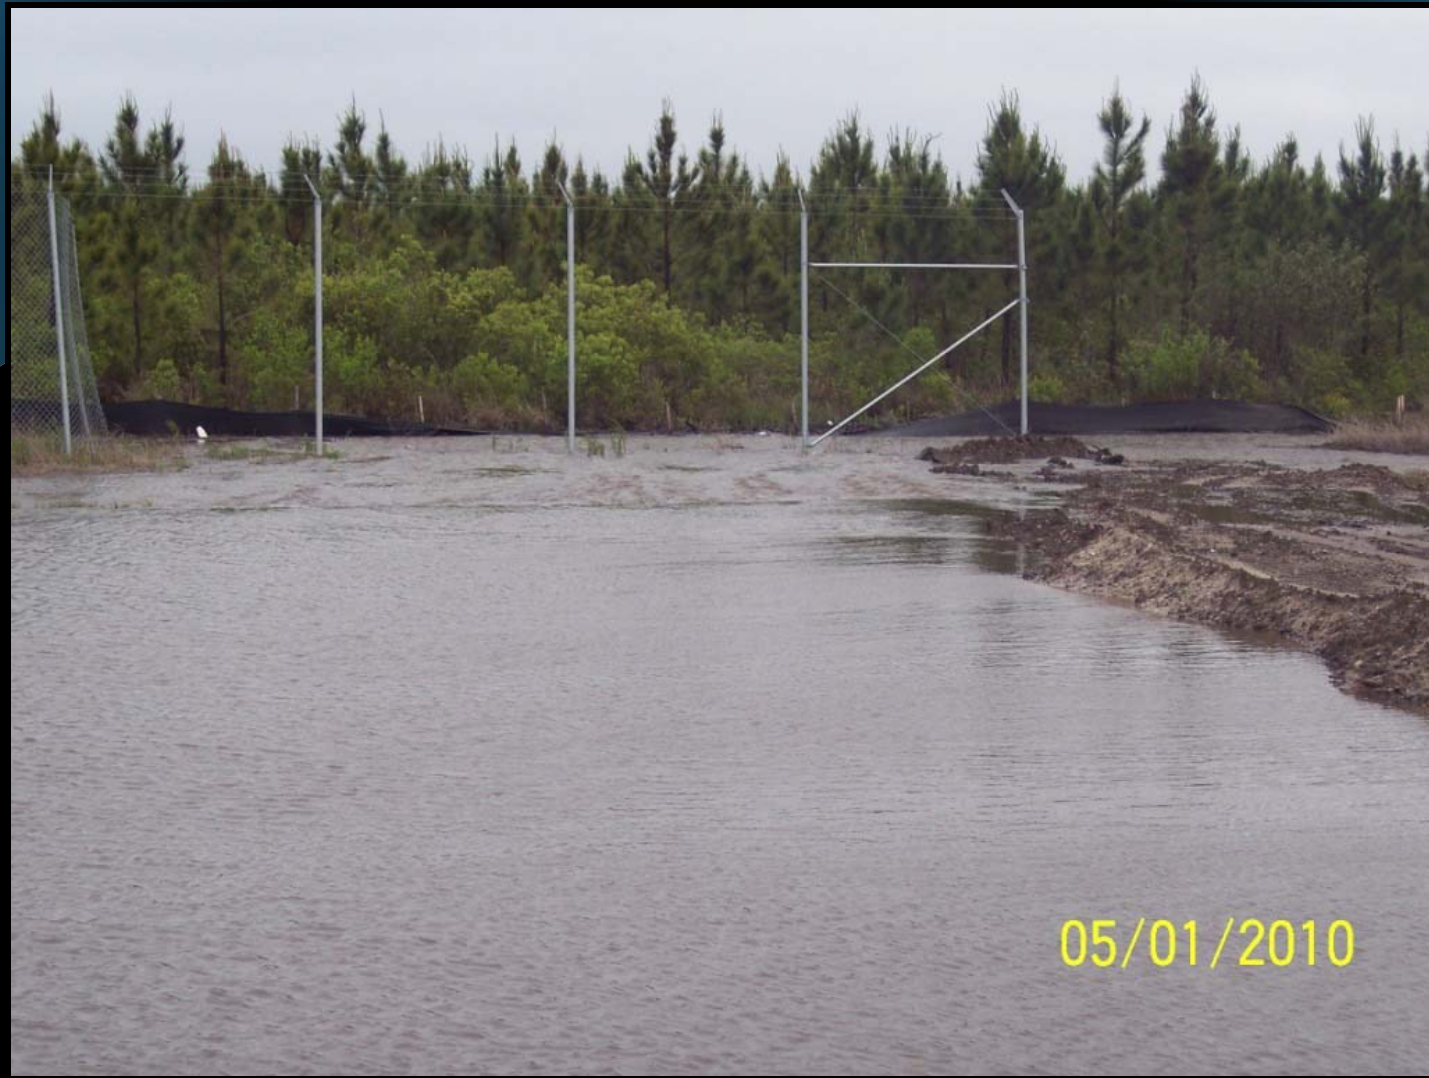
**Obstruction of Natural Drainage  
Flow Path During Construction**

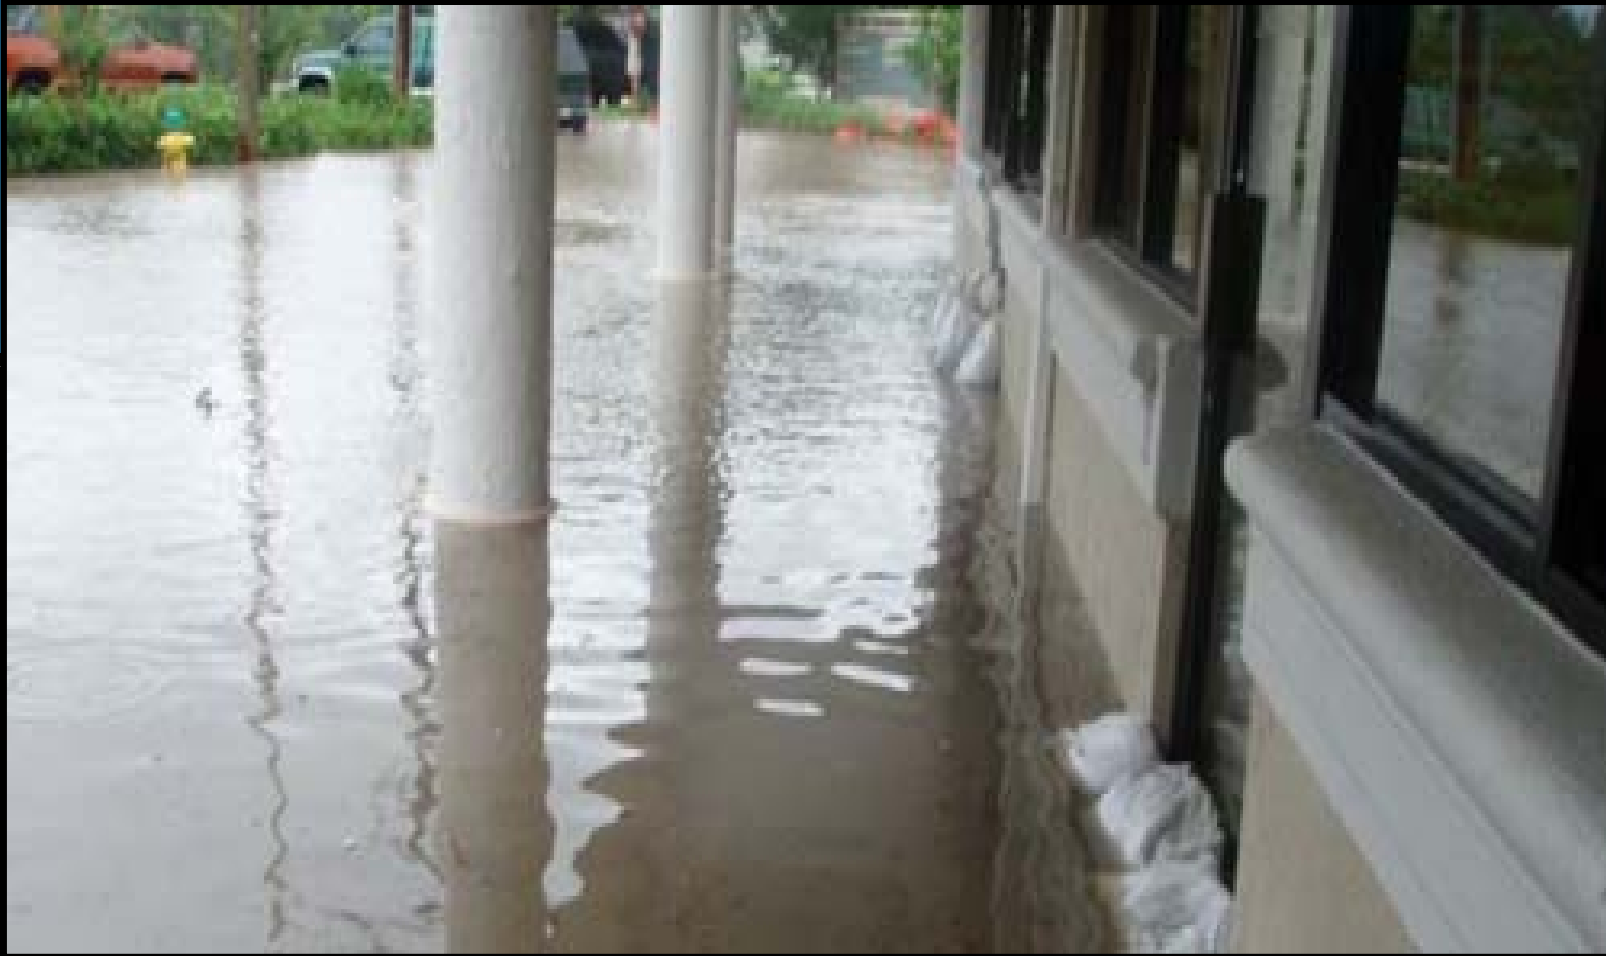
## Flooding at Downstream Building

Water entering building

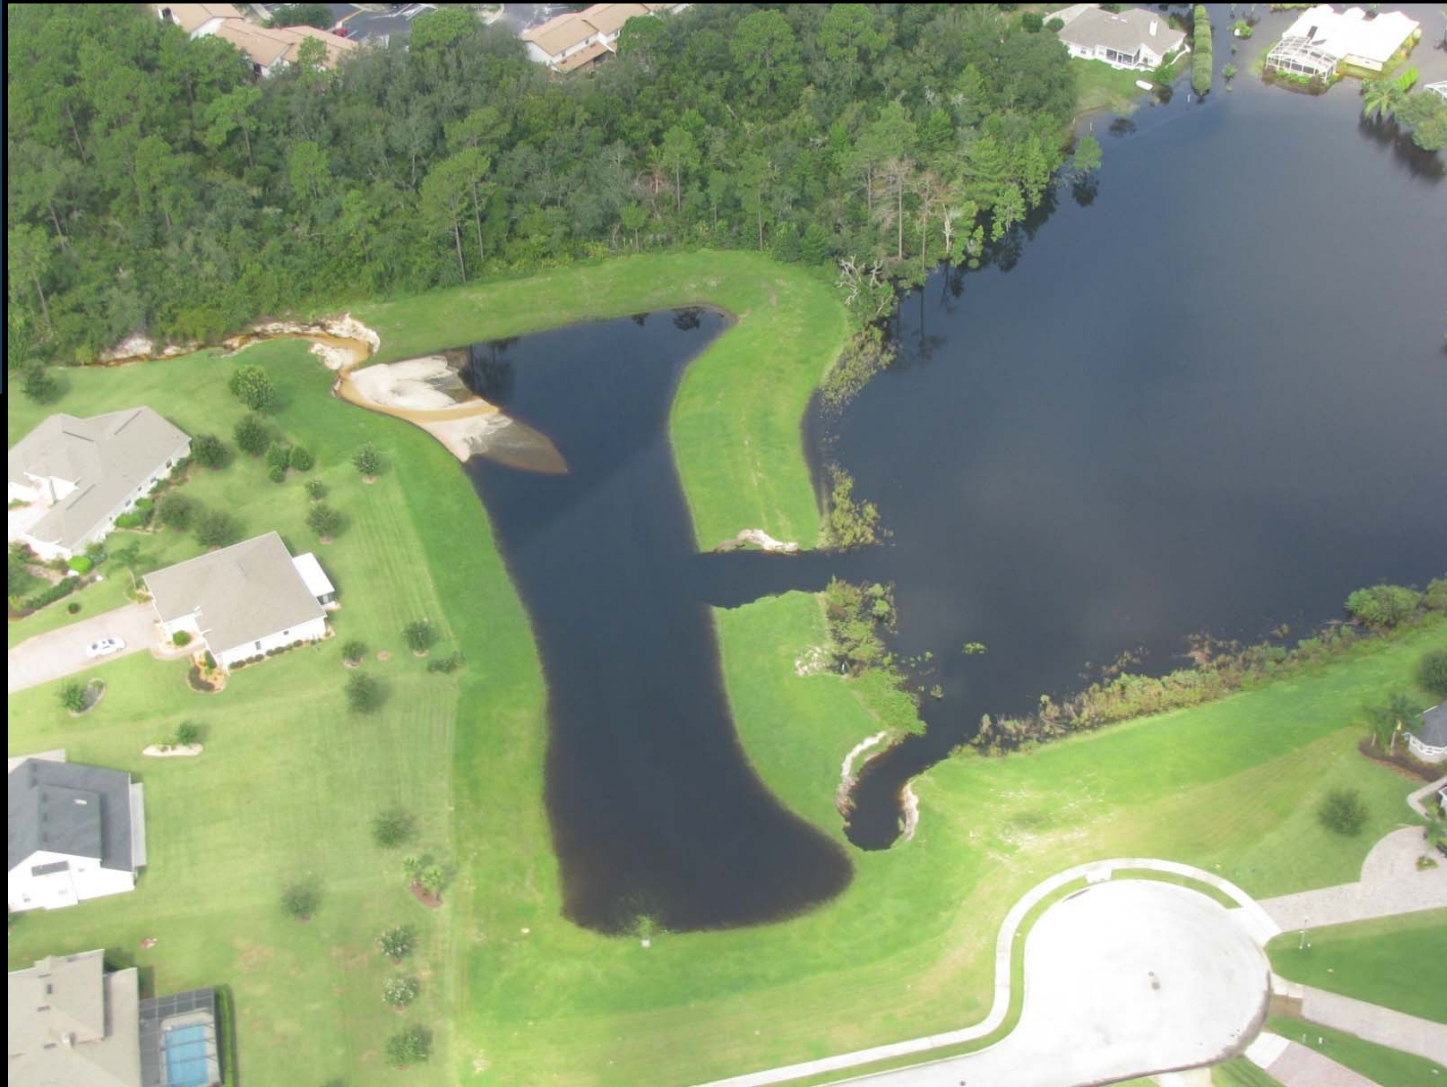
**Glen Club Drive Pond  
Berm Failure (Photo 2 of 4)**

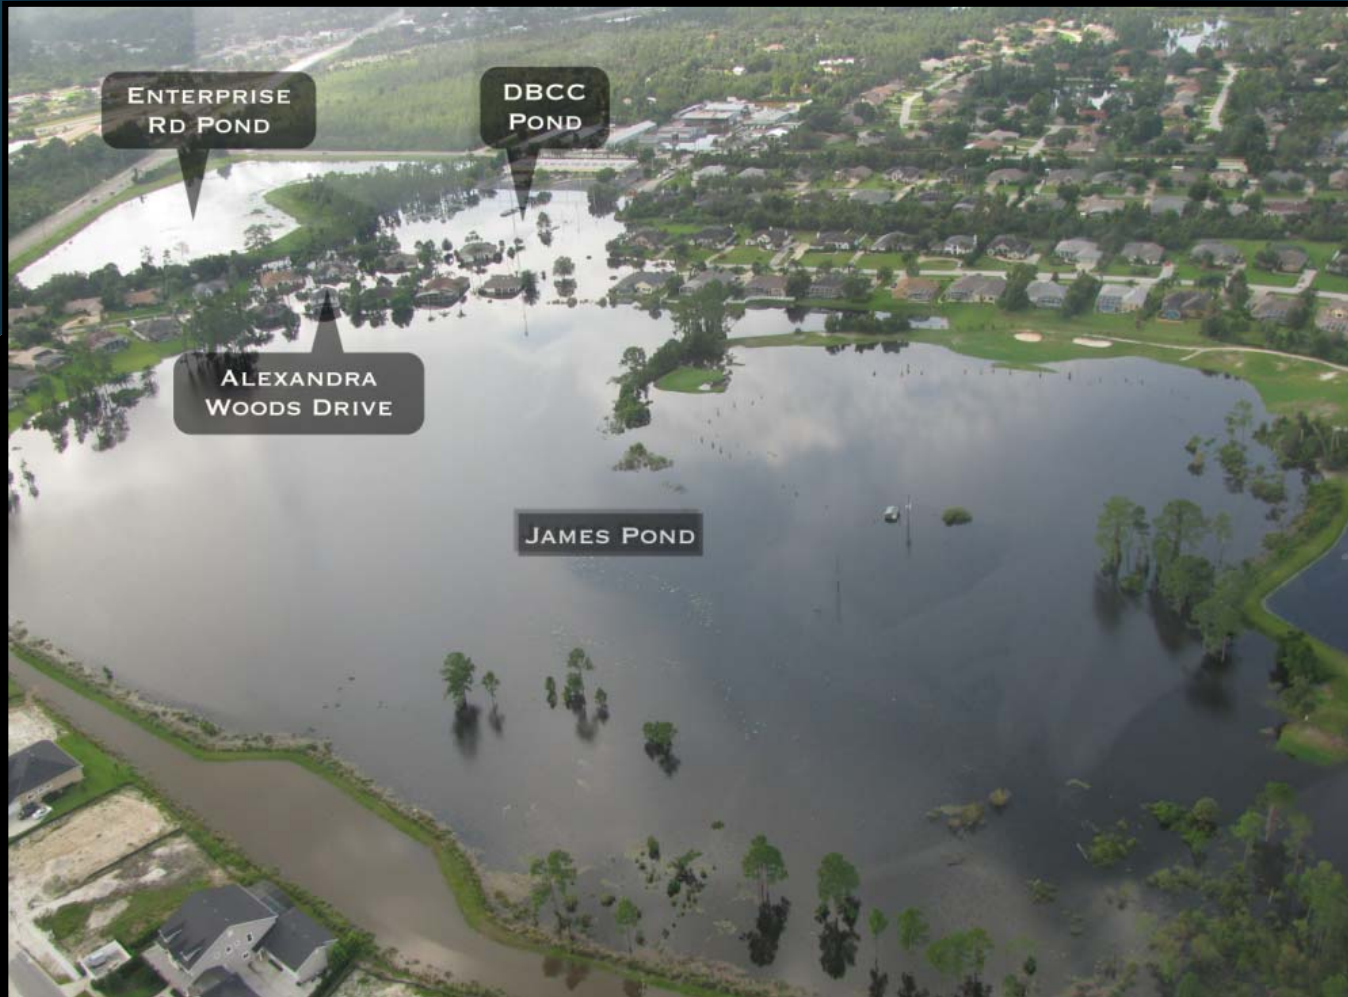
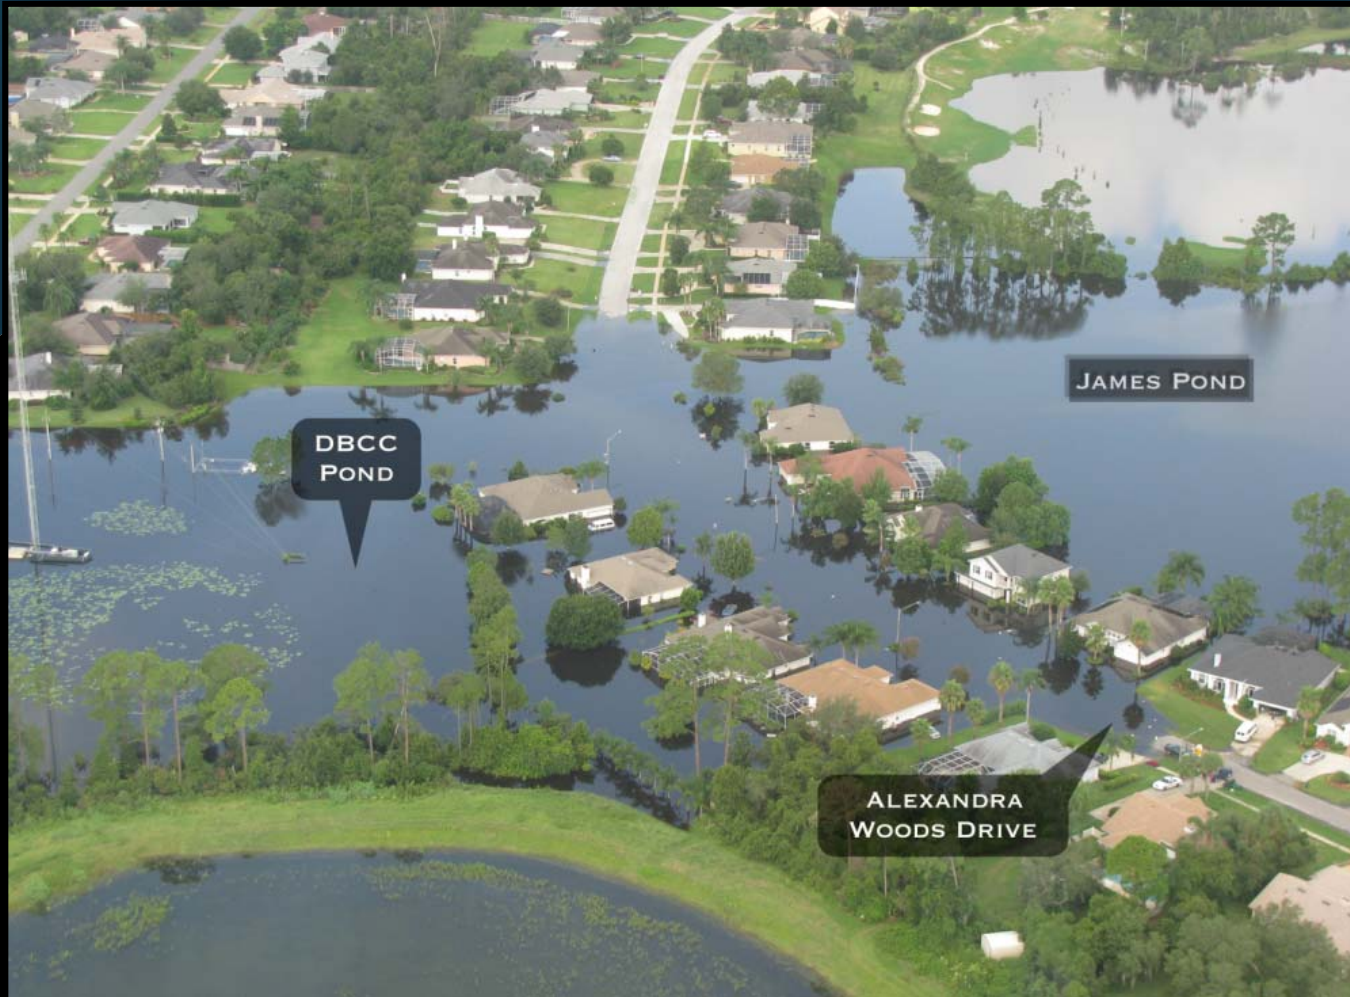
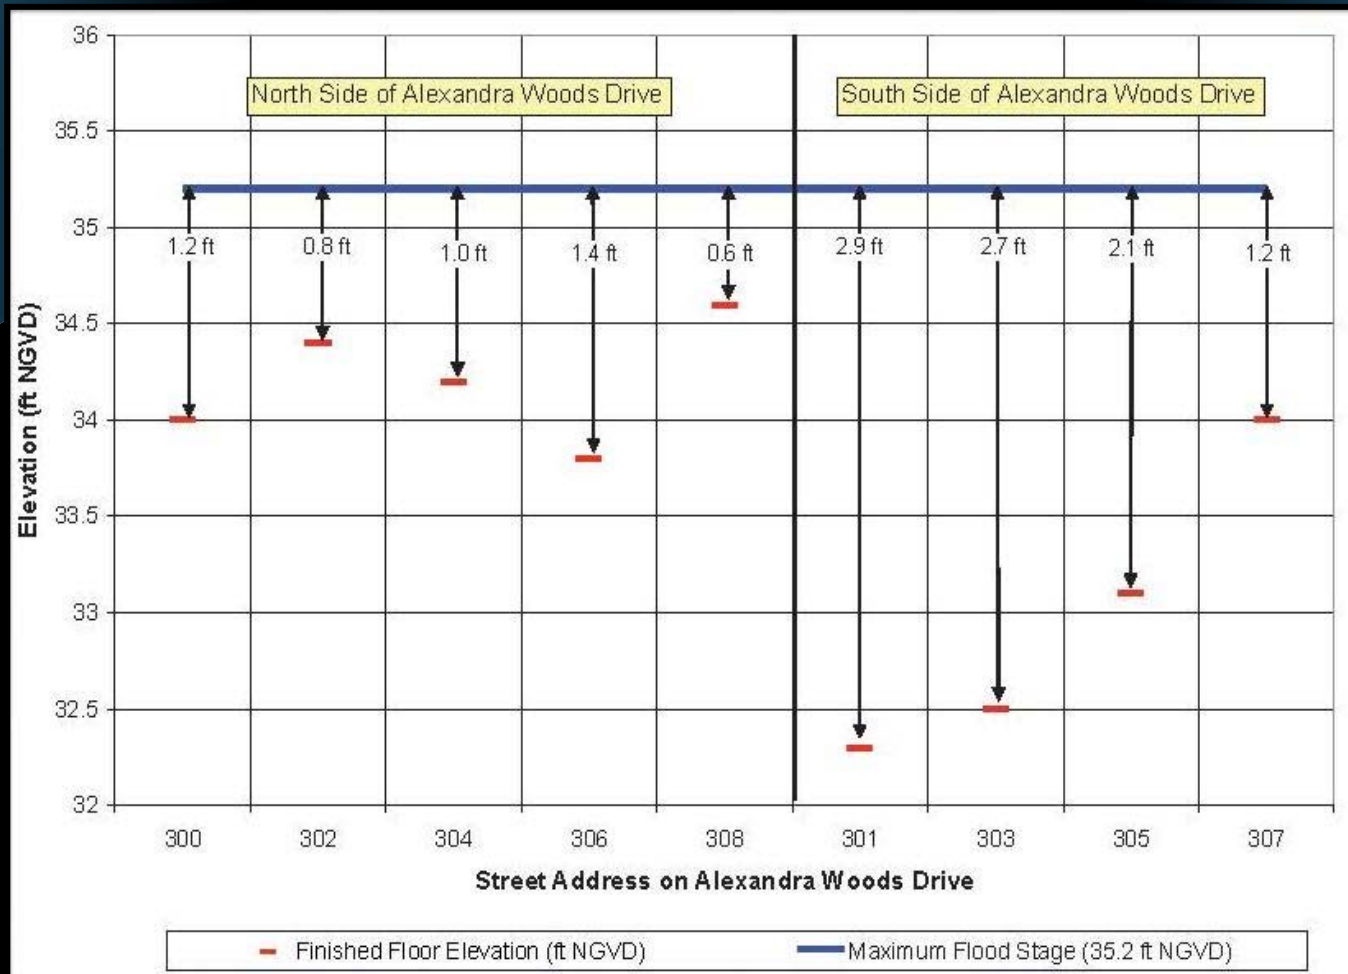
**Highbanks Enterprise Road Pond**  
**James Pond (9 structures flooded)**

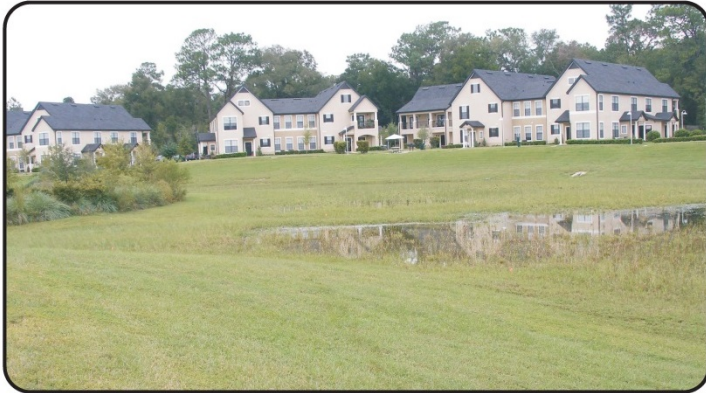
Photo 1. Shows Some Standing Water in Pond SMF-1 on October 24, 2007

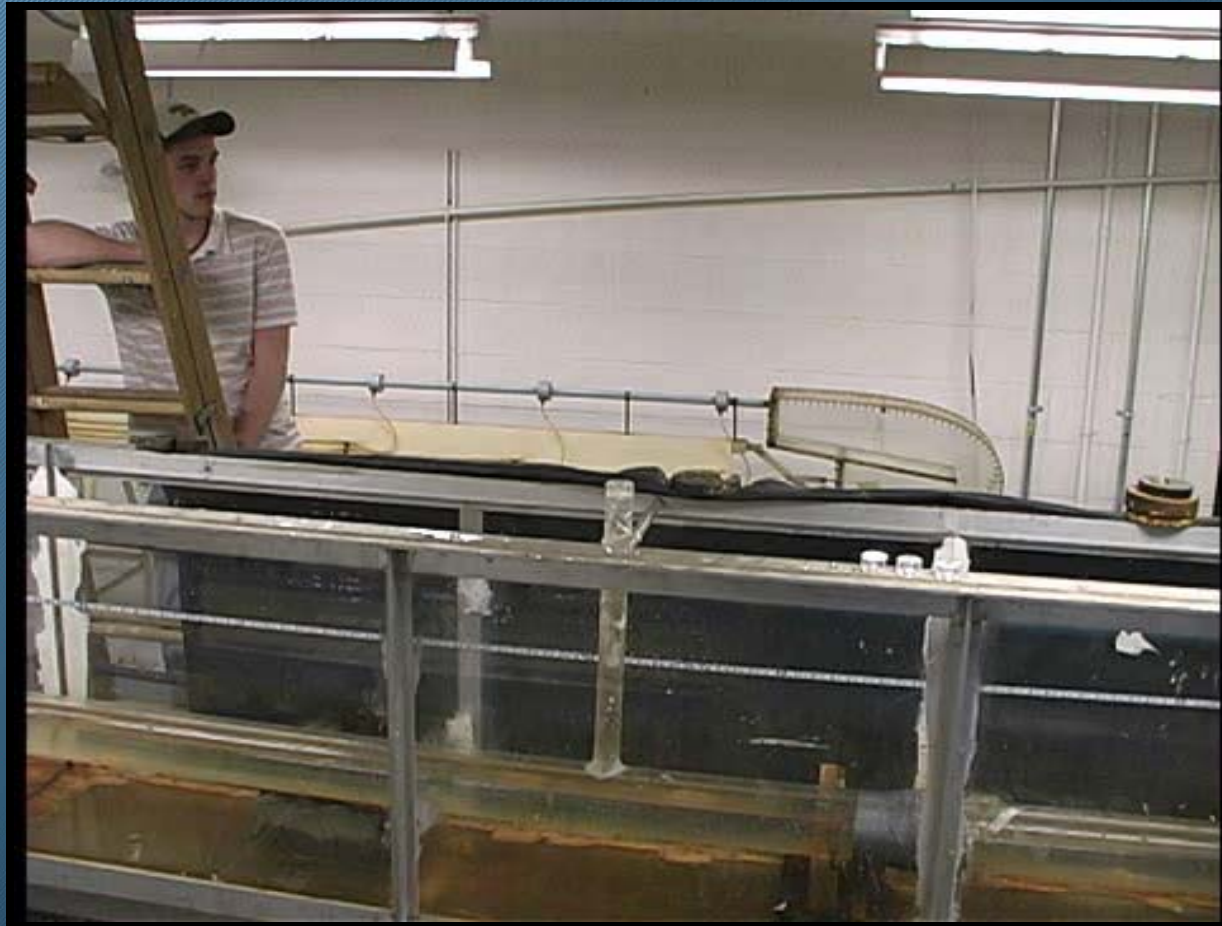
**Geyser**

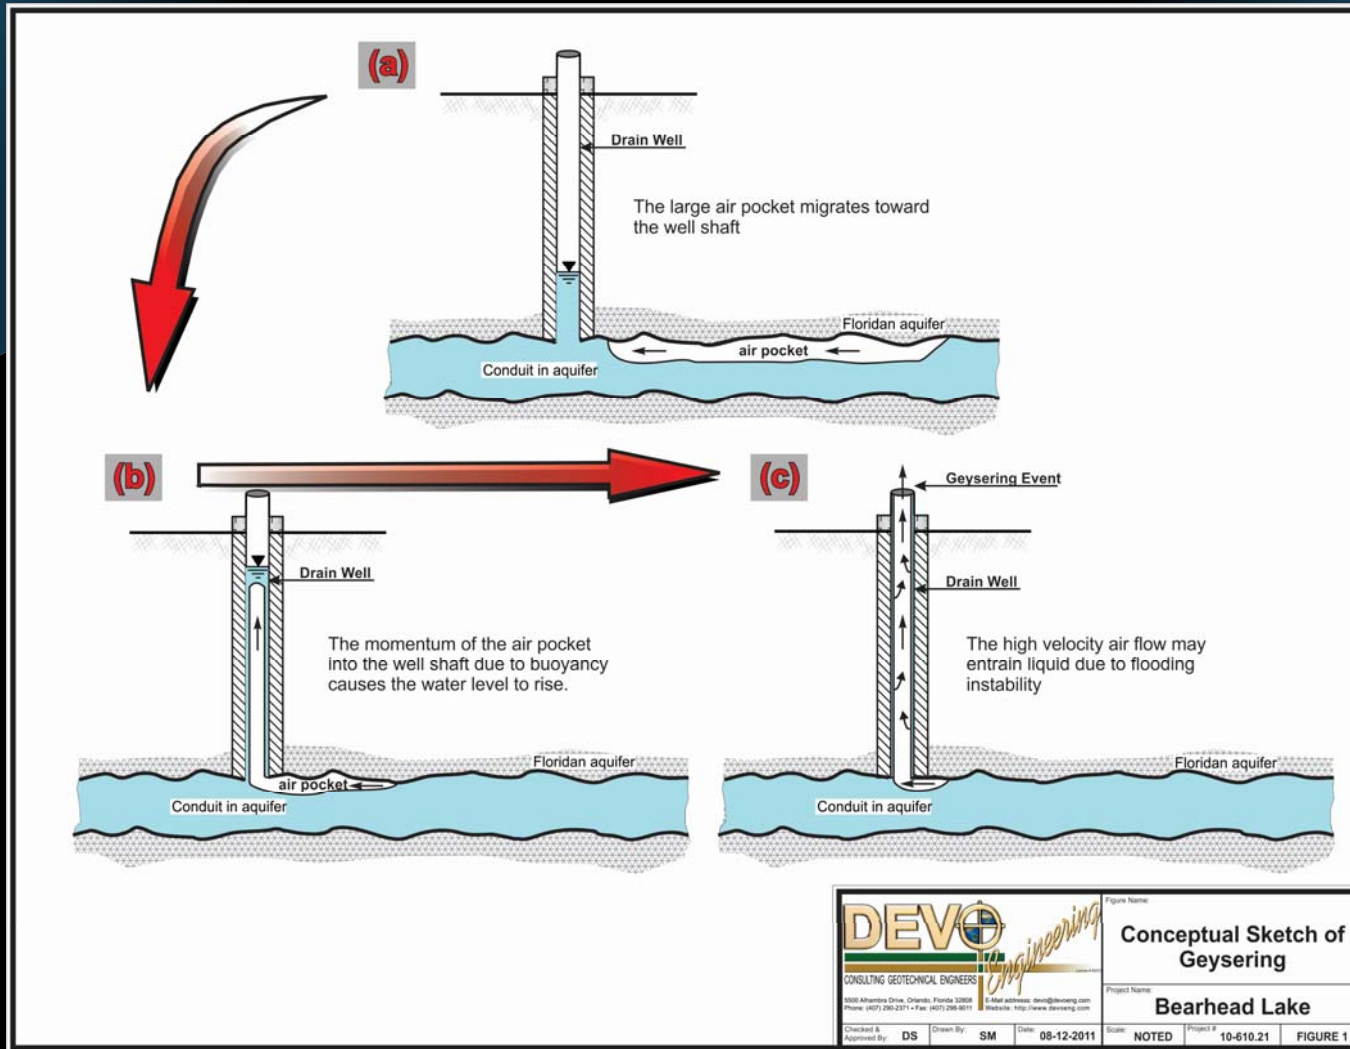
# Bearhead Lake Geysering

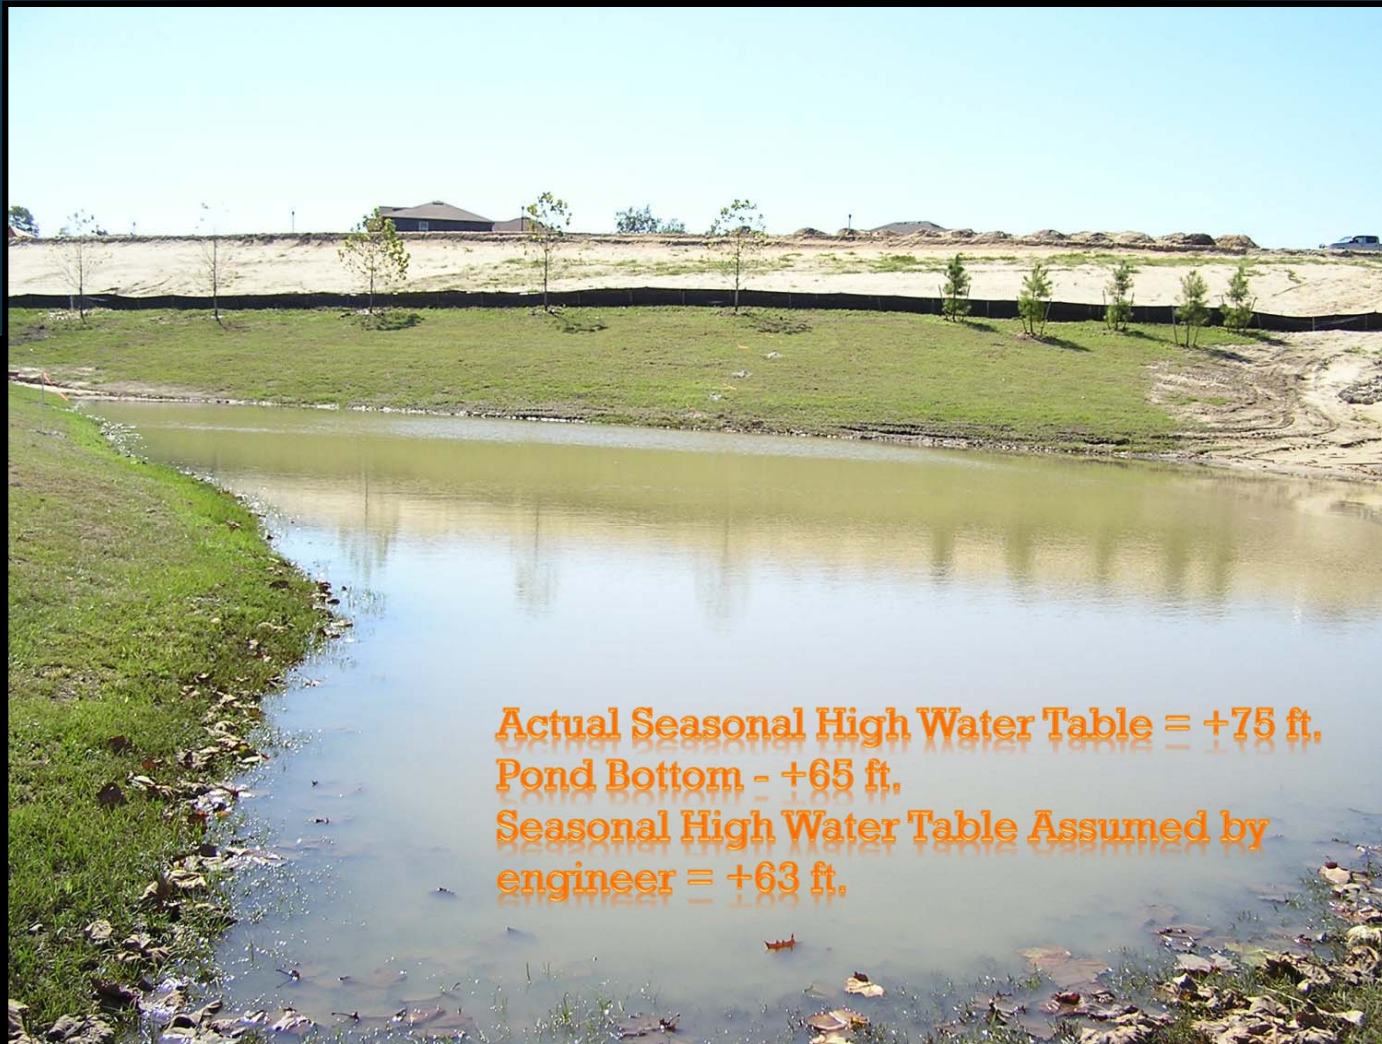
Actual Seasonal High Water Table = +75 ft,  
Pond Bottom - +65 ft,  
Seasonal High Water Table Assumed by  
engineer = +63 ft.

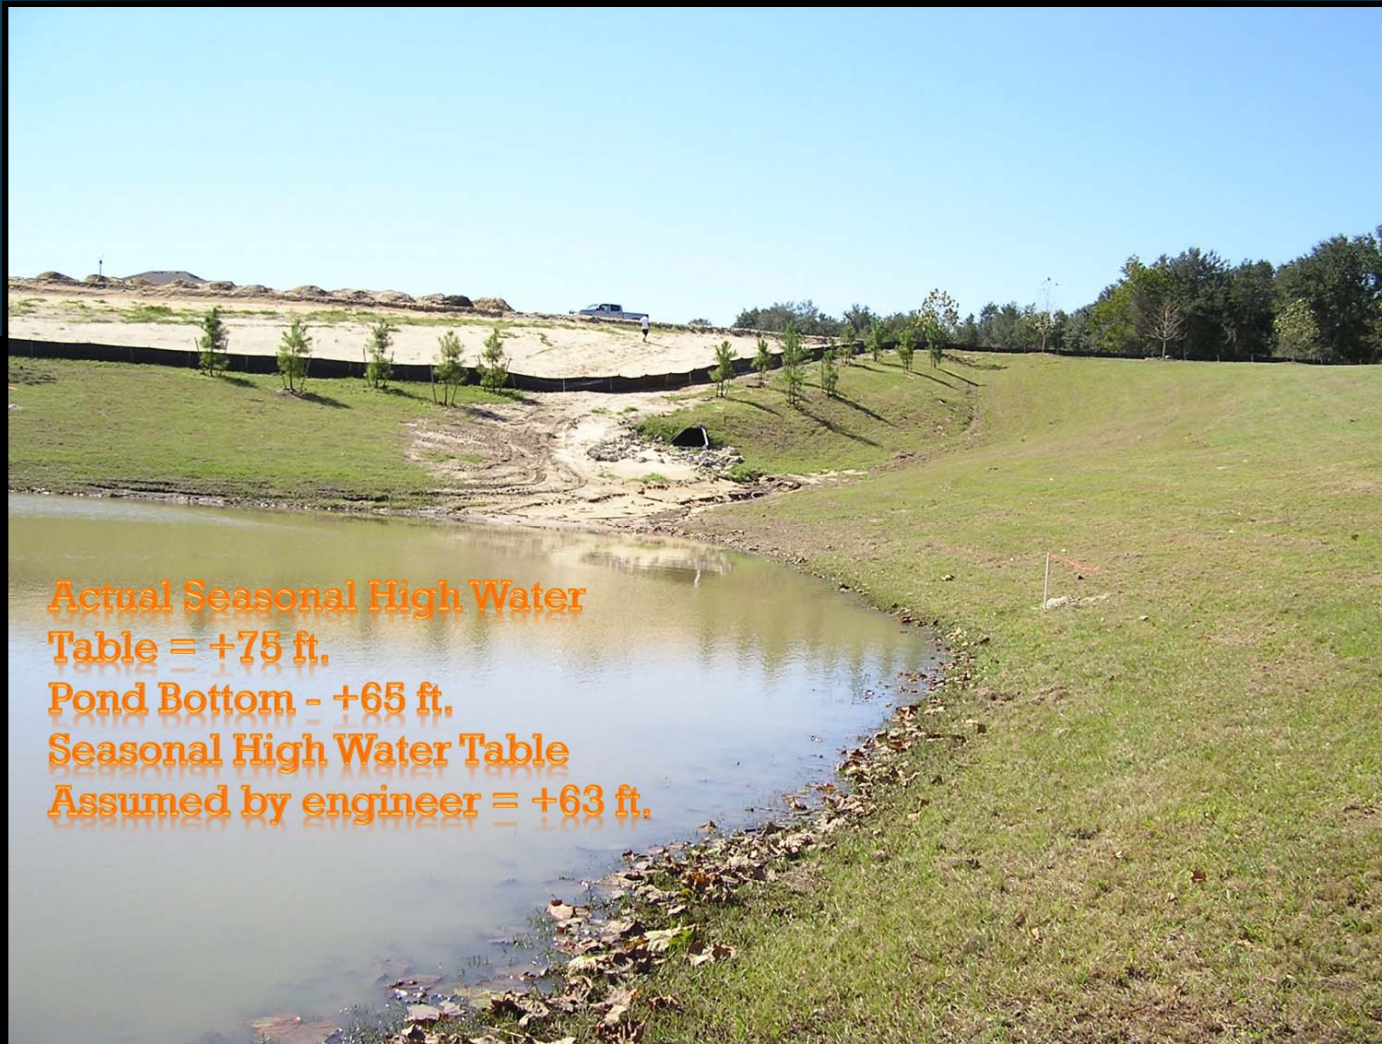
Actual Seasonal High Water  
Table = +75 ft.  
Pond Bottom - +65 ft.  
Seasonal High Water Table  
Assumed by engineer = +63 ft.

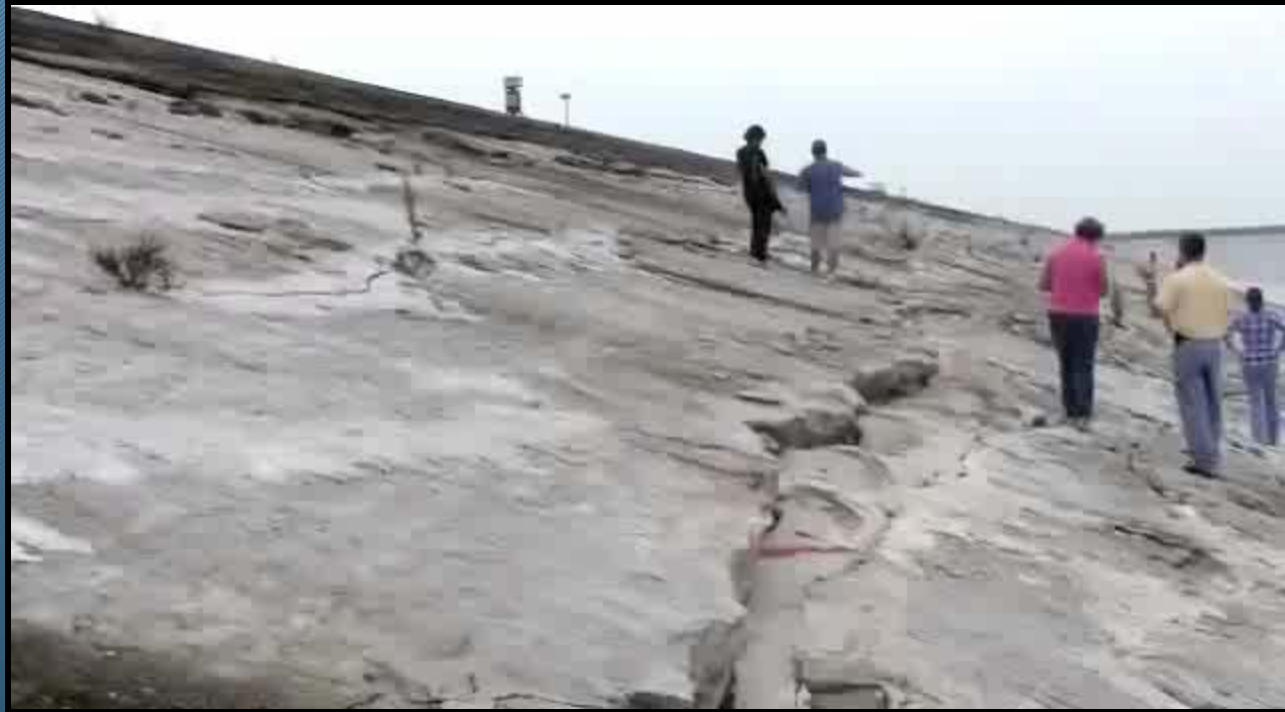
## Example of Cracking and Subsidence of Soil-Cement

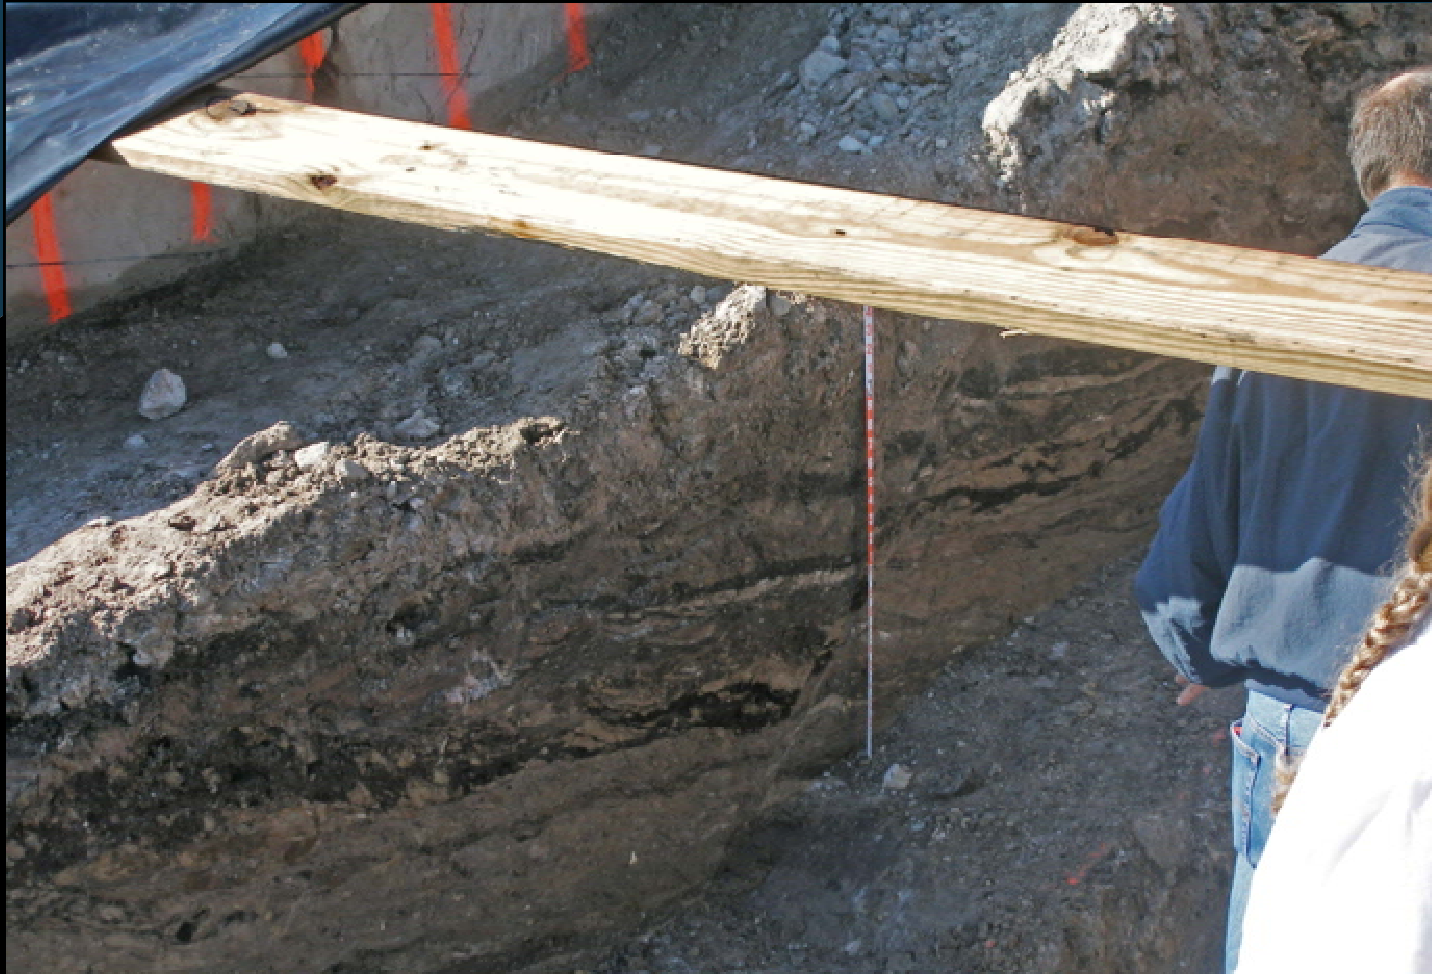
**Example of Test Pit Showing  
Shear Plane**

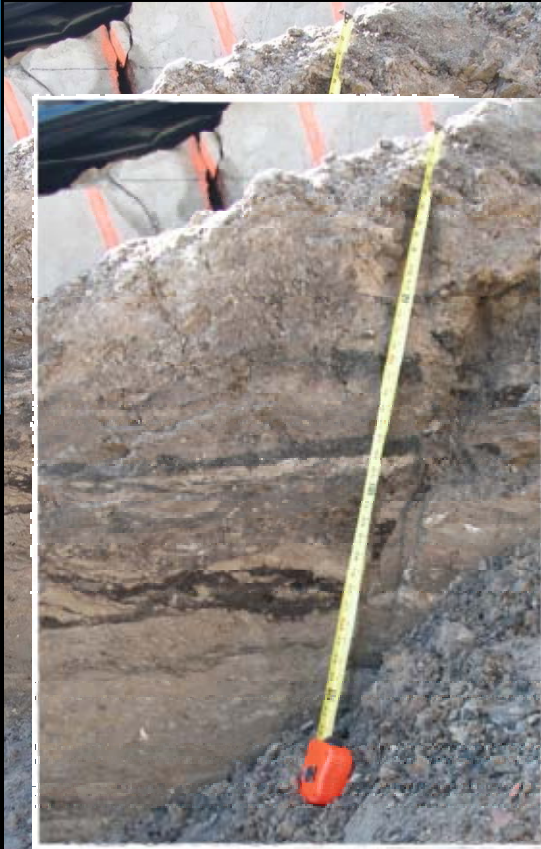
Close-up view of the shear failure plane on the southern pit wall

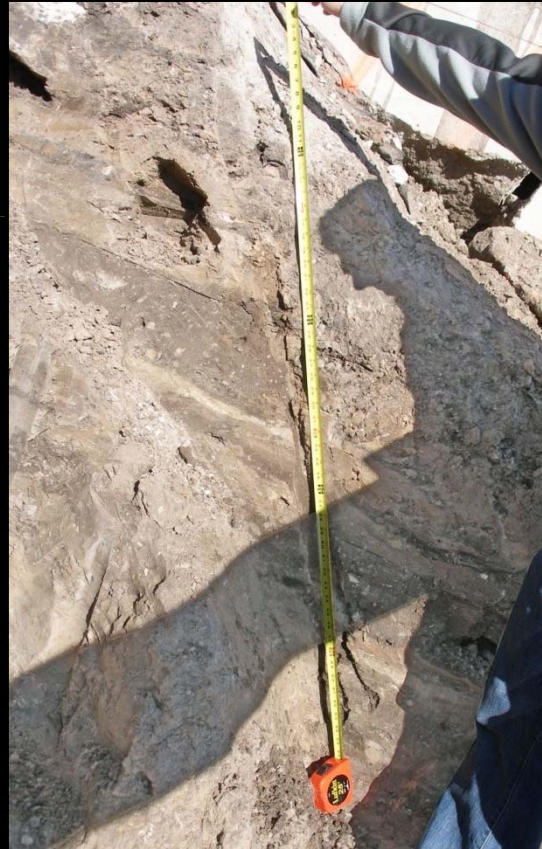
View looking at the shear failure plane on the northern pit wall

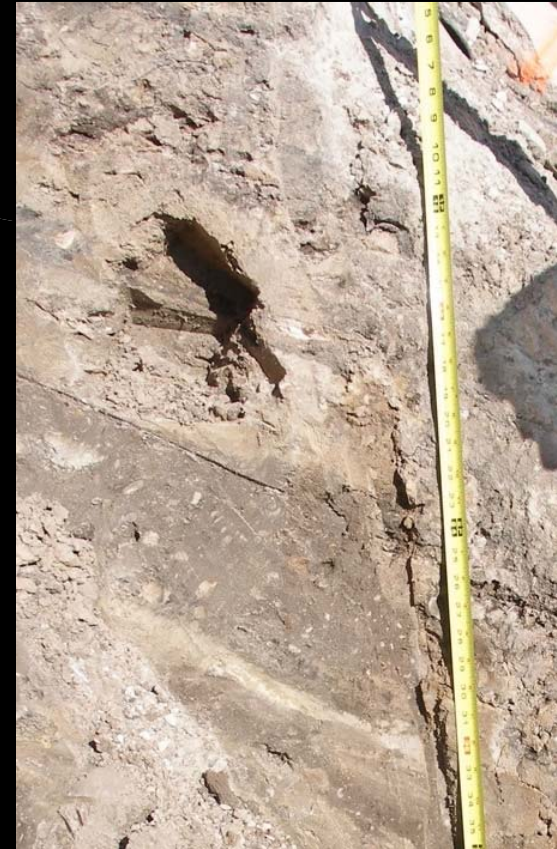
Close-up view of the shear failure plane on the northern pit wall
