PART 2

STORMWATER PERMITTING BIG PICTURE ISSUES

STORMWATER 2005

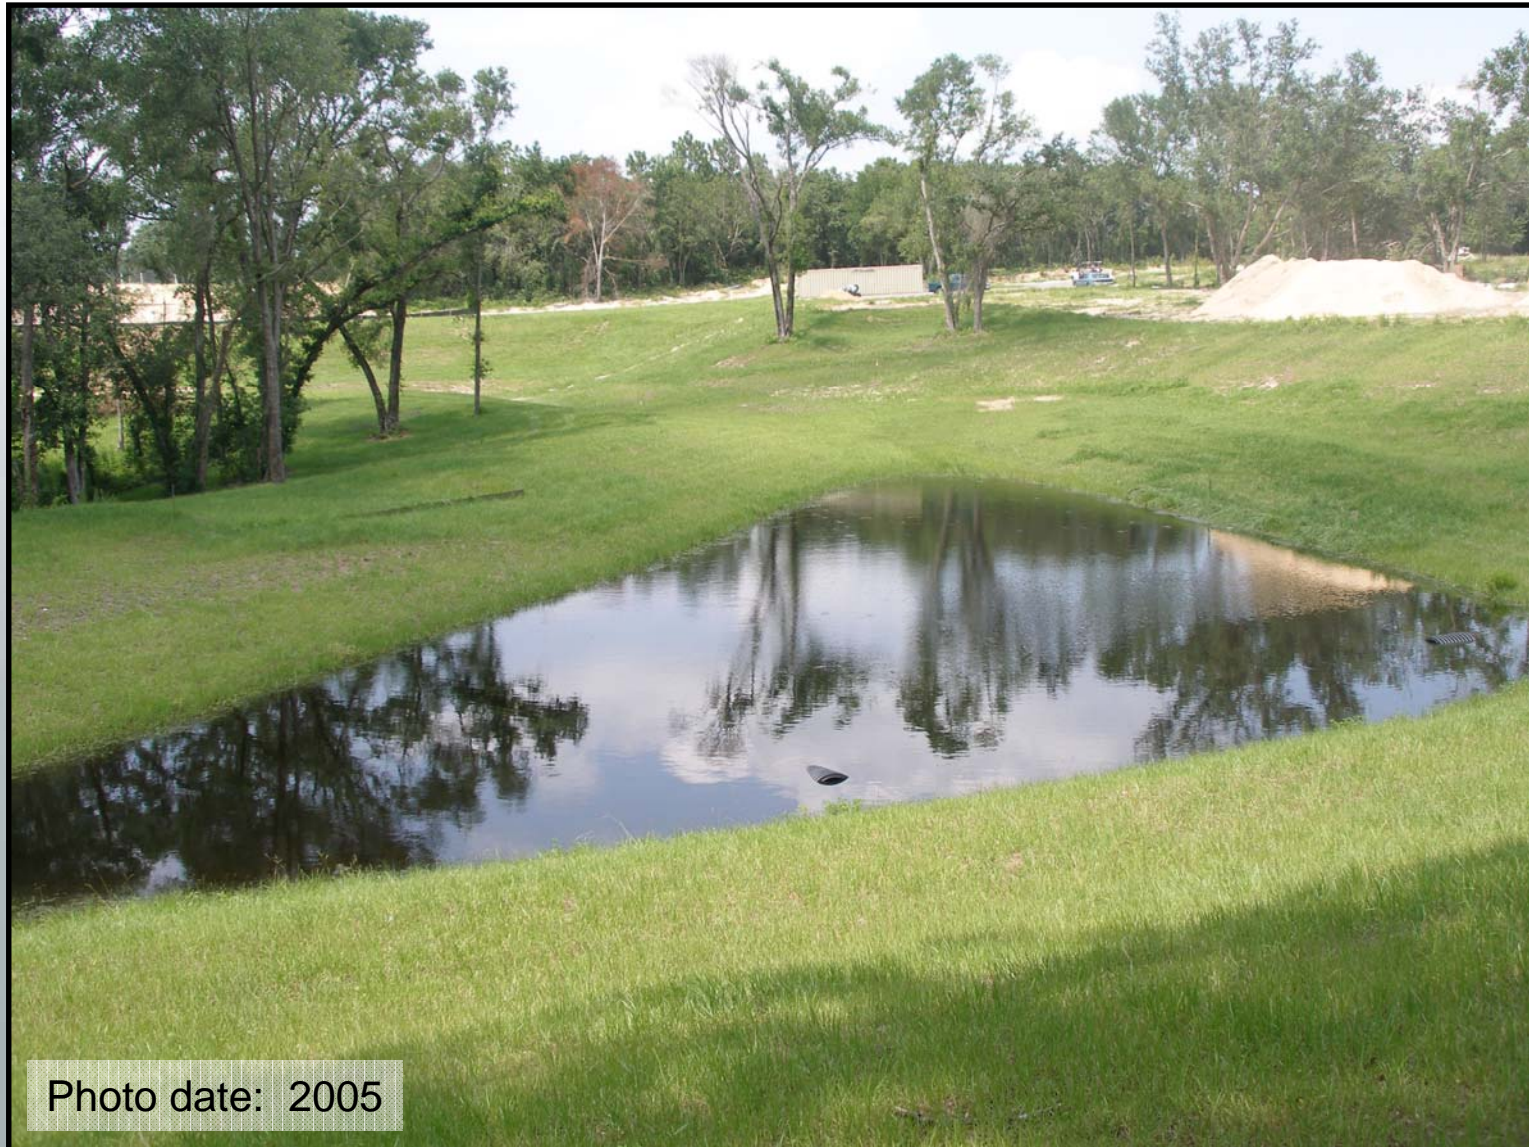
Wekiva Run – Pond 3

Dry Bottom Ponds Excavated into Clayey Soils

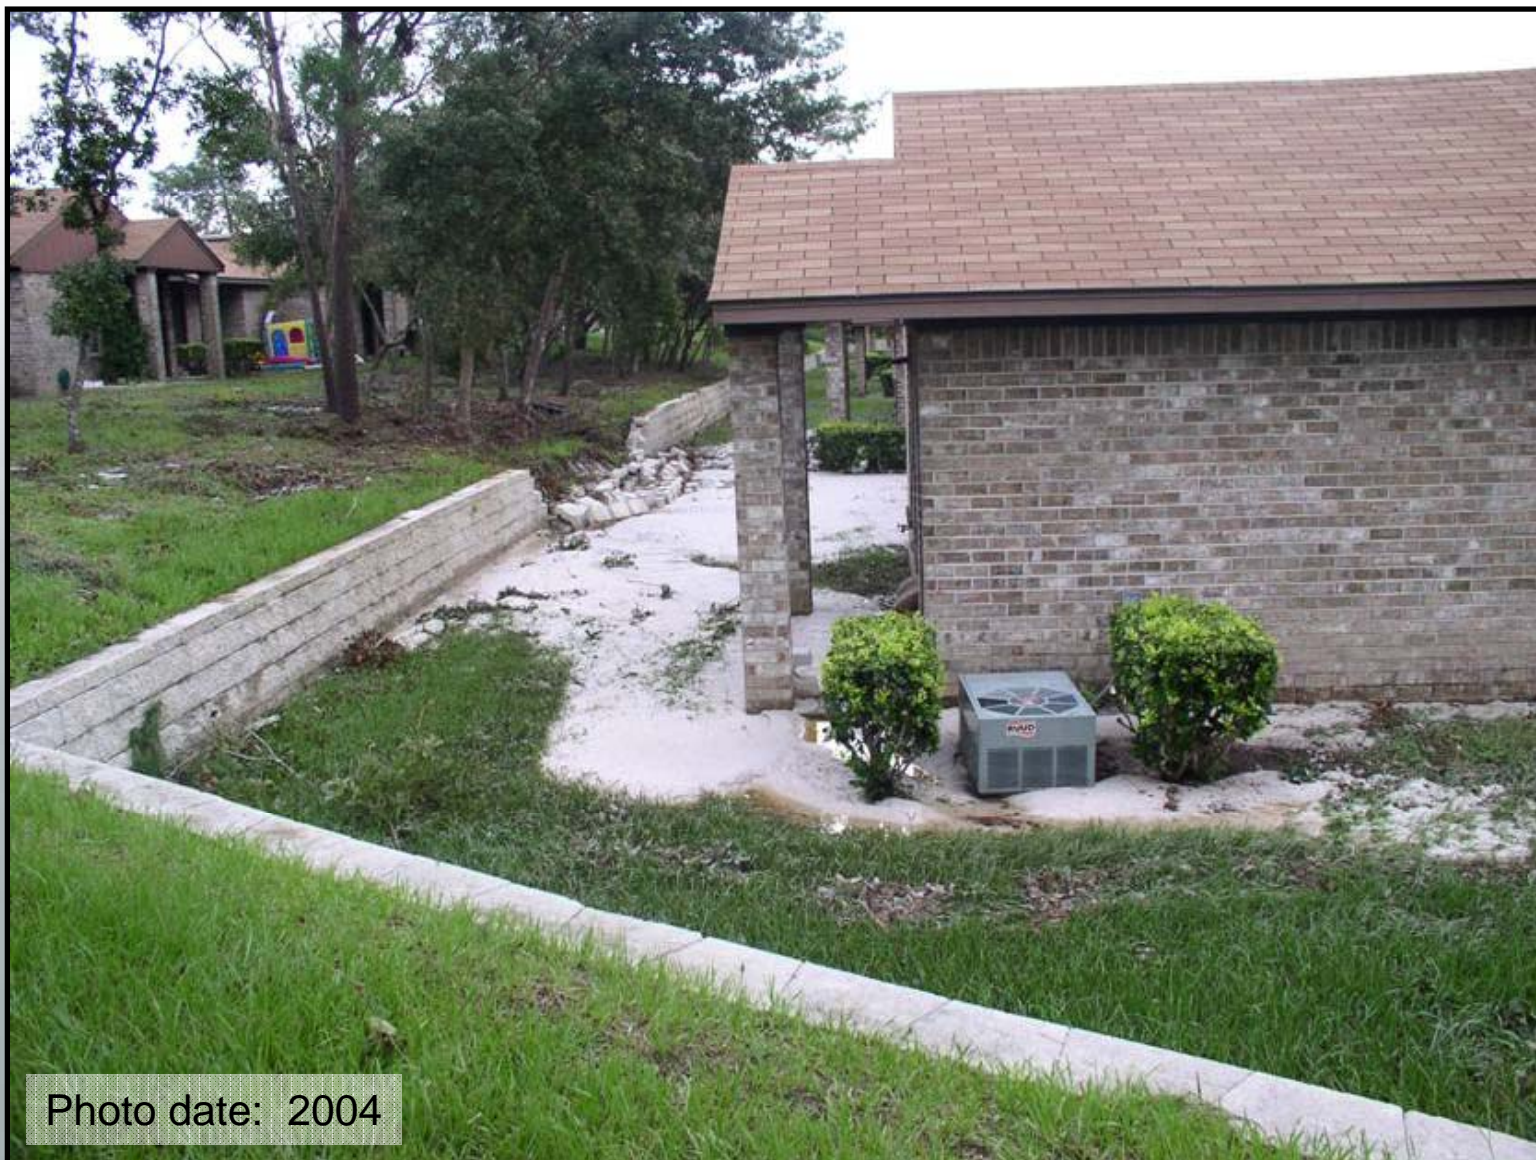
Site in Debarry

Pond Berm Failures & Flooding Consequences

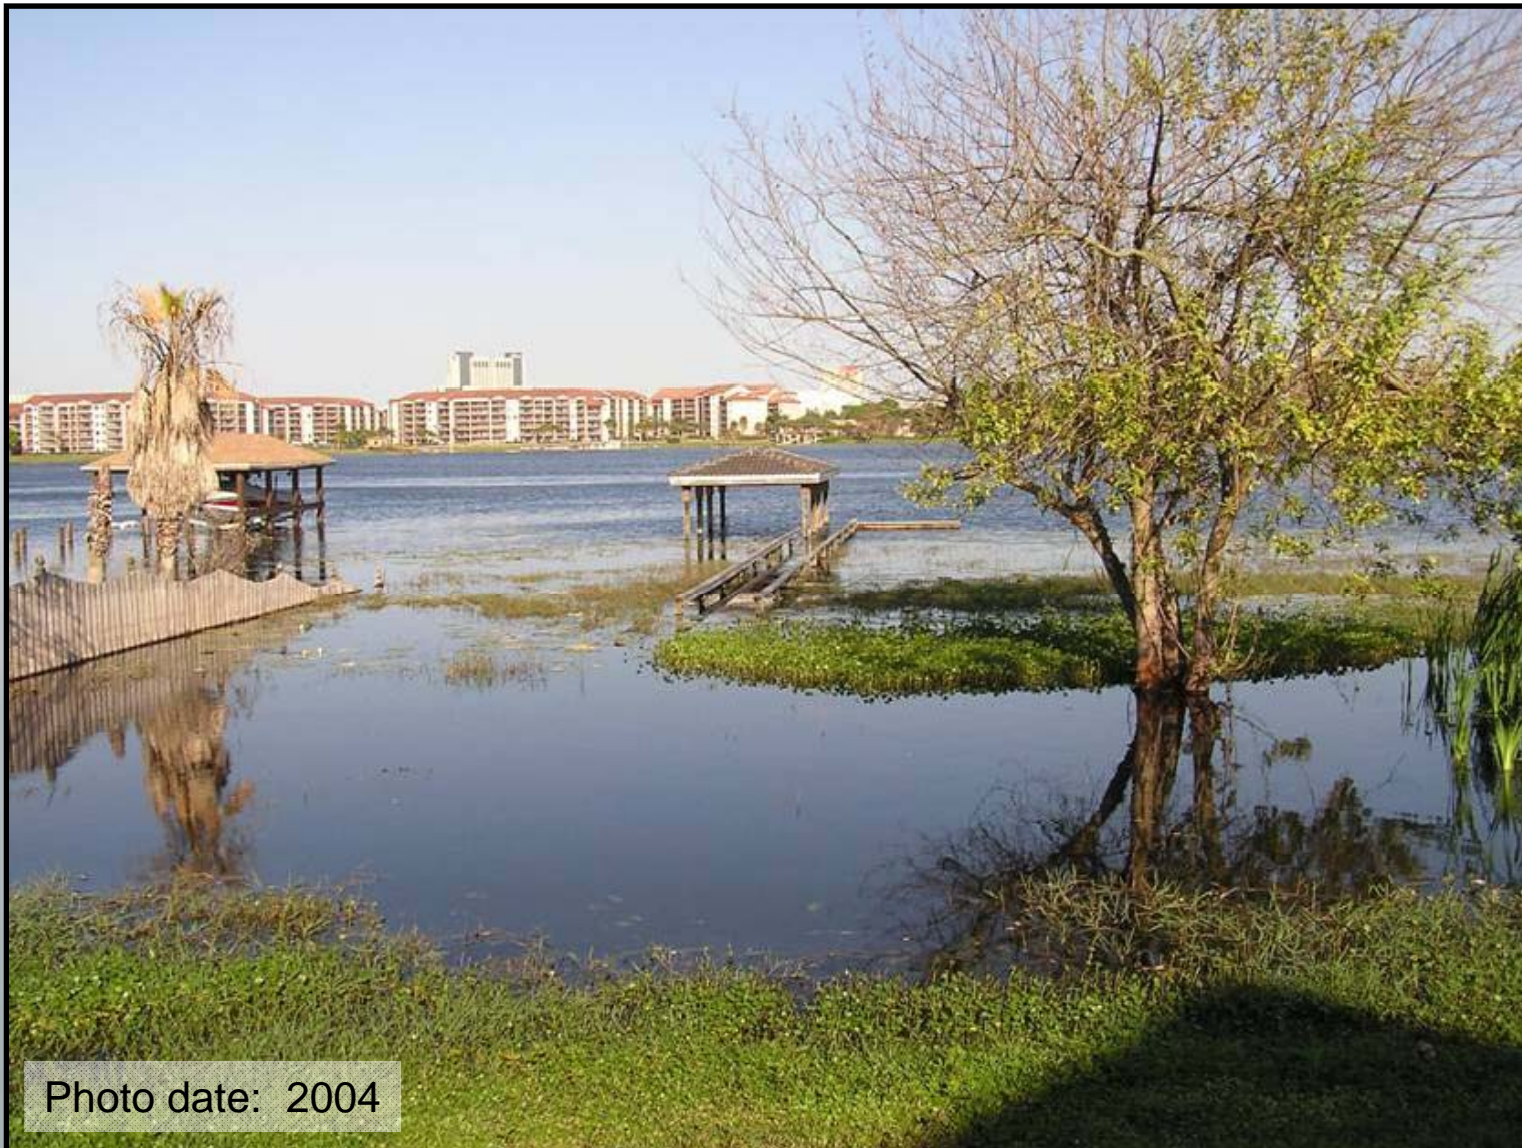
Big Sand Lake

Flooding of Land Locked Lakes

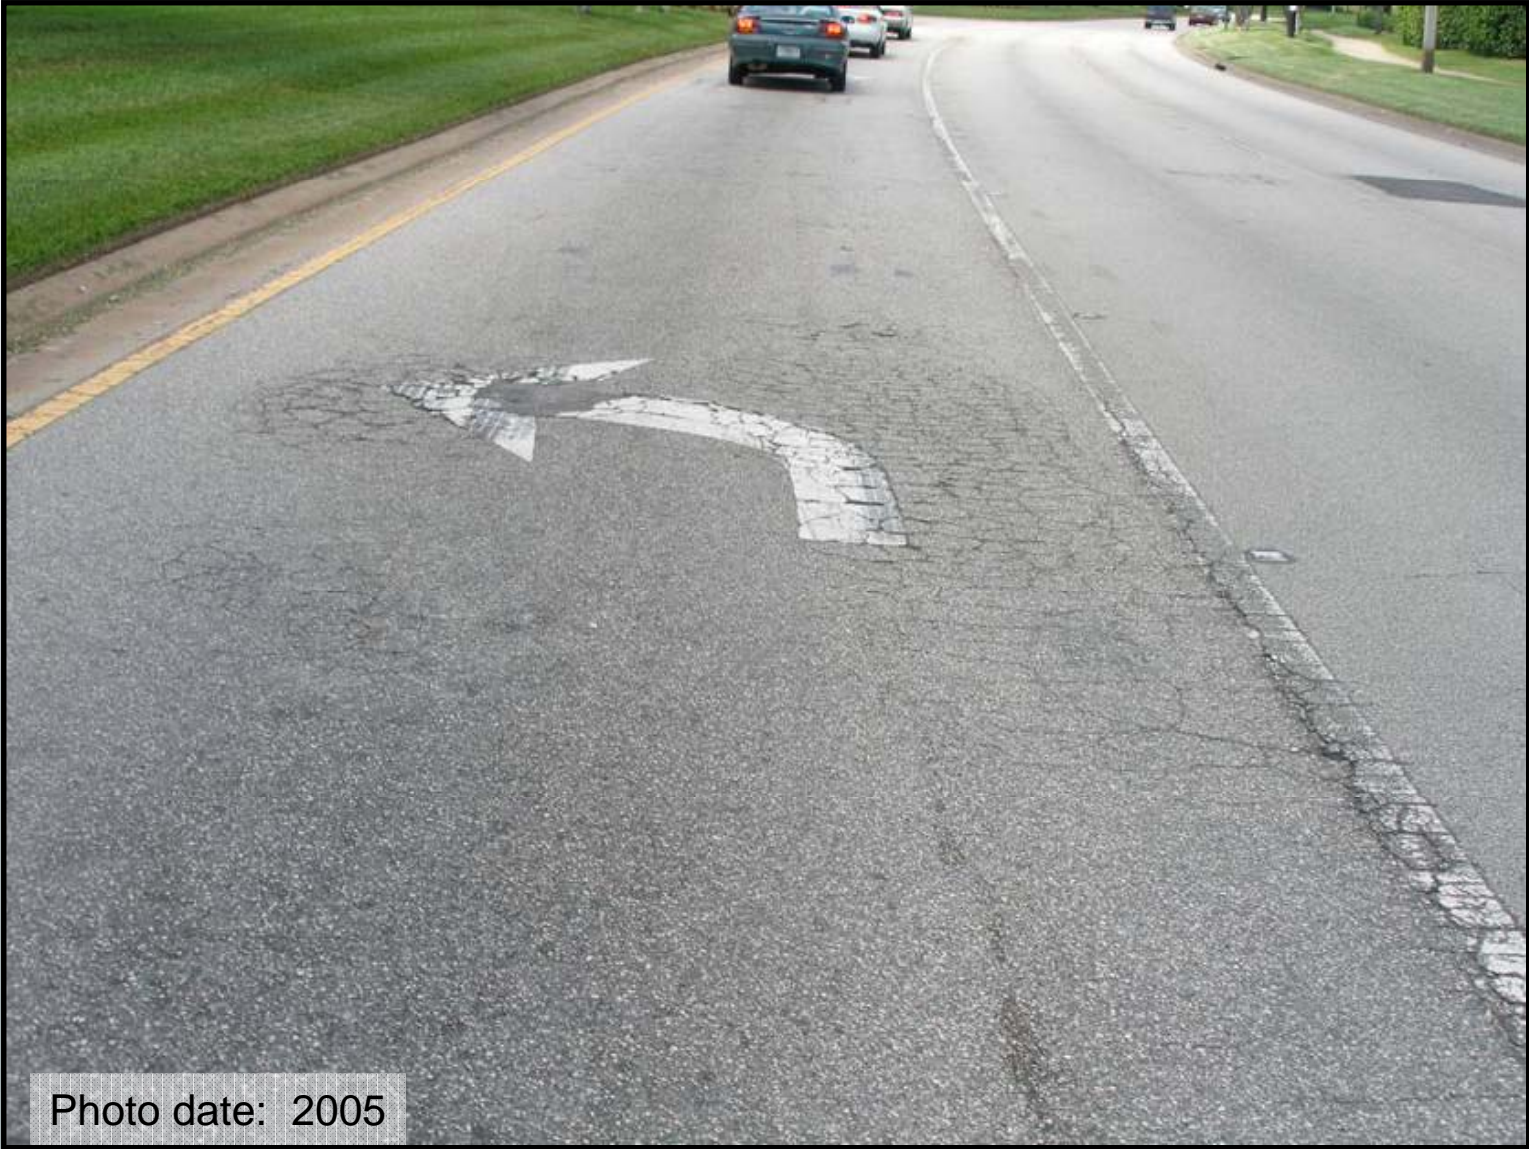
Hiawassee Road

Pavement Failure Due to Over Irrigation of Landscape Areas

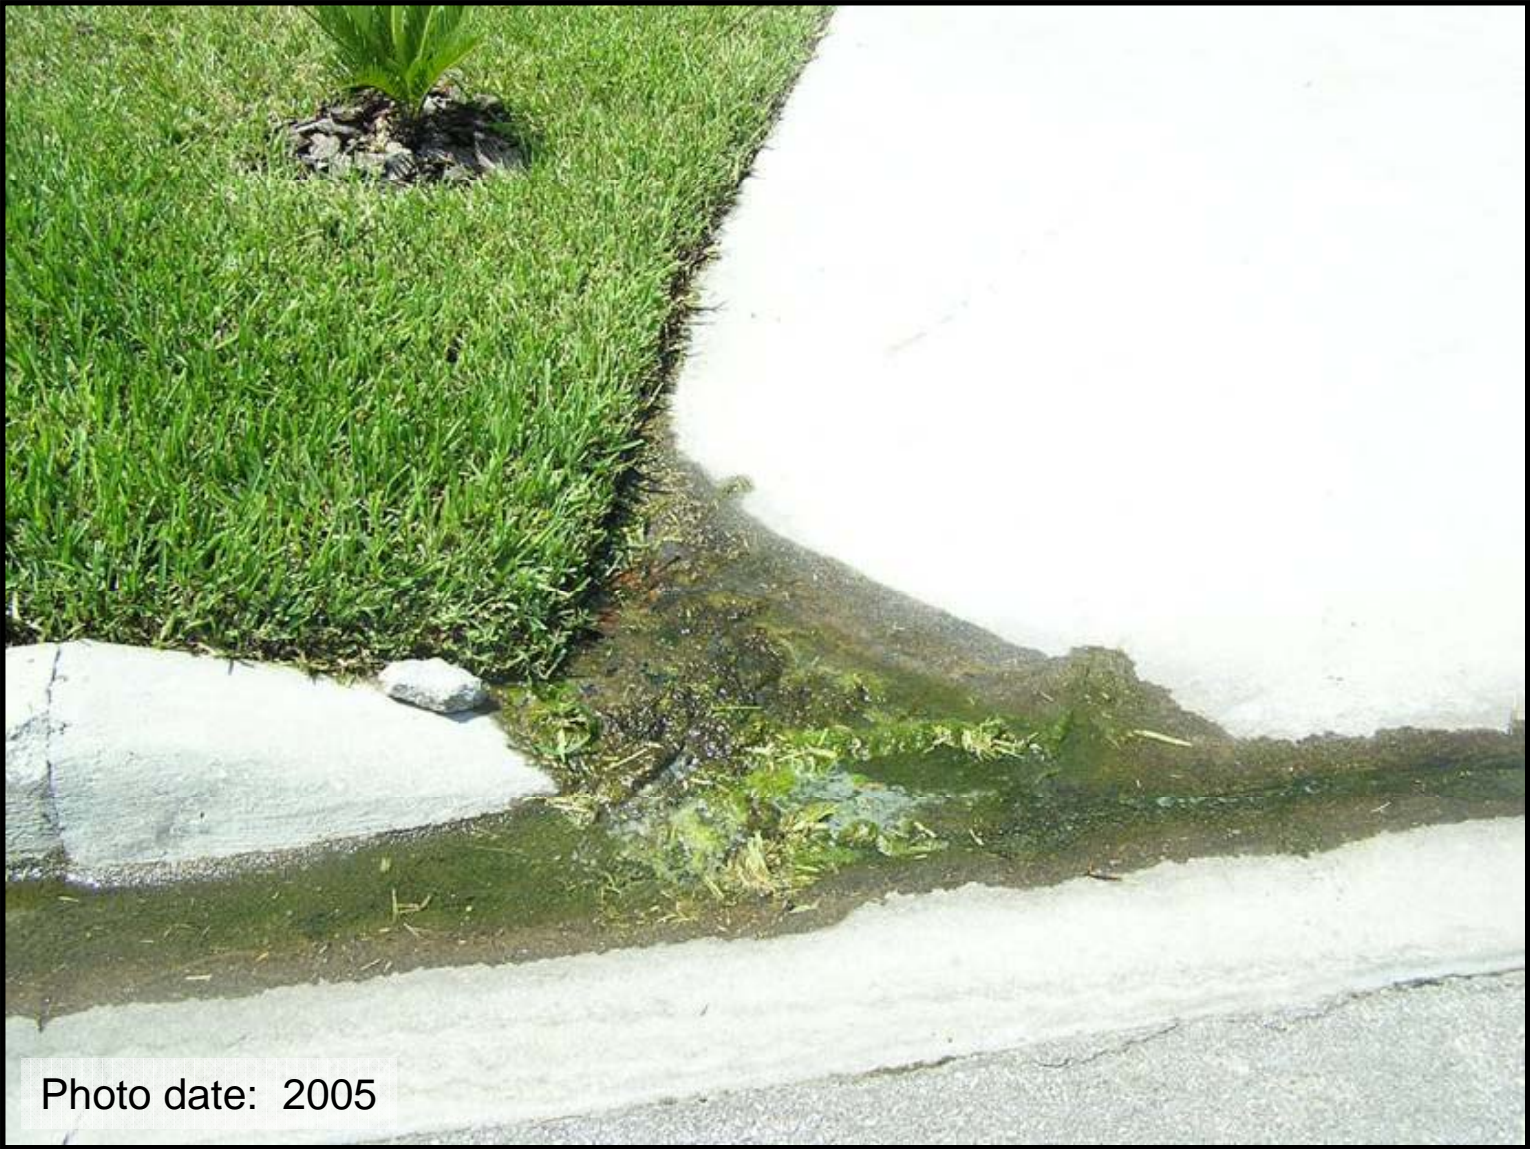
Site in Windermere

Perched Water Table Due to Low Permeability Lot Fill

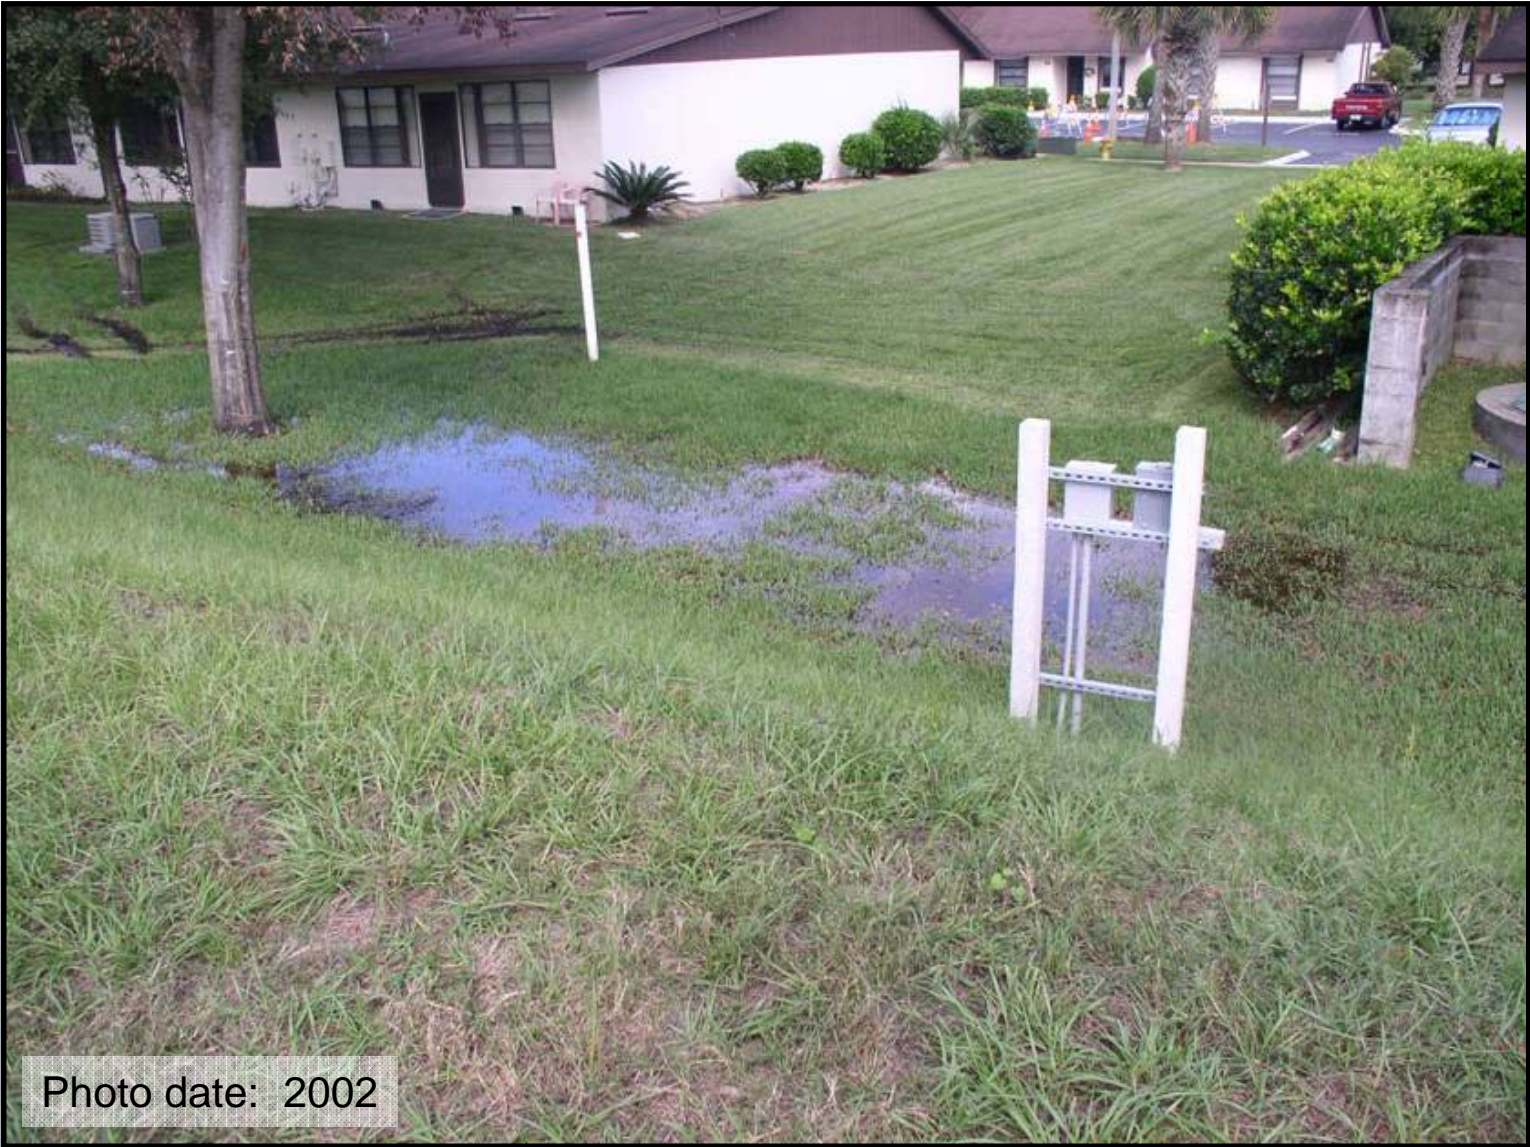
FDOT Saxon Pond

Seepage Through Pond Berms

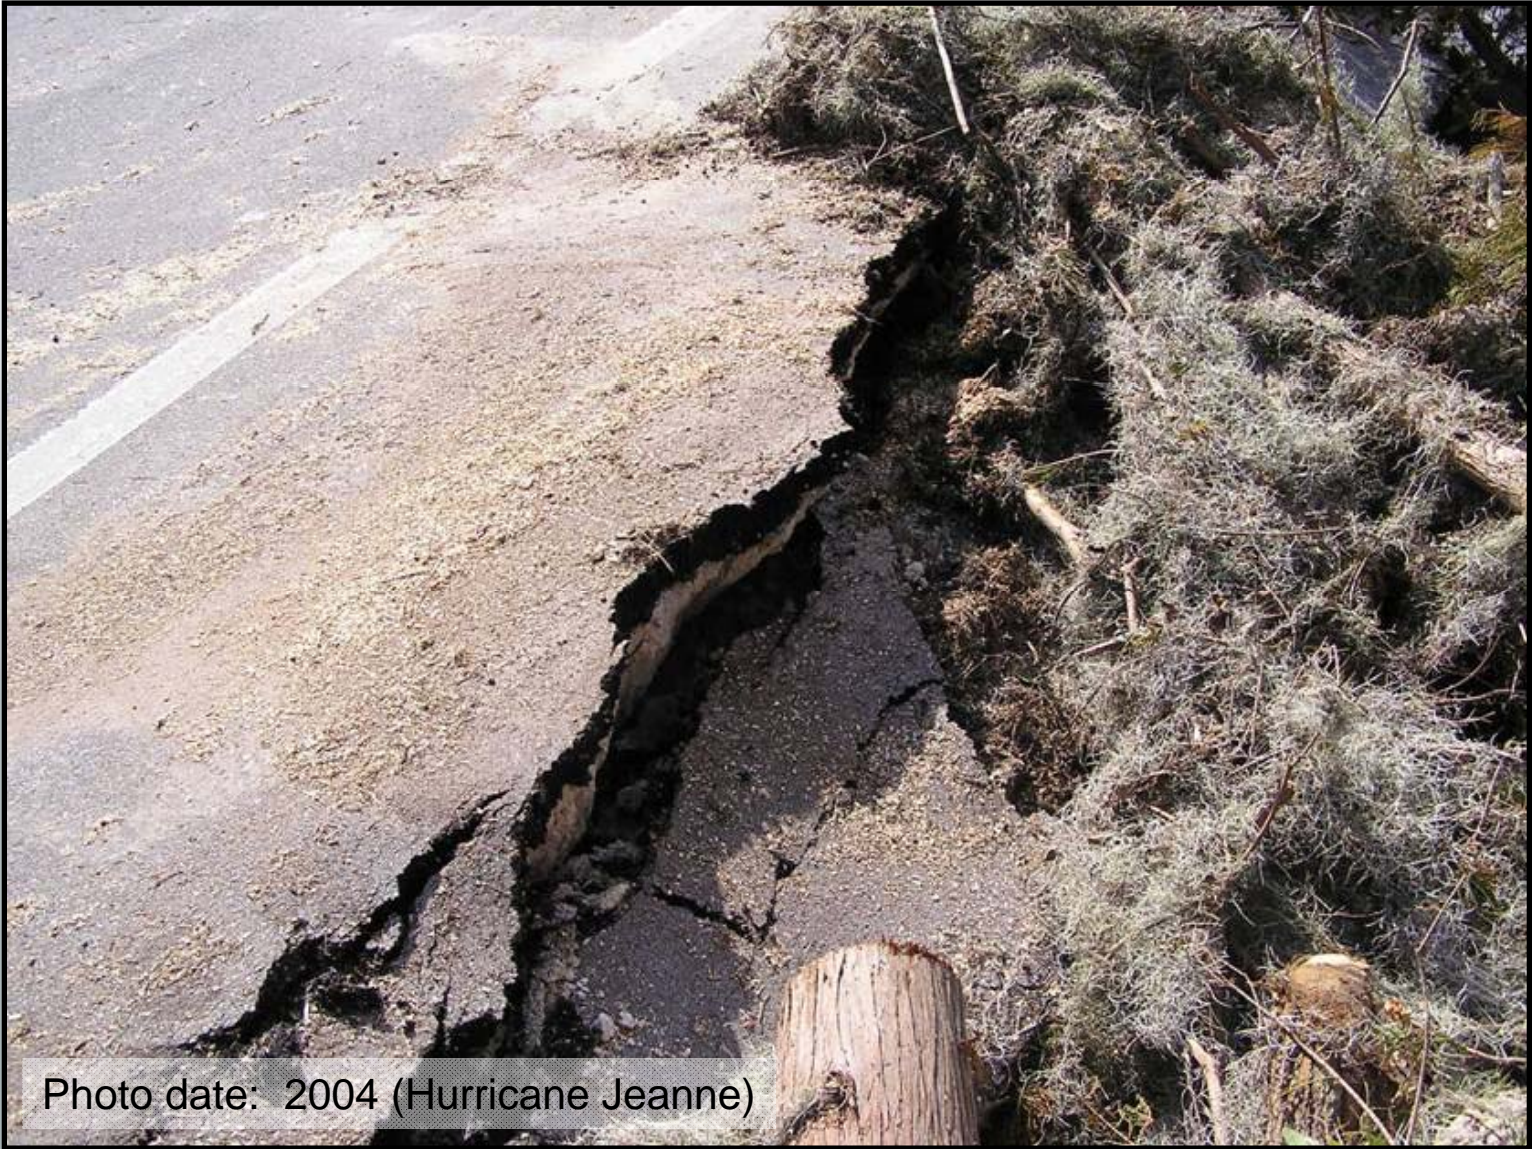
CR 561 Clermont

Side Slope Failures Due to Storm-Induced Wave Action

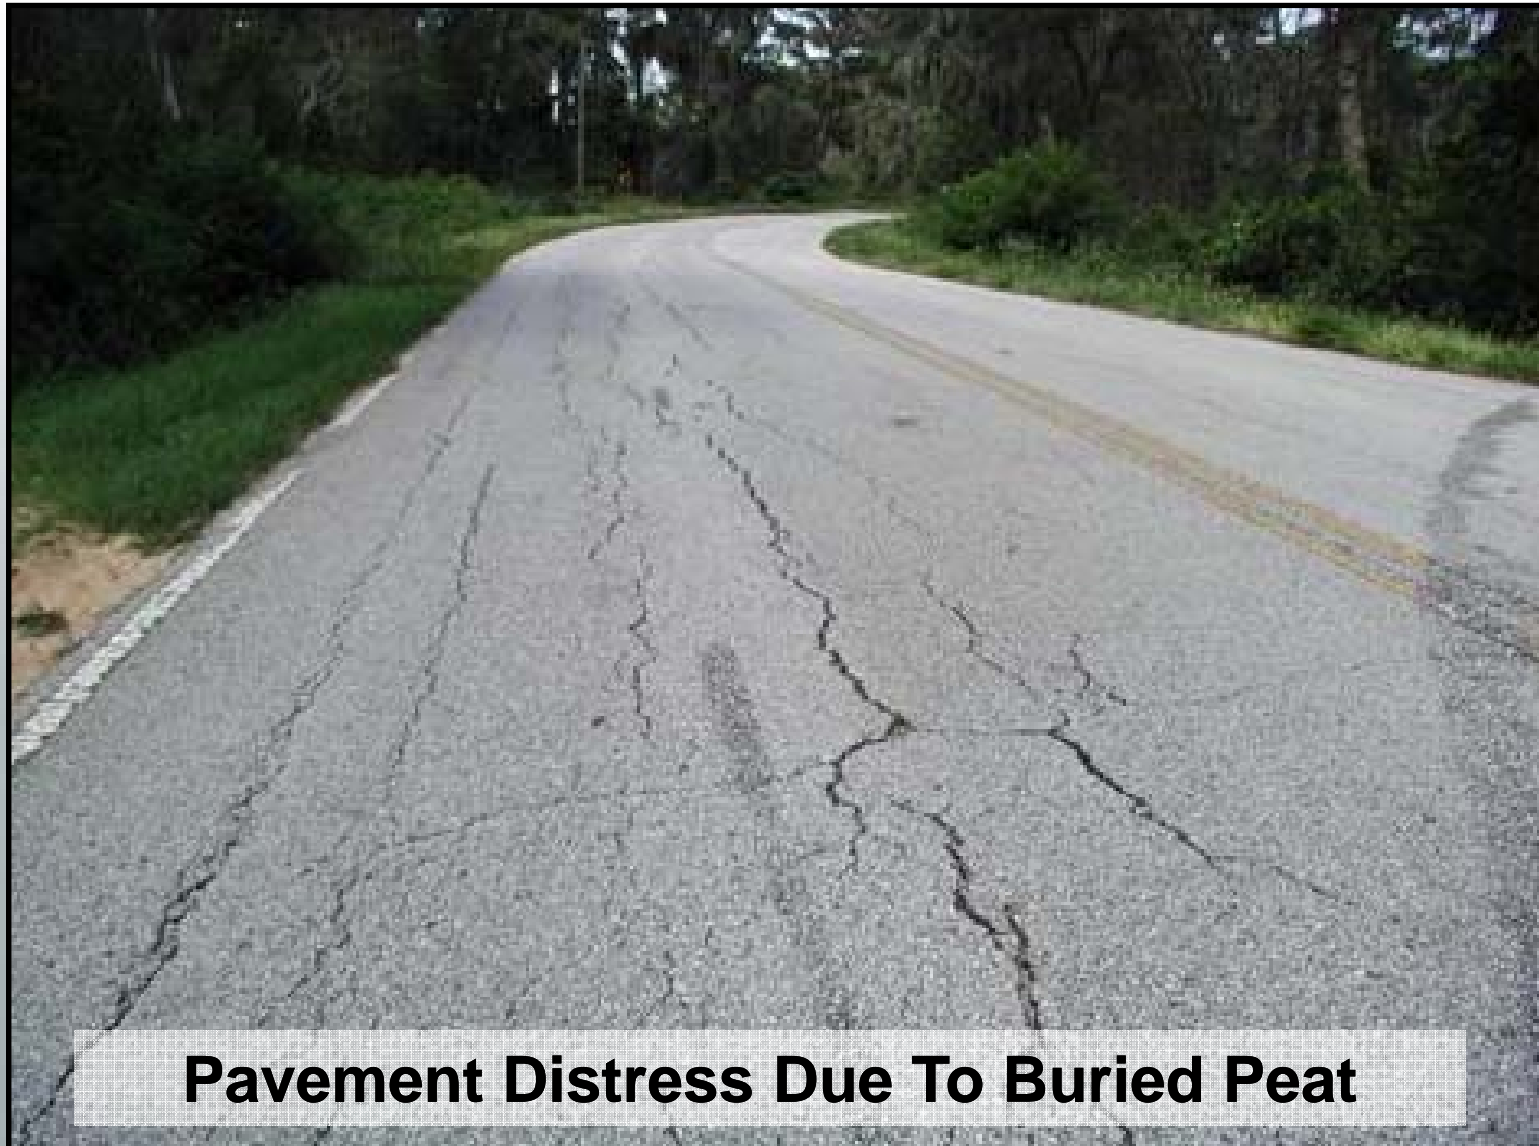
Clermont Chain of Lakes – CR 561

Pavement Distress Due To Buried Peat
