*Case Study in Settlement Distress
From Railway Vibrations*

The Preserve

at Lake Sylvania

Ocala, Florida

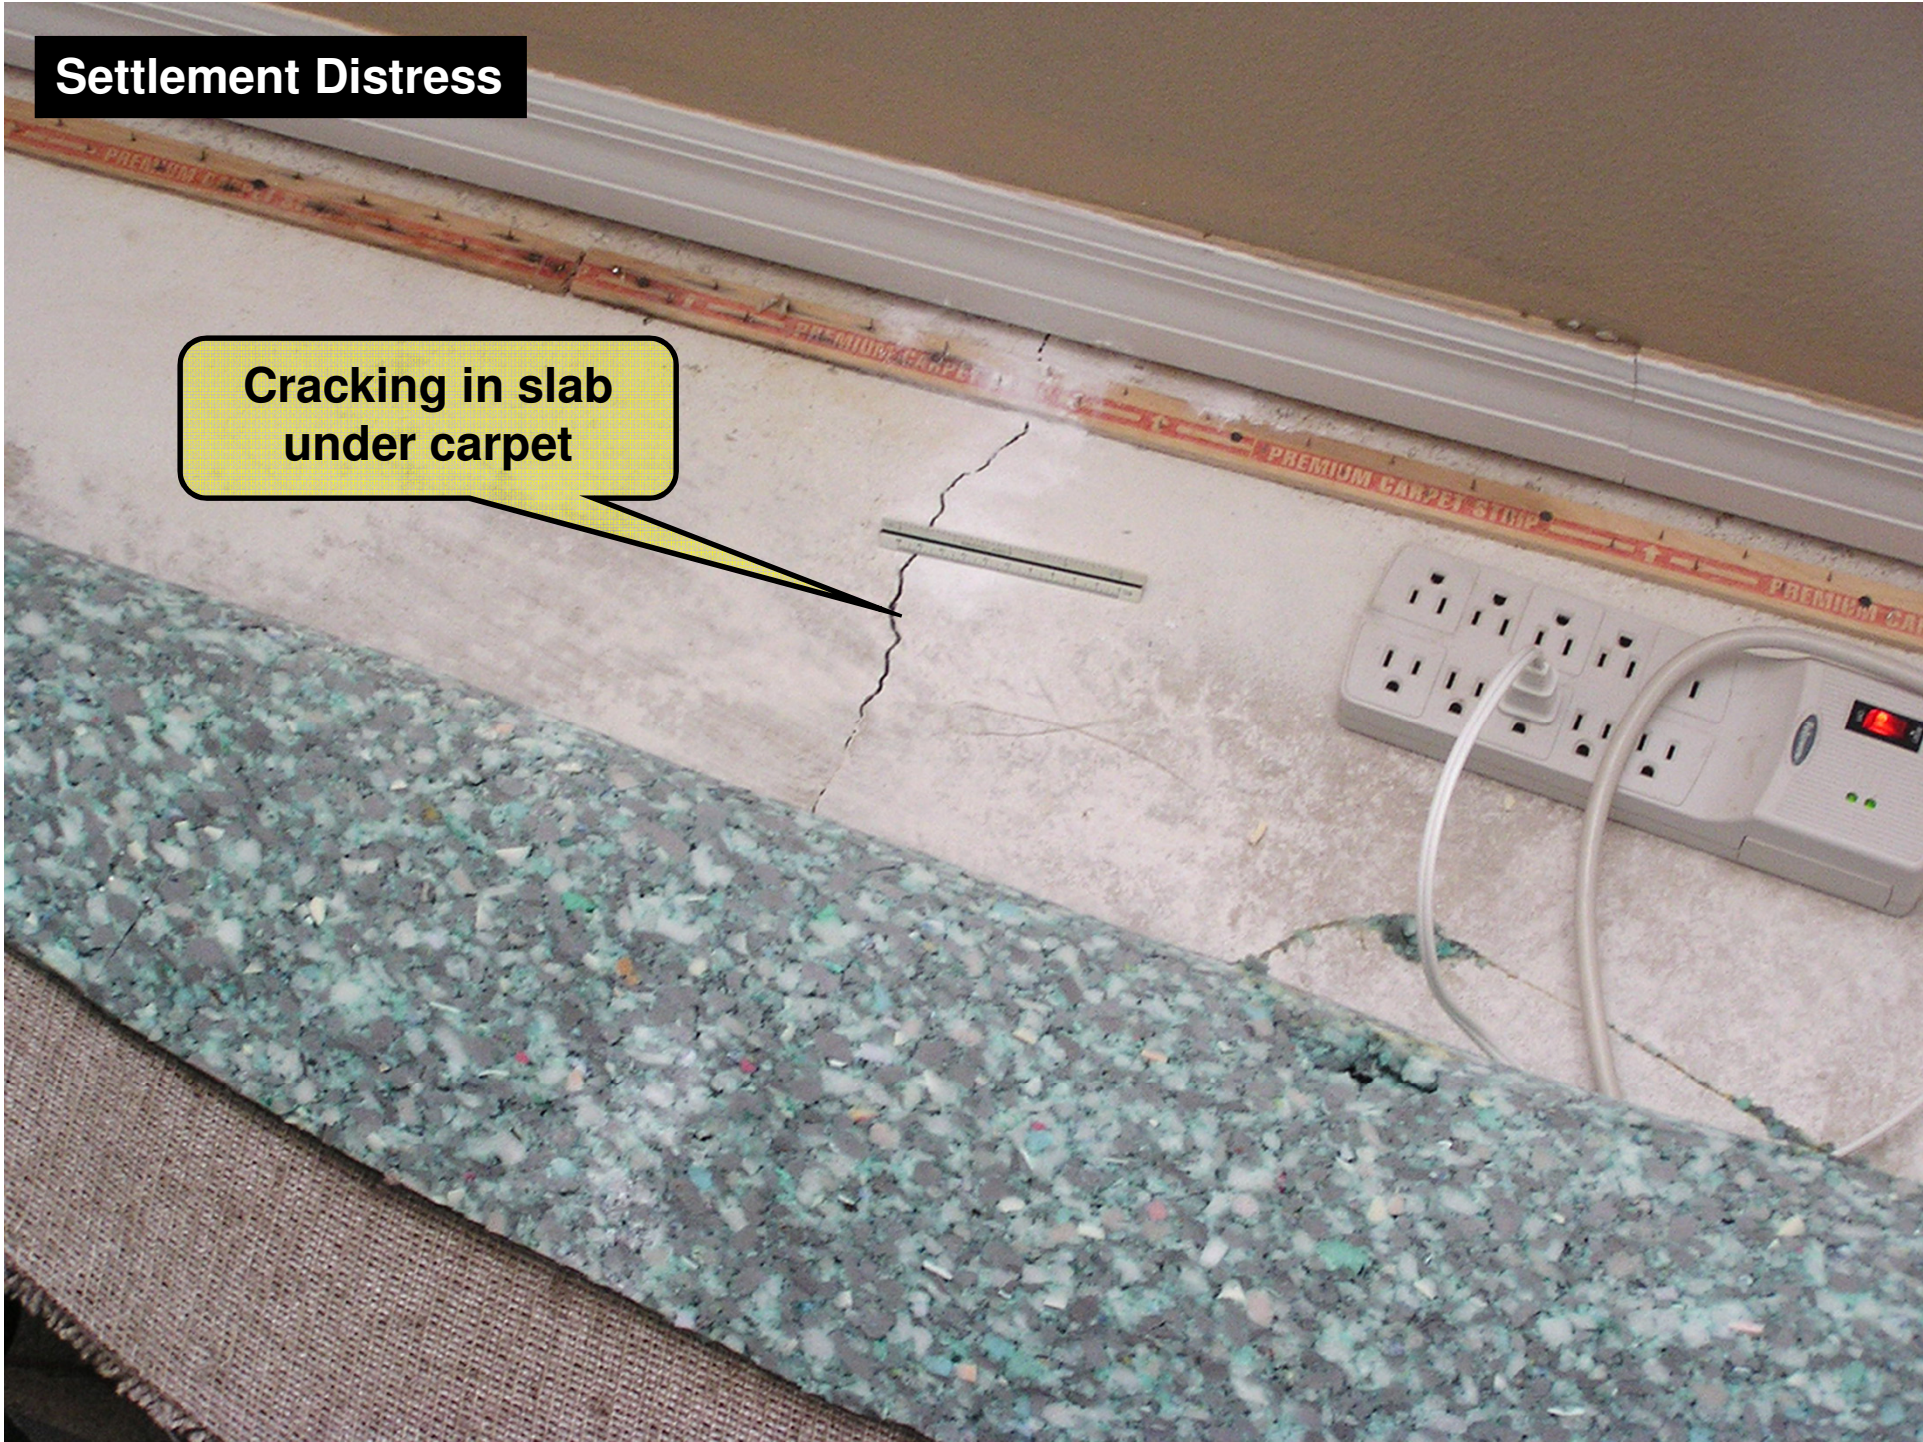
Cracking in slab
under carpet

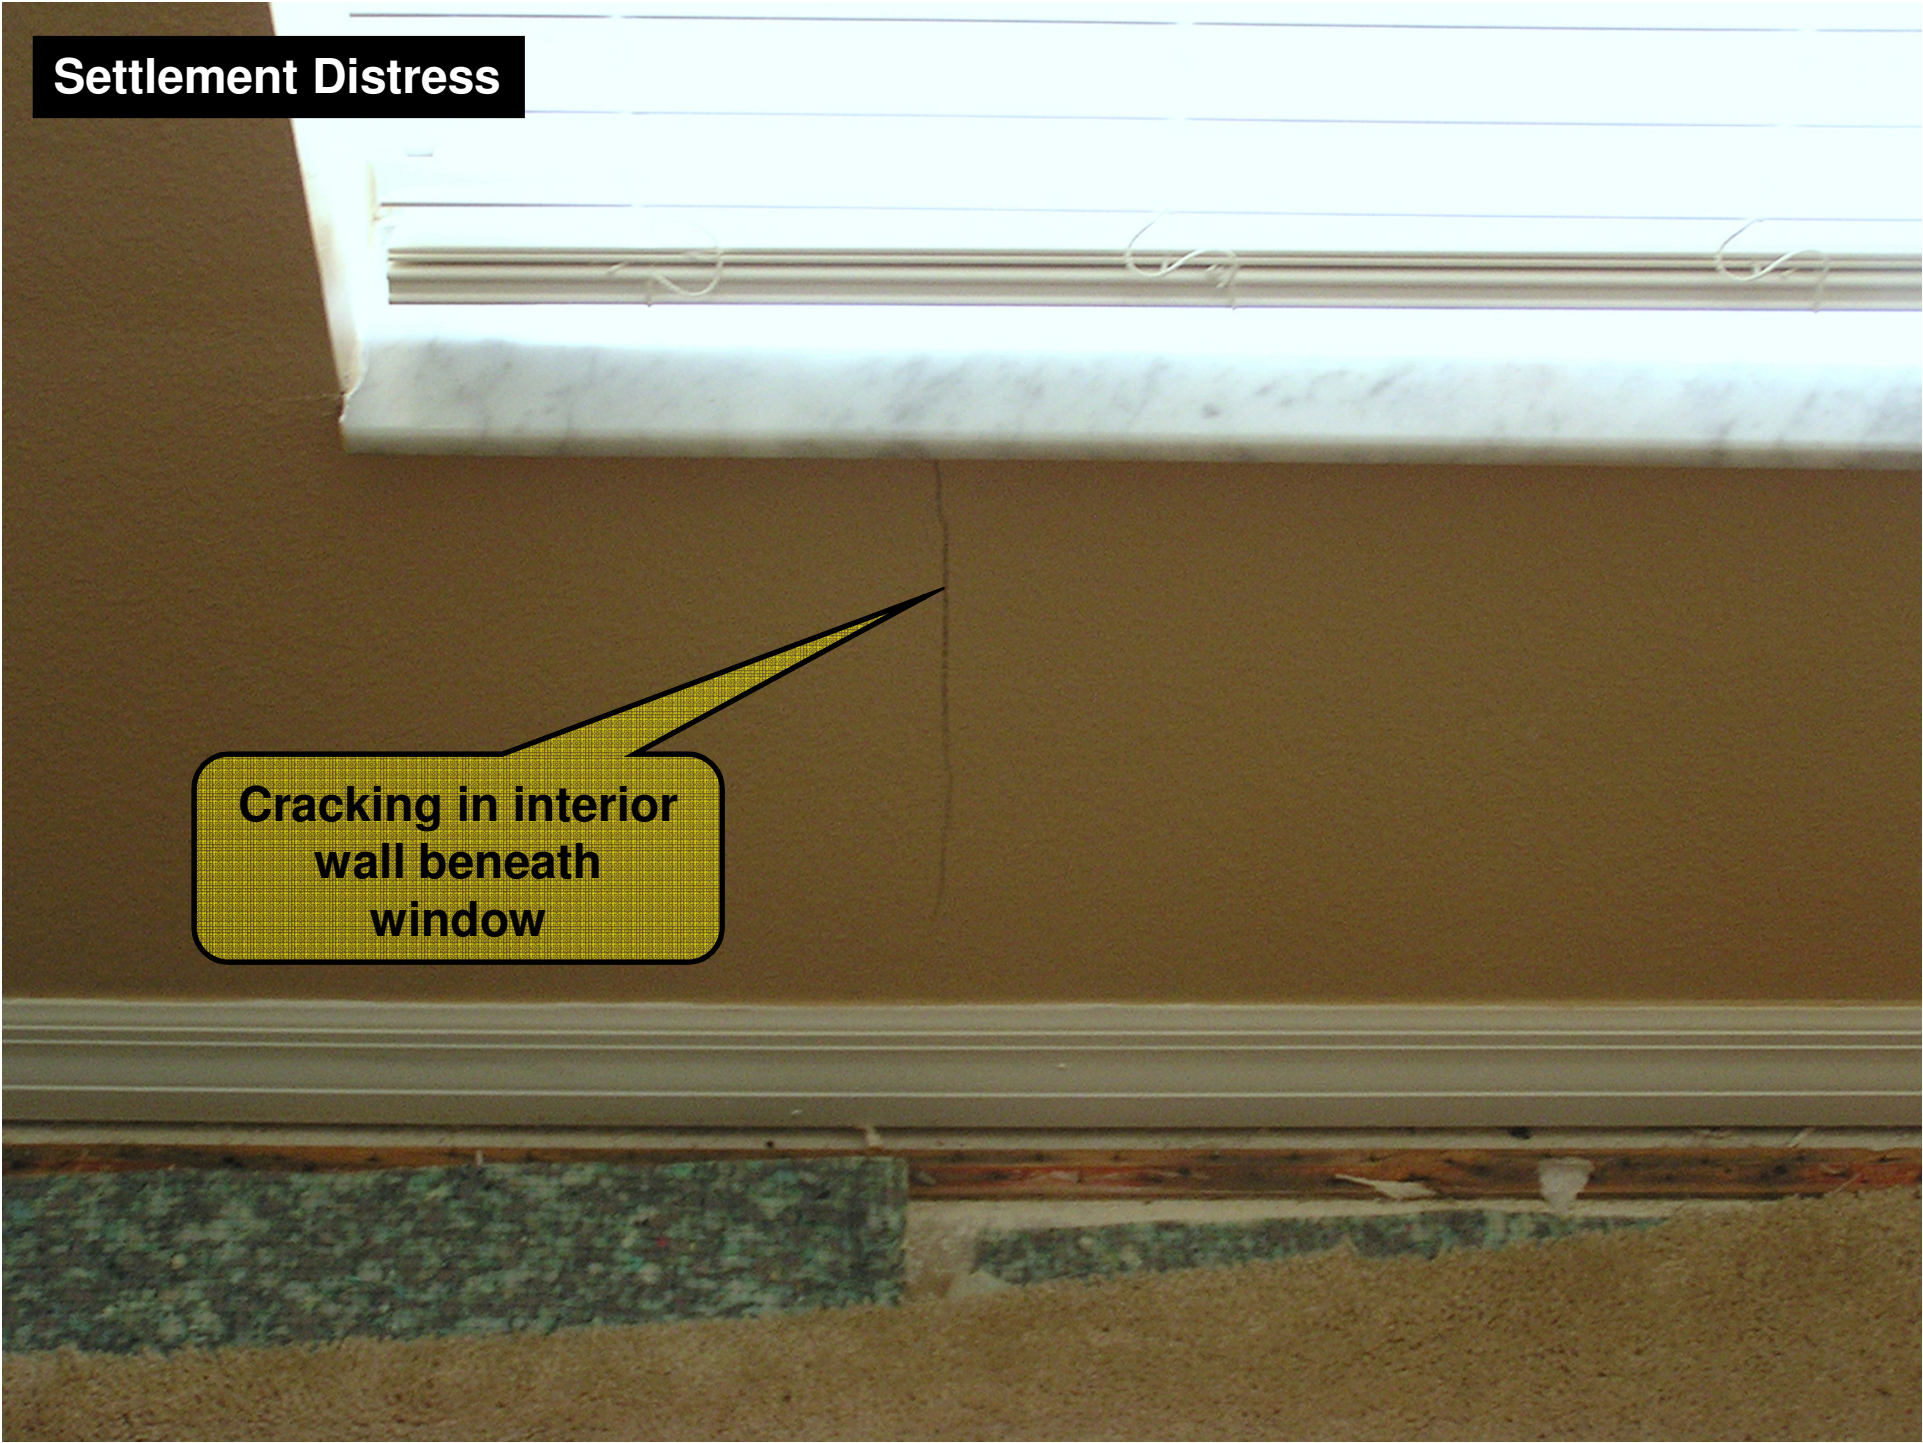
Cracking in interior wall beneath window

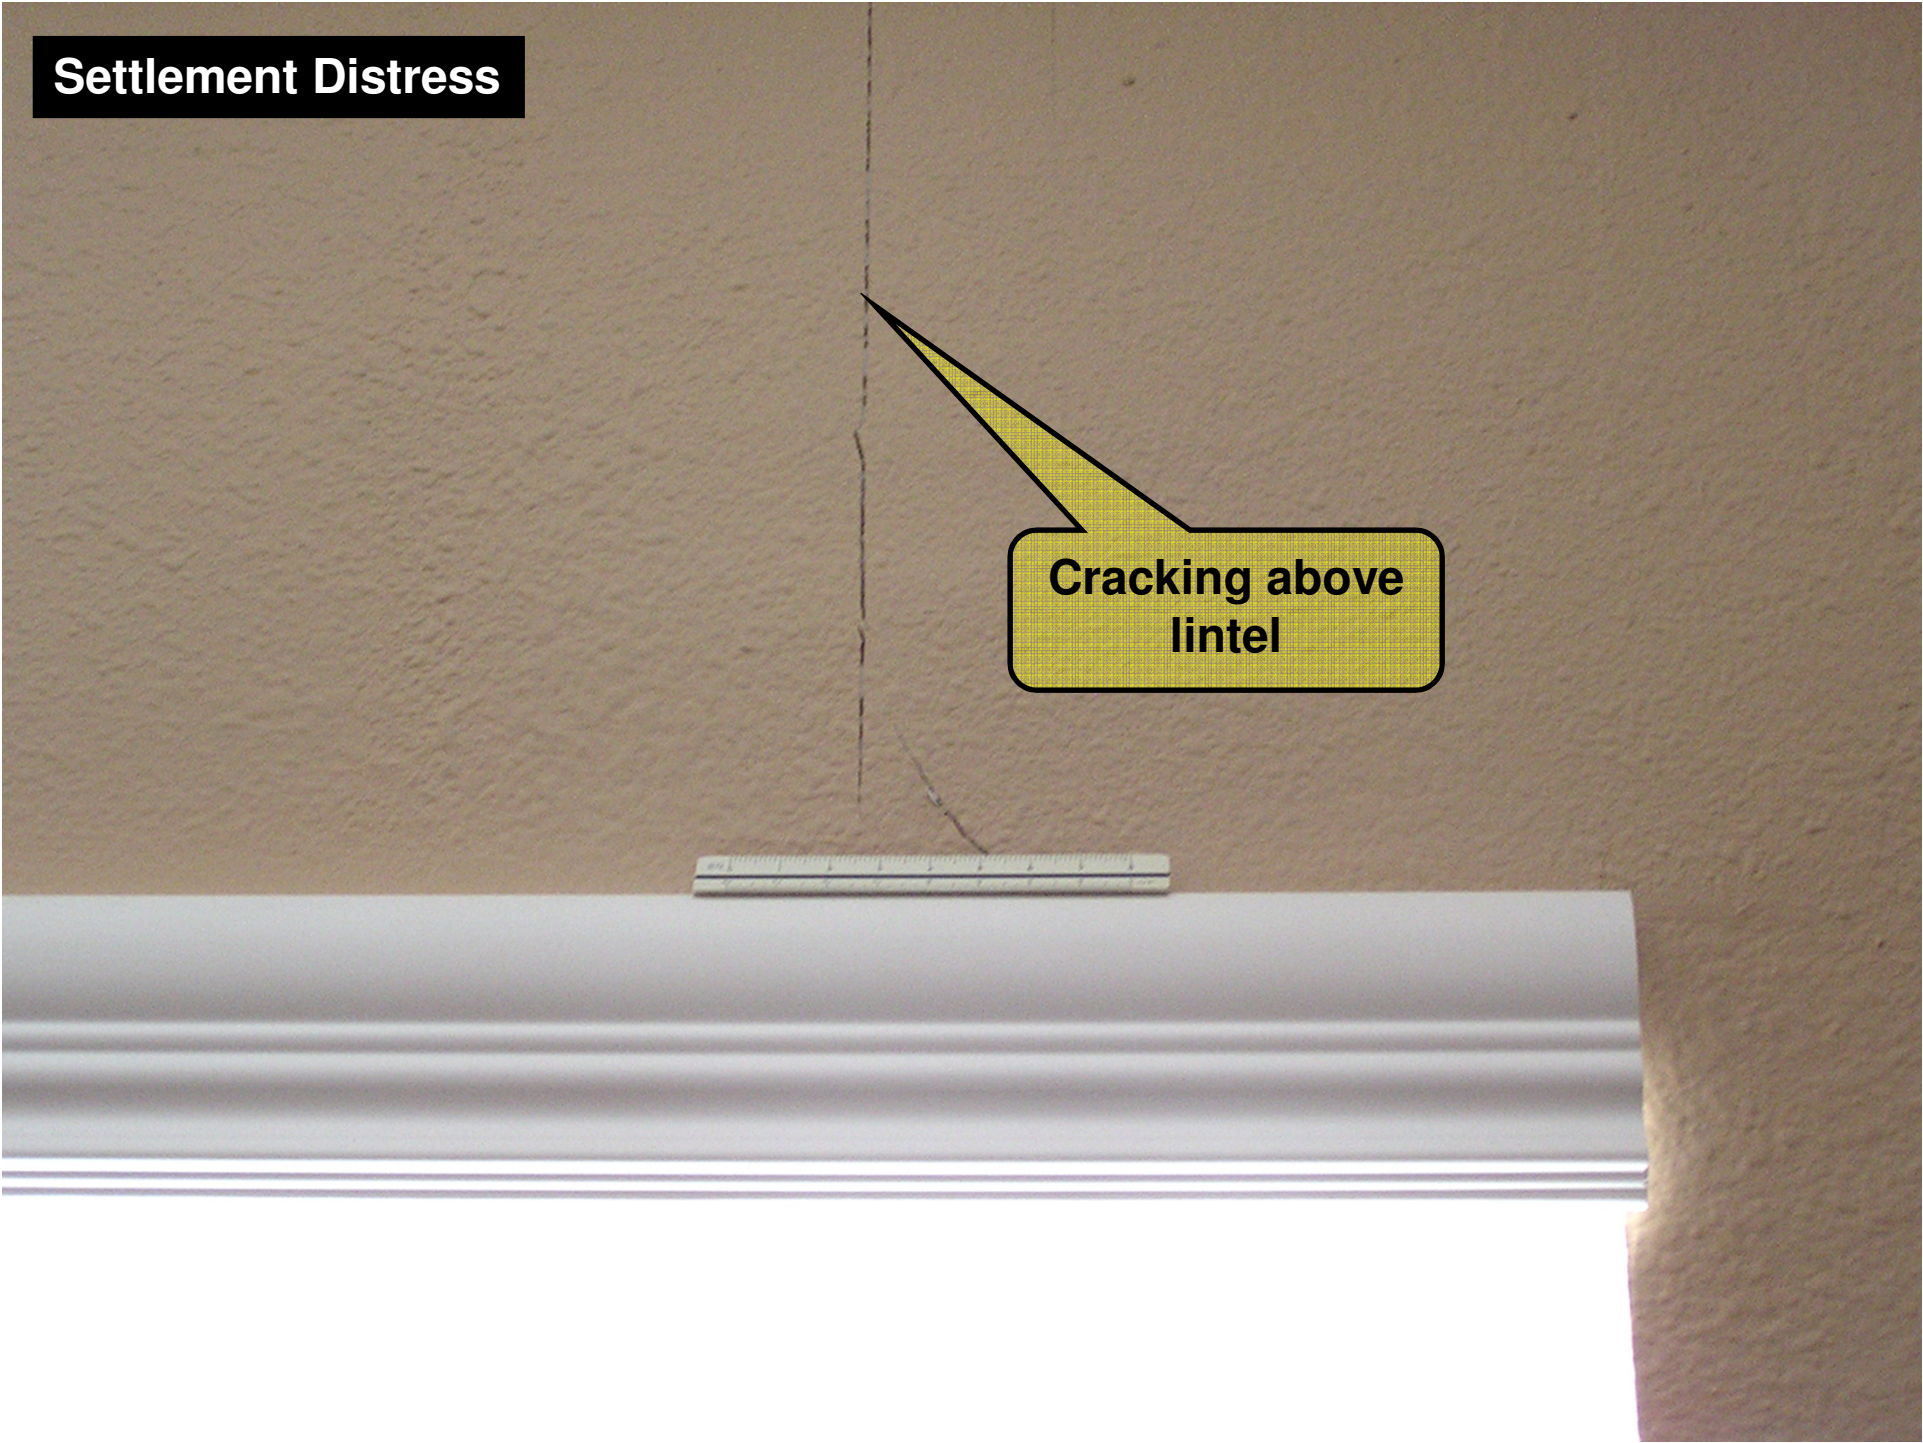
Cracking above
lintel

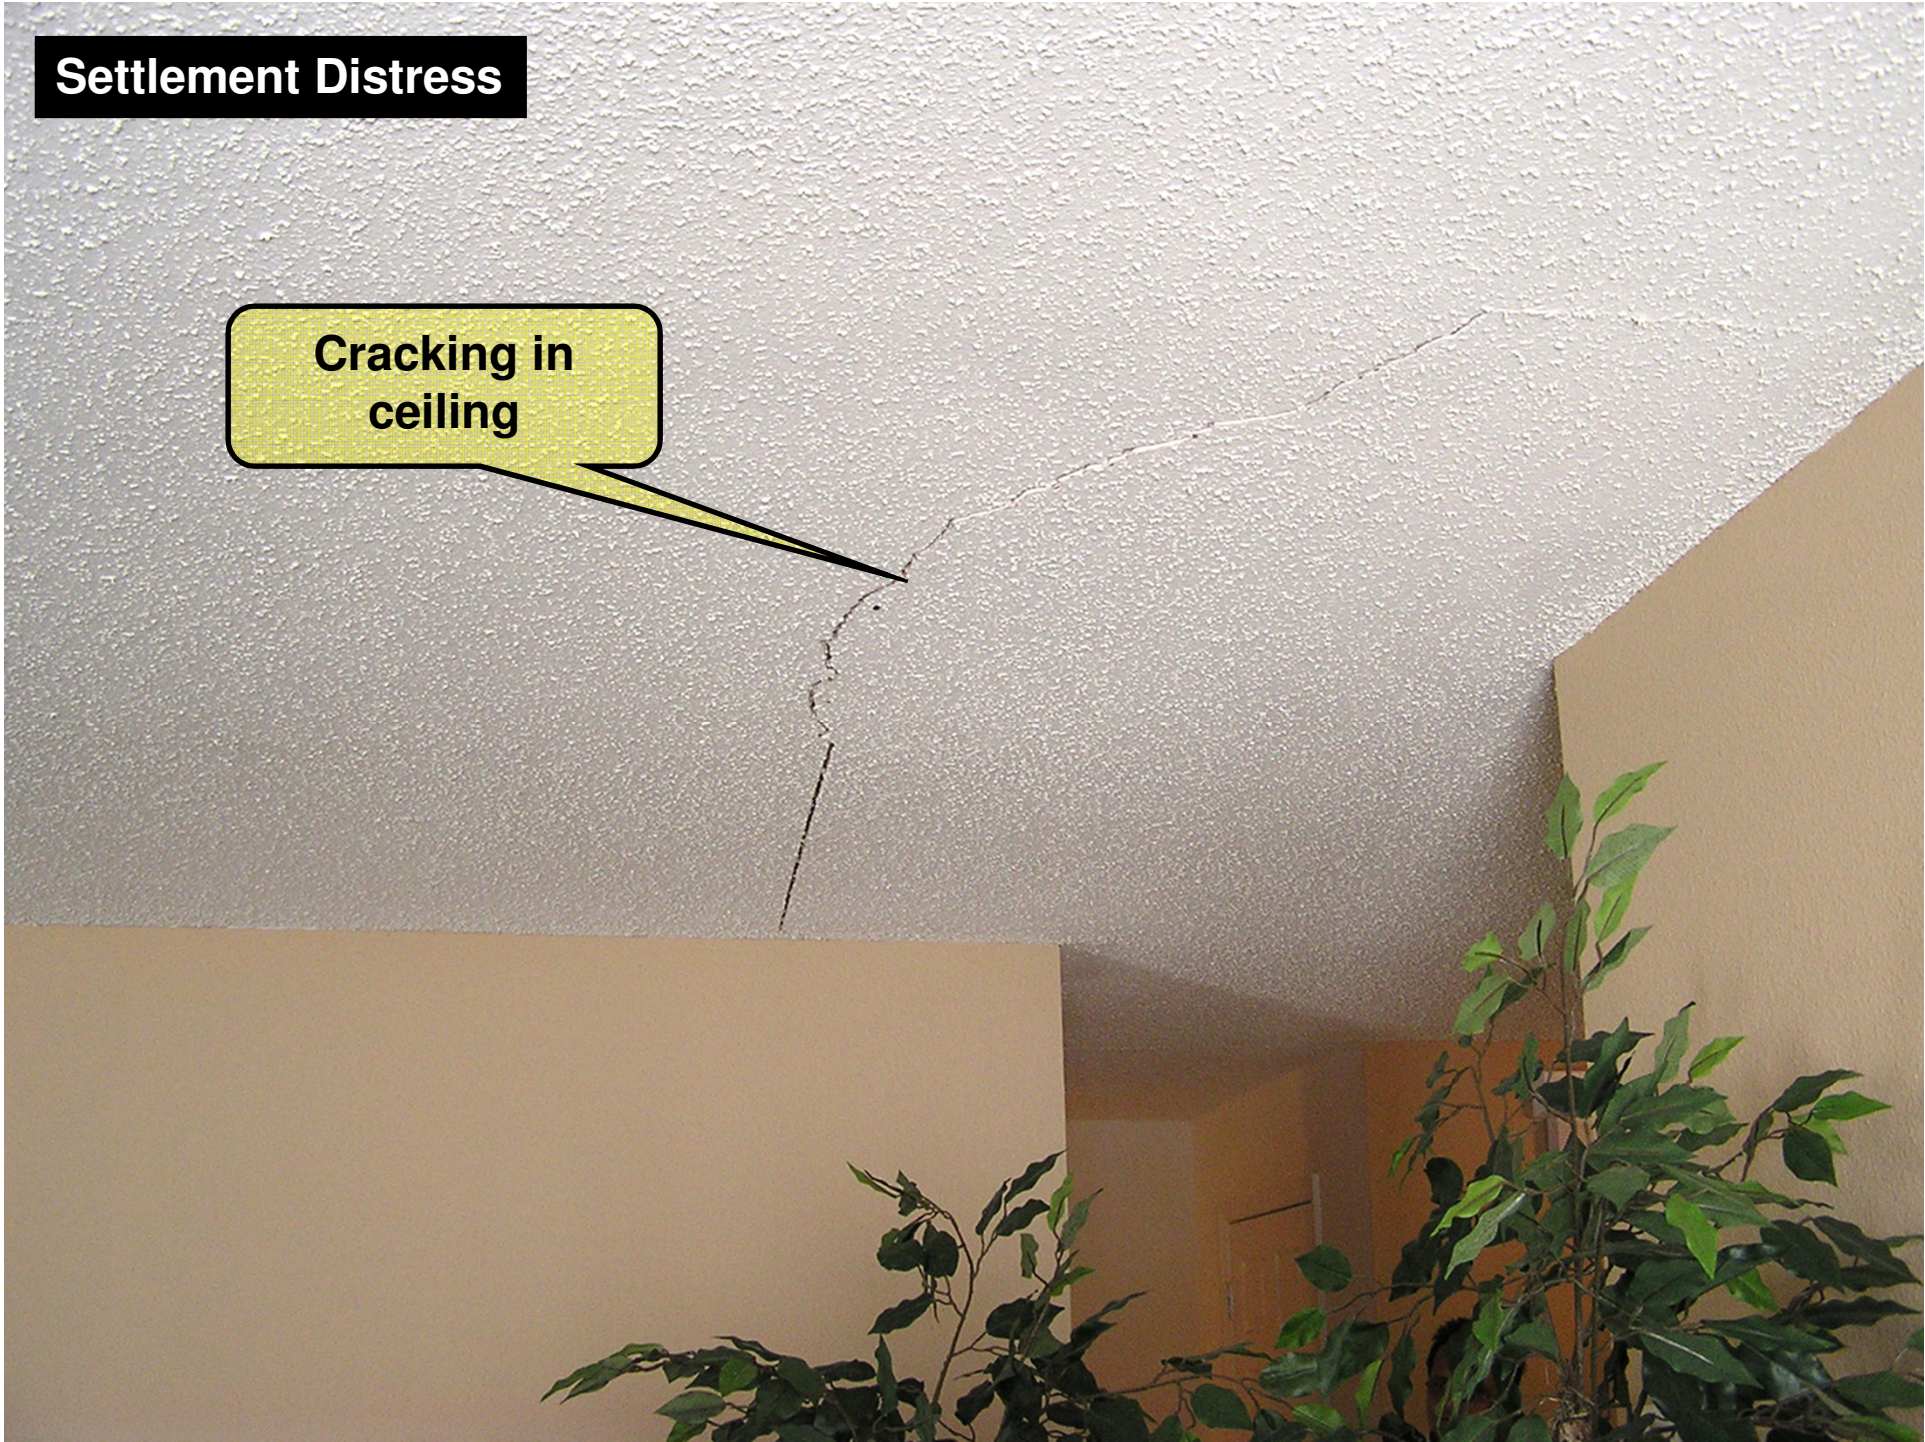
Cracking in ceiling

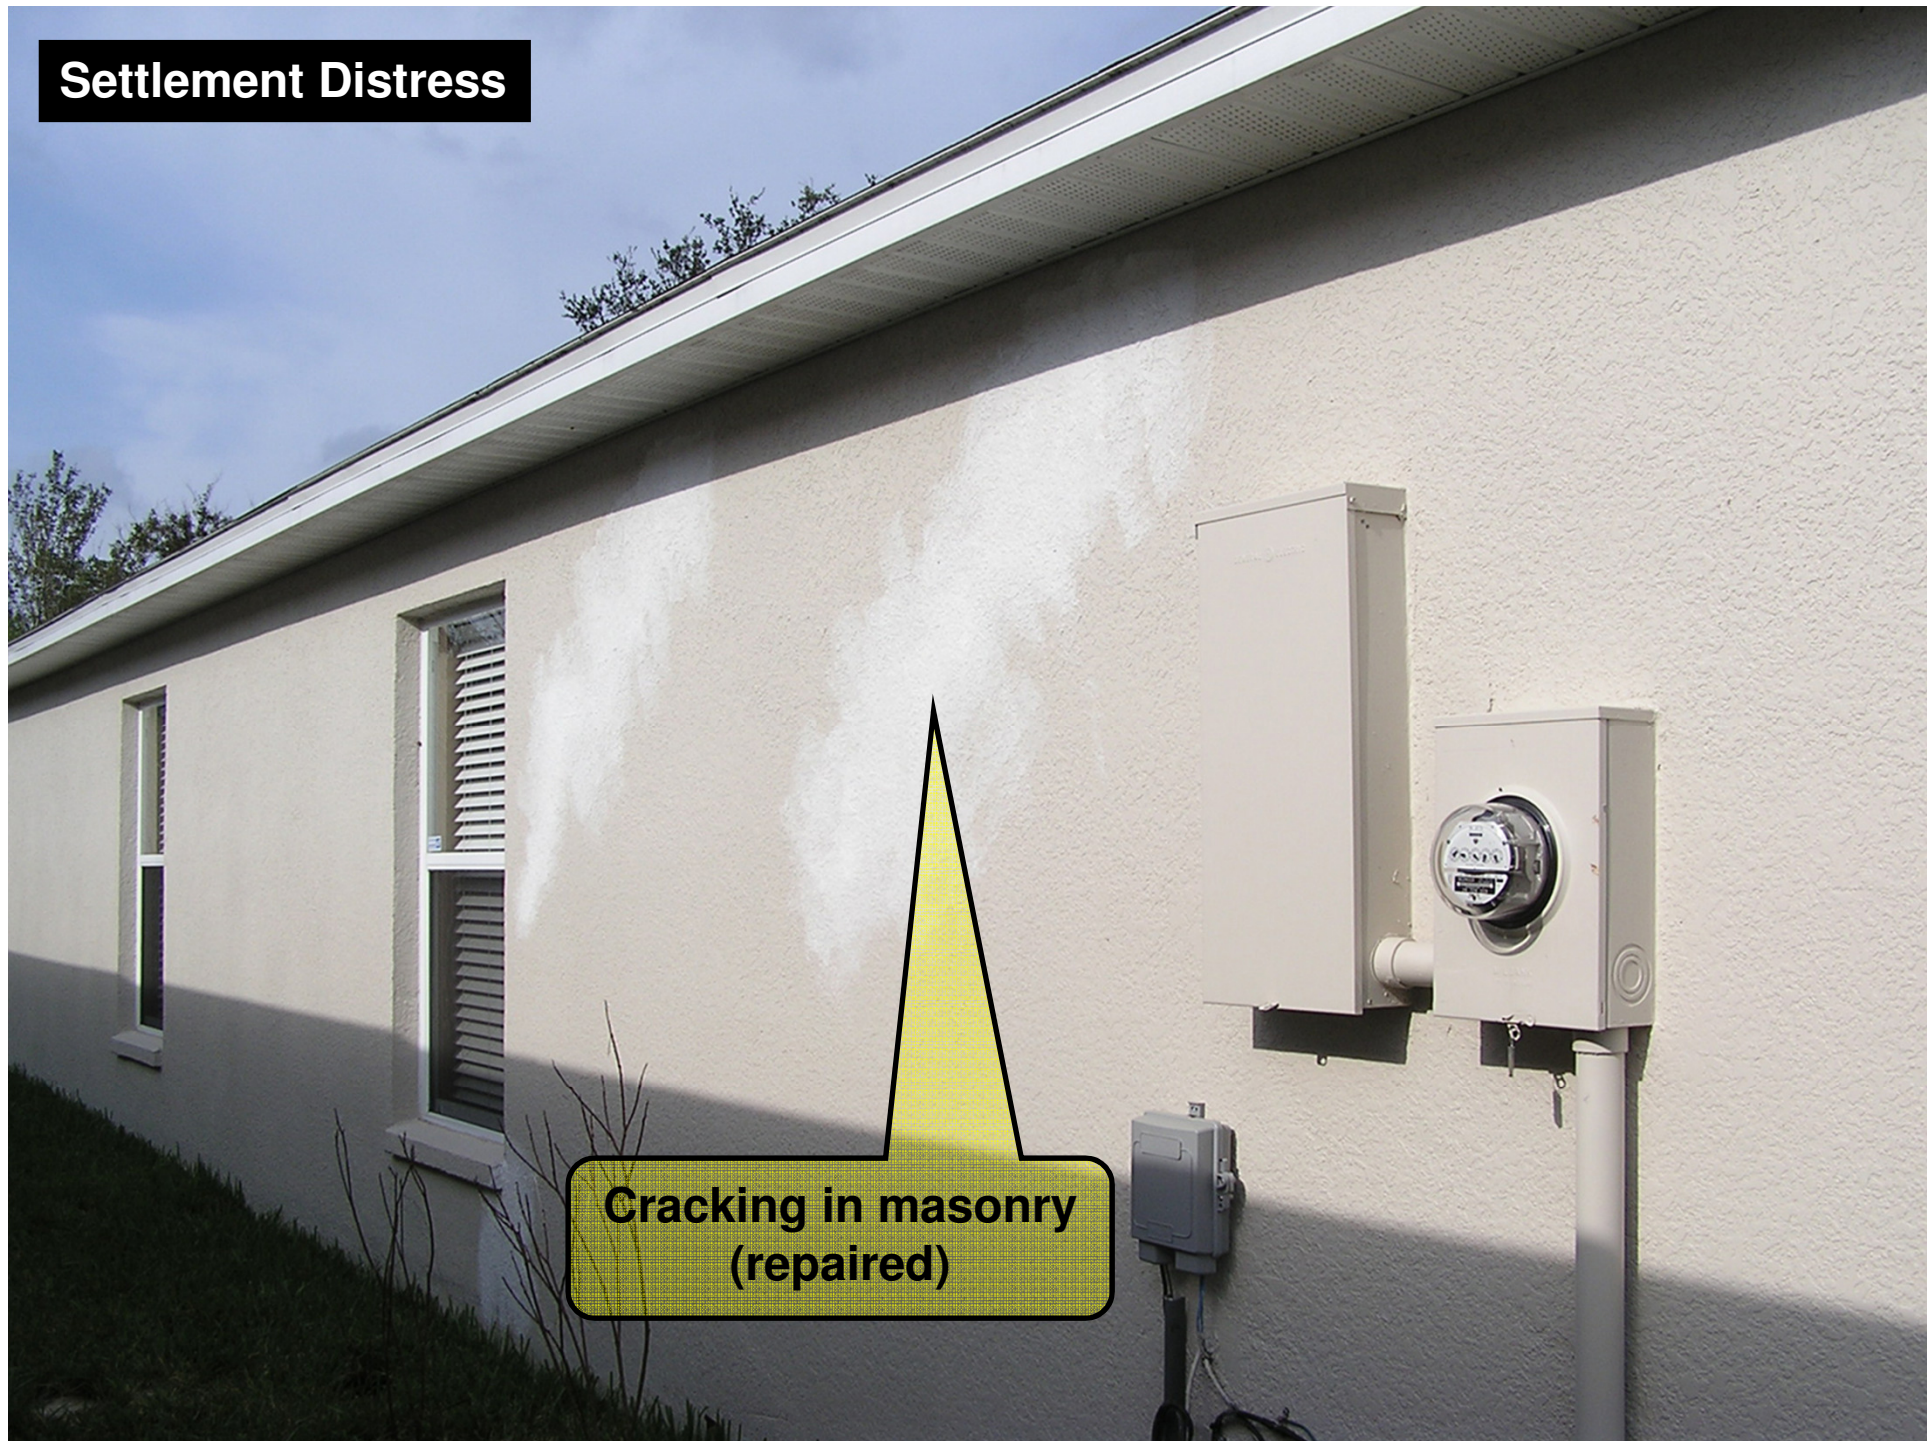
**Cracking in masonry
(repaired)**

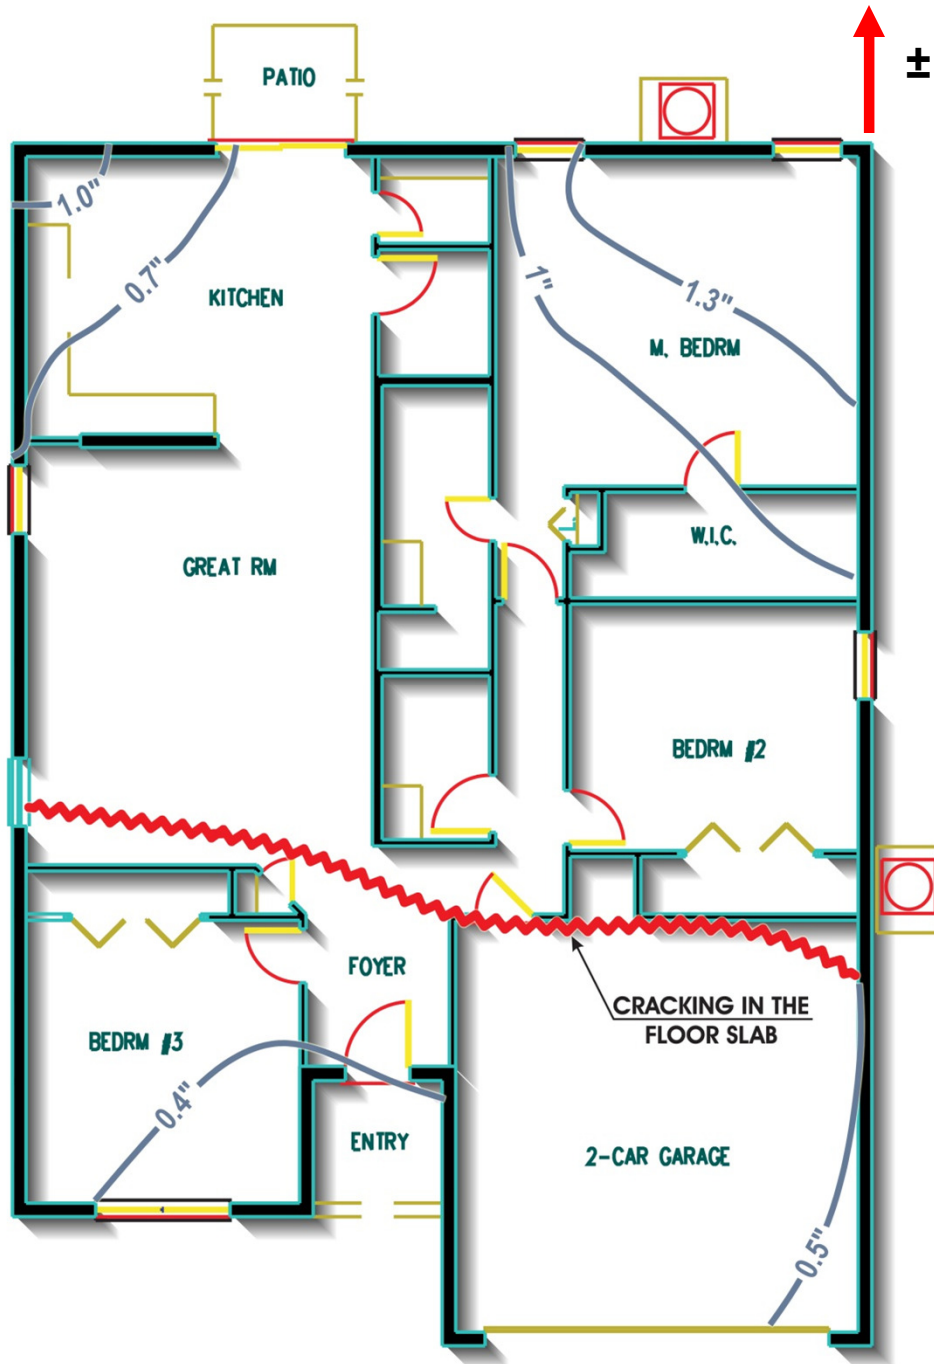
± 200 ft. to railroad track

Pattern of Settlement Distress

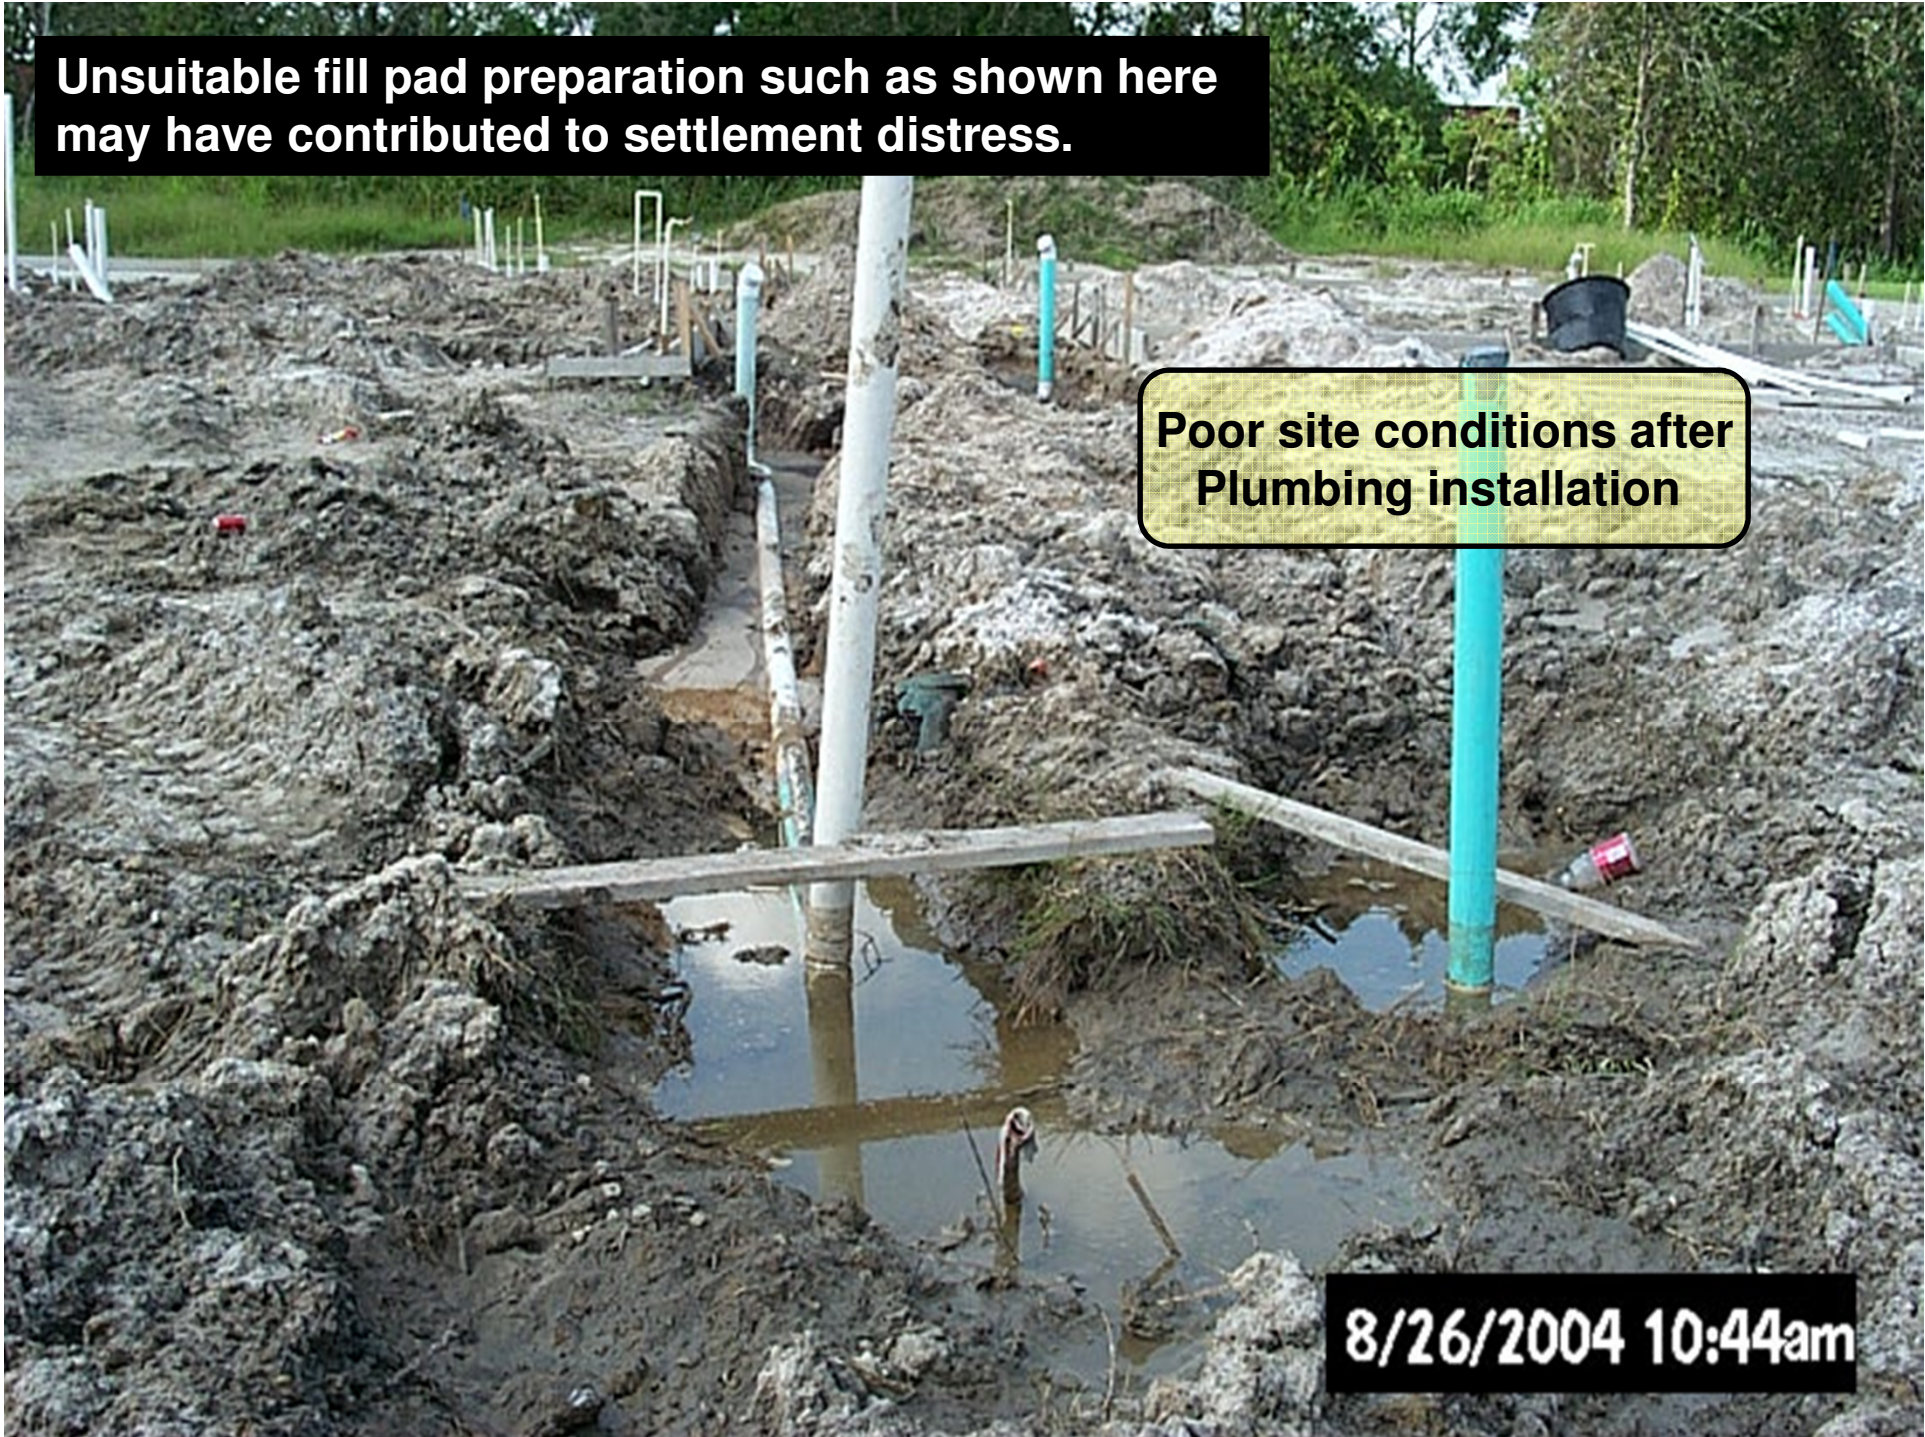
8/26/2004 10:44am

Unsuitable fill pad preparation such as shown here may have contributed to settlement distress.

Poor site conditions after Plumbing installation

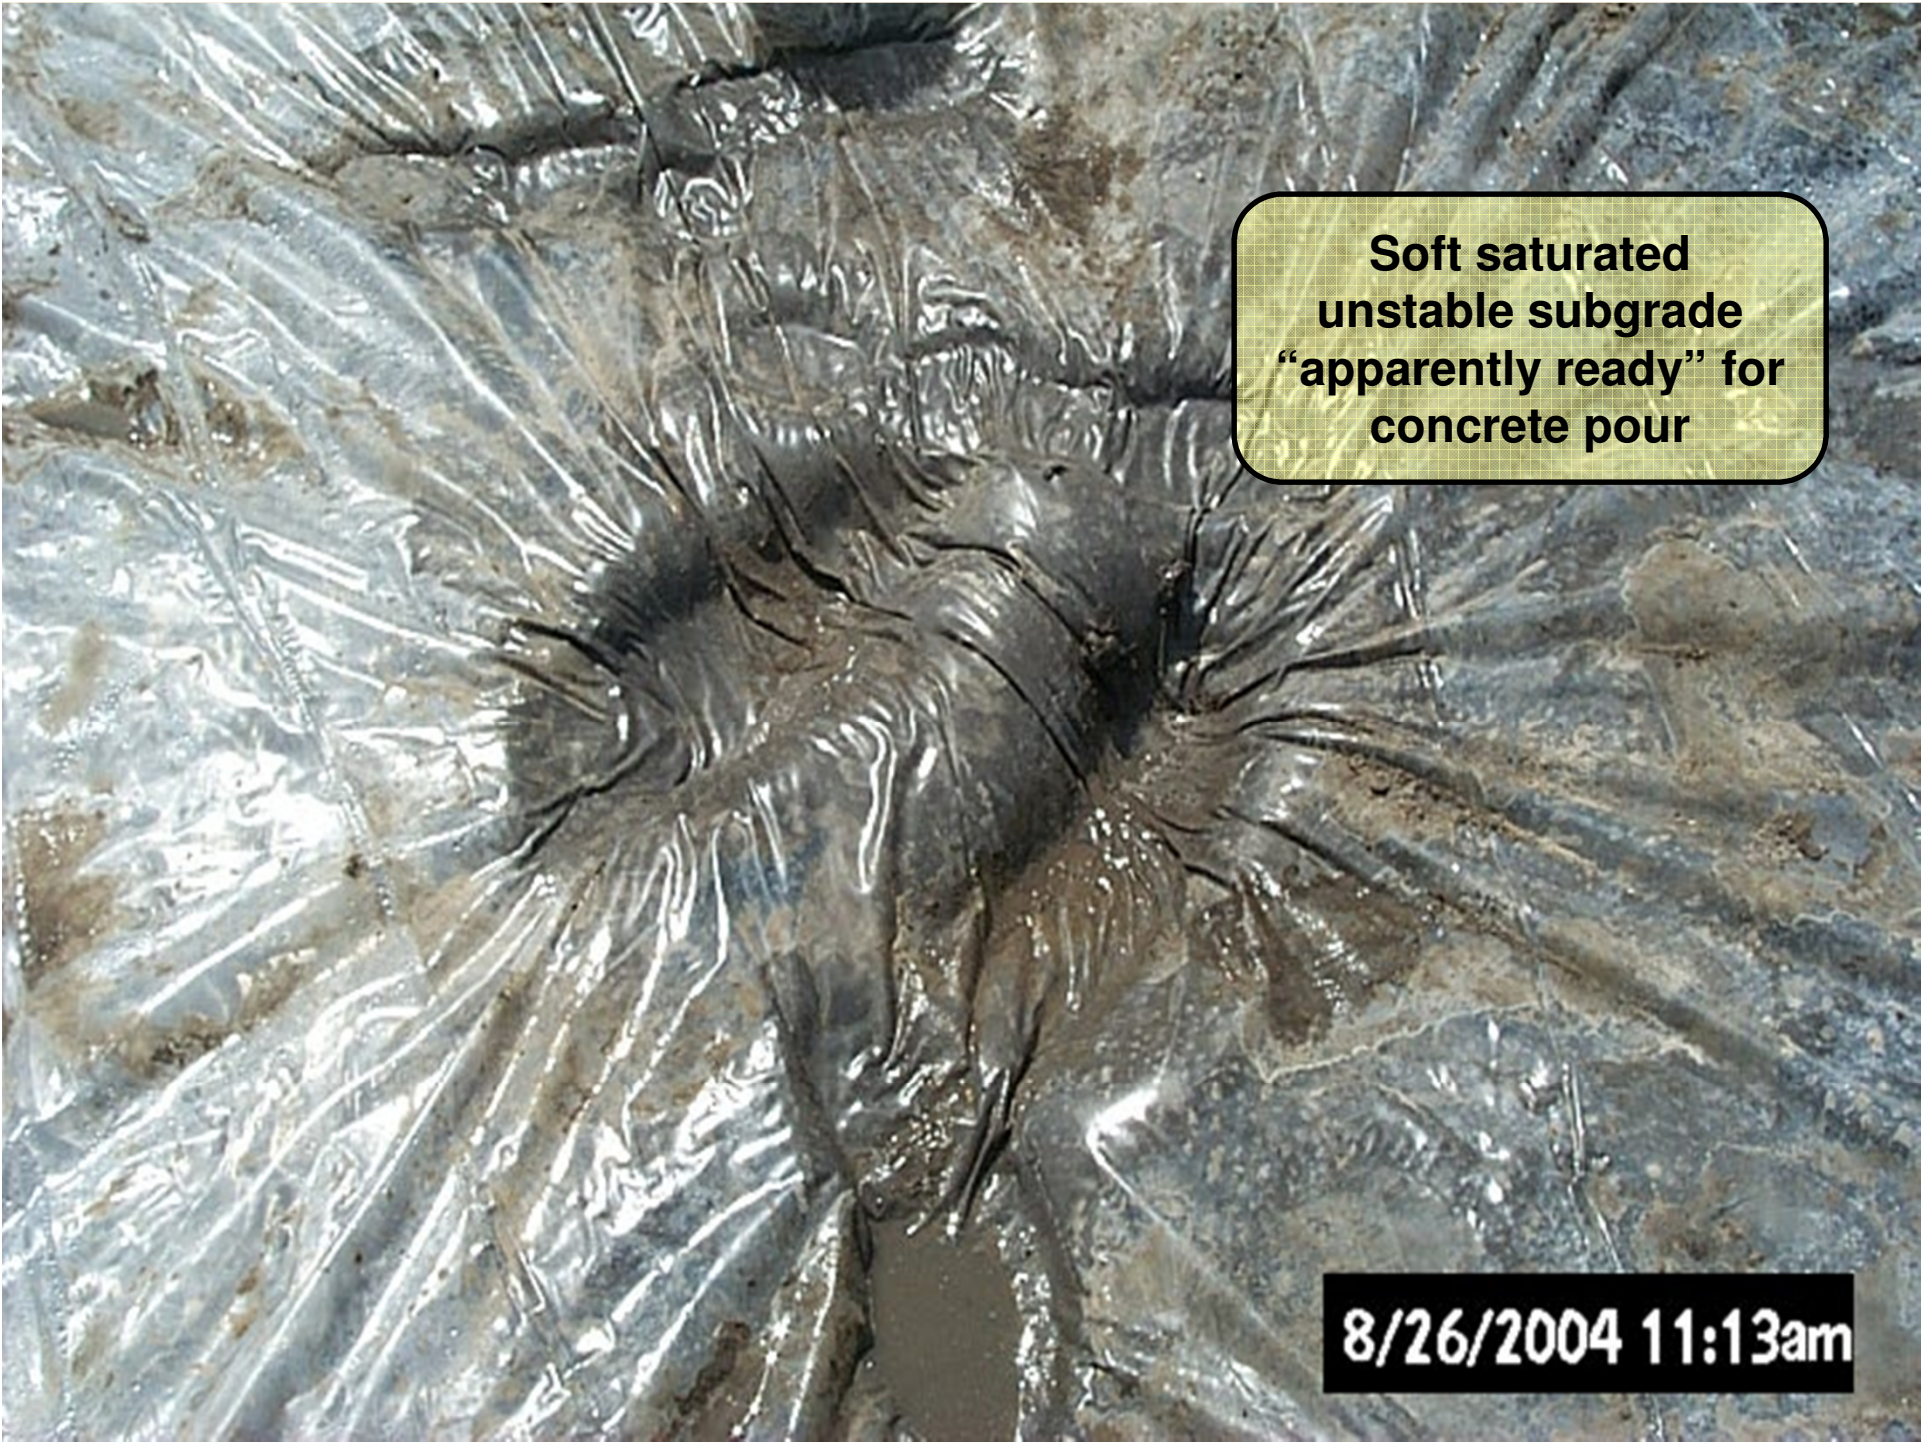
8/26/2004 11:13am

**Soft saturated
unstable subgrade
“apparently ready” for
concrete pour**

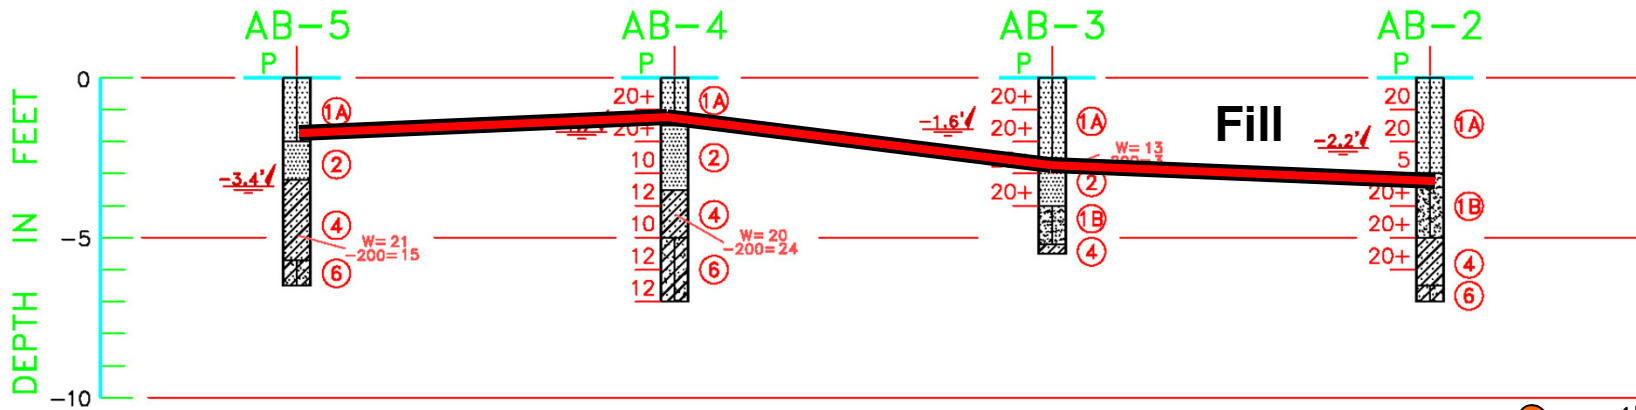
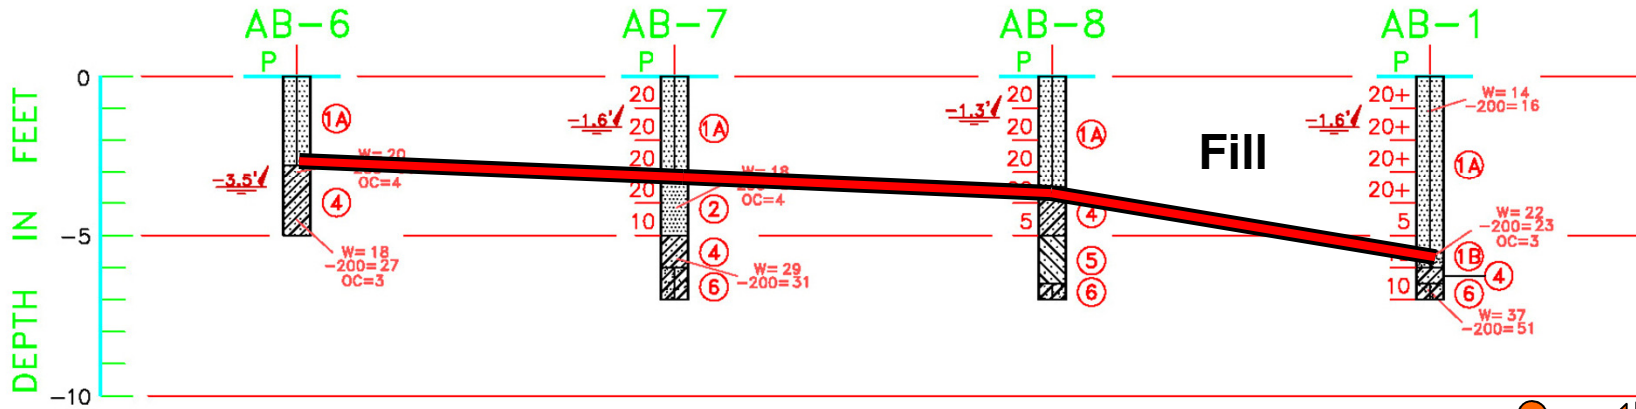
**Soil Cross
Sections
Around
Building Pad**

- There was no buried muck. Buried organic layers undergo time dependent settlement.
- This area is not within an active sinkhole zone.
- The fill material appears to be of suitable texture and is compacted, except that a 1-ft thick loose zone is observed at the base of the fill.
- There is no evidence of seepage related soil loss below the slab because the eroded soils would have been observed at some downgradient location.
