*Case Study in Settlement Distress
From Railway Vibrations*

The Preserve

at Lake Sylvania

Ocala, Florida

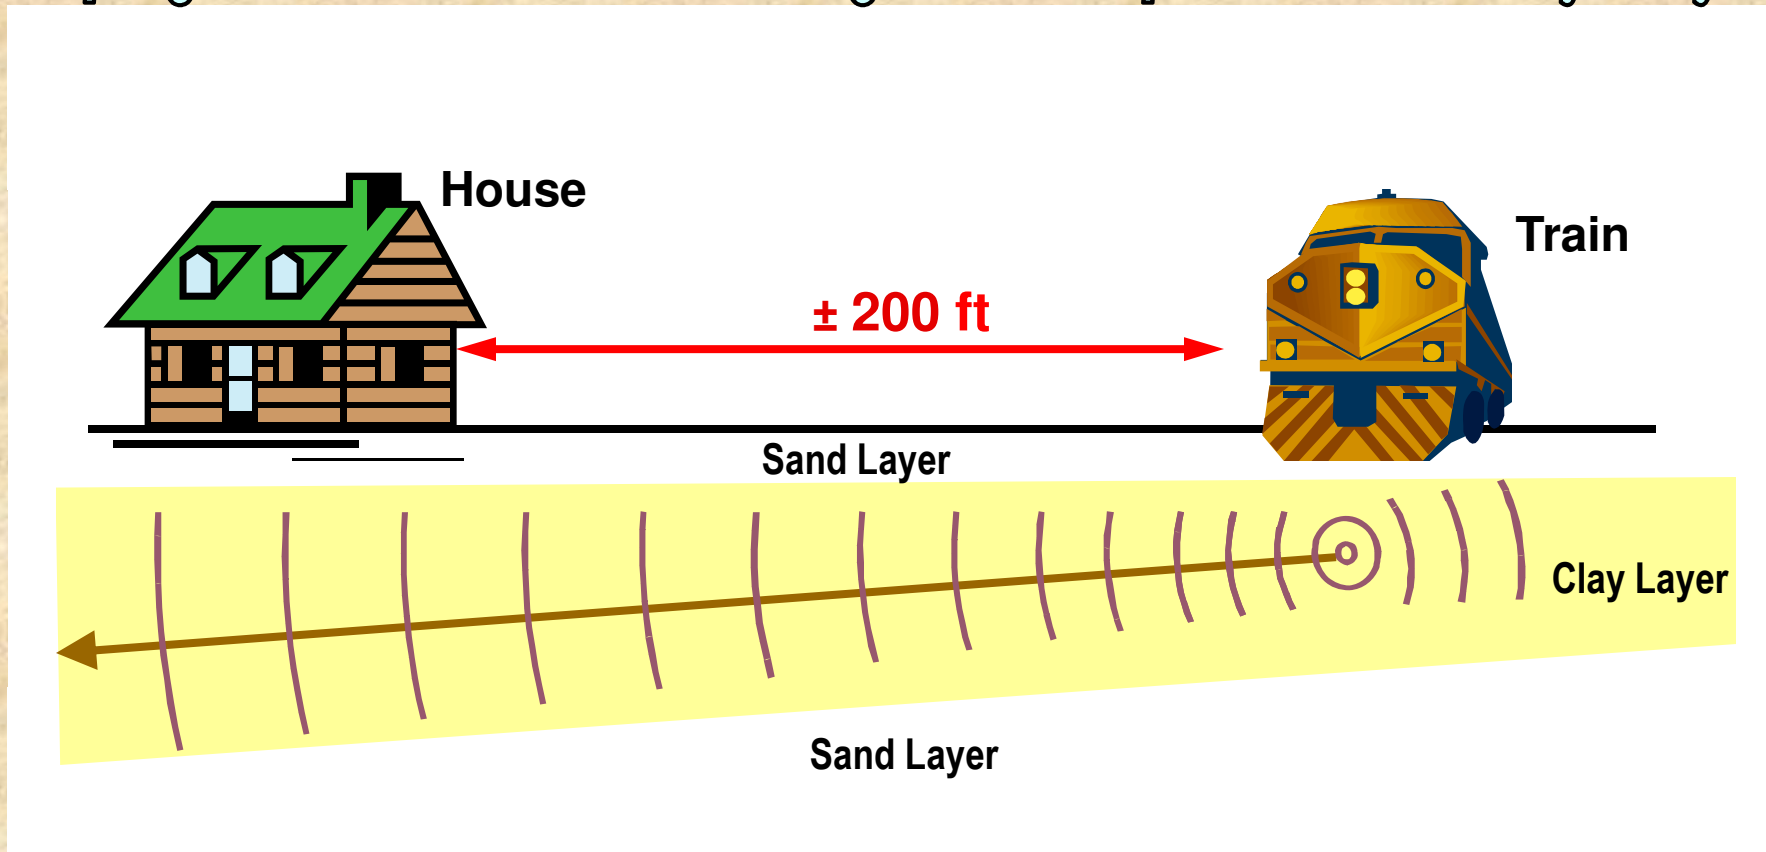
Propagatation of Wave Through Incompressible Clay Layer

- Vibrations from passing freight trains are being conducted through a layer of “fat” clay near the ground surface. This clay layer occurs at shallow depth beneath the railroad track, and extends beneath the building footprint where distress has occurred.
- The clay layer acts as a “shaking table” which further compacts the loose sandy soils above the clay.

This clay layer is incompressible during short term loading, and acts as a conduit for the transmission of vibrations from the freight train. As a result, vibrations are felt at a greater distance than would normally be expected.
