# ROADWAY PROJECTS WITH FOCUS ON SUBSURFACE / DRAINAGE & LITIGATION-RELATED ISSUES

## 2011 FACERS Annual Conference

- Devo Seereeram, Ph.D., P.E.  
Devo Engineering

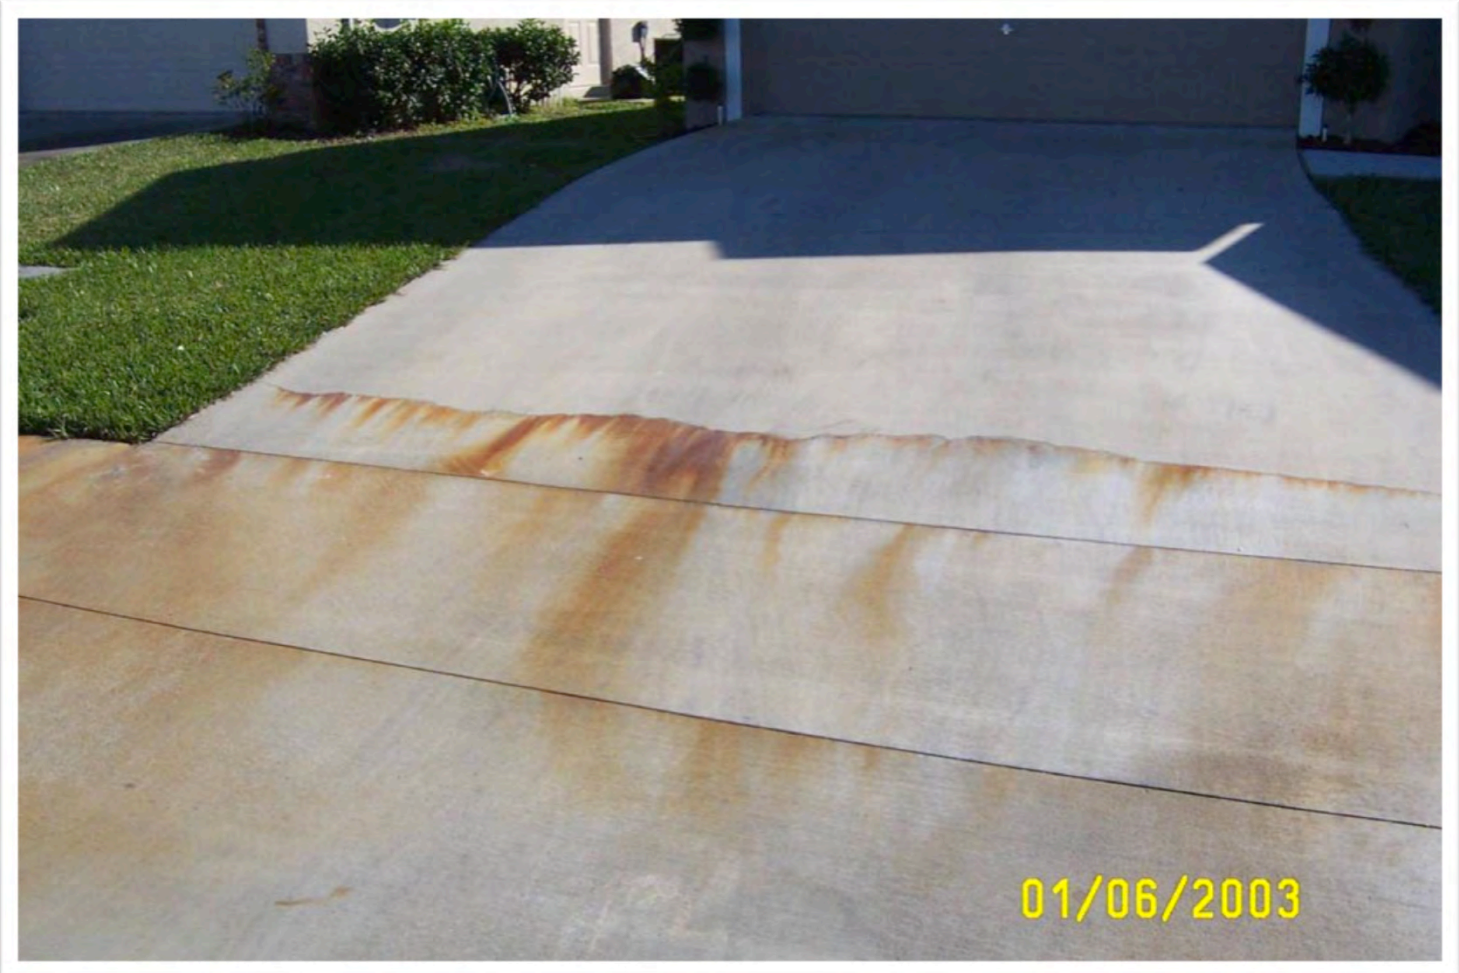
# Infrastructure failure from reclaimed water overirrigation - Country Club

Leaching Over Curb

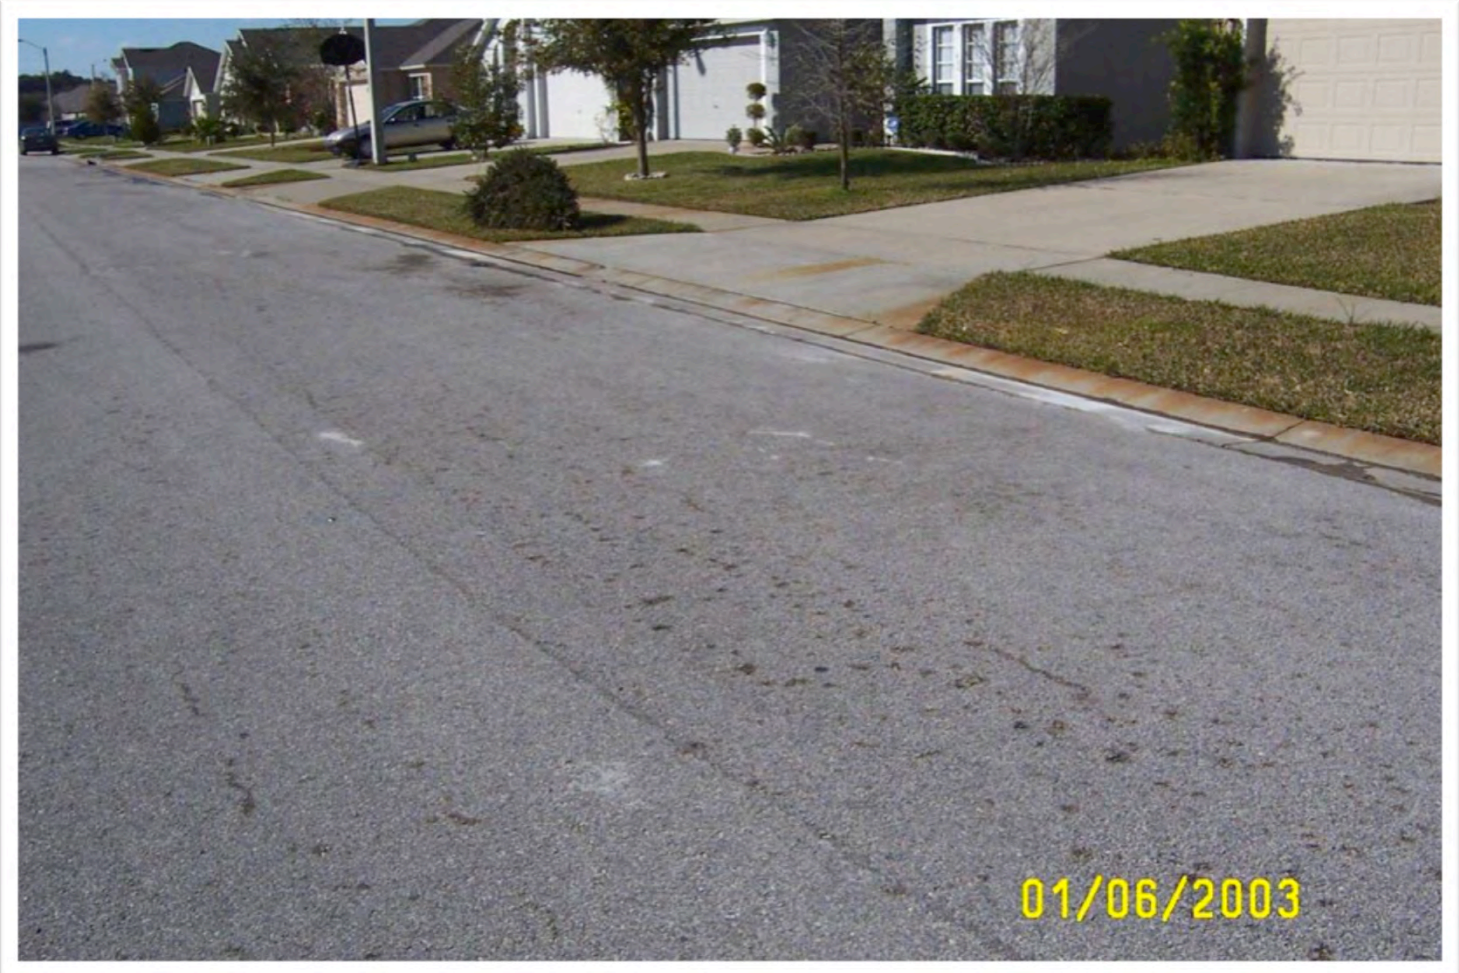
# Infrastructure failure from reclaimed water overirrigation - Country Club

Leaching Over Curb

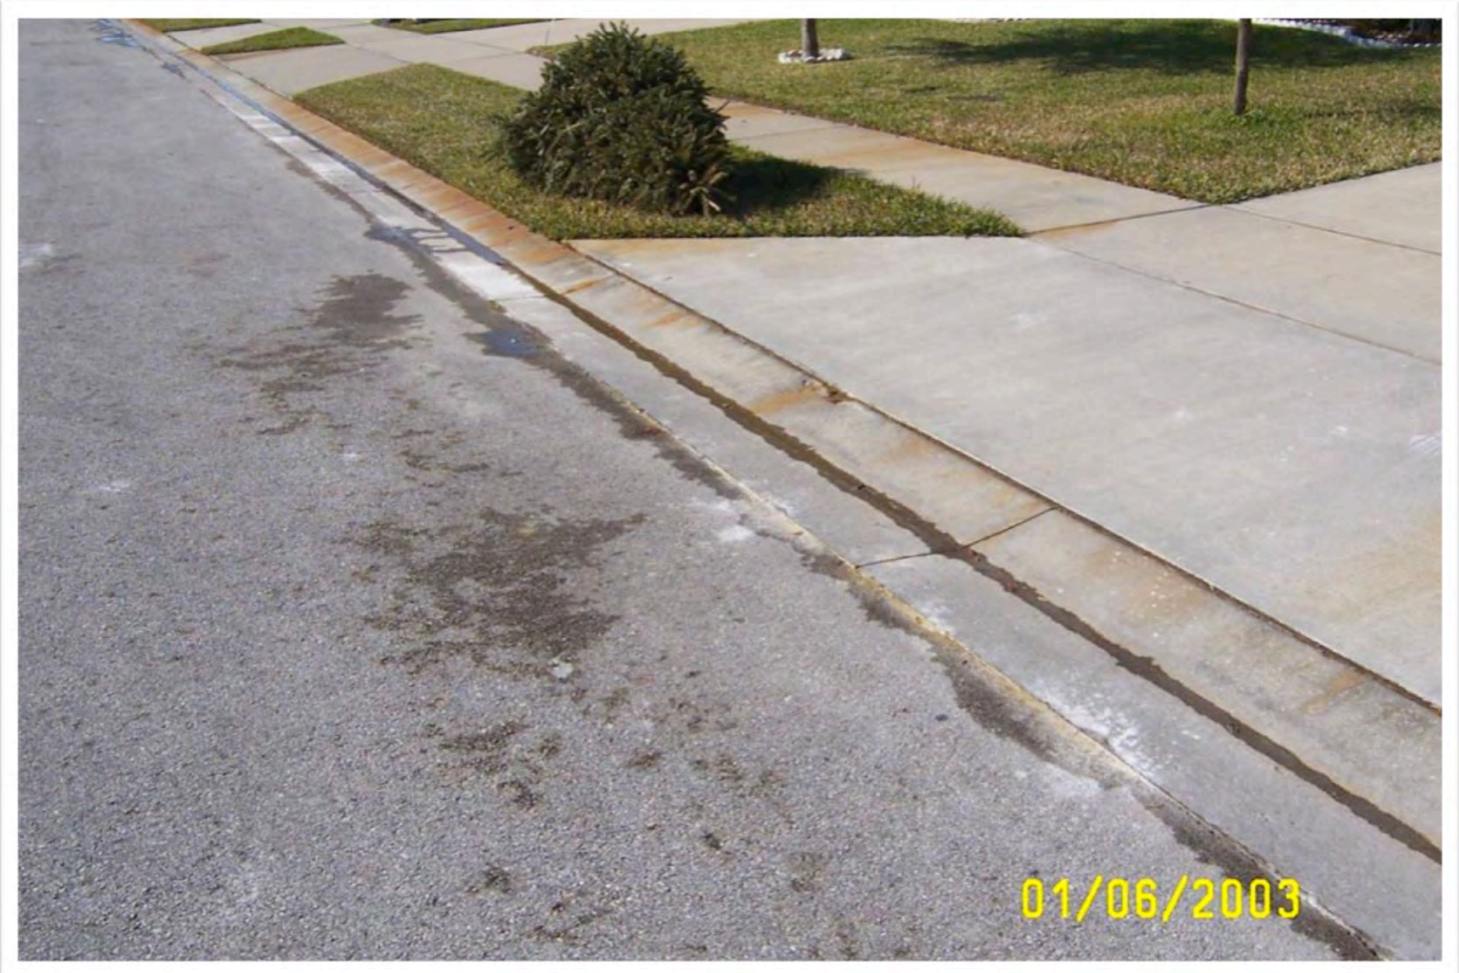
# Infrastructure failure from reclaimed water overirrigation - Country Club

Leaching Over Curb

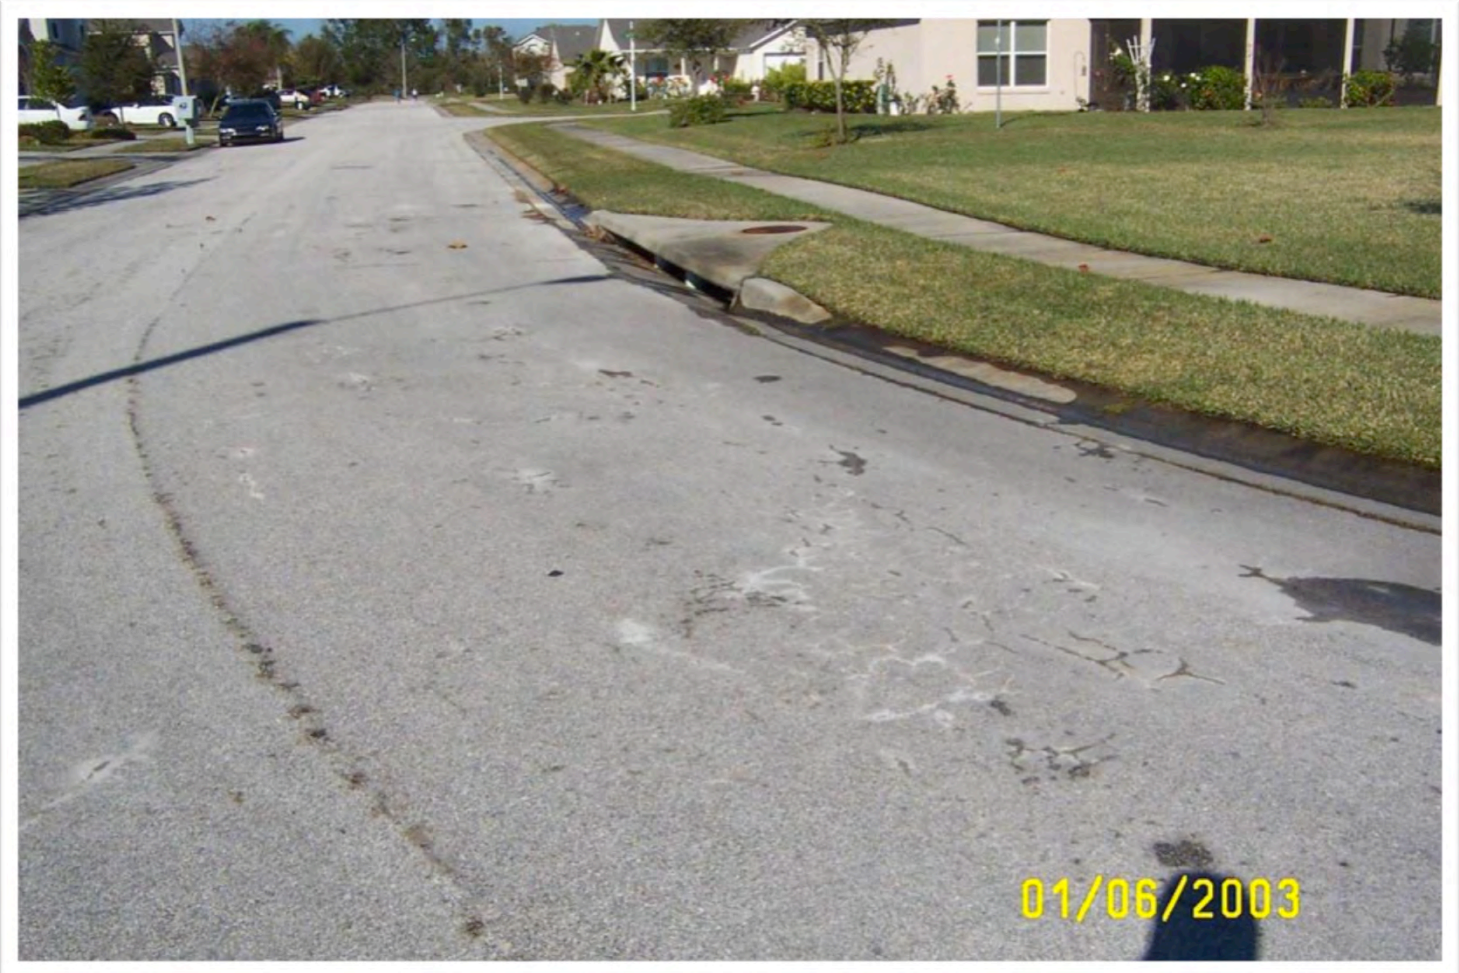
# Infrastructure failure from reclaimed water overirrigation - Country Club

Leaching Over Curb

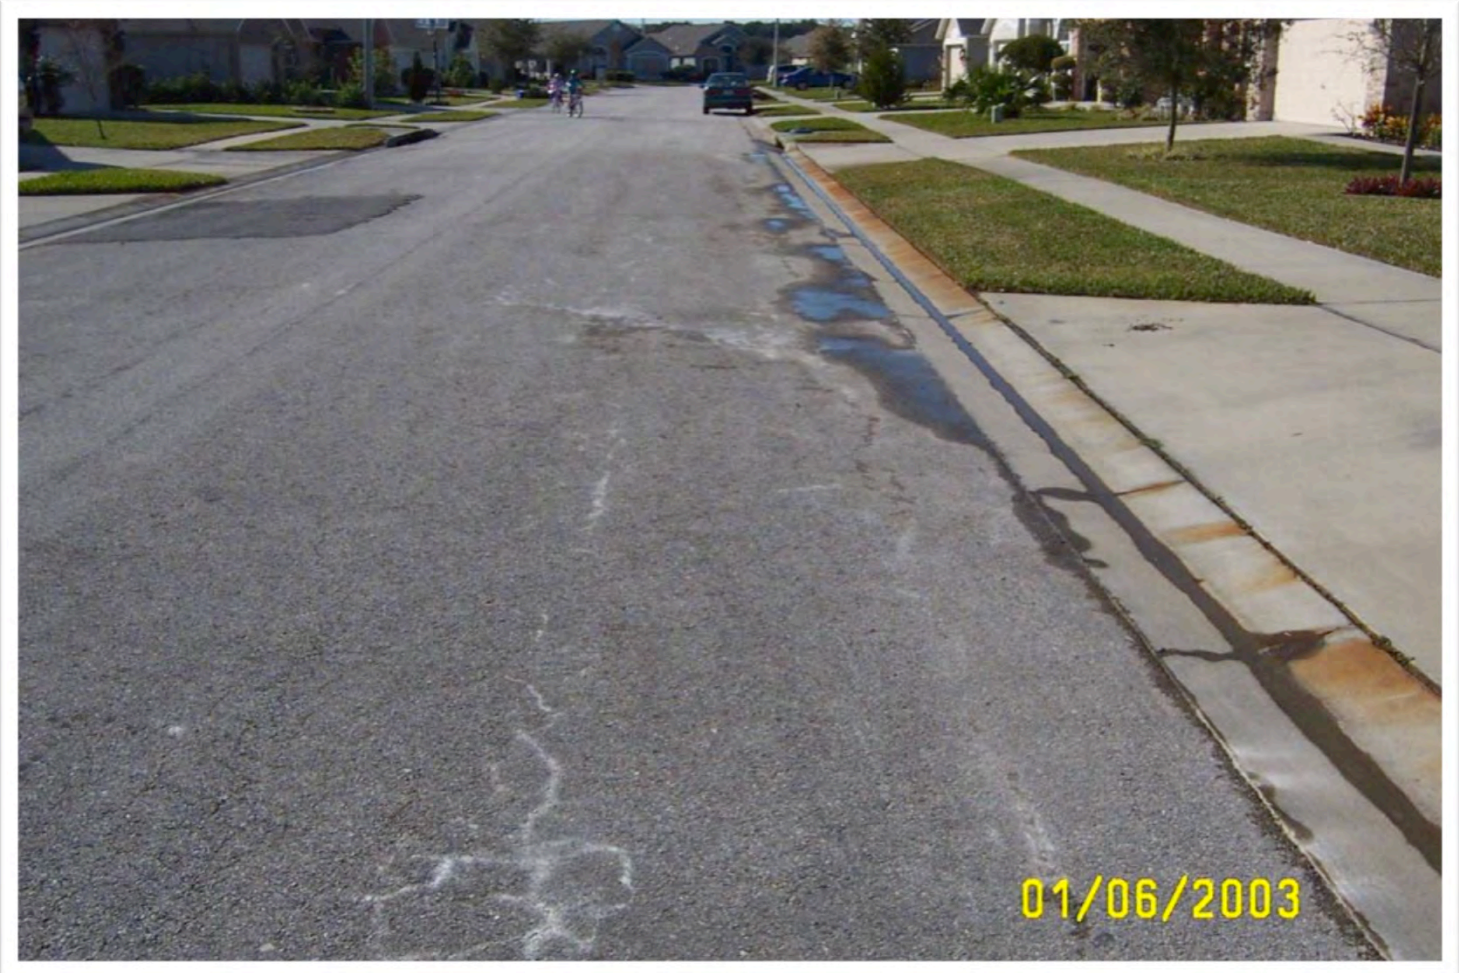
# Infrastructure failure from reclaimed water overirrigation - Country Club

Limerock Pumping From Base

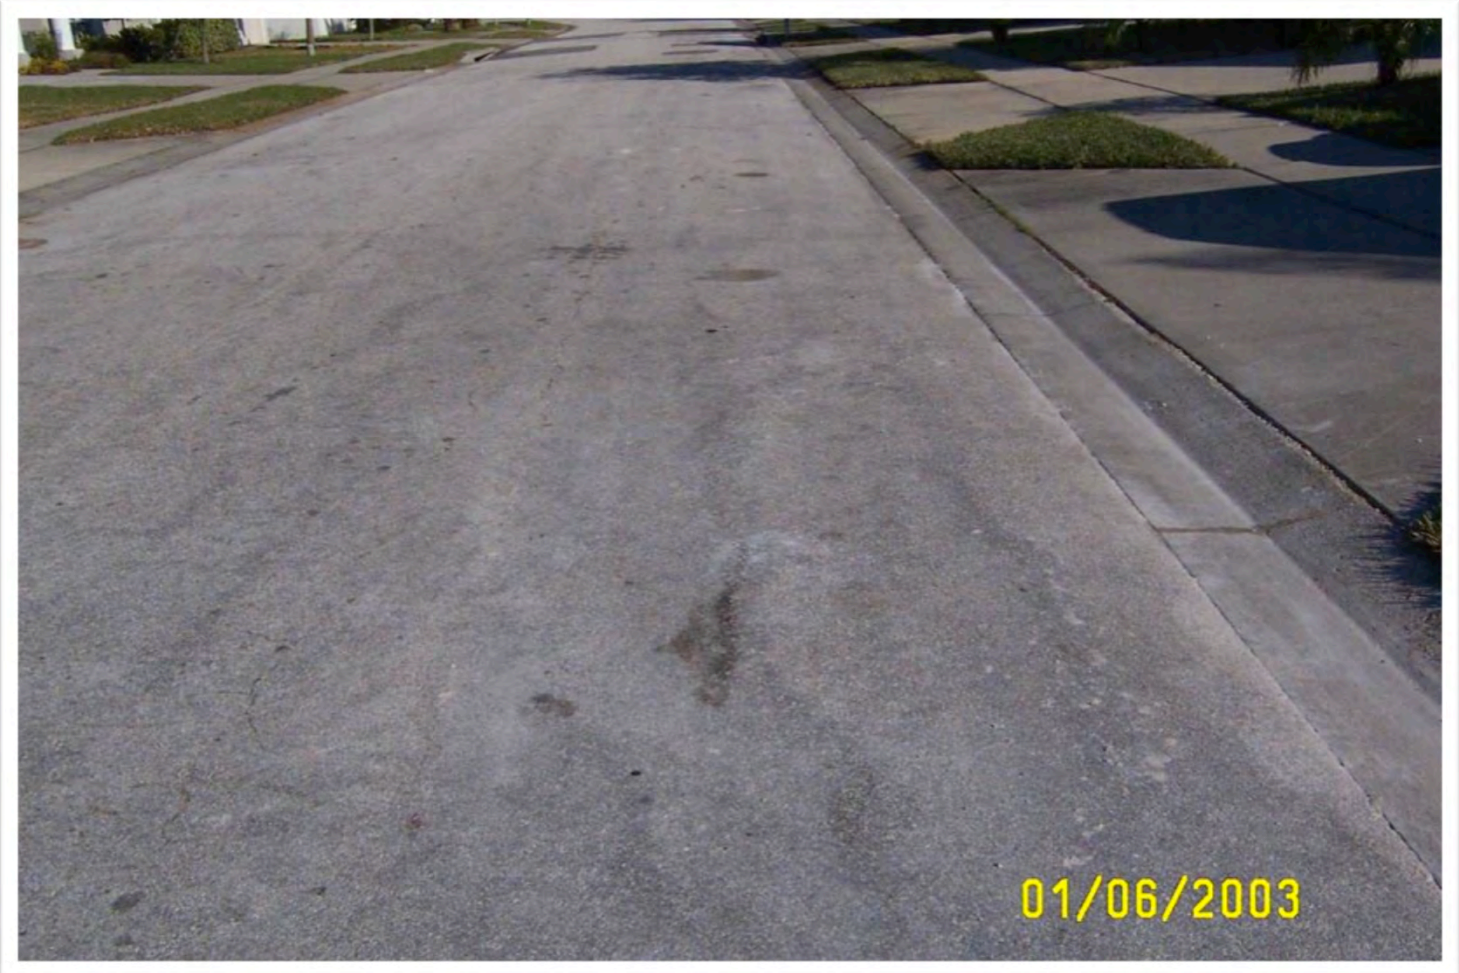
# Infrastructure failure from reclaimed water overirrigation - Country Club

Pavement Distress

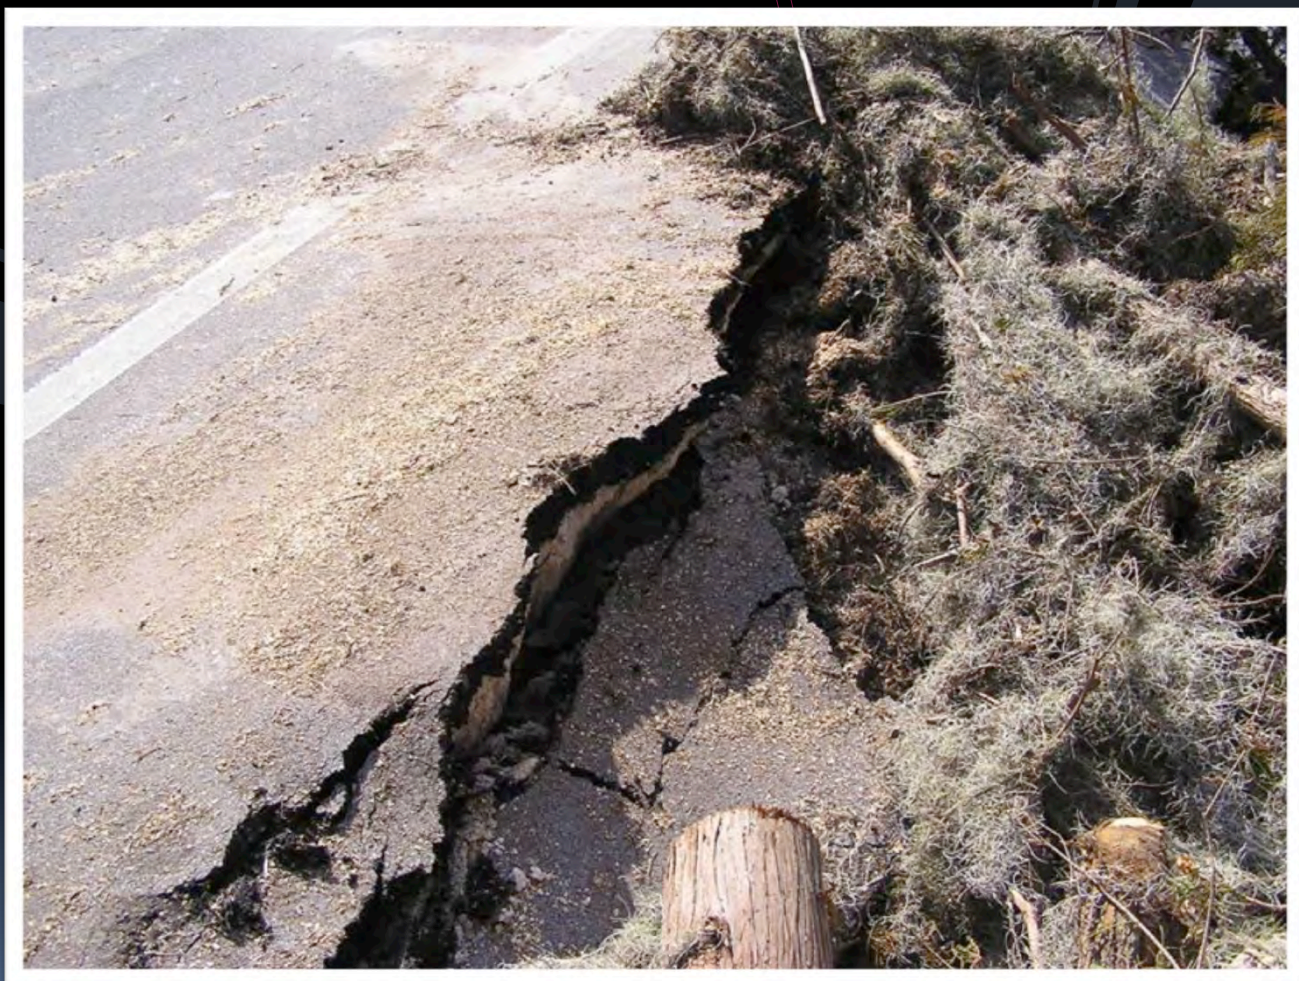
# CR 561 Clermont

# Embankment Washout Due to Storm-Induced Wave Action

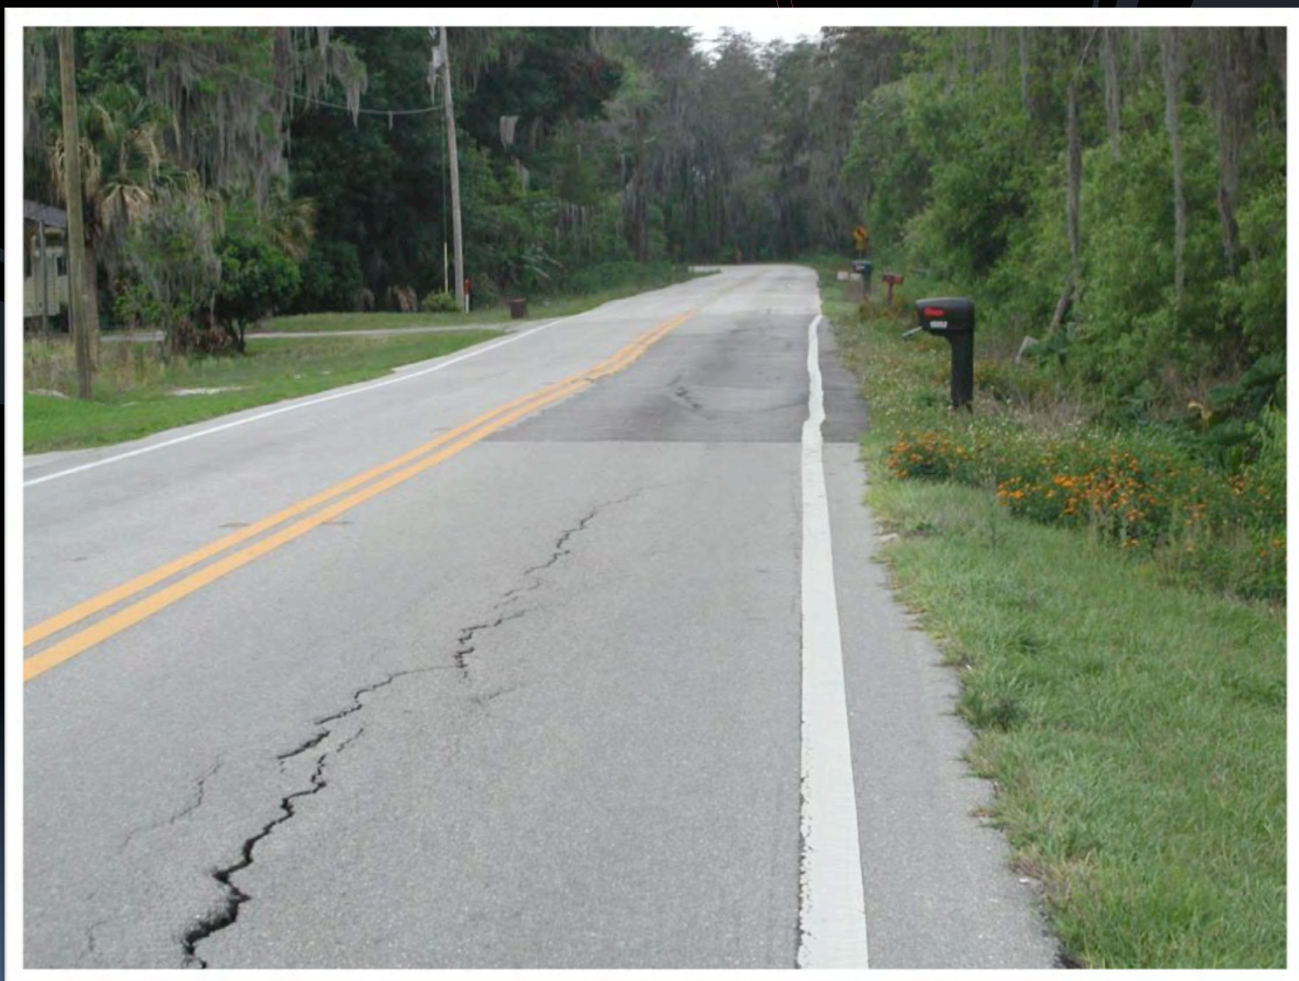
# Country Road 561

Pavement Distress

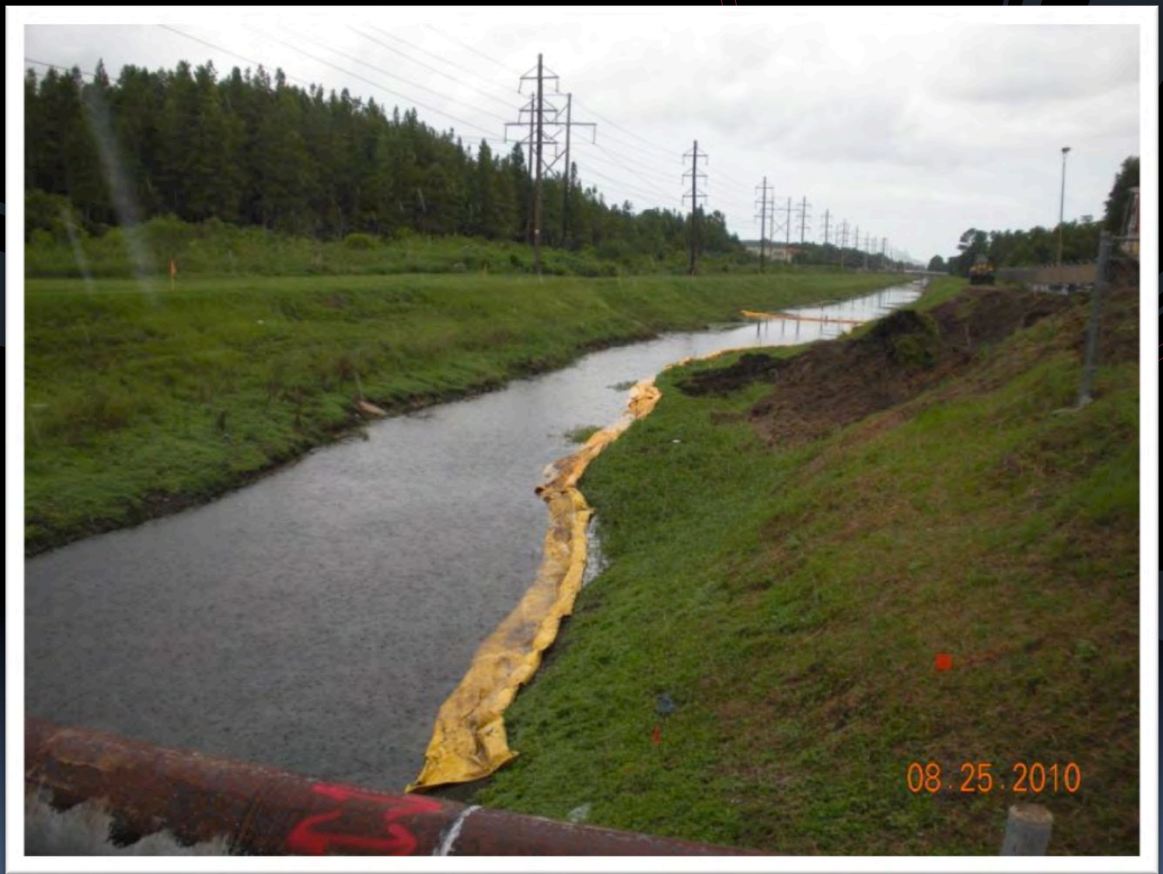
View of slope failure before any attempt to reshape

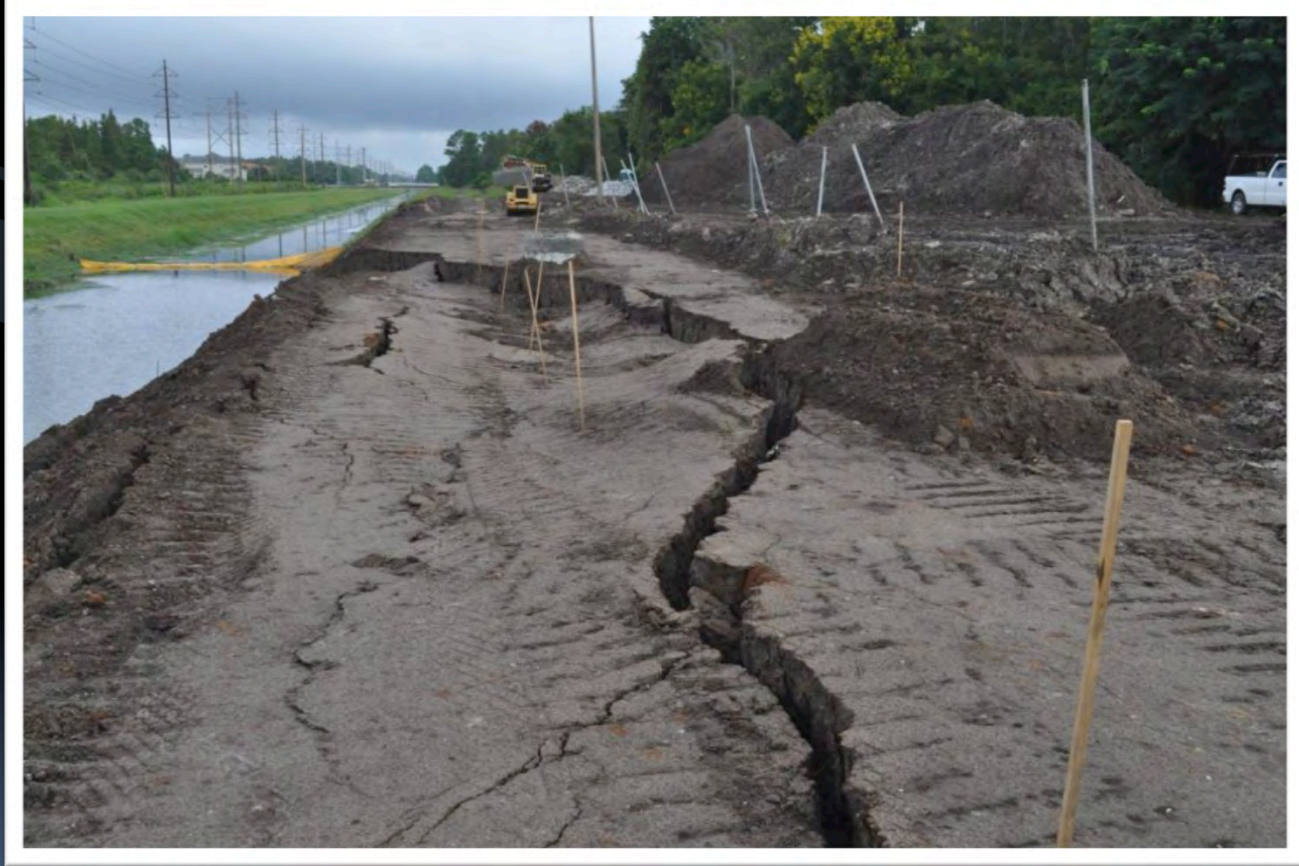
Failure of filled slope due to improper locking

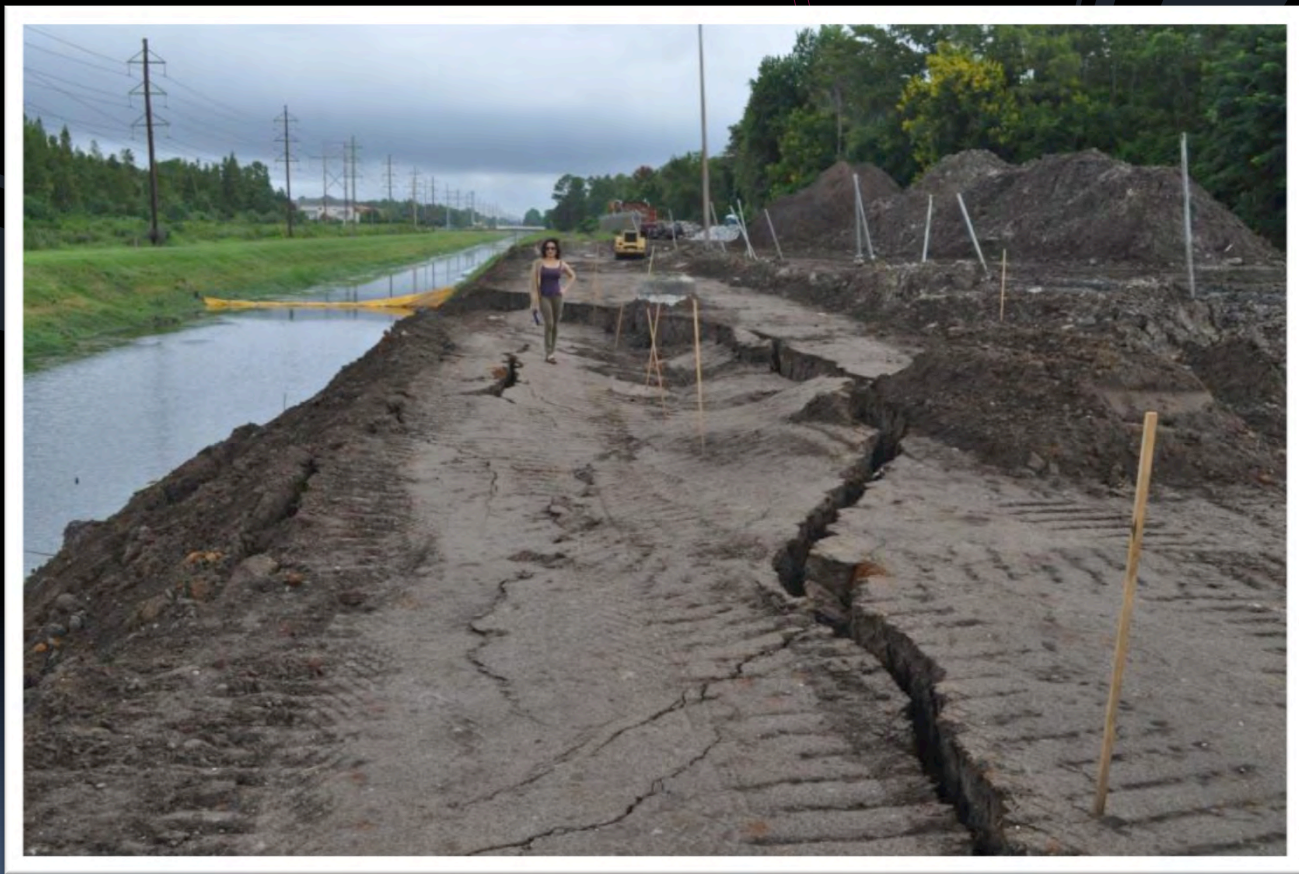
Failure due to pretty surcharge load

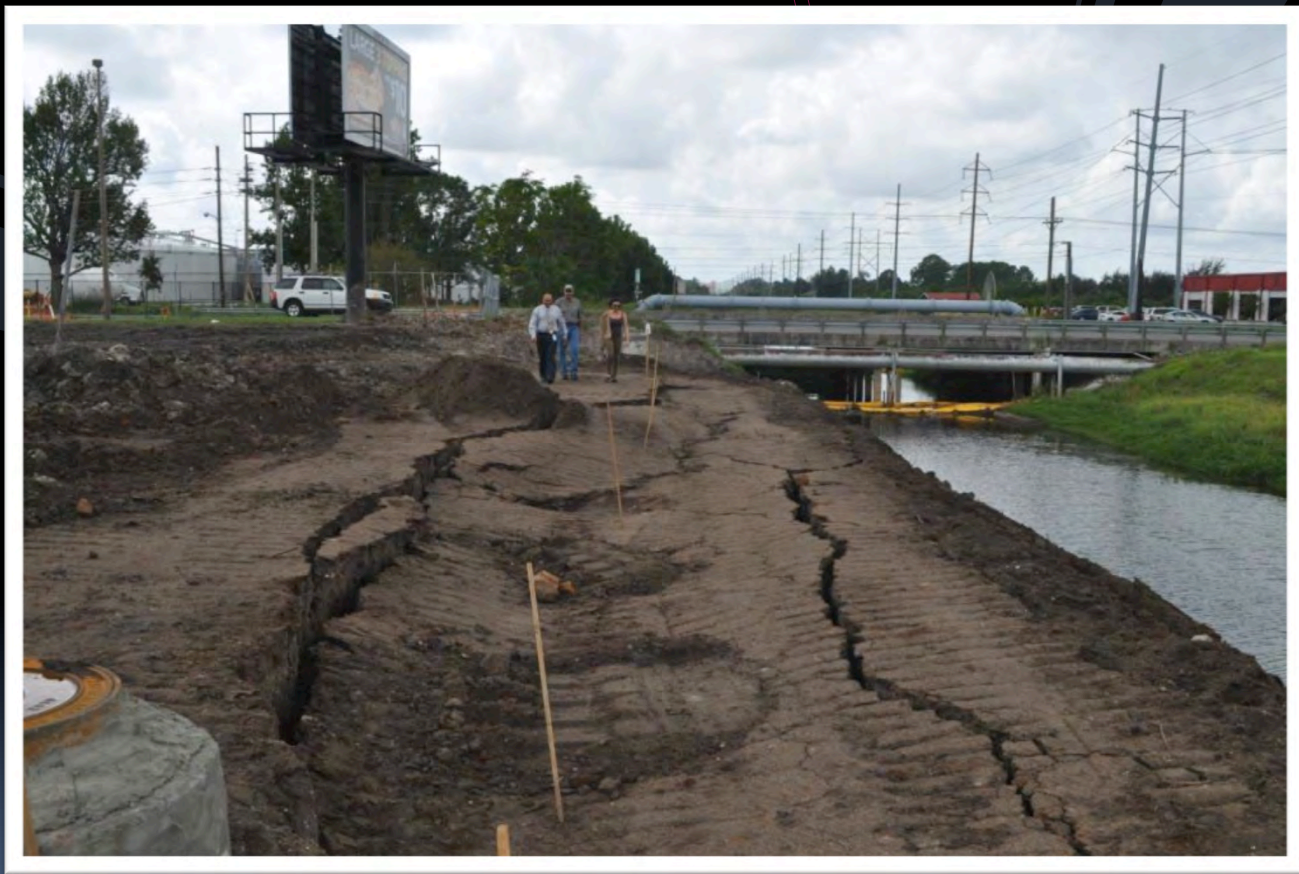
Another view of failed slope

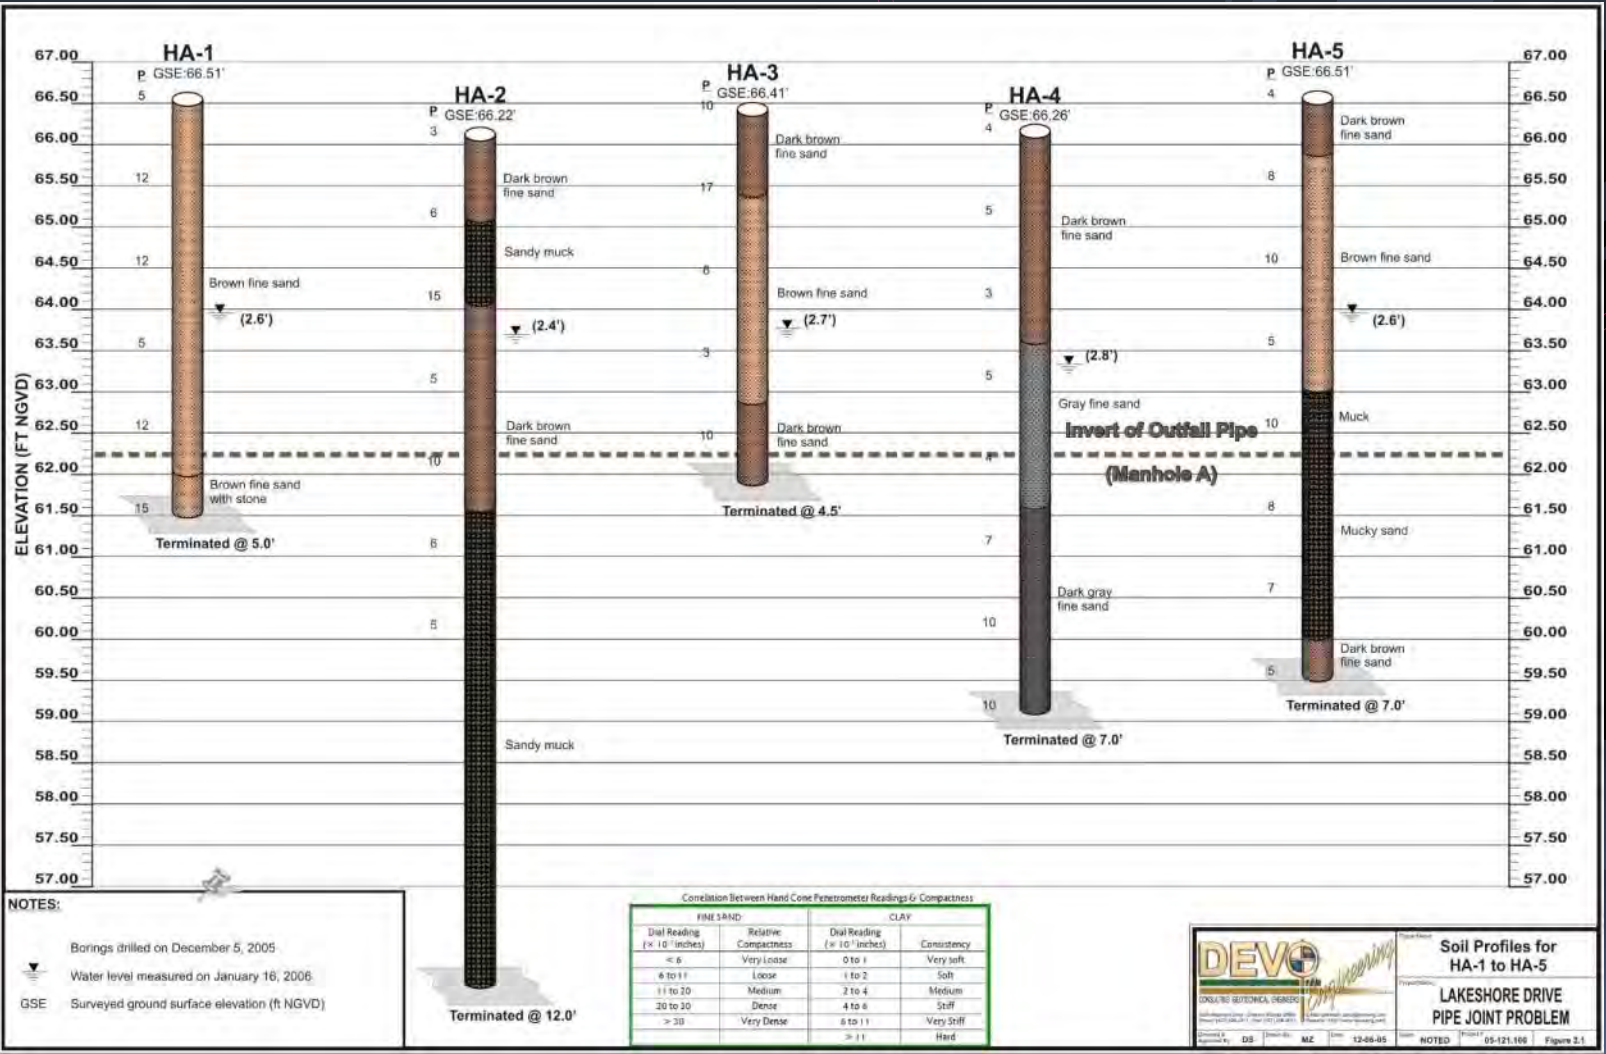
Pipe joints separated due to differential settlement

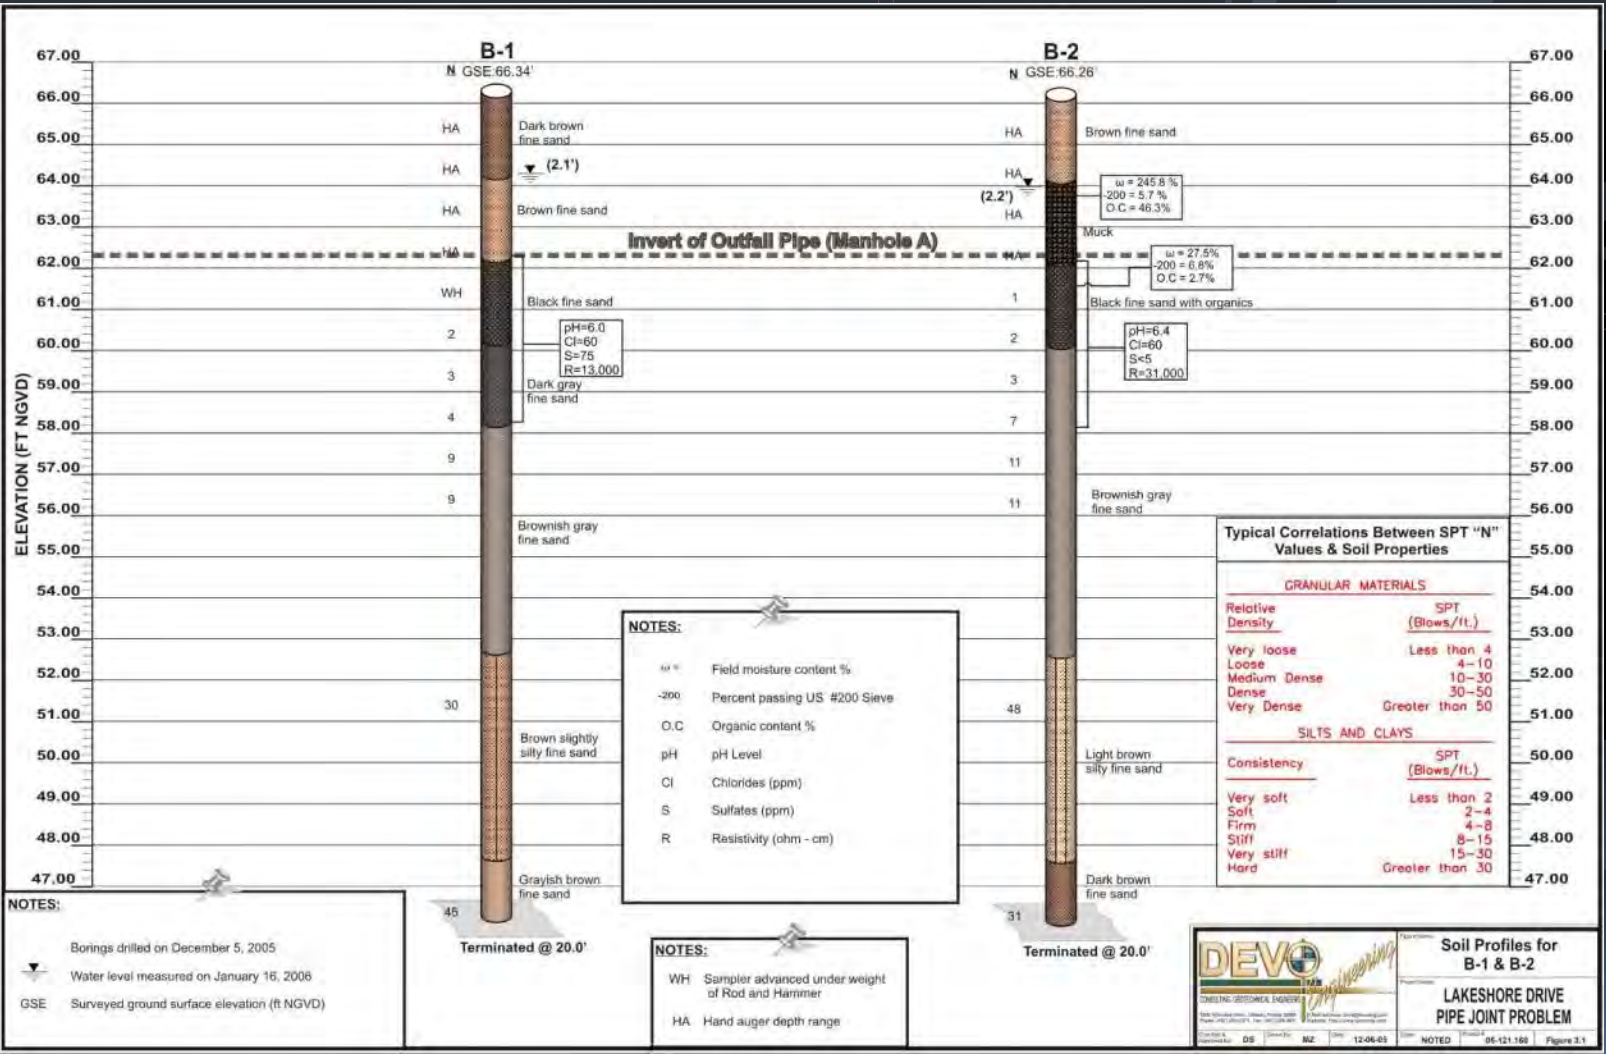
Pipe invert on muck

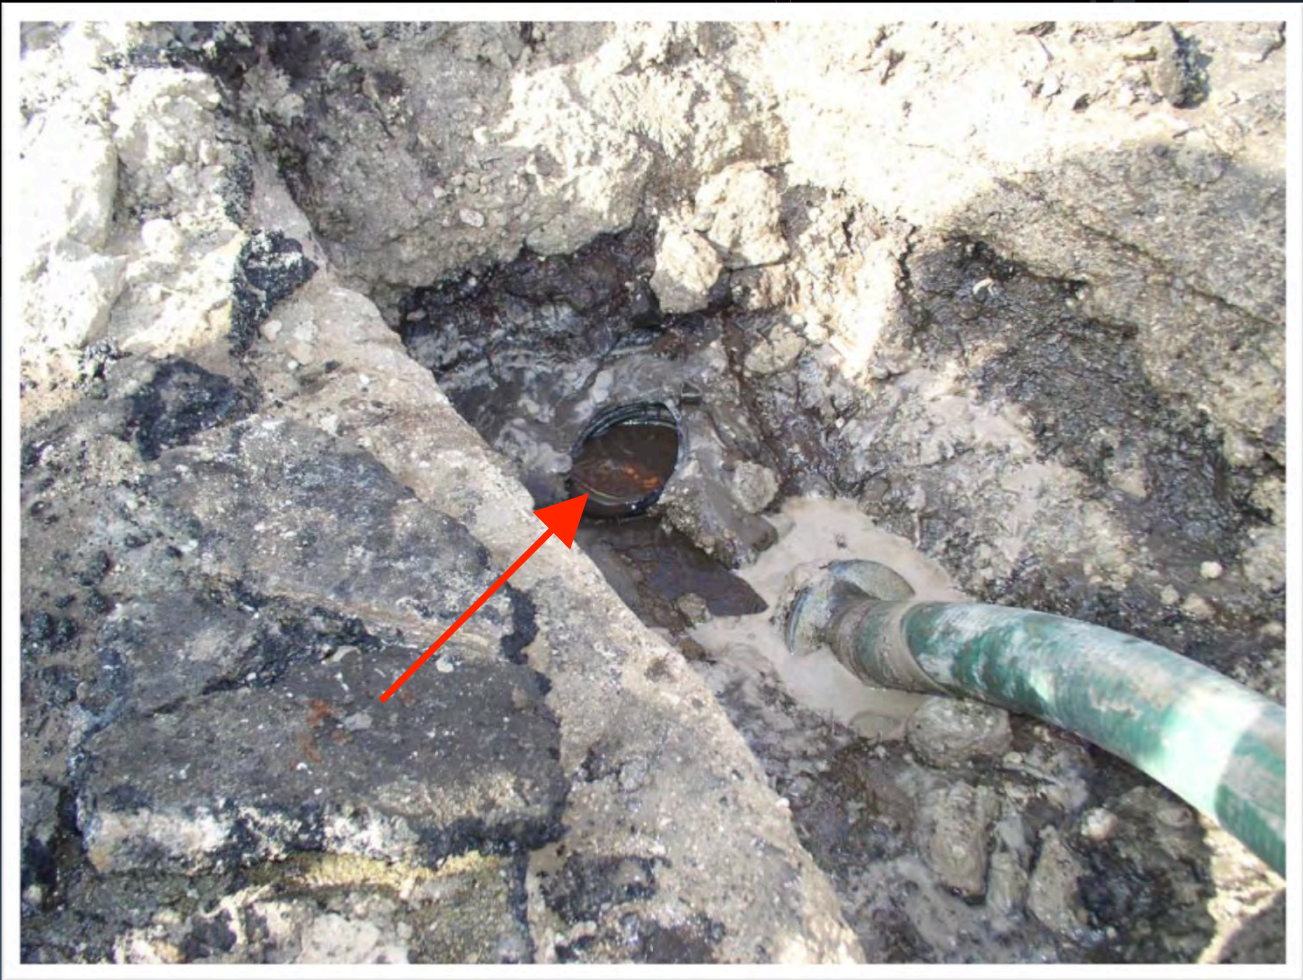
Relic Sock Drain

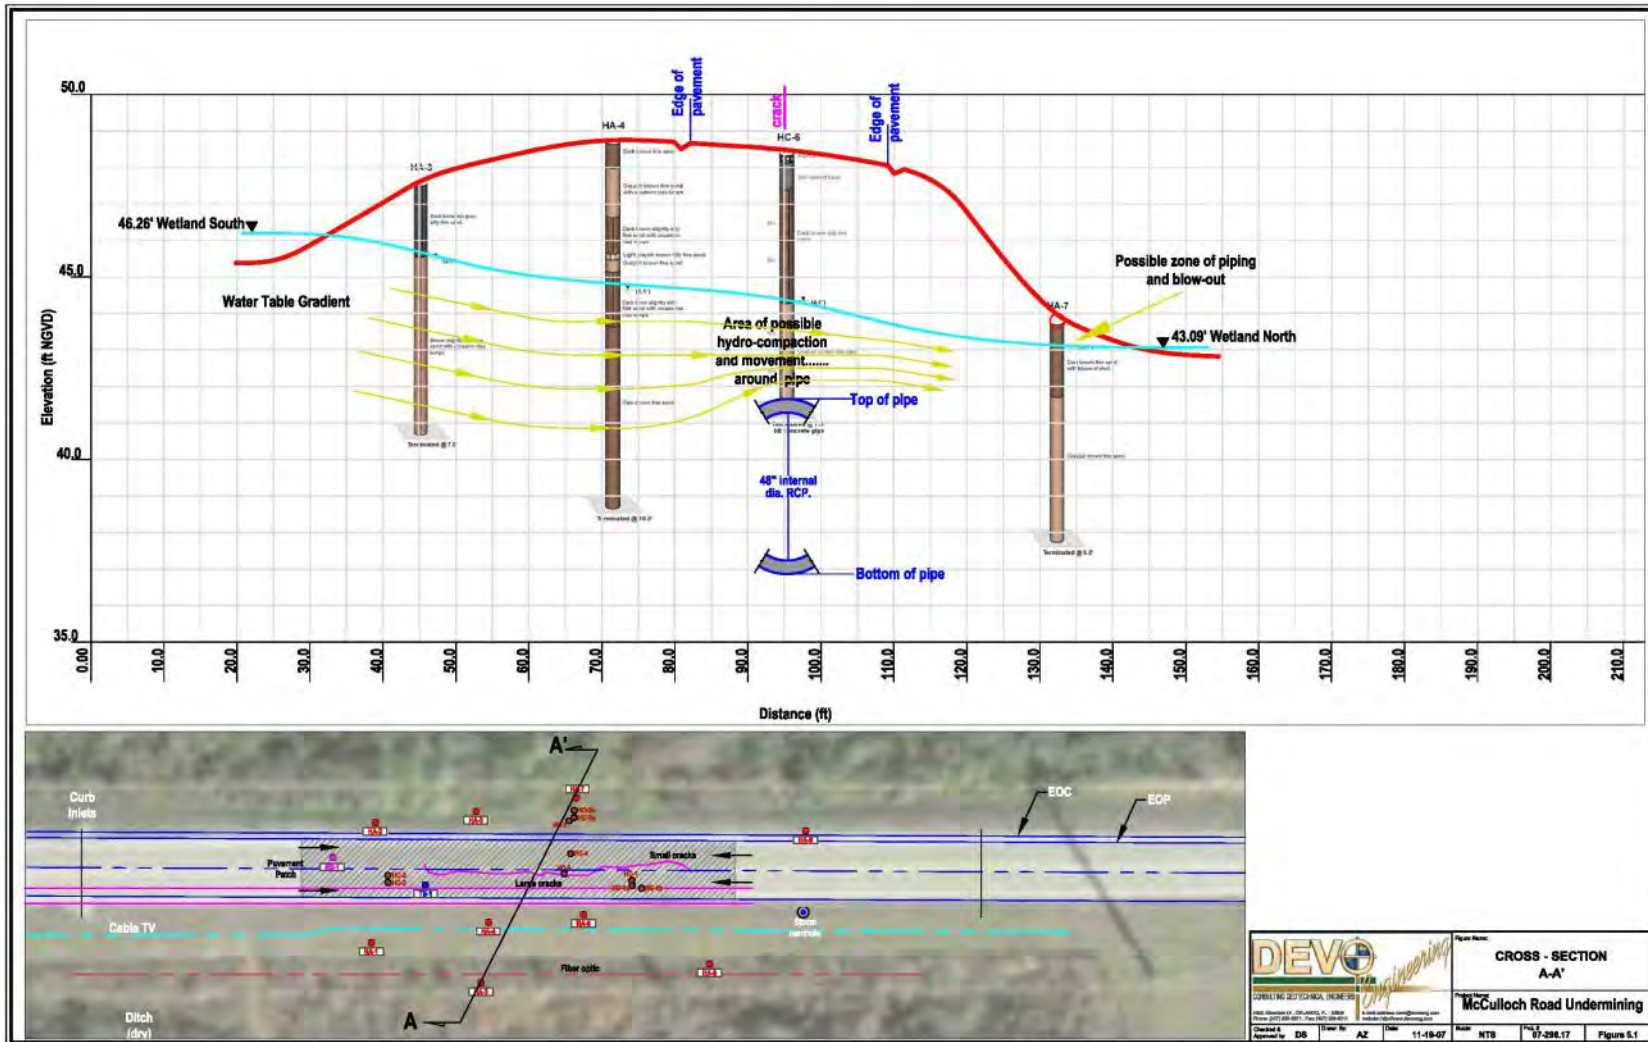
Subsurface Mechanism

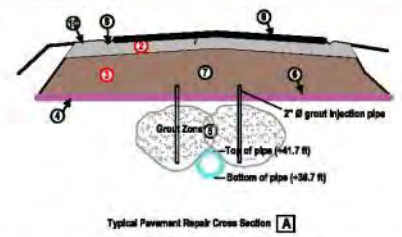
Project Name: <b>RETROFIT PLAN</b>
	Project Title: <b>McCulloch Road Undermining</b>
Date: 02-11-07	Scale: Noted
Author: DB	Check: AZ
Date: 07-2006-17	Figure: 6.1

There are very loose backfill soils in the general area of the pipe zone beneath the pavement. Invasive repairs by way of open excavation would be very time consuming, impractical to maintain traffic along the roadway and would require construction dewatering.

The conceptual repair plan for the pavement distress is presented in Figure 6.1 and its principal elements are described below.

Reconstruct the pavement to a depth of 3 ft, incorporating a layer of uniaxial geogrid like Tenaxar UX-1400 or equivalent within the subgrade as shown in Figure 6.1.

We recommend that the pipe zone be compaction grouted beneath the depth of pavement reconstruction. The injection pipes should be installed to a depth of 8ft below the reduced roadway level along both sides of the reuse main at 10 ft intervals and a cementitious grout should then be applied with a maximum pressure of 25psi. Adequate care should be exercised to ensure that the pressure distribution is properly balanced along both sides of the reuse pipe to avoid displacing it. The embankment should be properly monitored for uplift and the injection pipes withdrawn while pumping as necessary.

Install an interceptor trench to cutoff ground water flow from the southern isolated wetland towards the north across the roadway embankment. It is necessary to take the outfall pipe to the wetland crossing to the east of the County's pond to create a positive outfall.

Install a 6 ft tall vertical HPDE liner or equivalent around the northern limit of the southern isolated wetland to a depth of +41 ft NGVD to prevent dehydration impacts to this wetland.
