# ROADWAY PROJECTS WITH FOCUS ON SUBSURFACE / DRAINAGE & LITIGATION-RELATED ISSUES

## 2011 FACERS Annual Conference

- Devo Seereeram, Ph.D., P.E.  
Devo Engineering

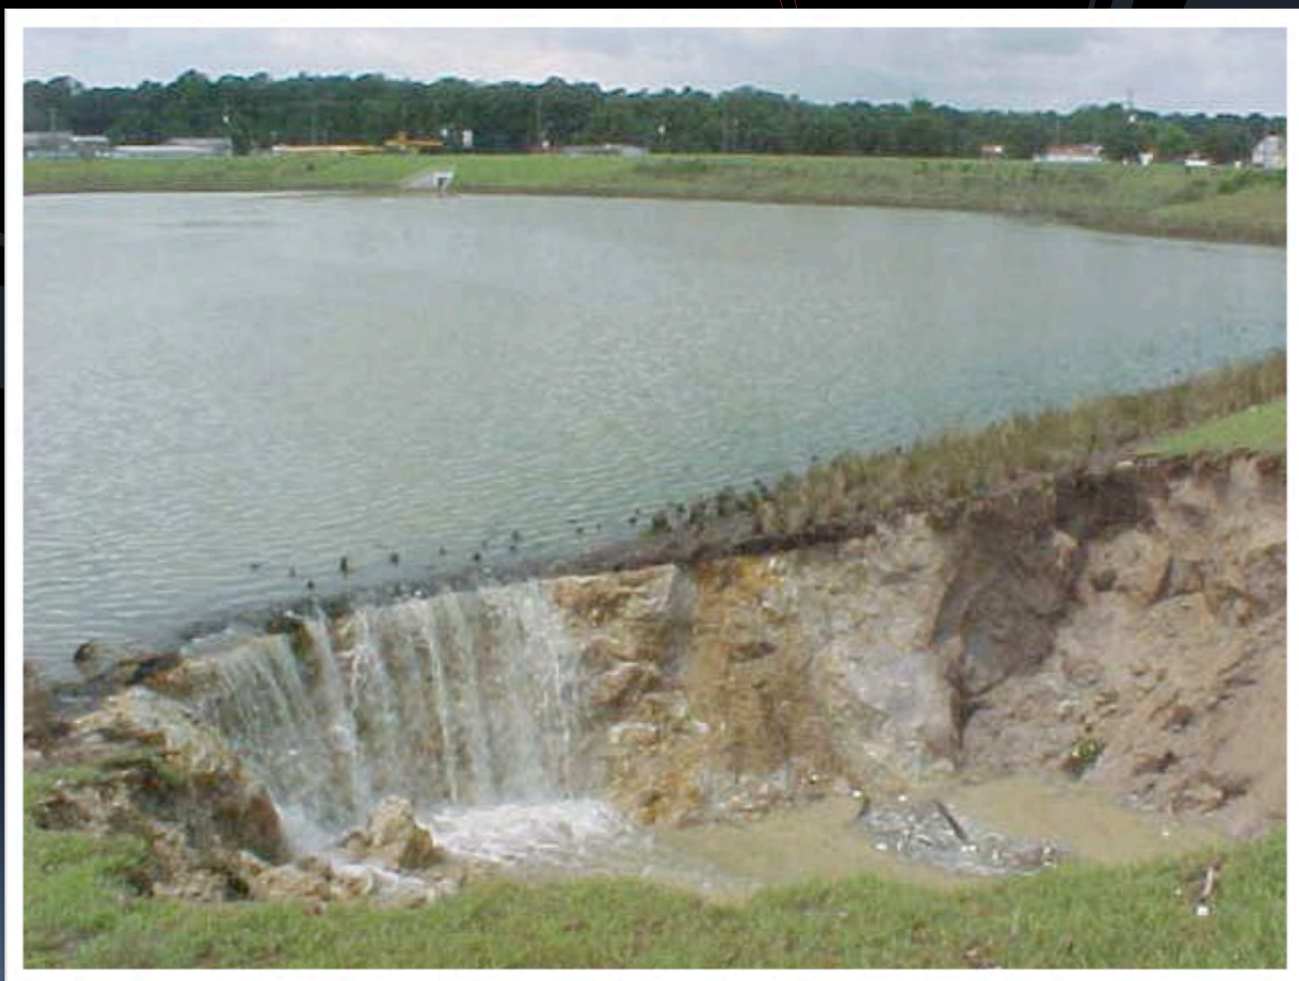
RSF sinkhole 1

# Failure of clay liner in wet pond - FSU Regional Stormwater Pond

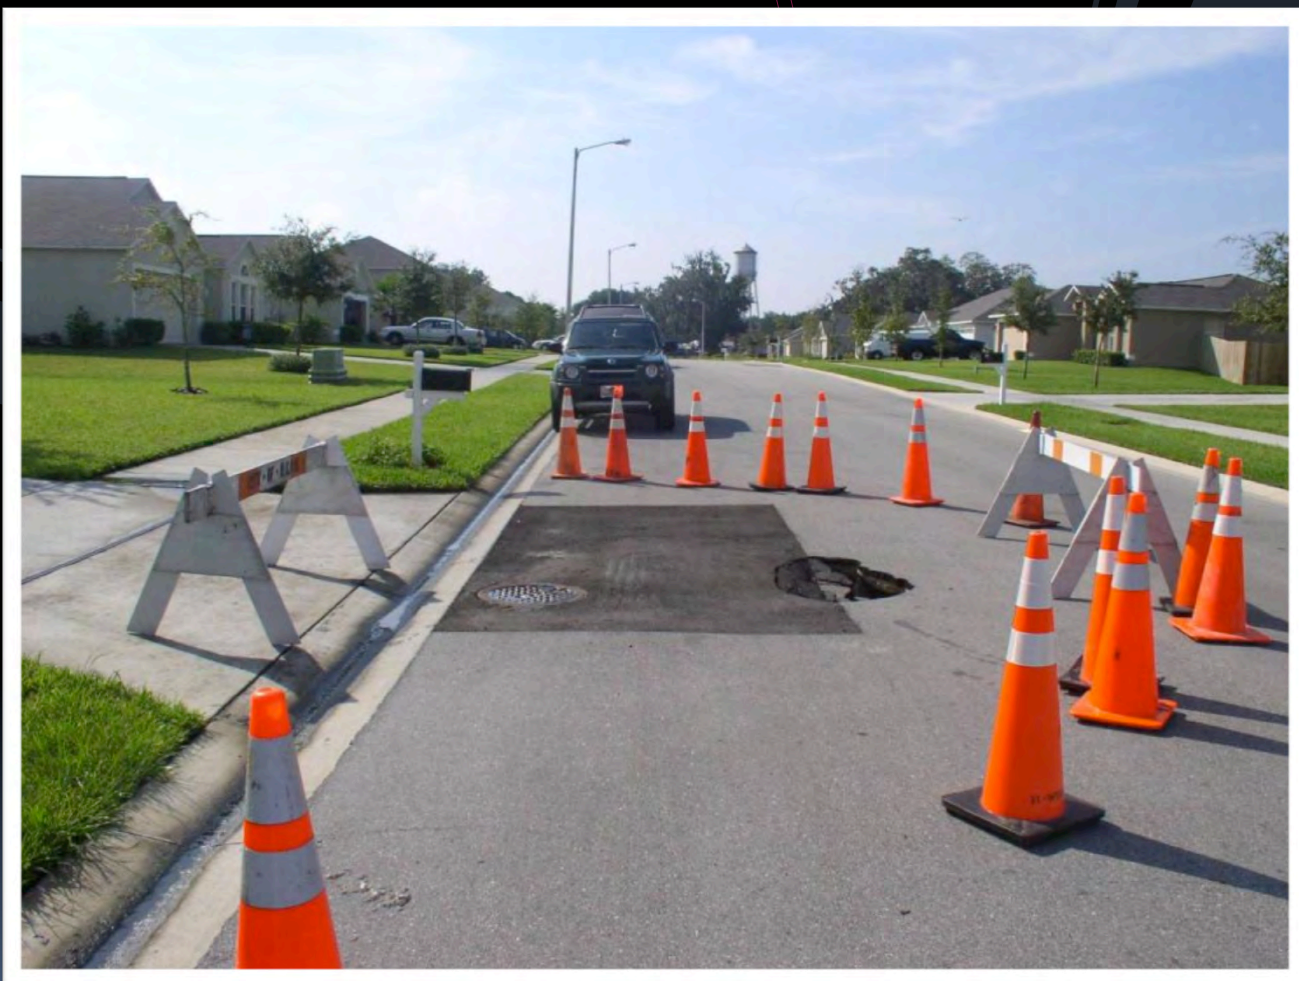
Sand flowing into leaking manhole leading to loss of soil and "sinkhole"

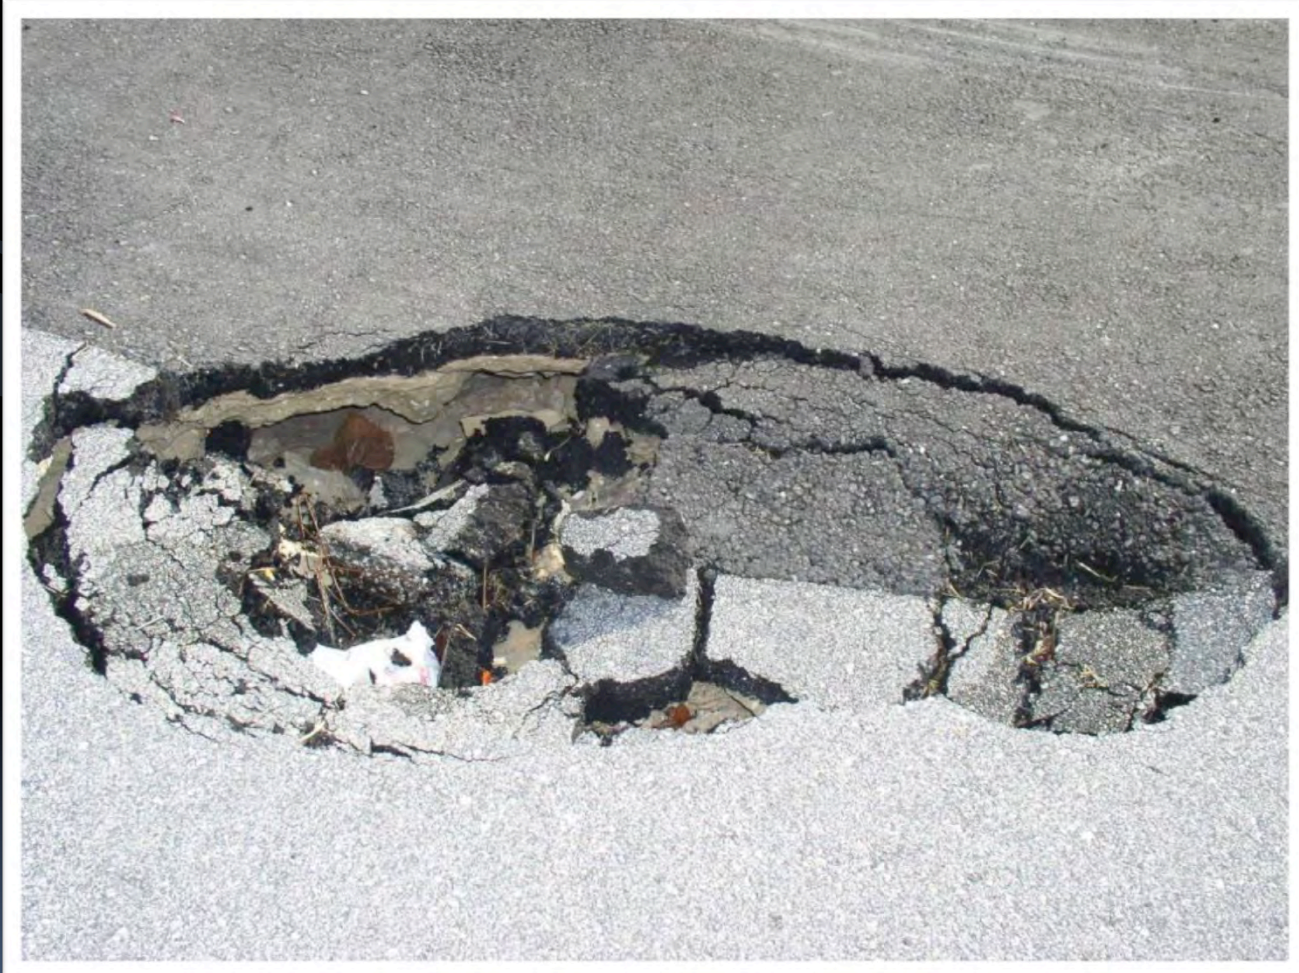
Close-up view of "sinkhole"

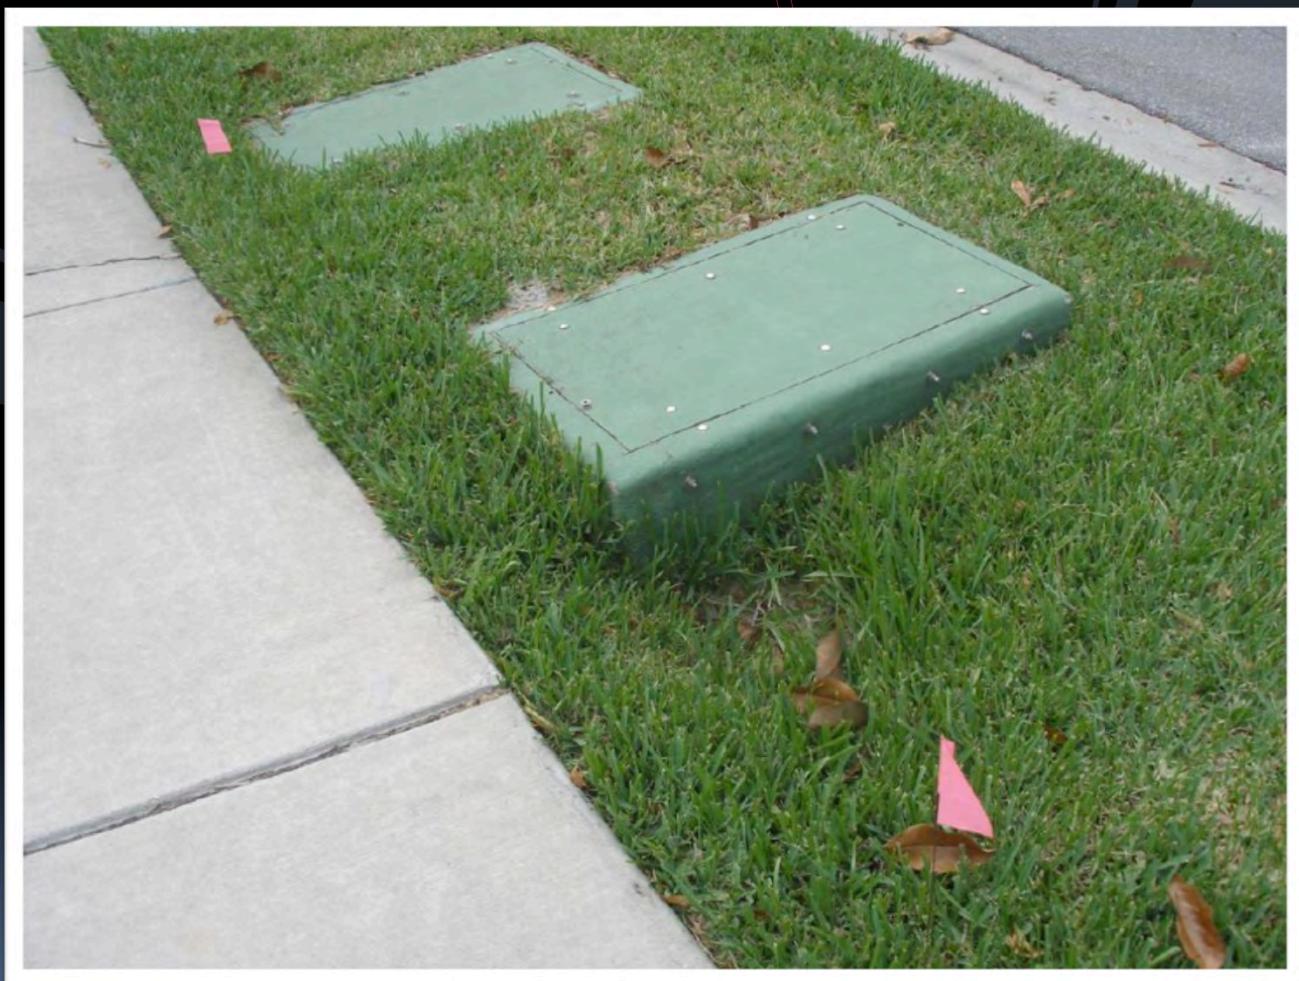
Settlement of soil around structure

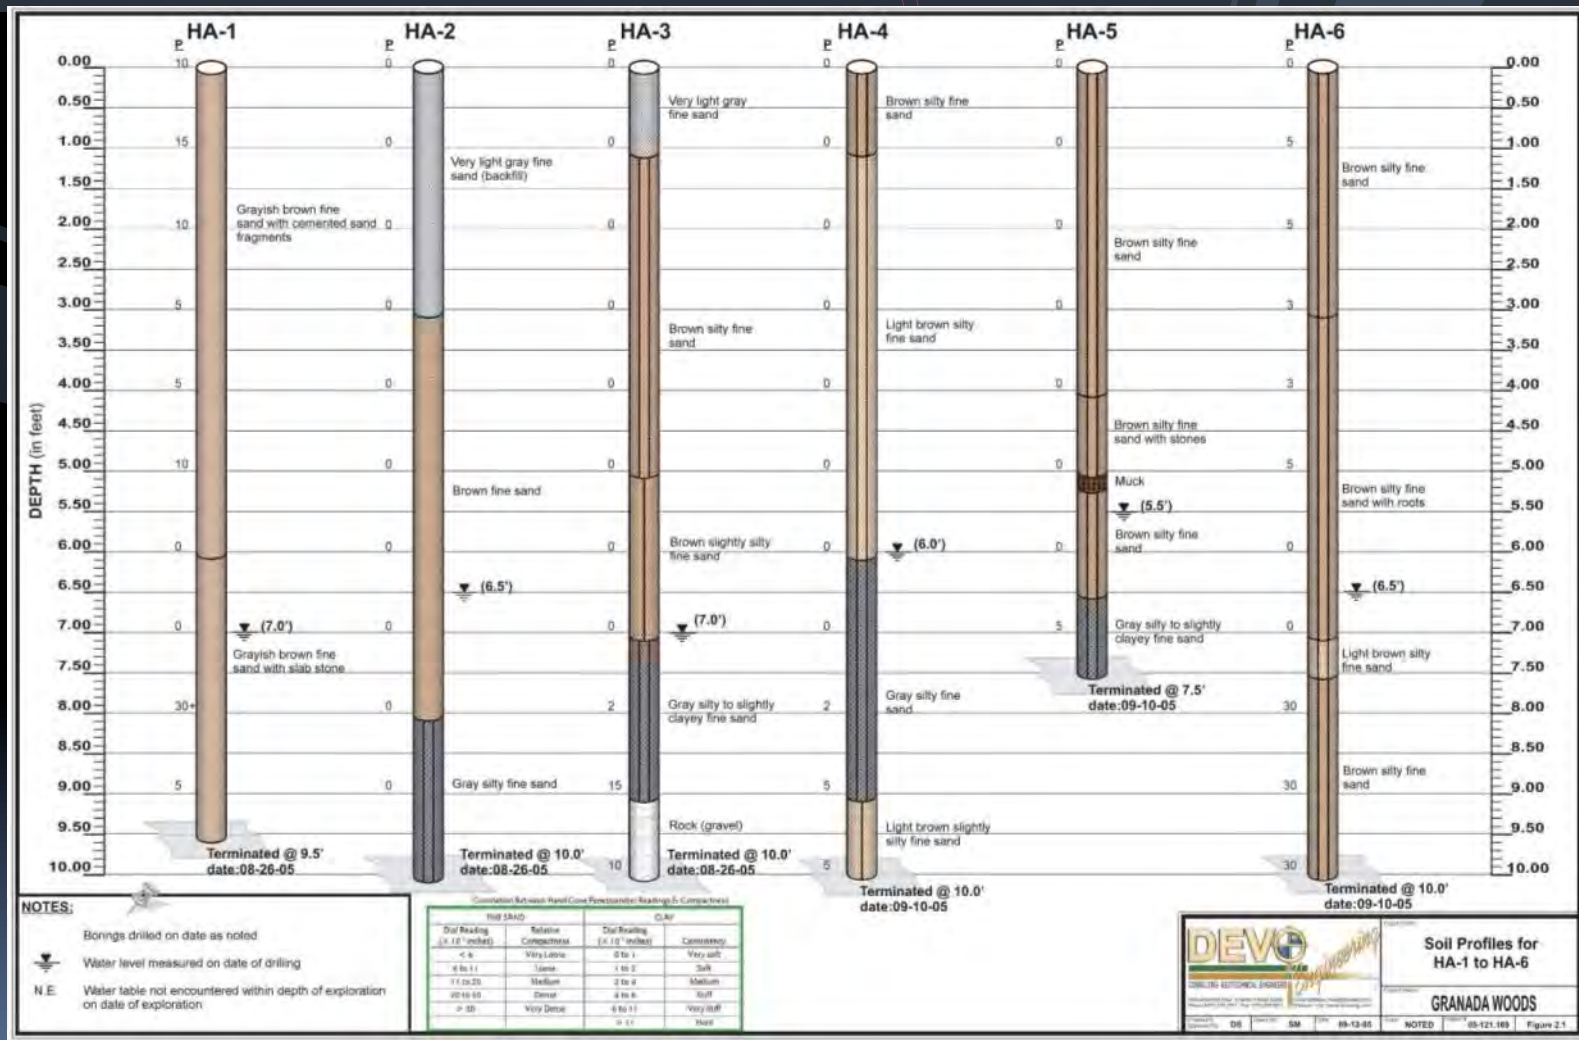
Soil stratigraphy and compactness around structure
