# Litigation Prone Areas of Stormwater Management

FLORIDA  
ENGINEERING  
SOCIETY

*When:* Wednesday,  
September 14, 2011  
*Where:* The Westin  
Lake Mary, Orlando  
2974 International Parkway  
Lake Mary, FL 32746-1409

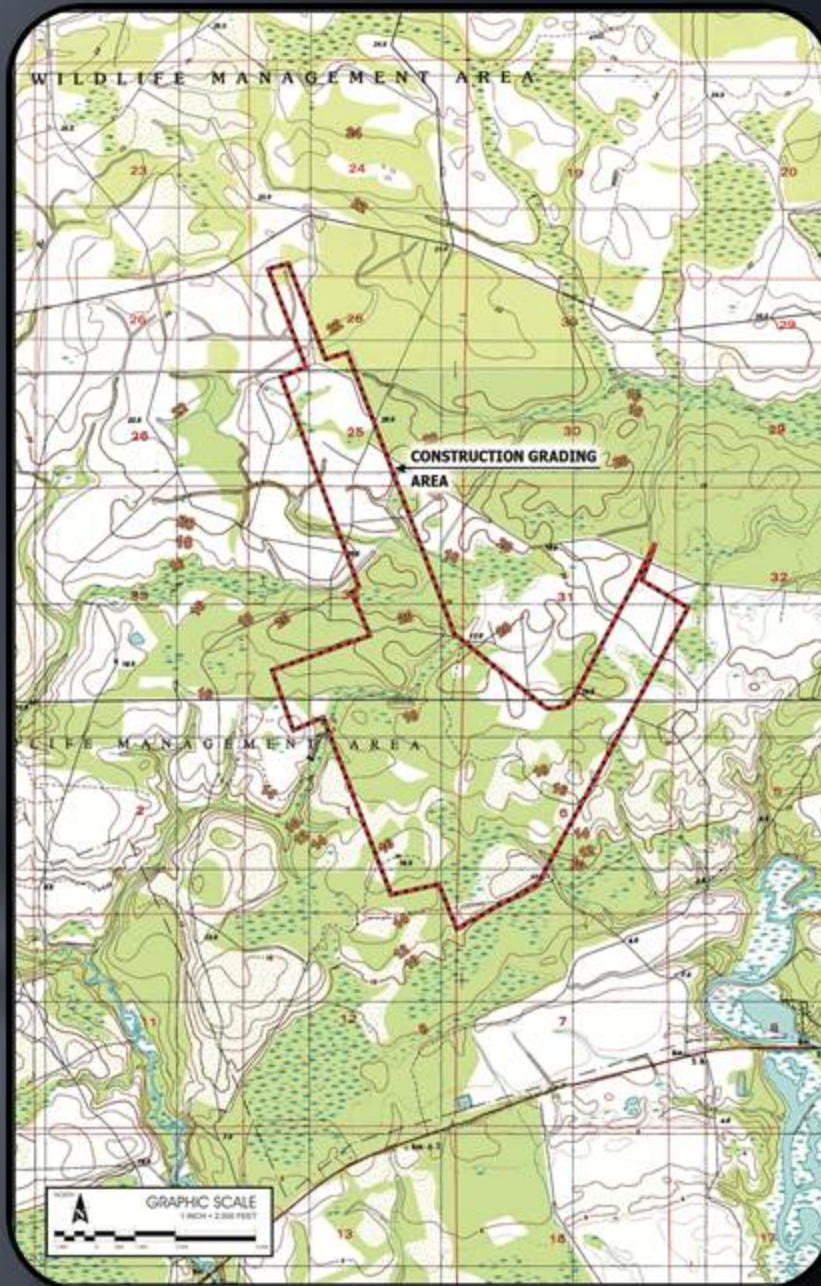
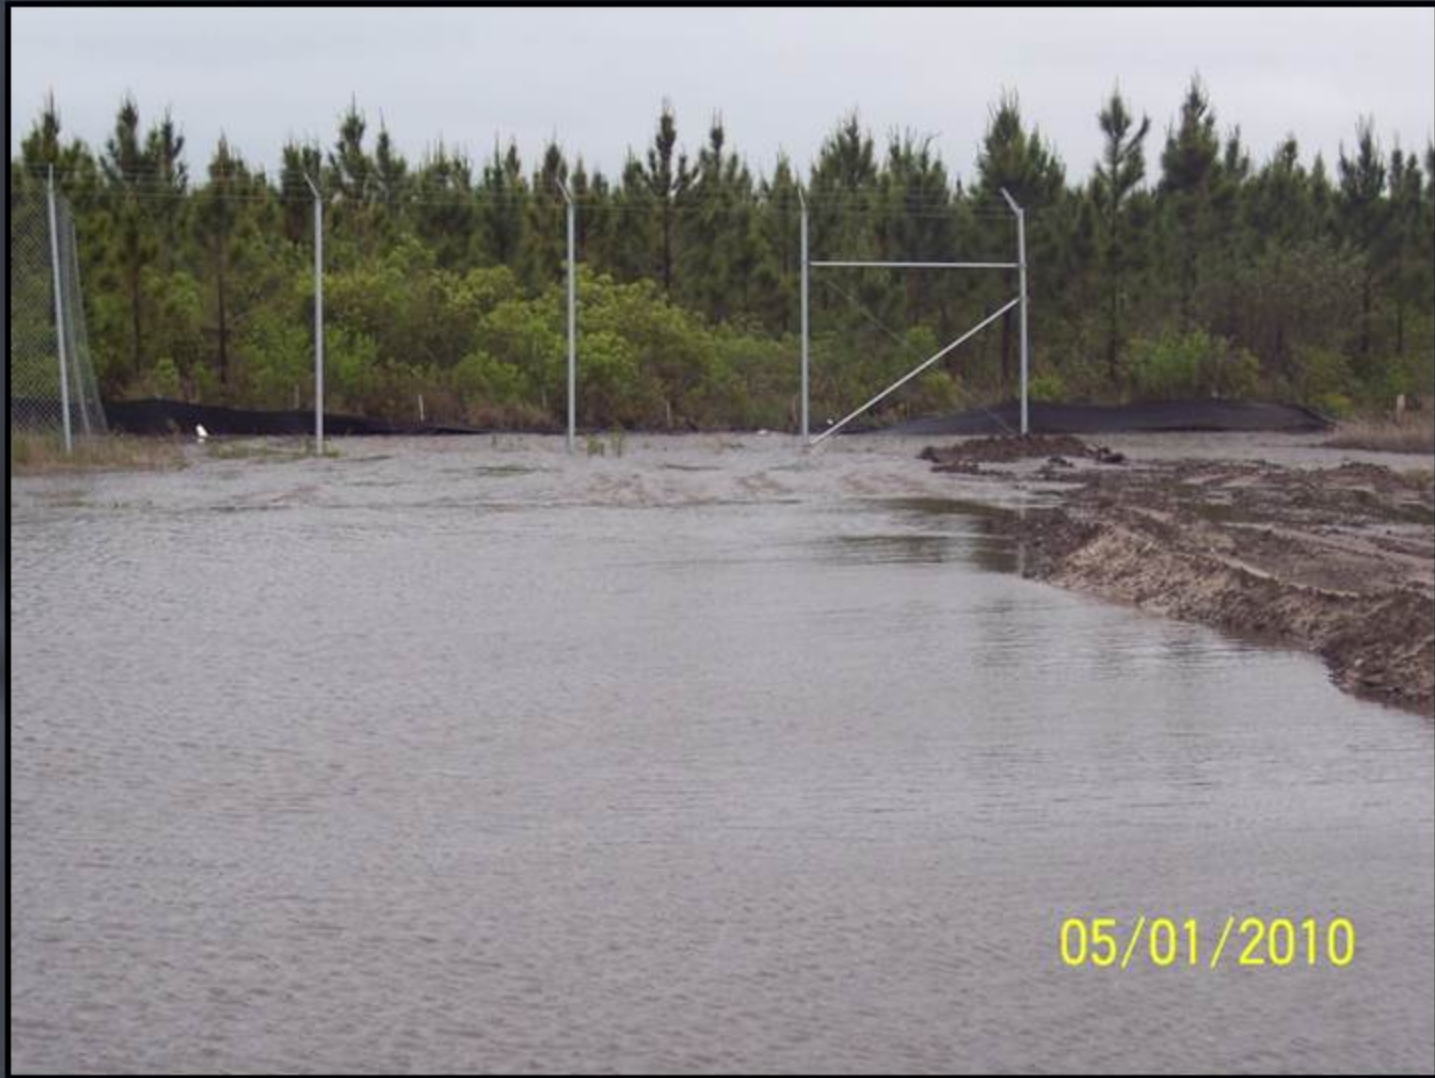
Topic #1: First, during construction, the contractor may not have considered the natural flow paths for stormwater runoff through his work site with the result that some flow lines are obstructed leading to upstream blockages and impoundments, some of which may fail with a “tidal wave” effect. These failures cause significant erosion and environmental damage since they release a lot of sediment-laden water.

Obstruction of Natural  
Drainage Flow Path During  
Construction

Obstruction of Natural Drainage  
Flow Path During Construction

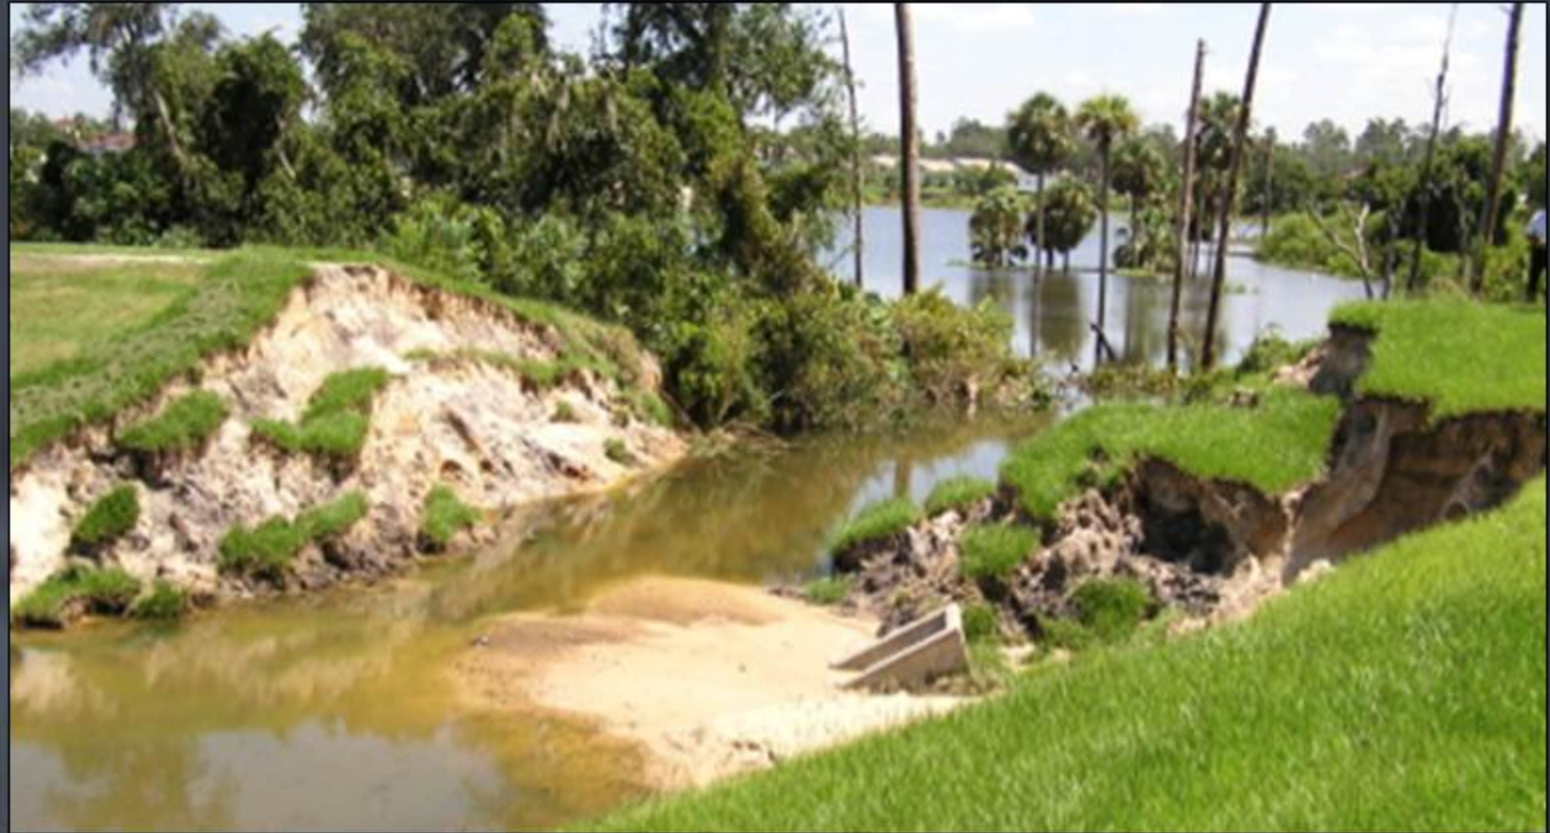
## Berm Failure

During the early days of Tropical Storm Fay, Project X stormwater pond experienced a berm failure as a result of uncontrolled discharge over the berm

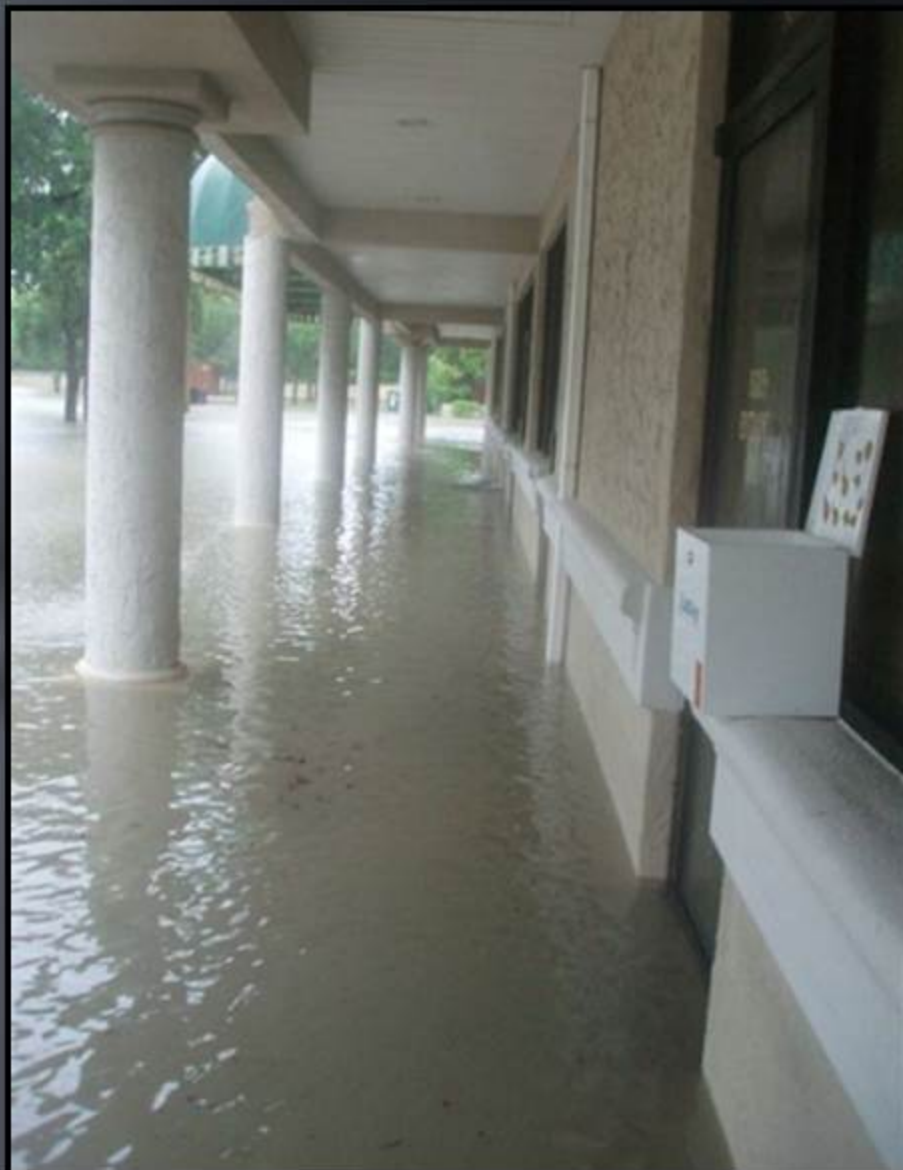
## Flooding at Downstream Building

Water entering building

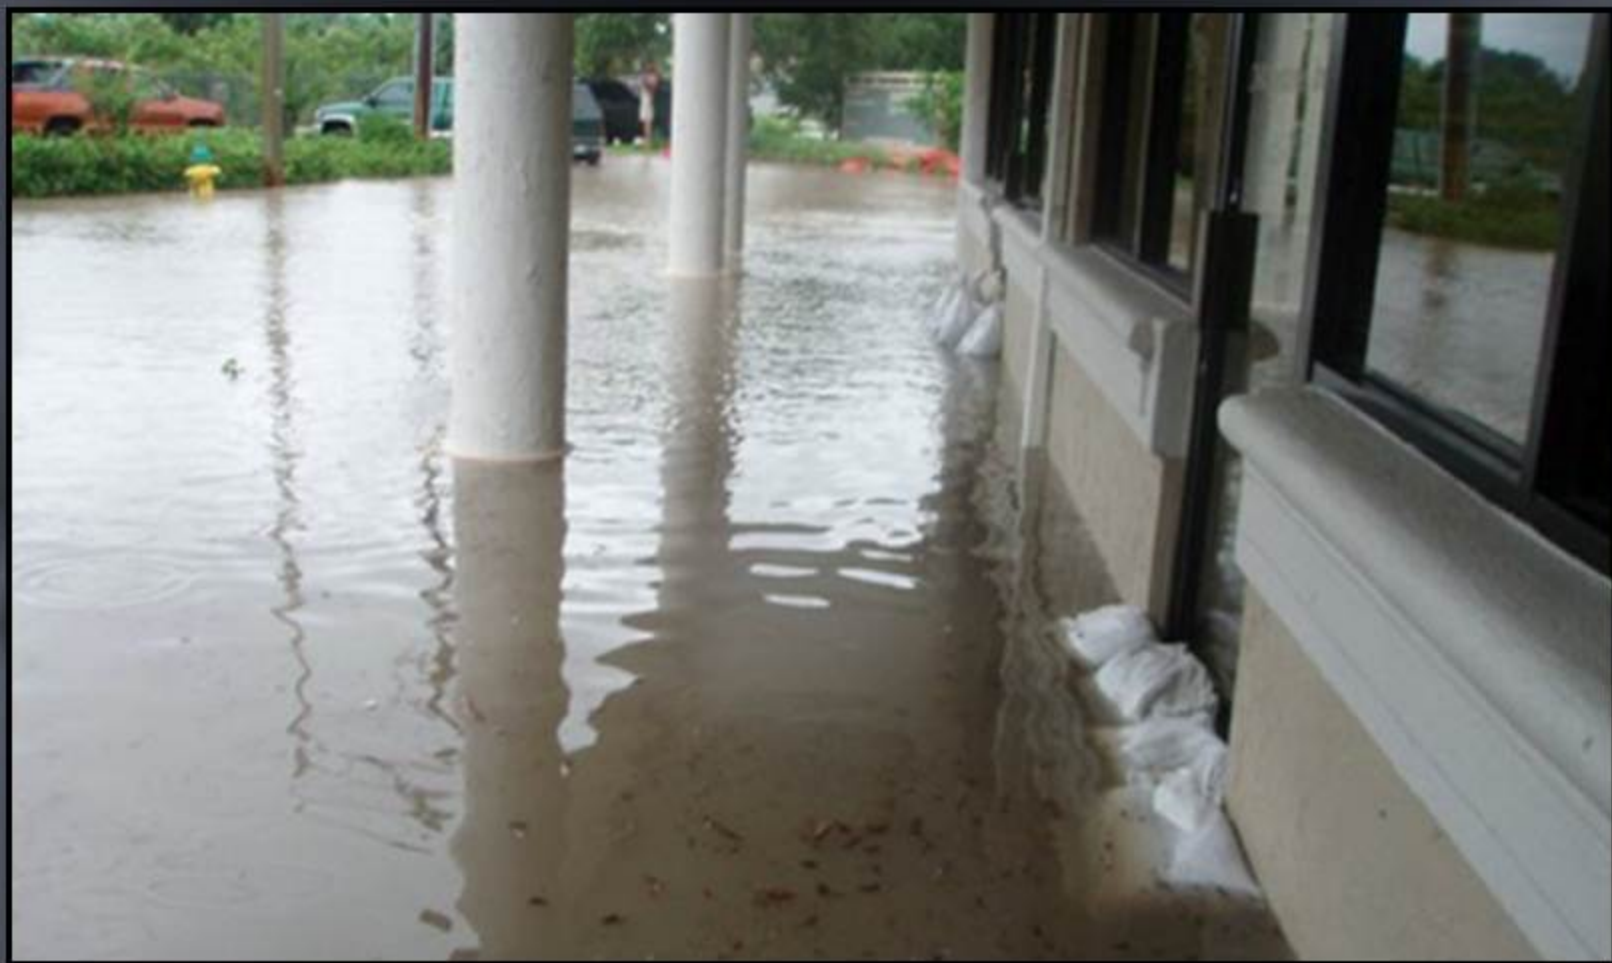
**Flooding at Downstream Building**

Sandbags stacked against entrance door.

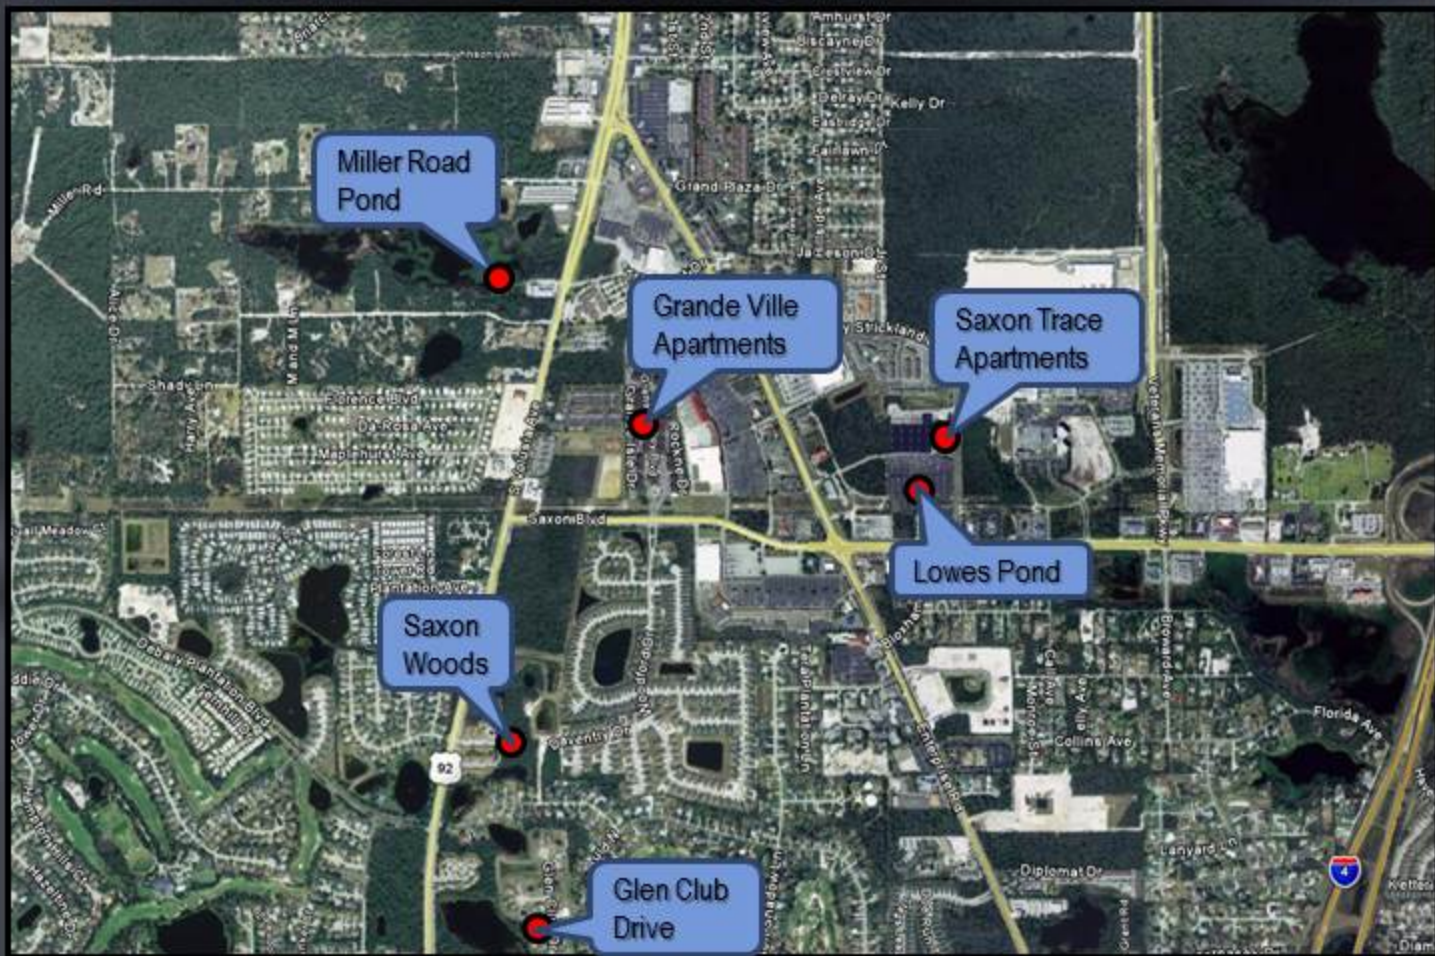
Topic #4: Stormwater impoundment failures leading to sudden releases of stormwater causing flooding and damage to downstream properties.

Pond Berms Failures (Tropical Storm Fay)

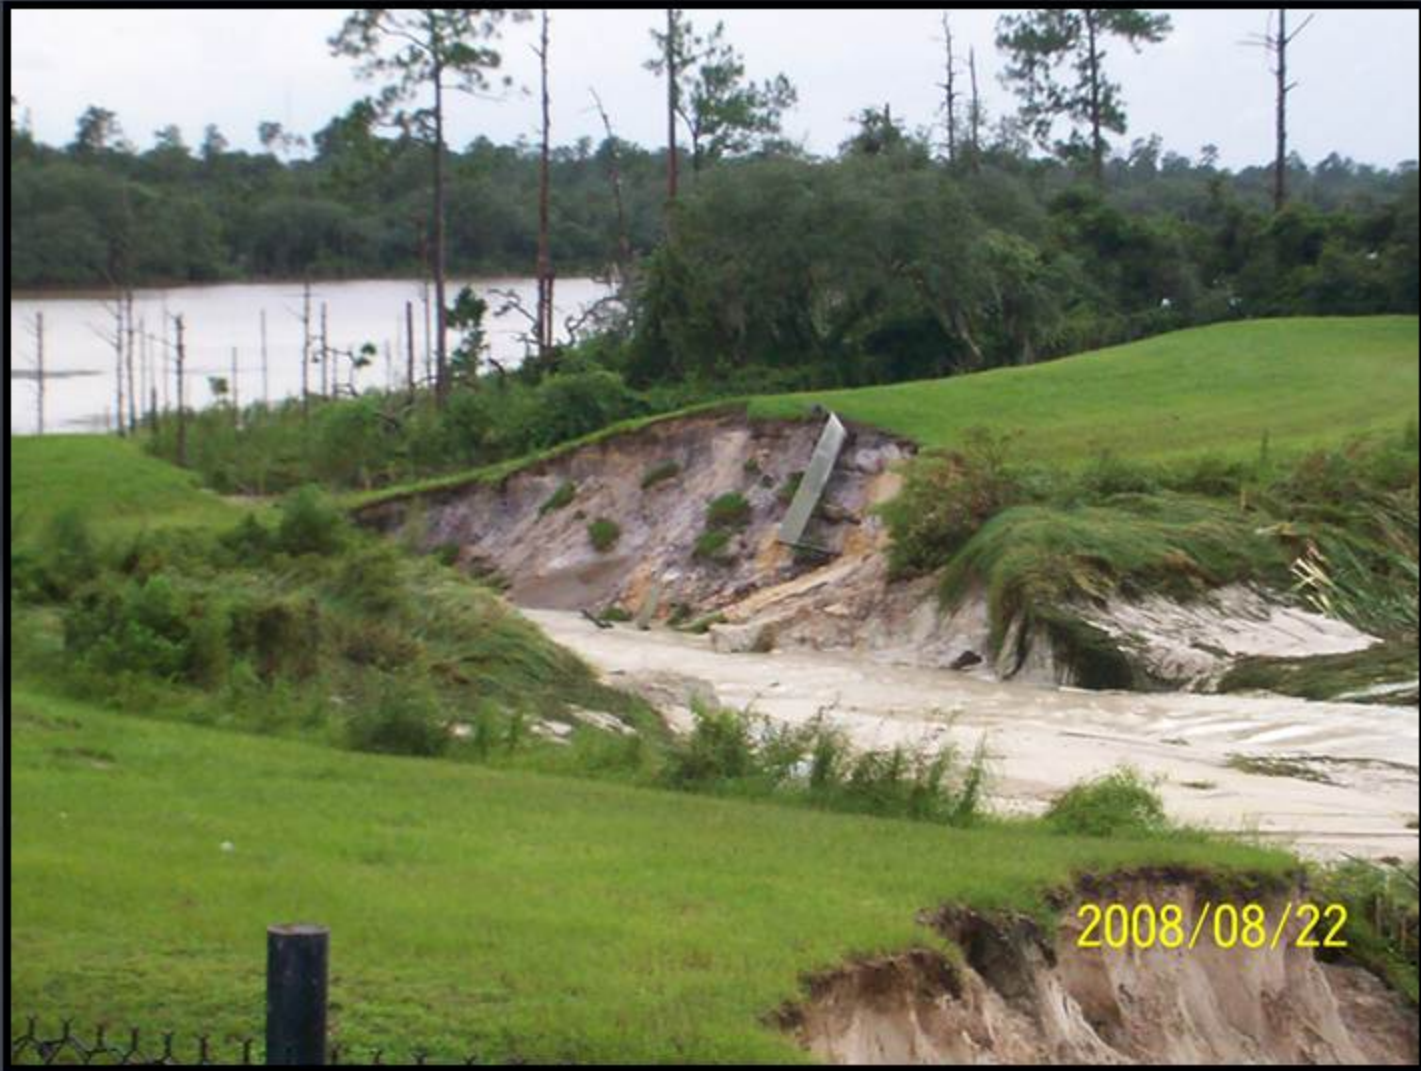
Miller Road Pond Outfall  
(Photo 1 of 4)

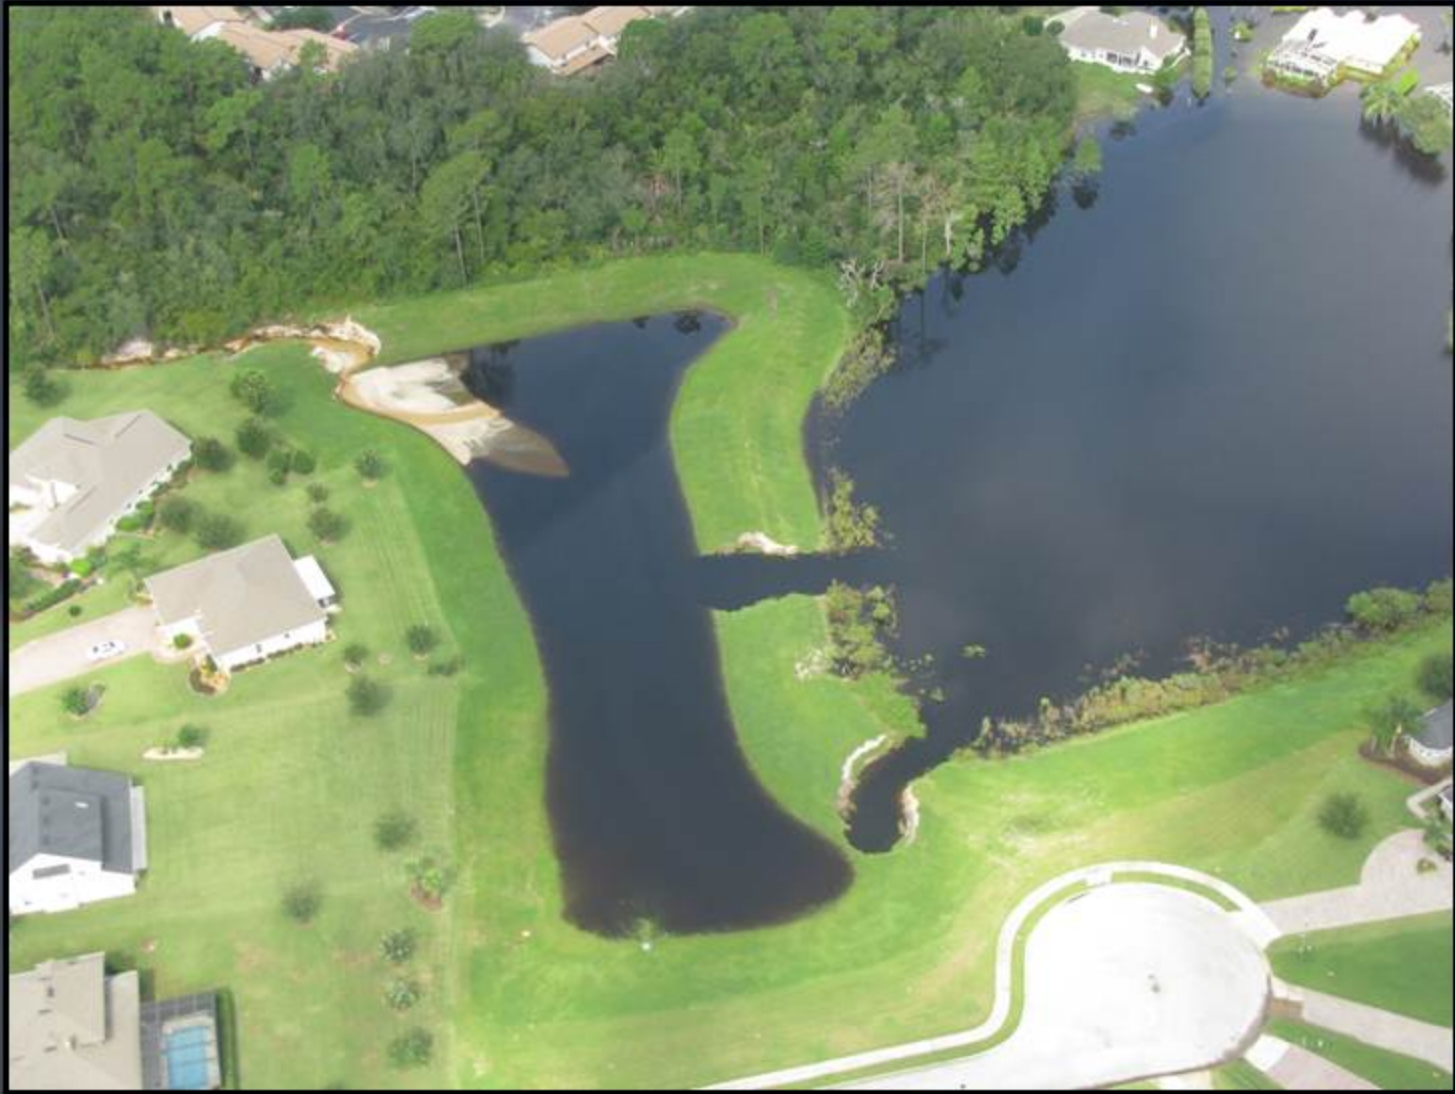
Glen Club Drive Pond Berm  
Failure (Photo 2 of 4)

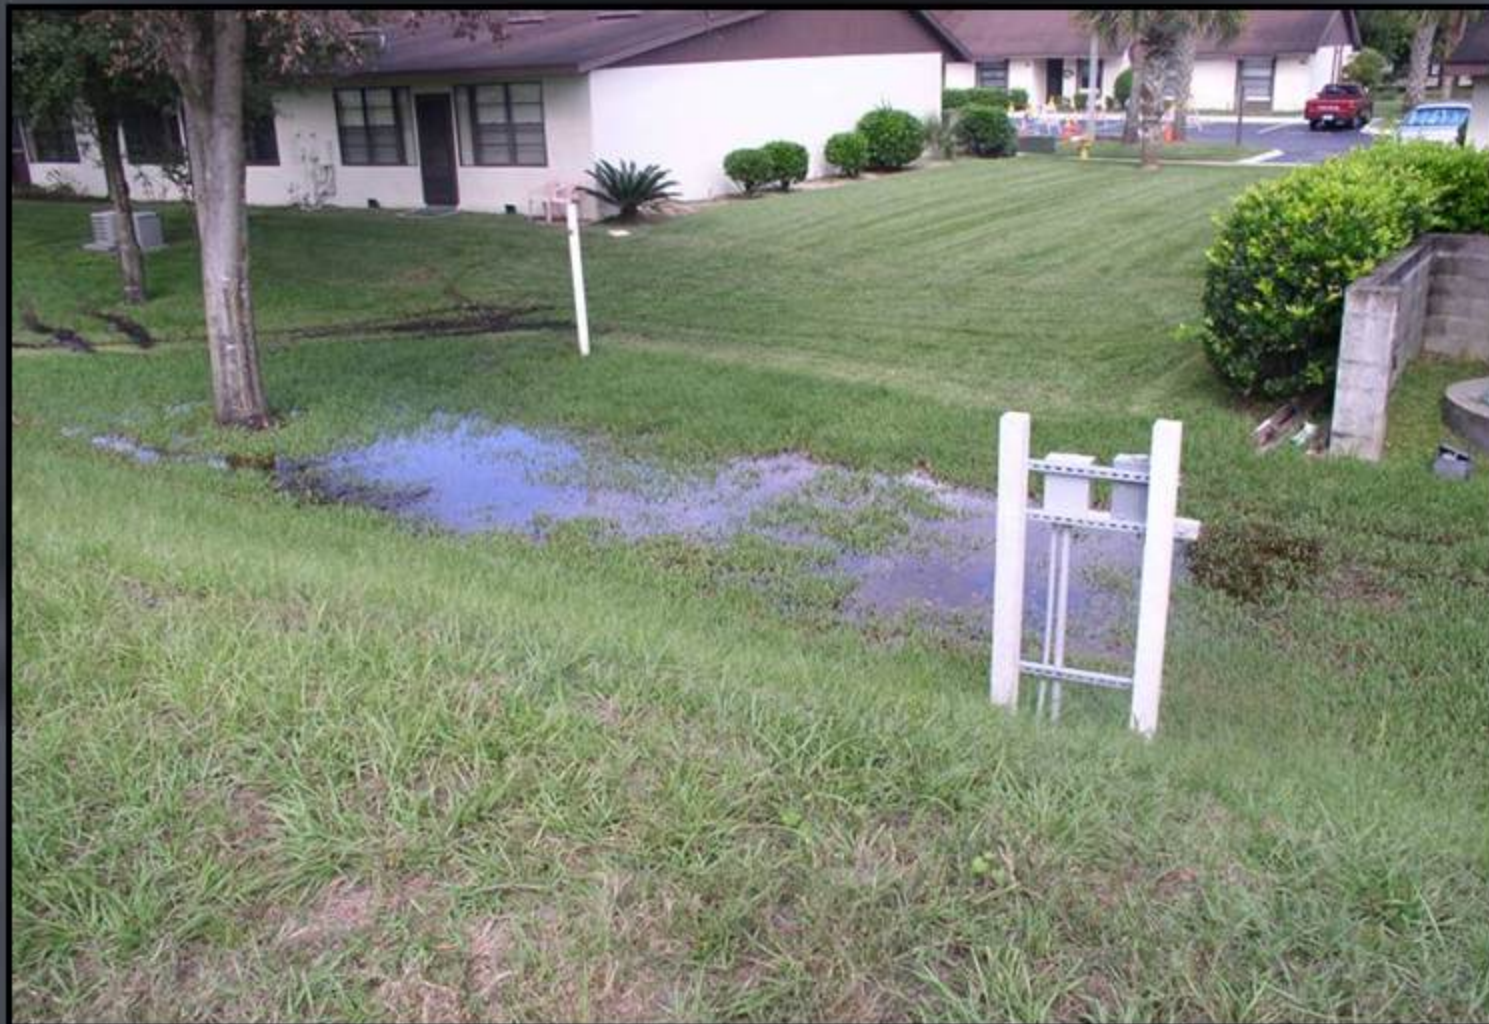
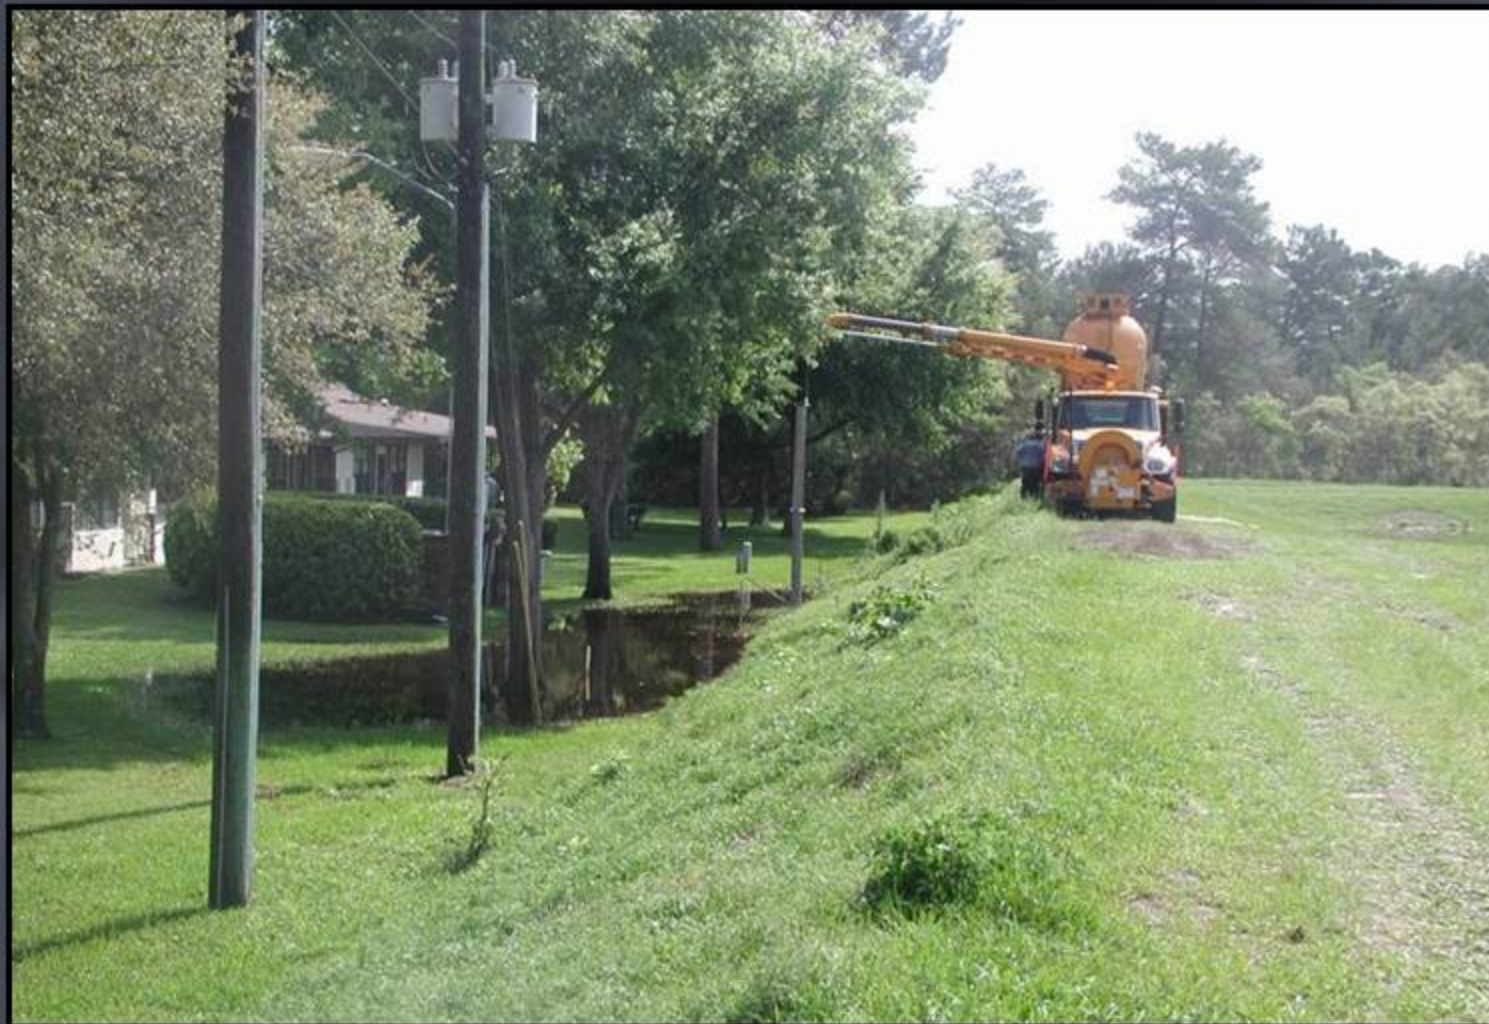
Topic #5: Seepage through pond berms or an artificial rise in the water table in the locality of a stormwater storage system which causes nuisance flooding or chronic wetness/seepage/flooding to adjacent land owners. Some lake level modification projects which raise lake levels can impact lakeshore residents, especially those on septic tanks.

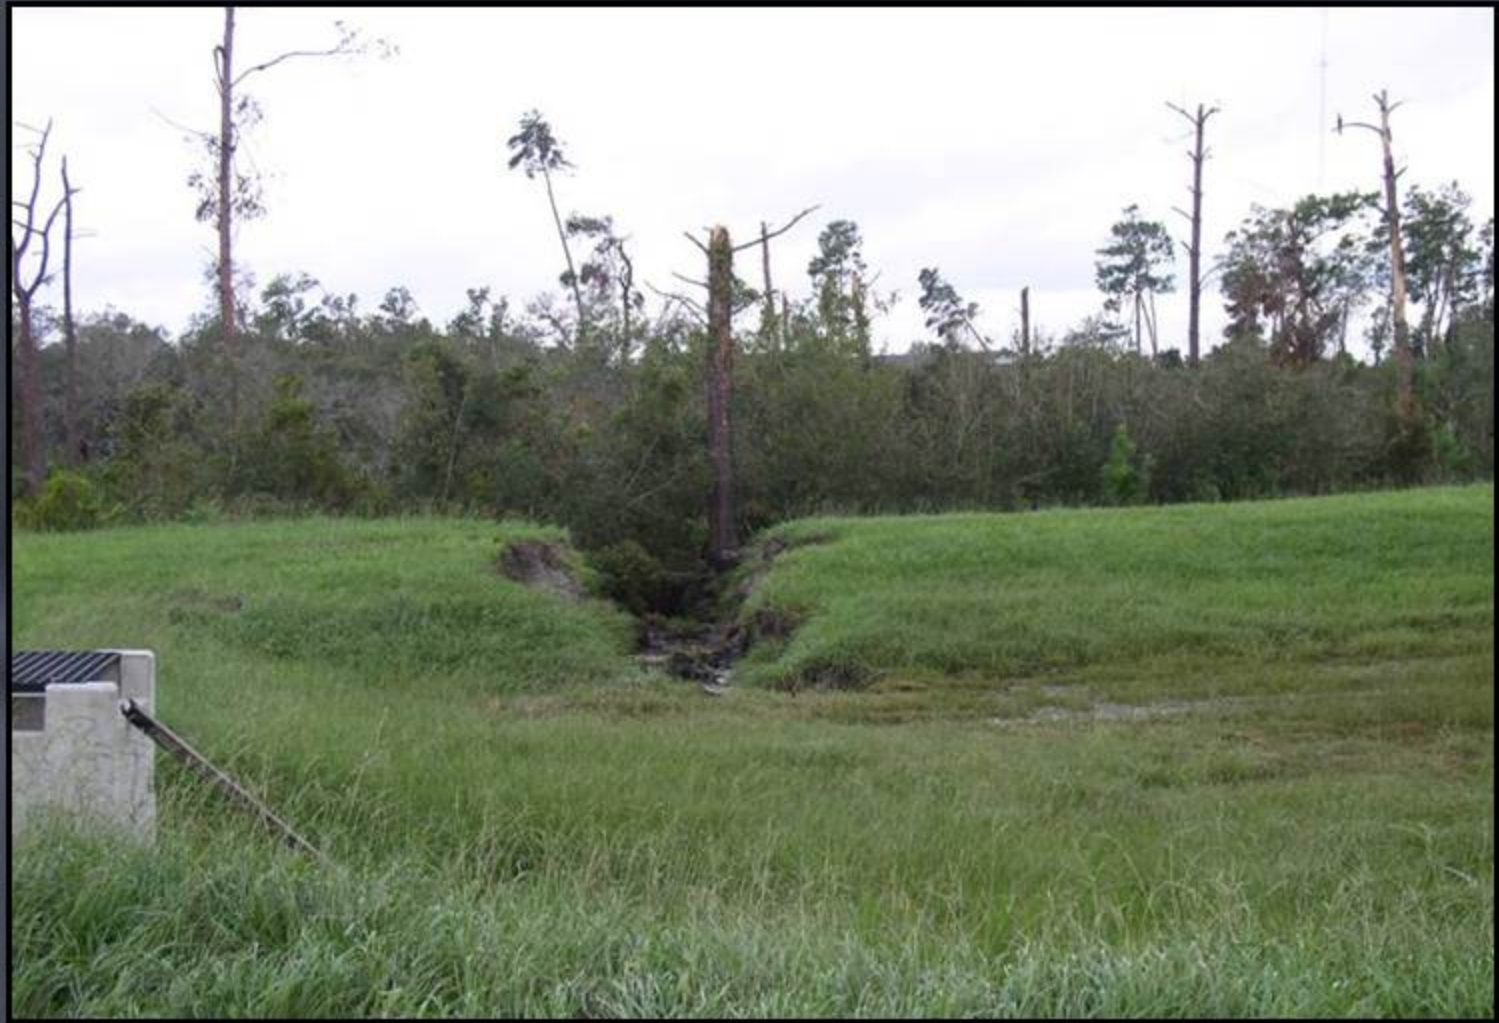
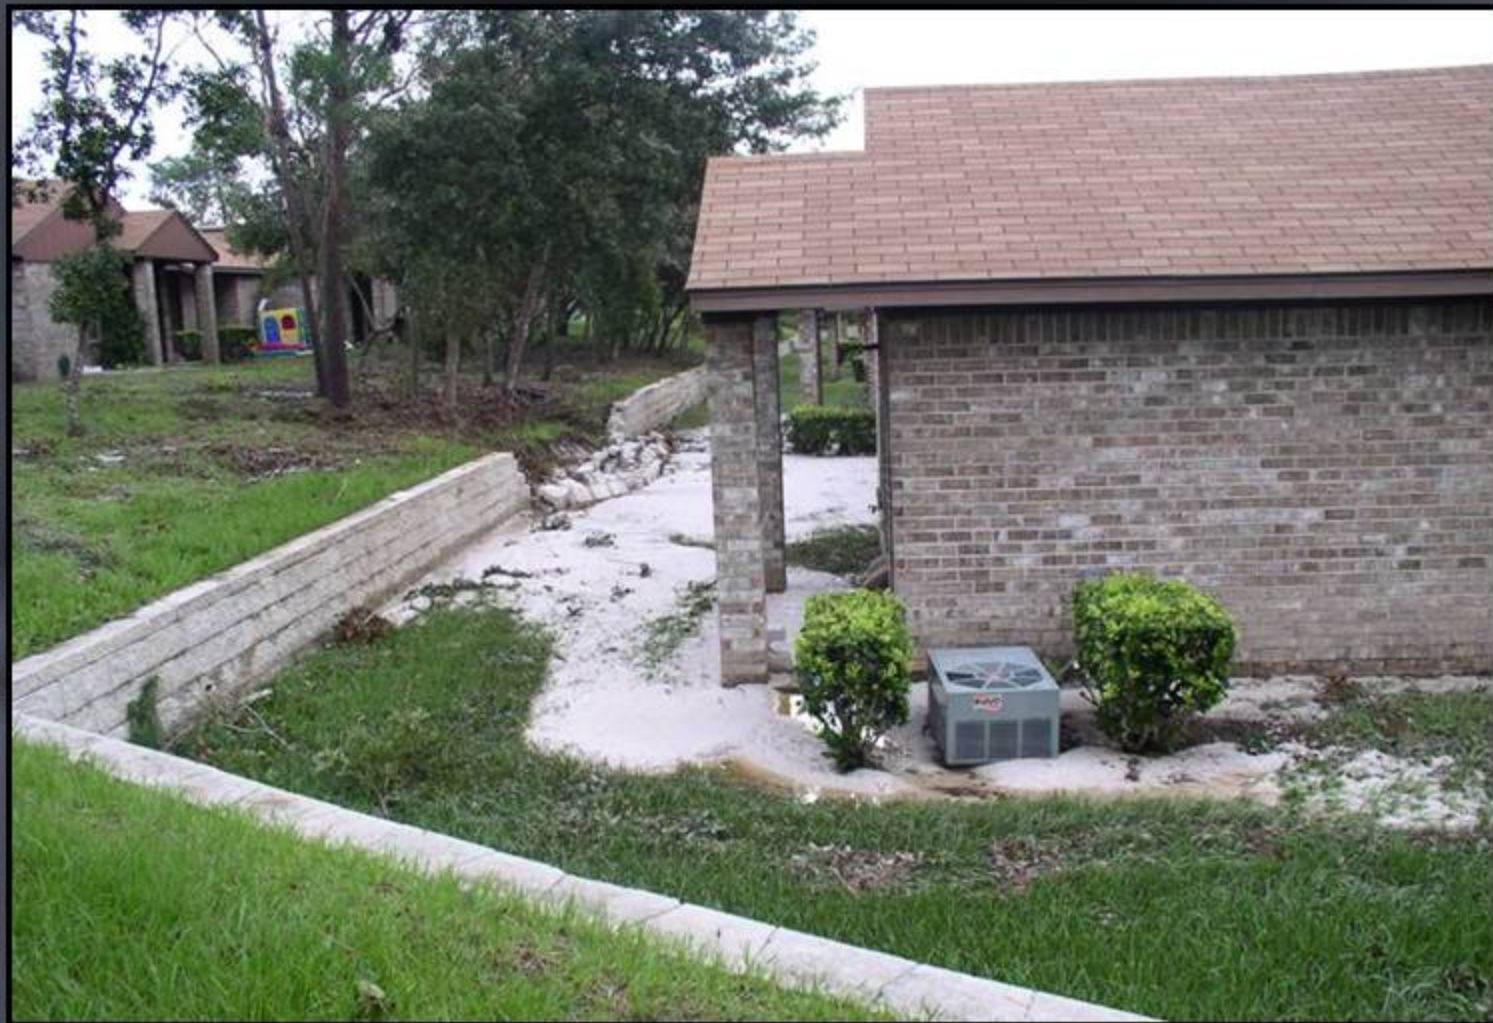
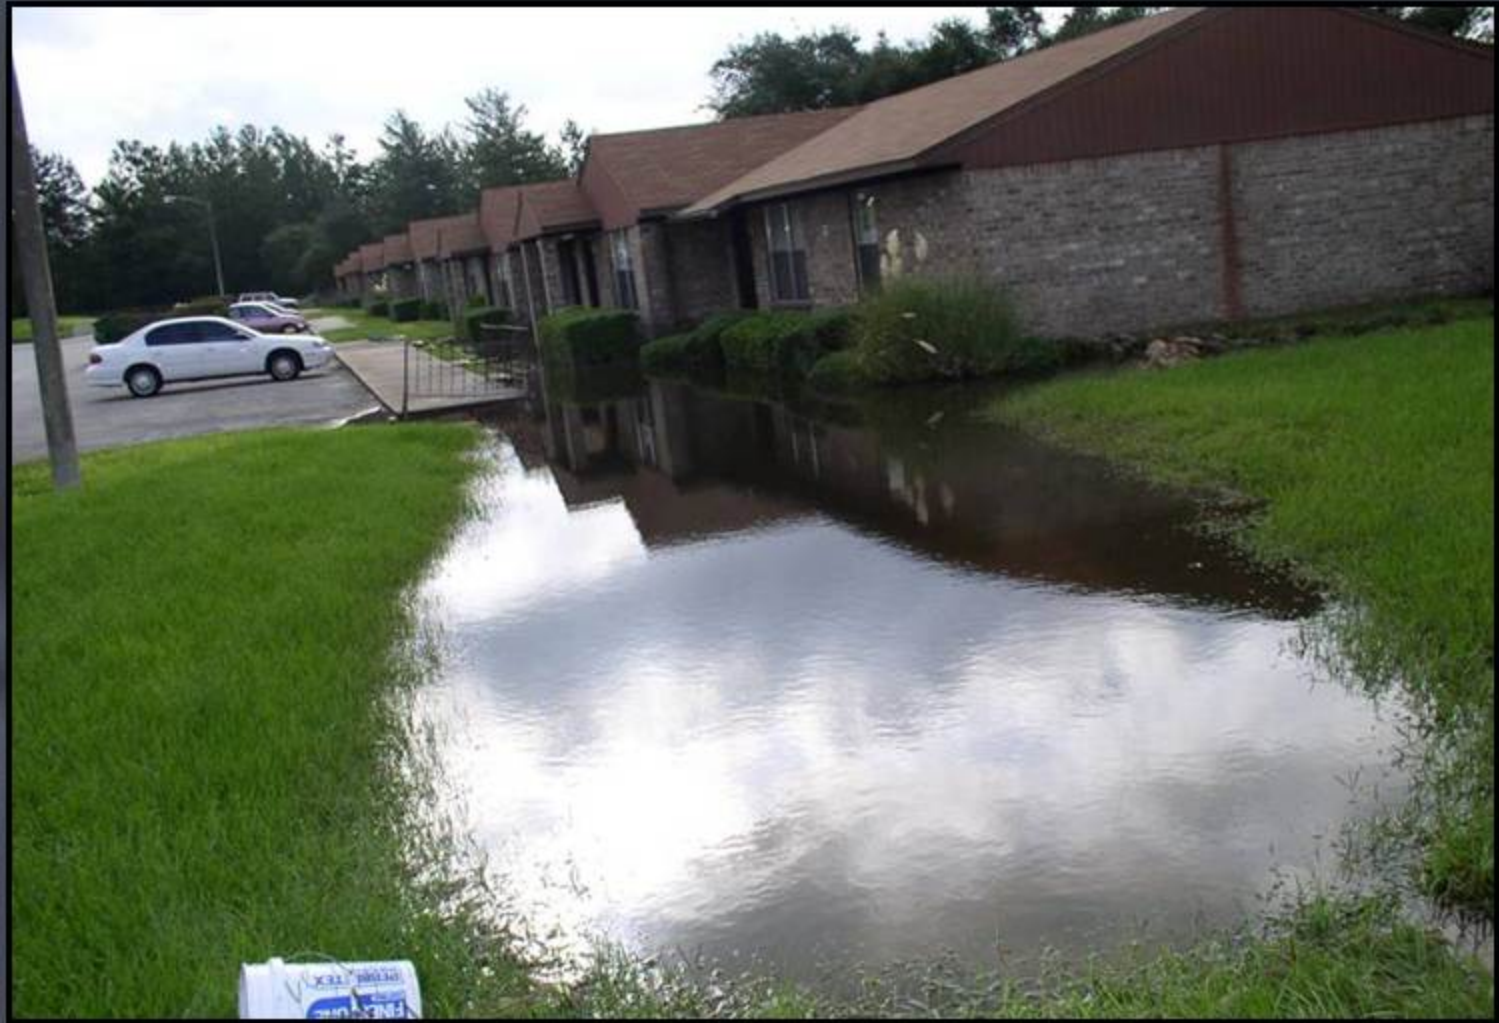
Topic #6: Construction errors such as improper sand in filter systems, incorrect elevations for berms (too low), dumping debris in fill berms, no seepage collars on pipes to prevent blow-outs, etc.

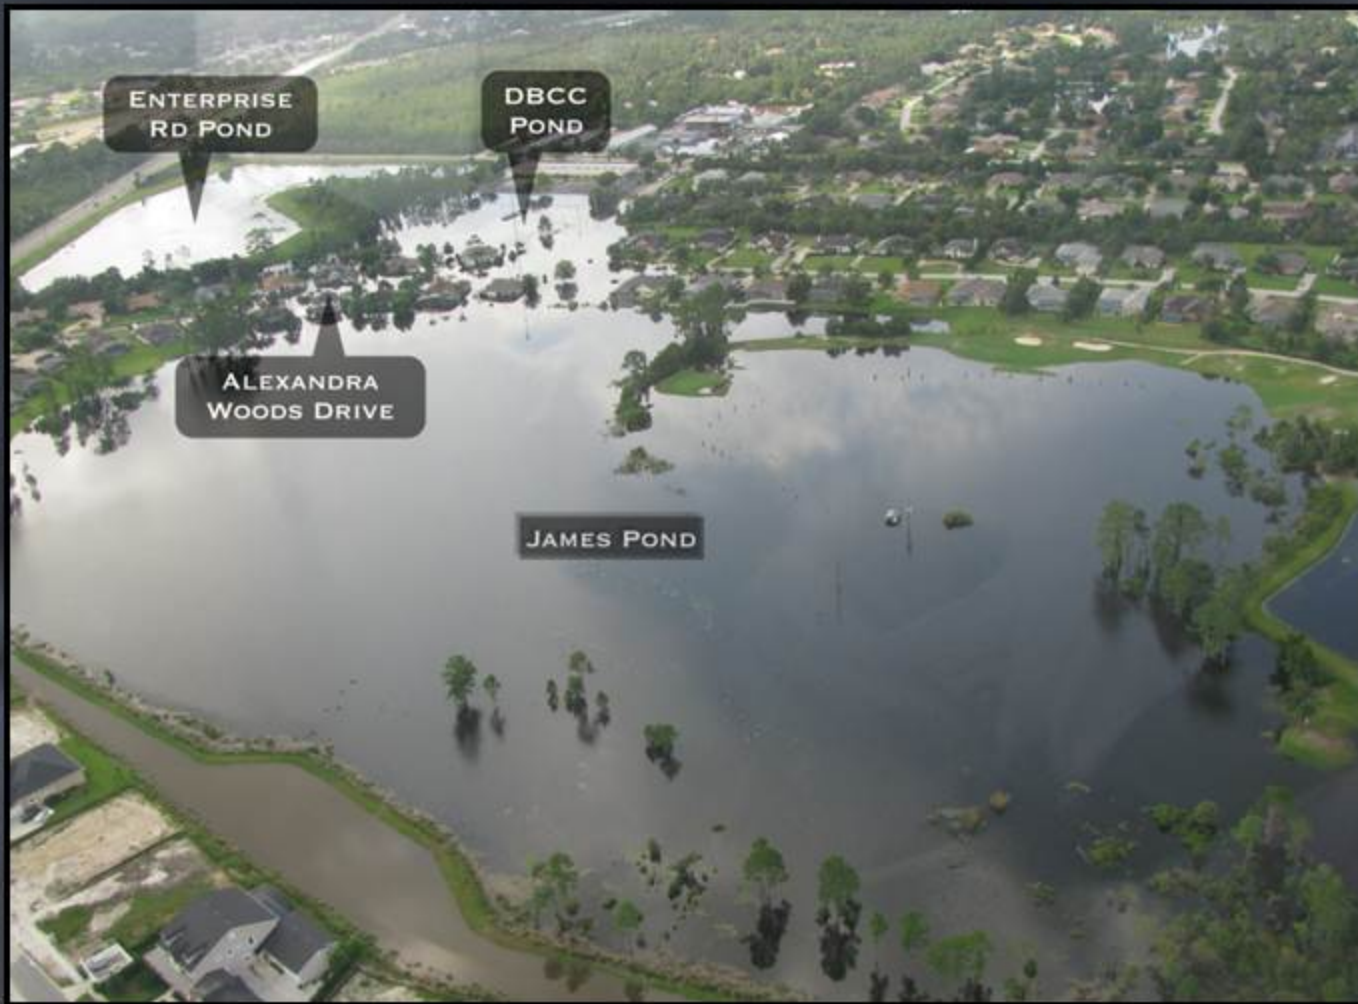
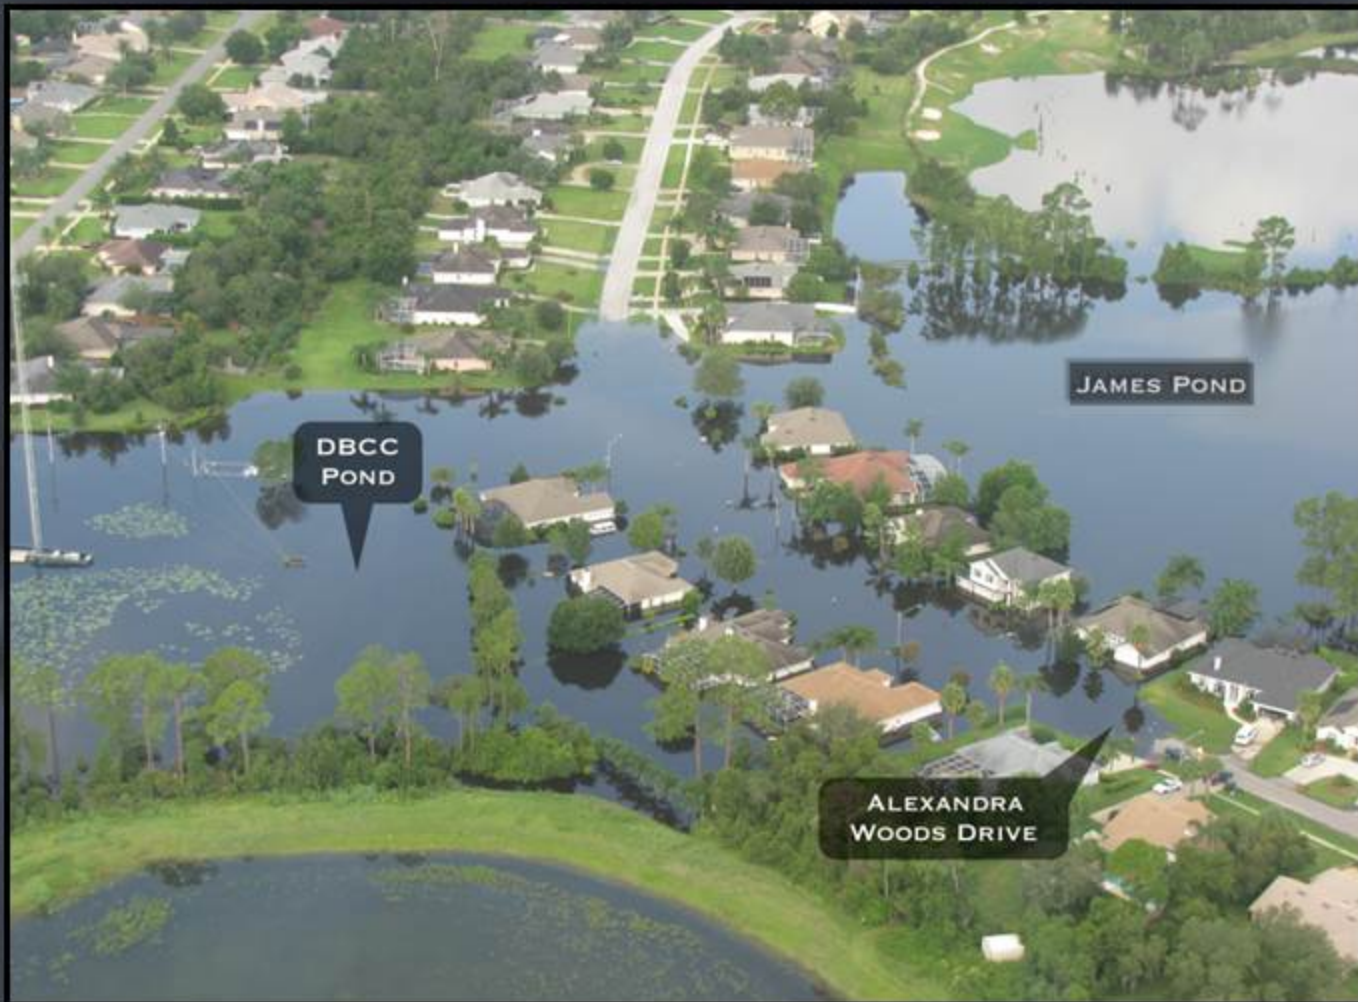
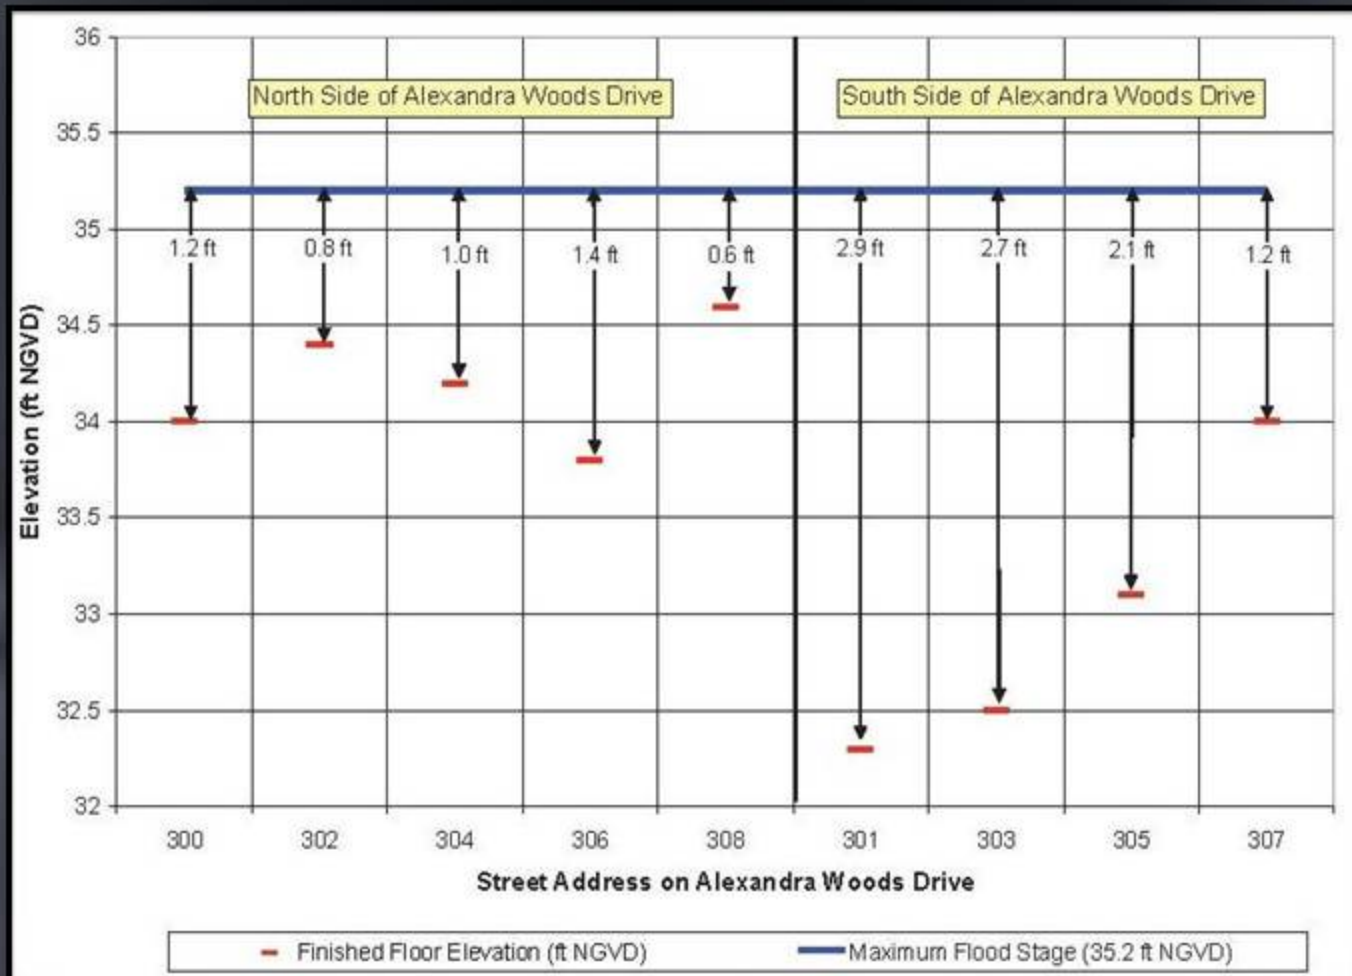
Highbanks Enterprise Road Pond  
James Pond (9 structures flooded)
