# Litigation Prone Areas of Stormwater Management

FLORIDA  
ENGINEERING  
SOCIETY

*When:* Wednesday,  
September 14, 2011  
*Where:* The Westin  
Lake Mary, Orlando  
2974 International Parkway  
Lake Mary, FL 32746-1409

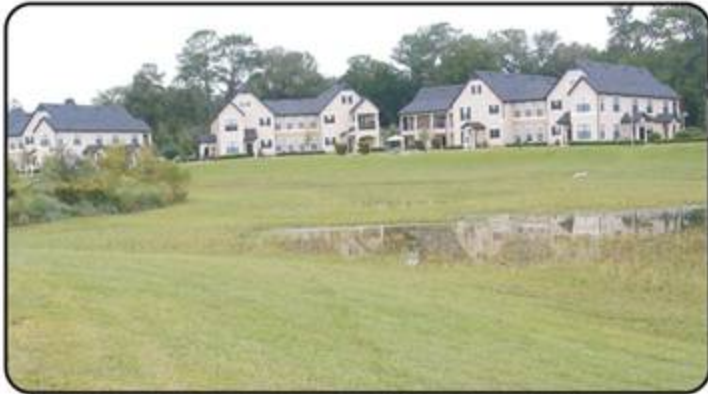
Photo 1. Shows Some Standing Water in Pond SMF-1 on October 24, 2007

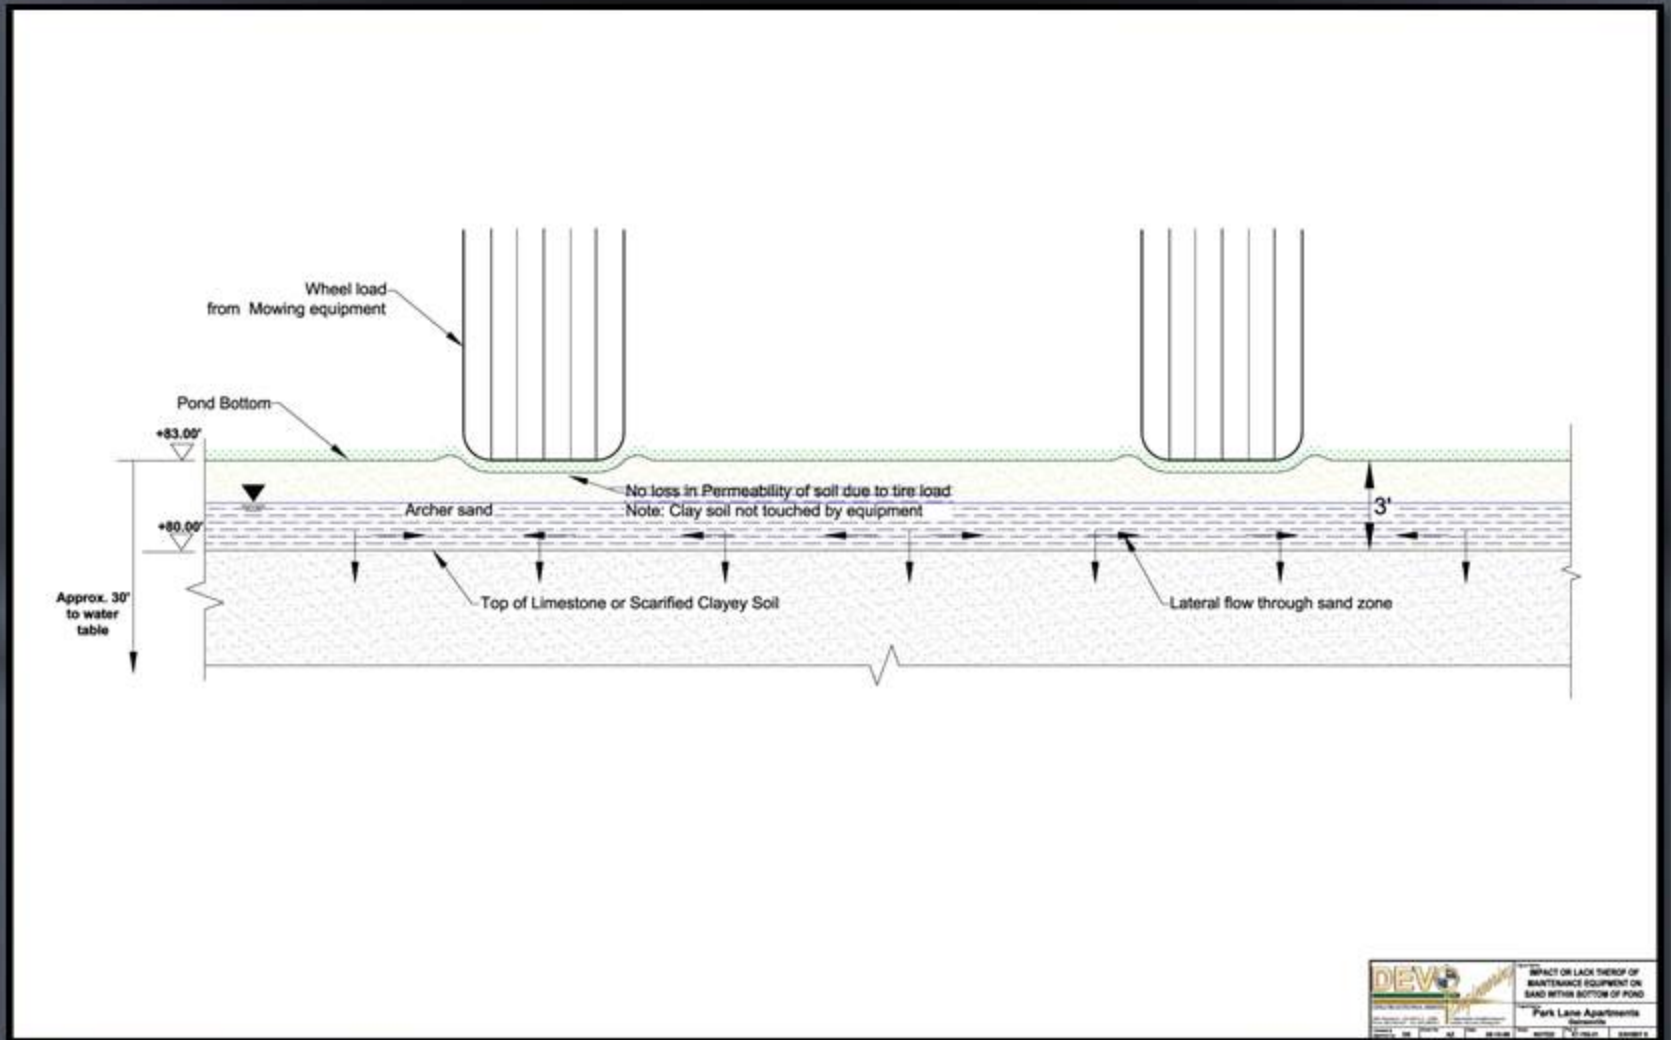
Impact or Lack thereof of maintenance  
Equipment on Sand within bottom of pond

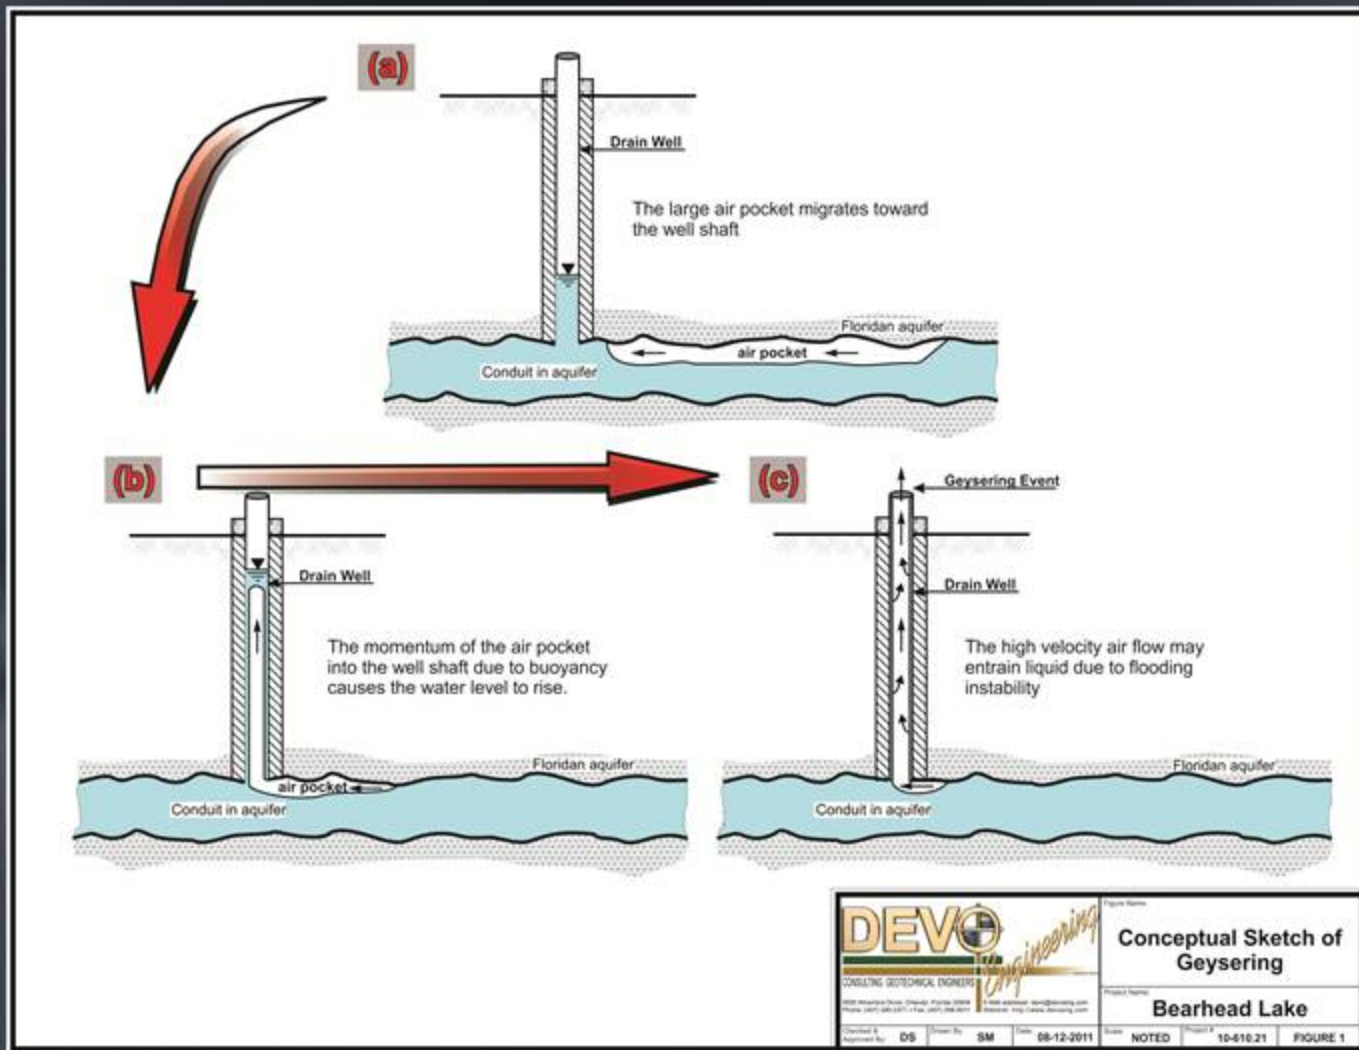
Bearhead Lake Geysering

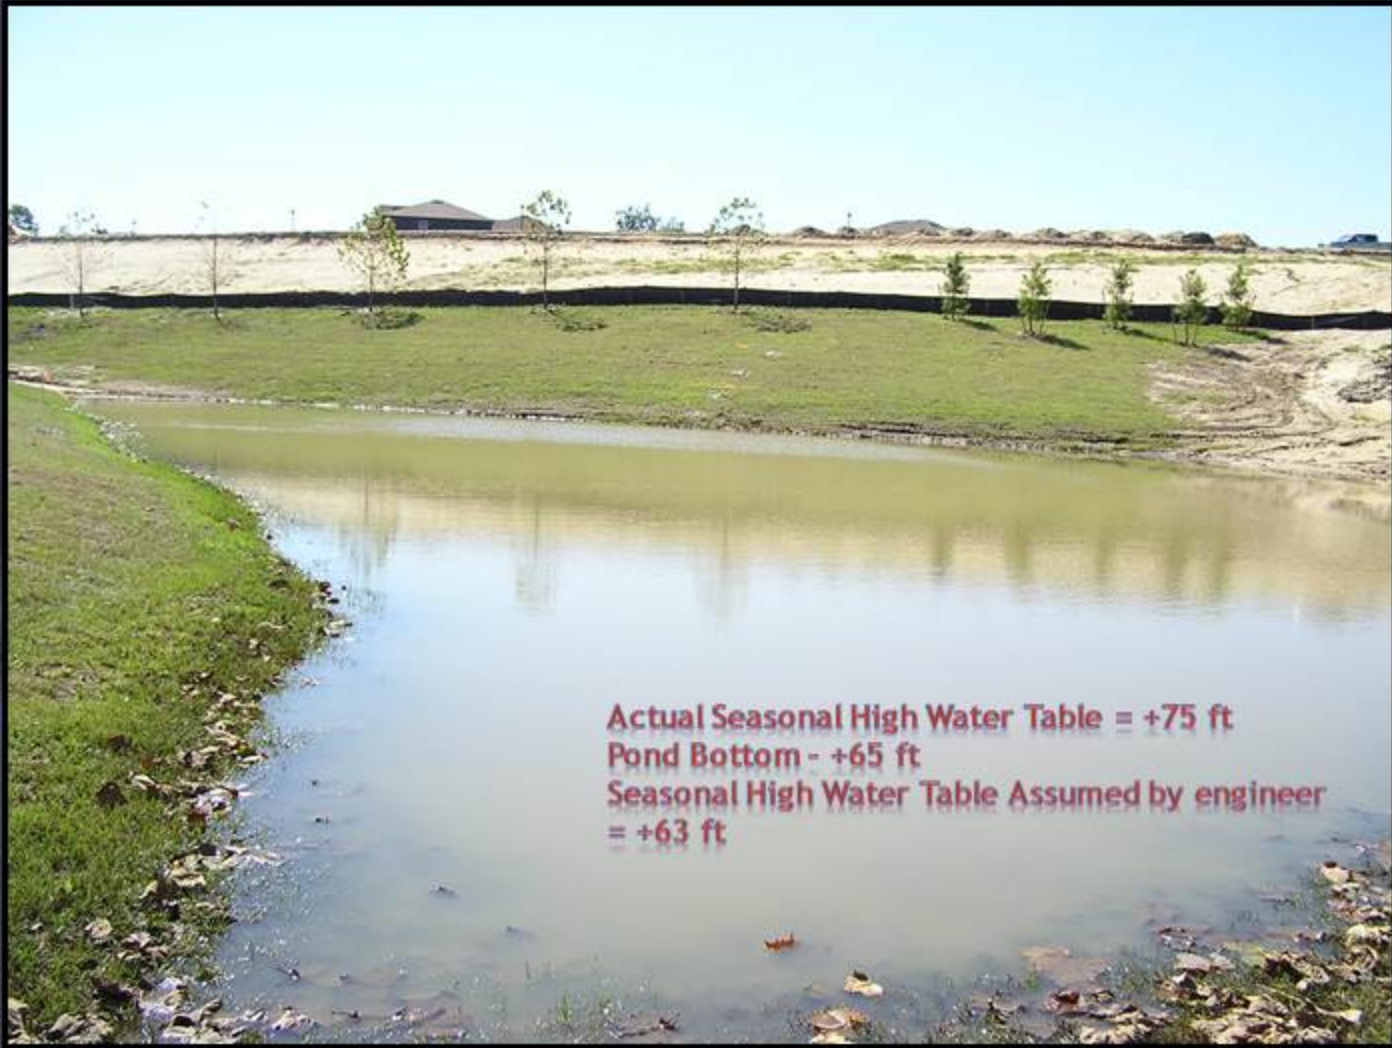
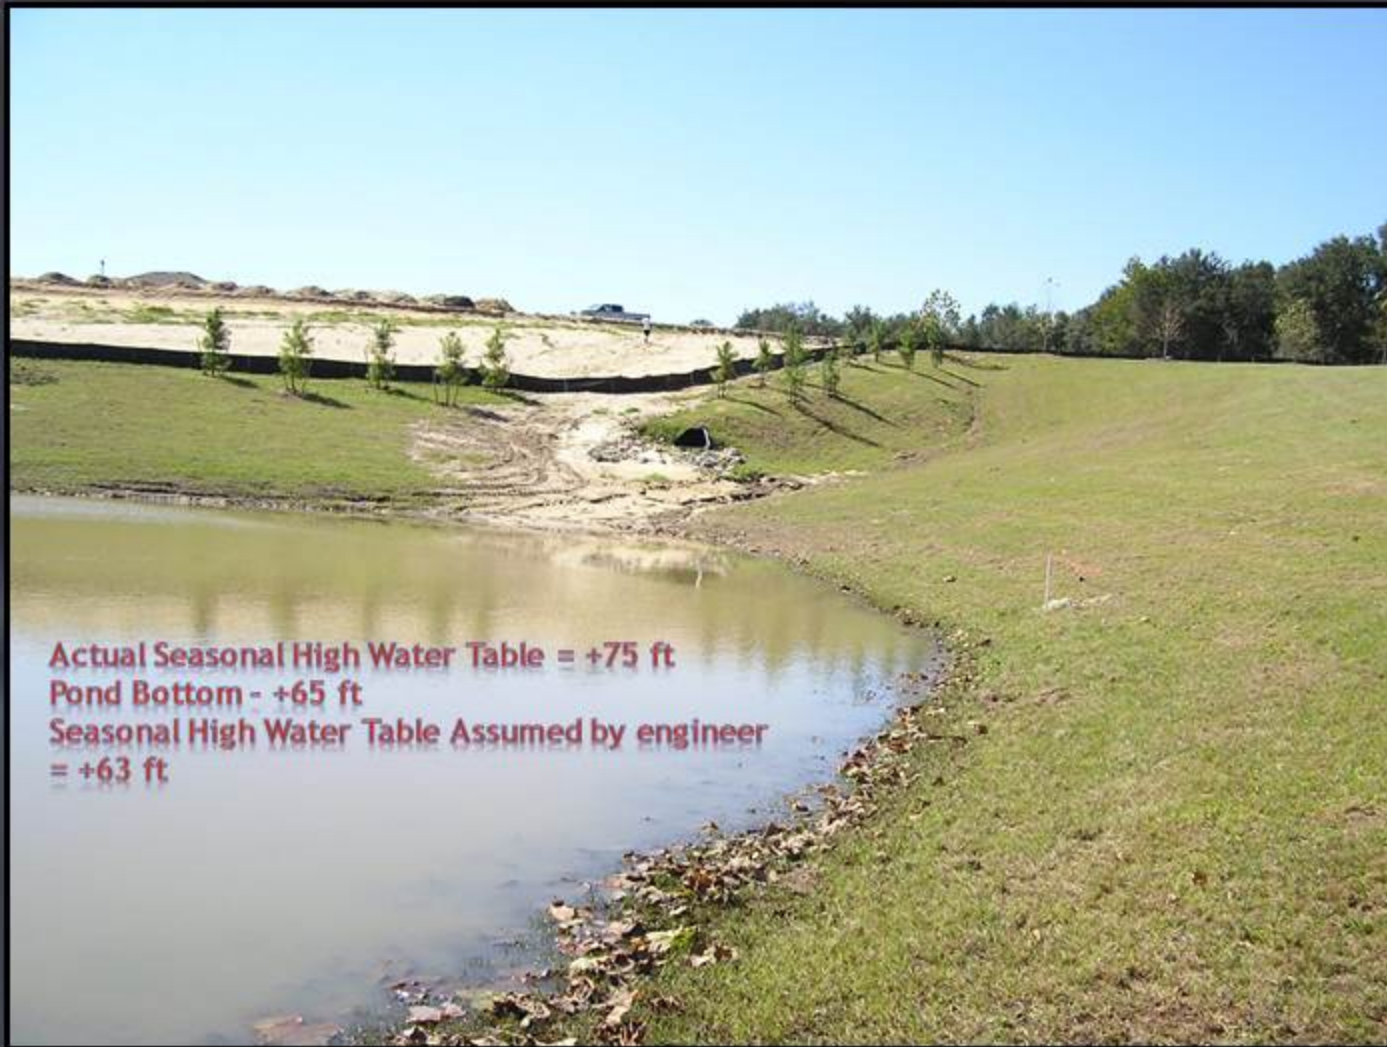
Topic #21: Dry pond turns out being a lake due to bad call of water table by geotechnical engineer. Developer sues geotech engineer since a wet pond redesign requires more land. Resulting lake is named after the geotech engineer so it does not suffer from anonymity.

Dry Ponds and Mis-Estimated  
Seasonal High Water Table

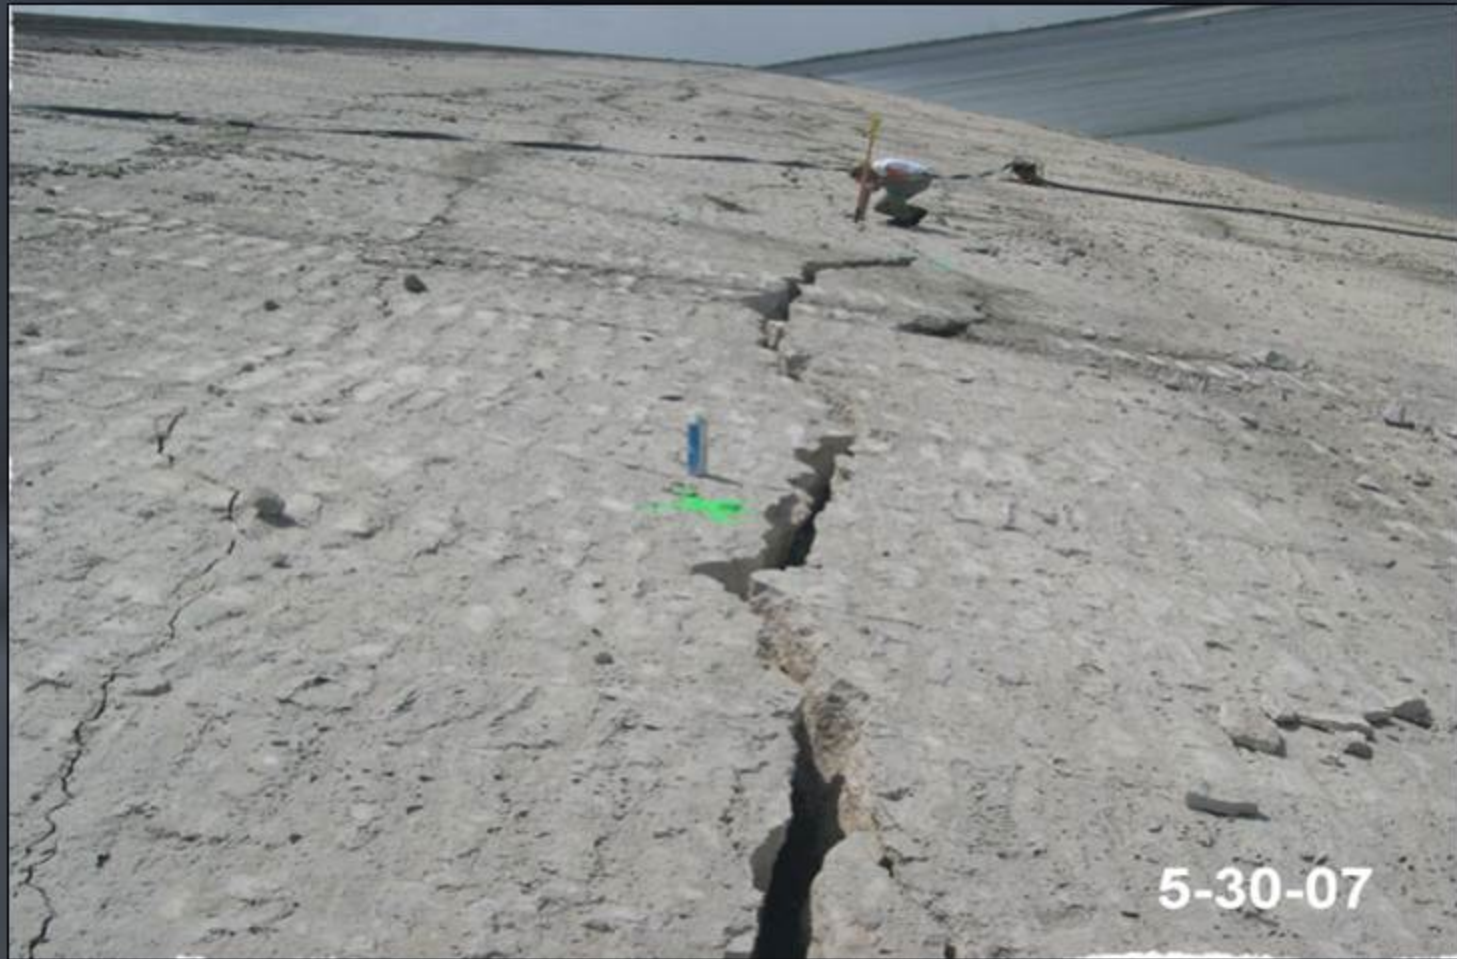
Topic #24: Impoundment side-slope design errors which lead to slope failures or blowouts from seepage forces.

Example of Gaping Cracks in  
Soil-Cement

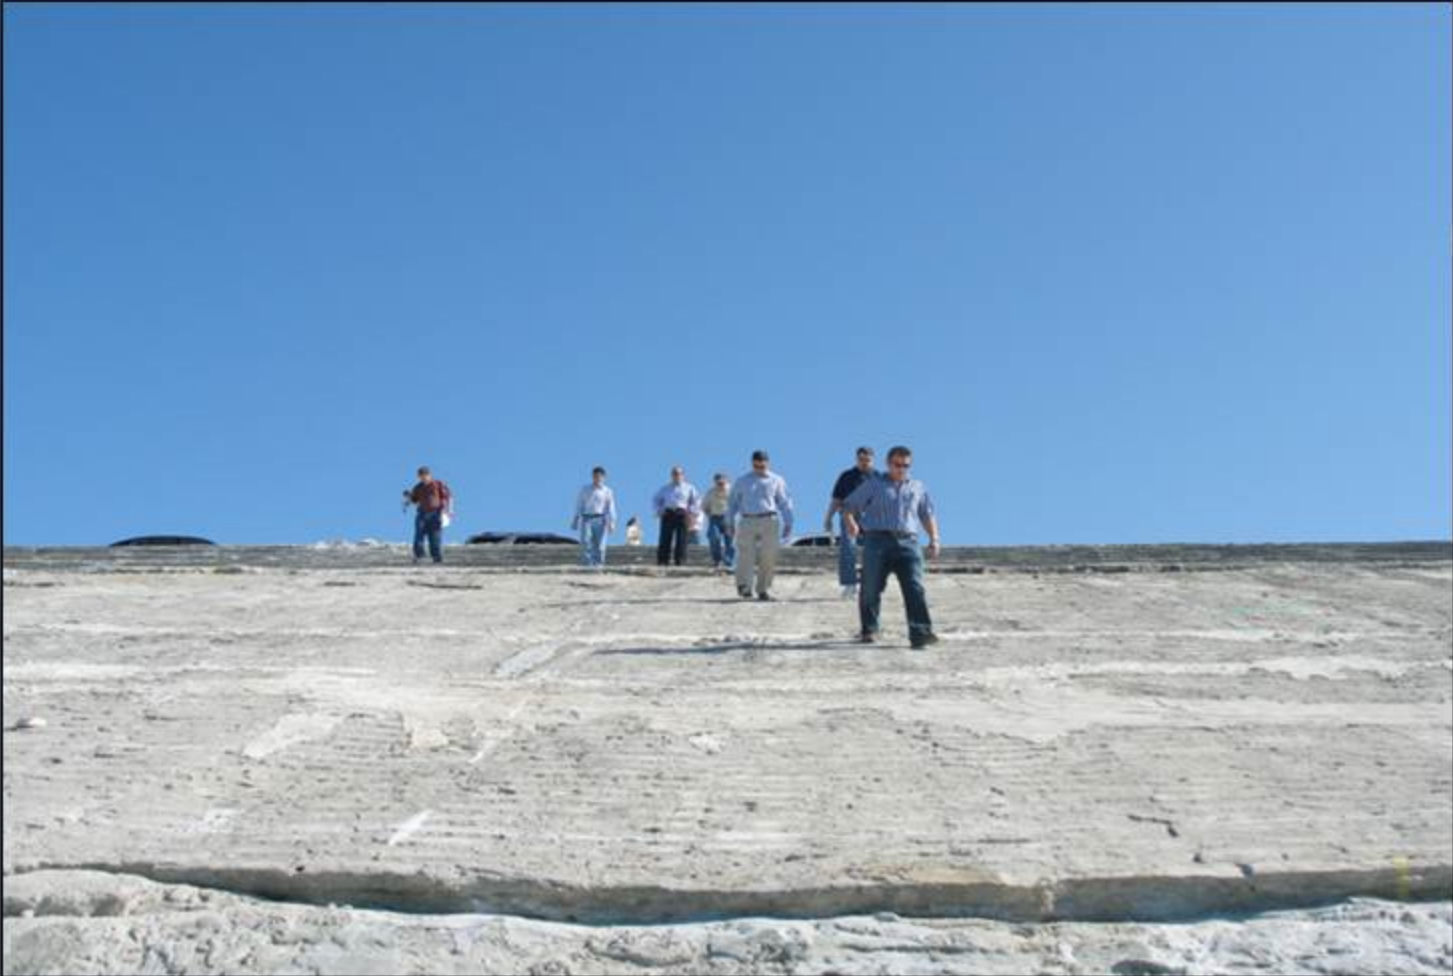
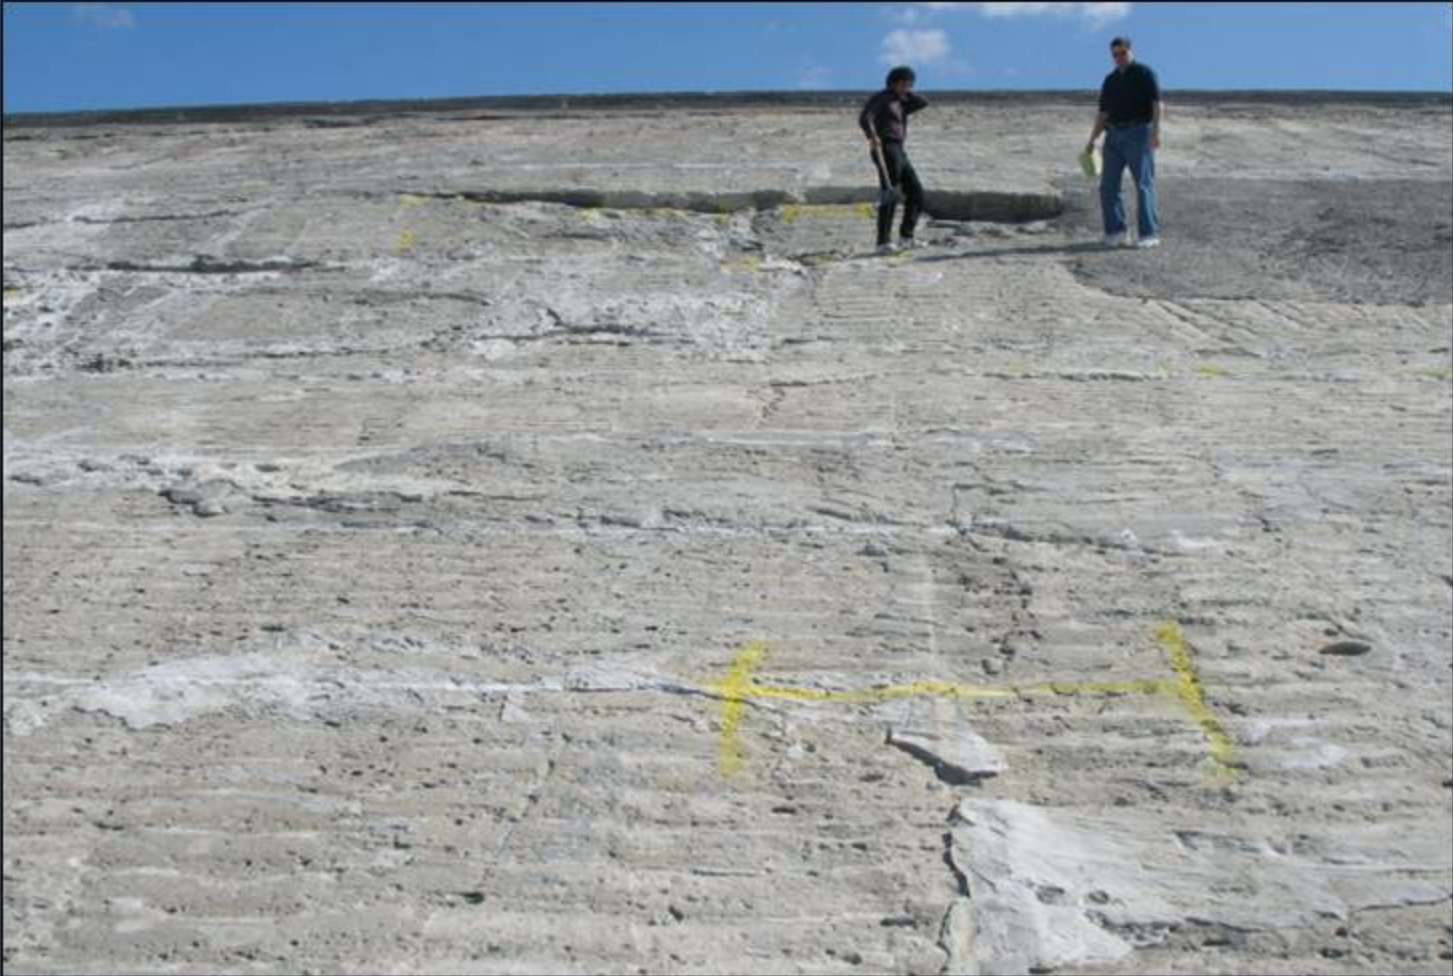
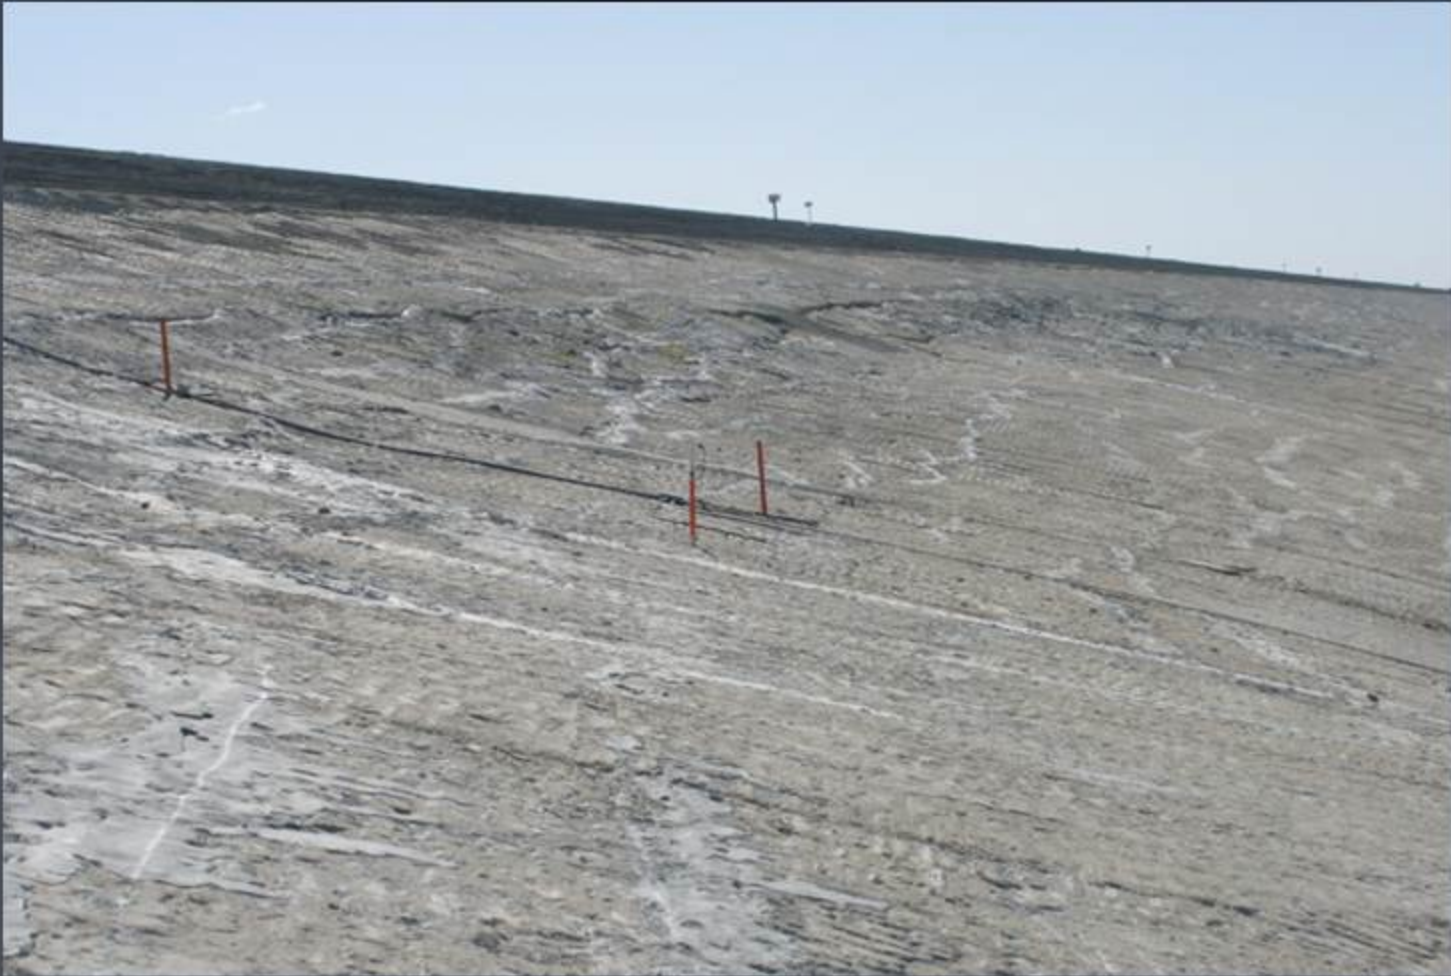
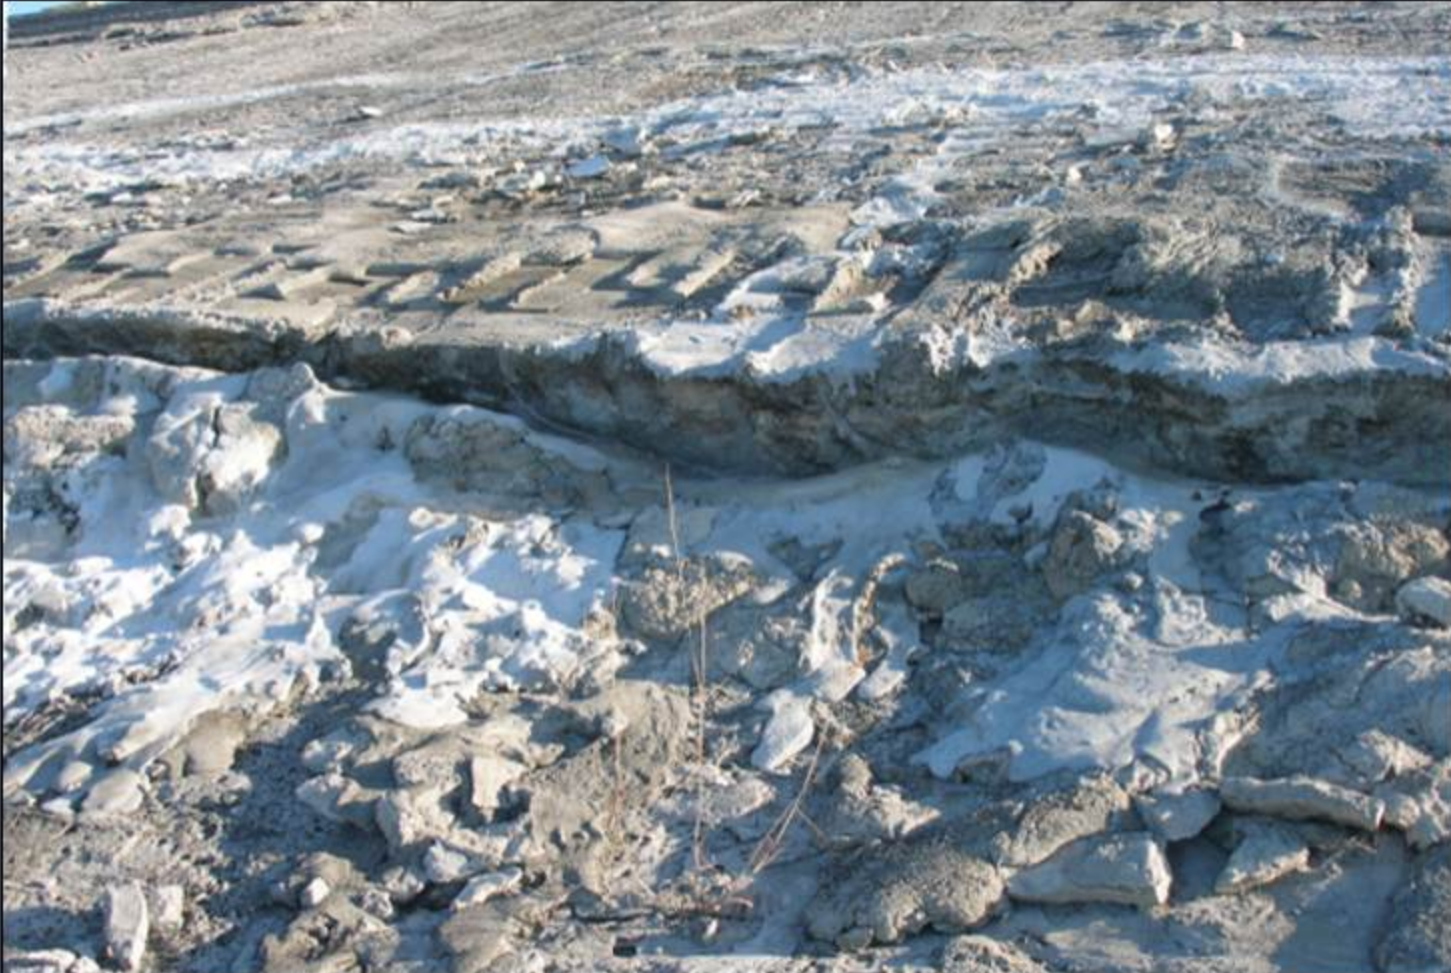
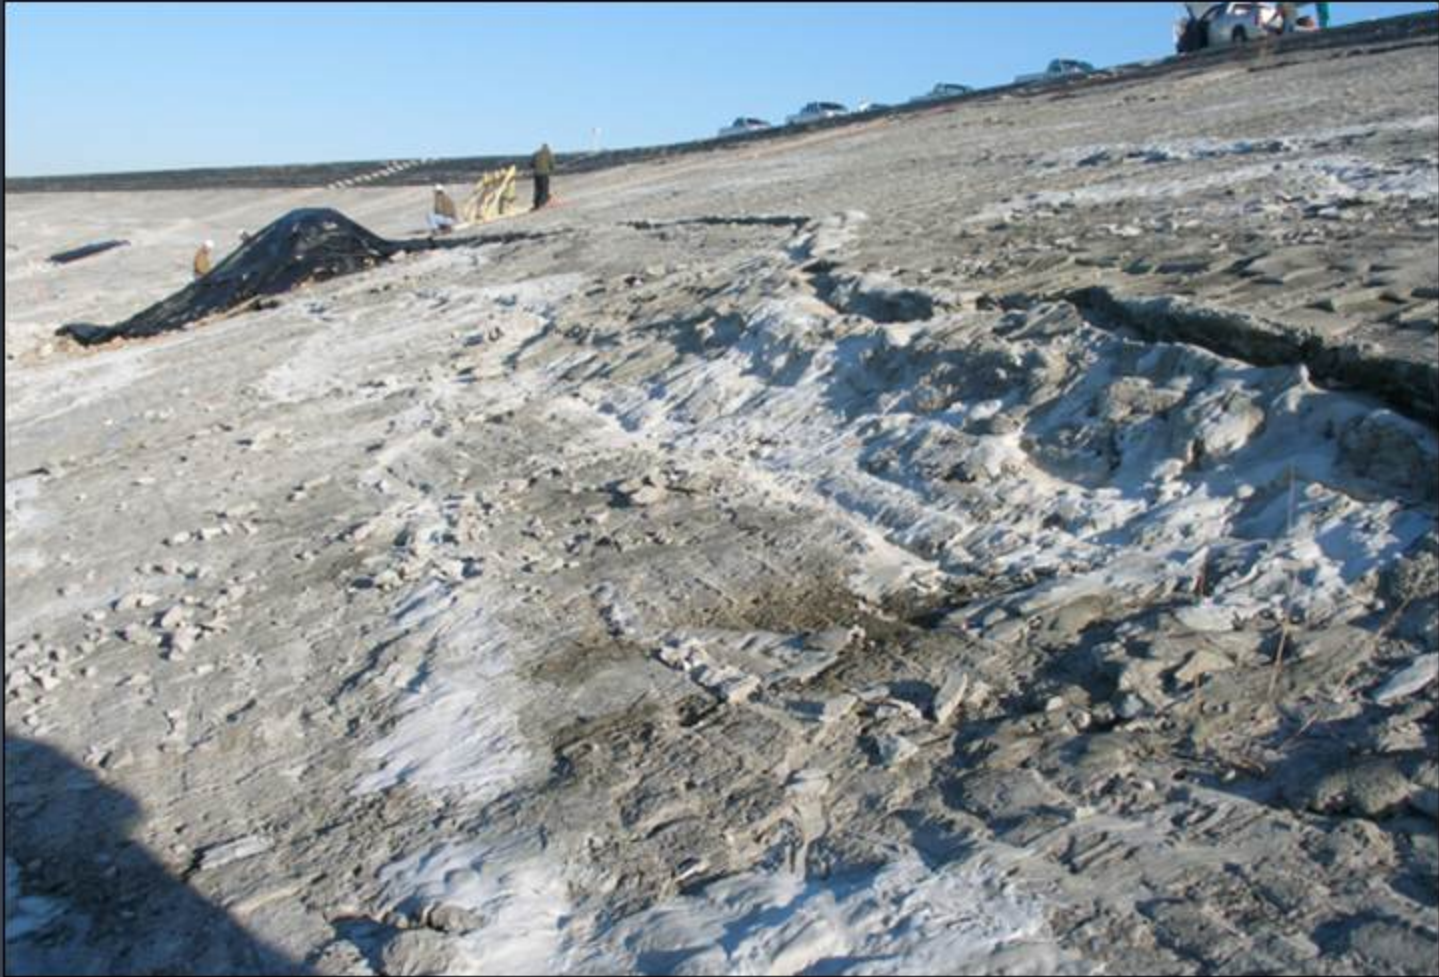
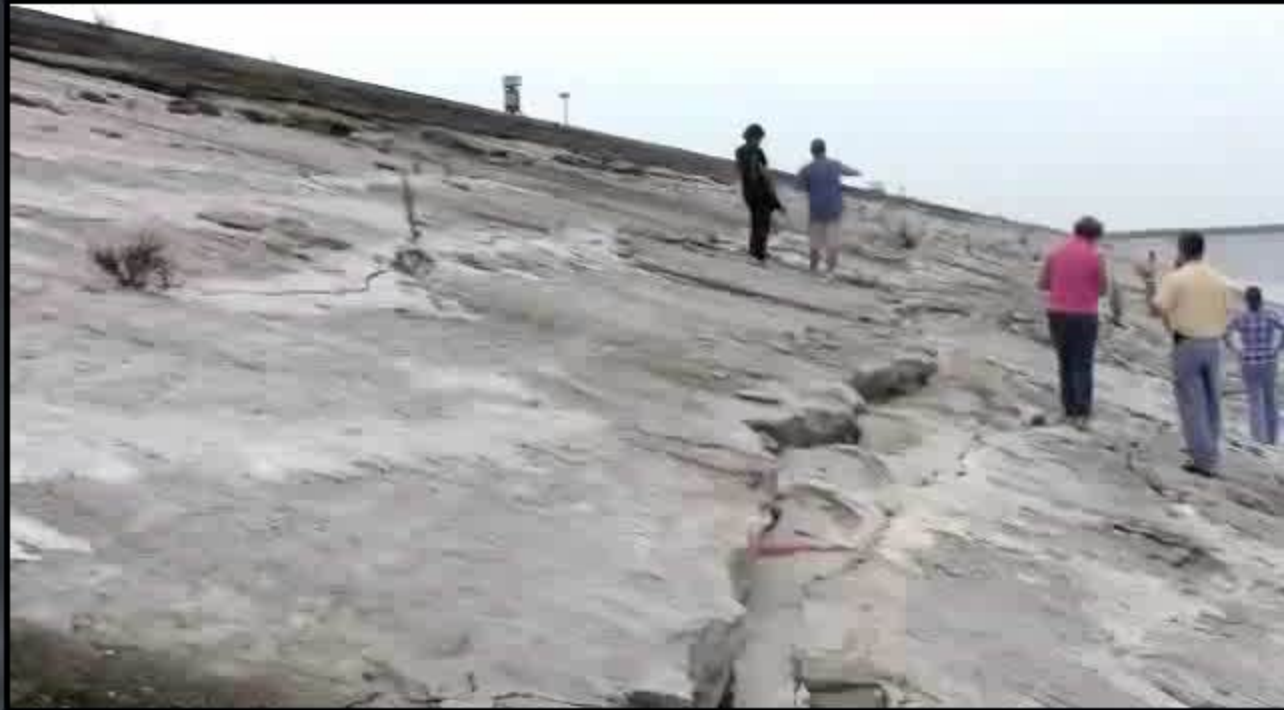
Example of Cracking and Subsidence of Soil-Cement

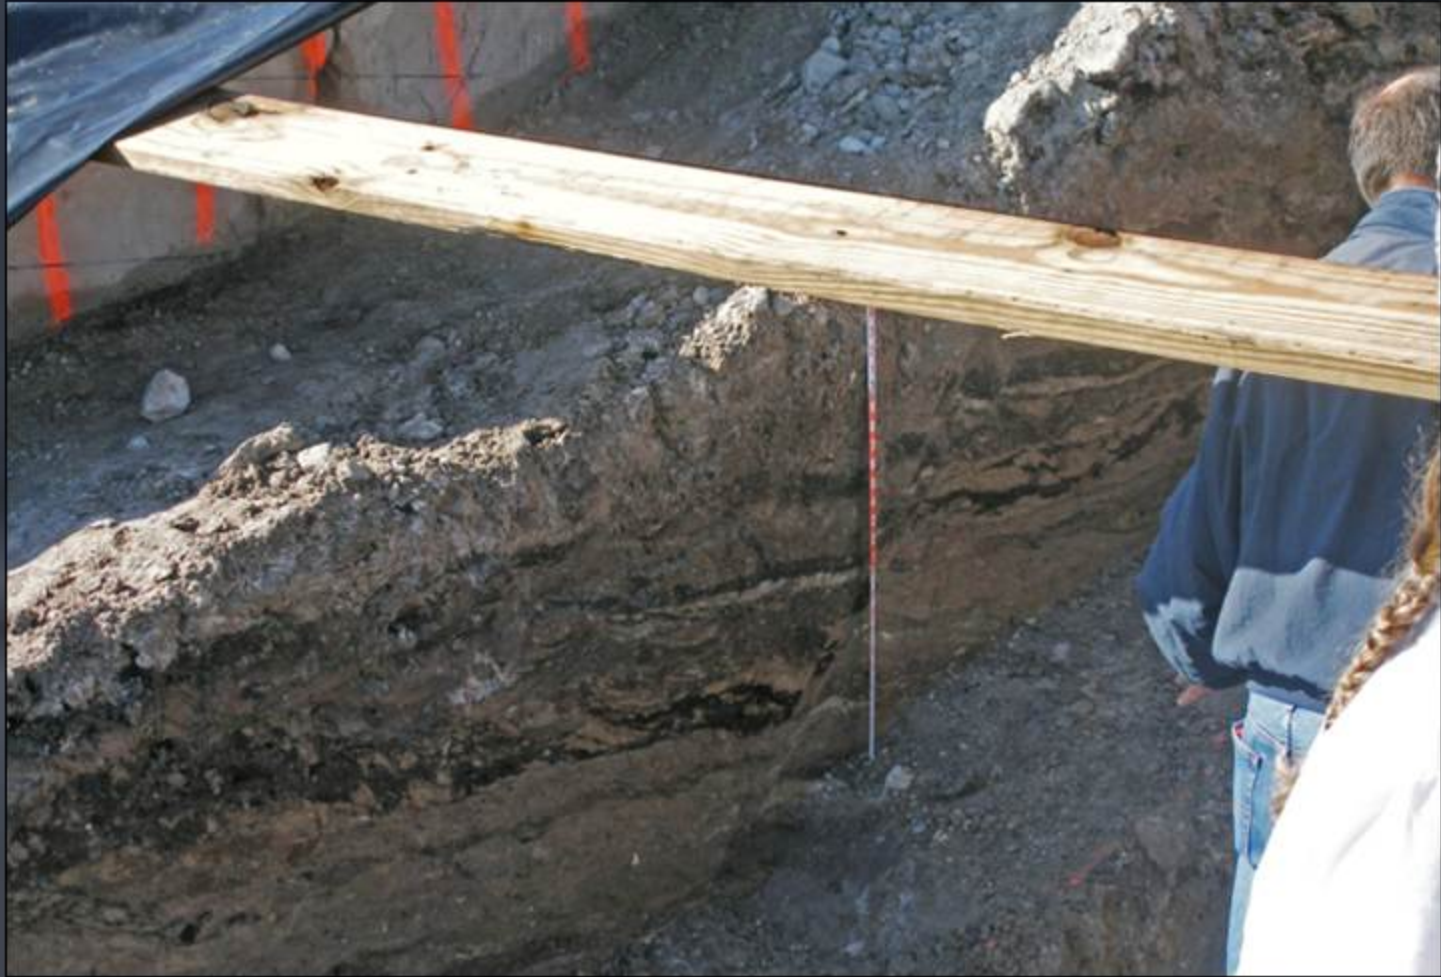
Example of Test Pit Showing  
Shear Plane

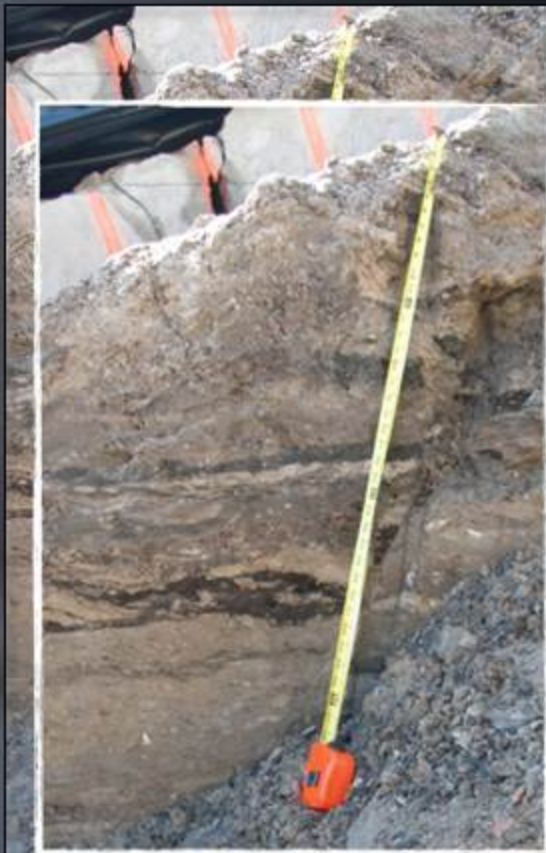
Close-up view of the shear failure plane on the southern pit wall

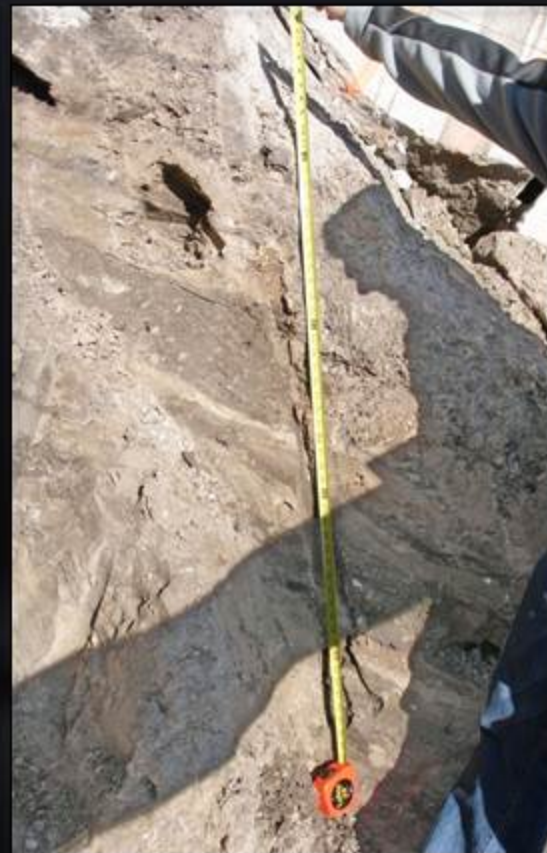
View looking at the shear failure plane on the northern pit wall

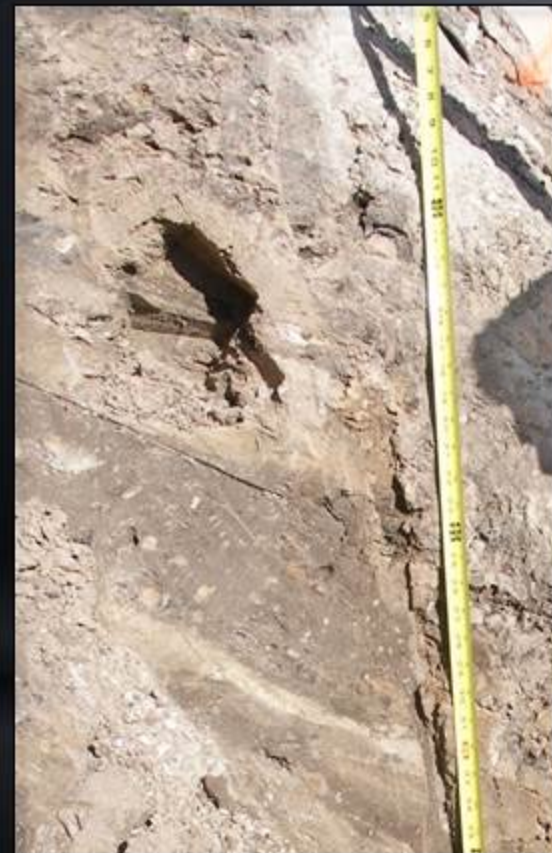
Close-up view of the shear failure plane on the northern pit wall
