2009 GMEC Conference

Dr. Devo Seereeram, Ph.D., P.E.,
Devo Engineering

Major Geotechnical Failures As a Result of Tropical Storm Fay
(With a Focus on DeBary, Orange City, and Rock Springs Localities in Central Florida)

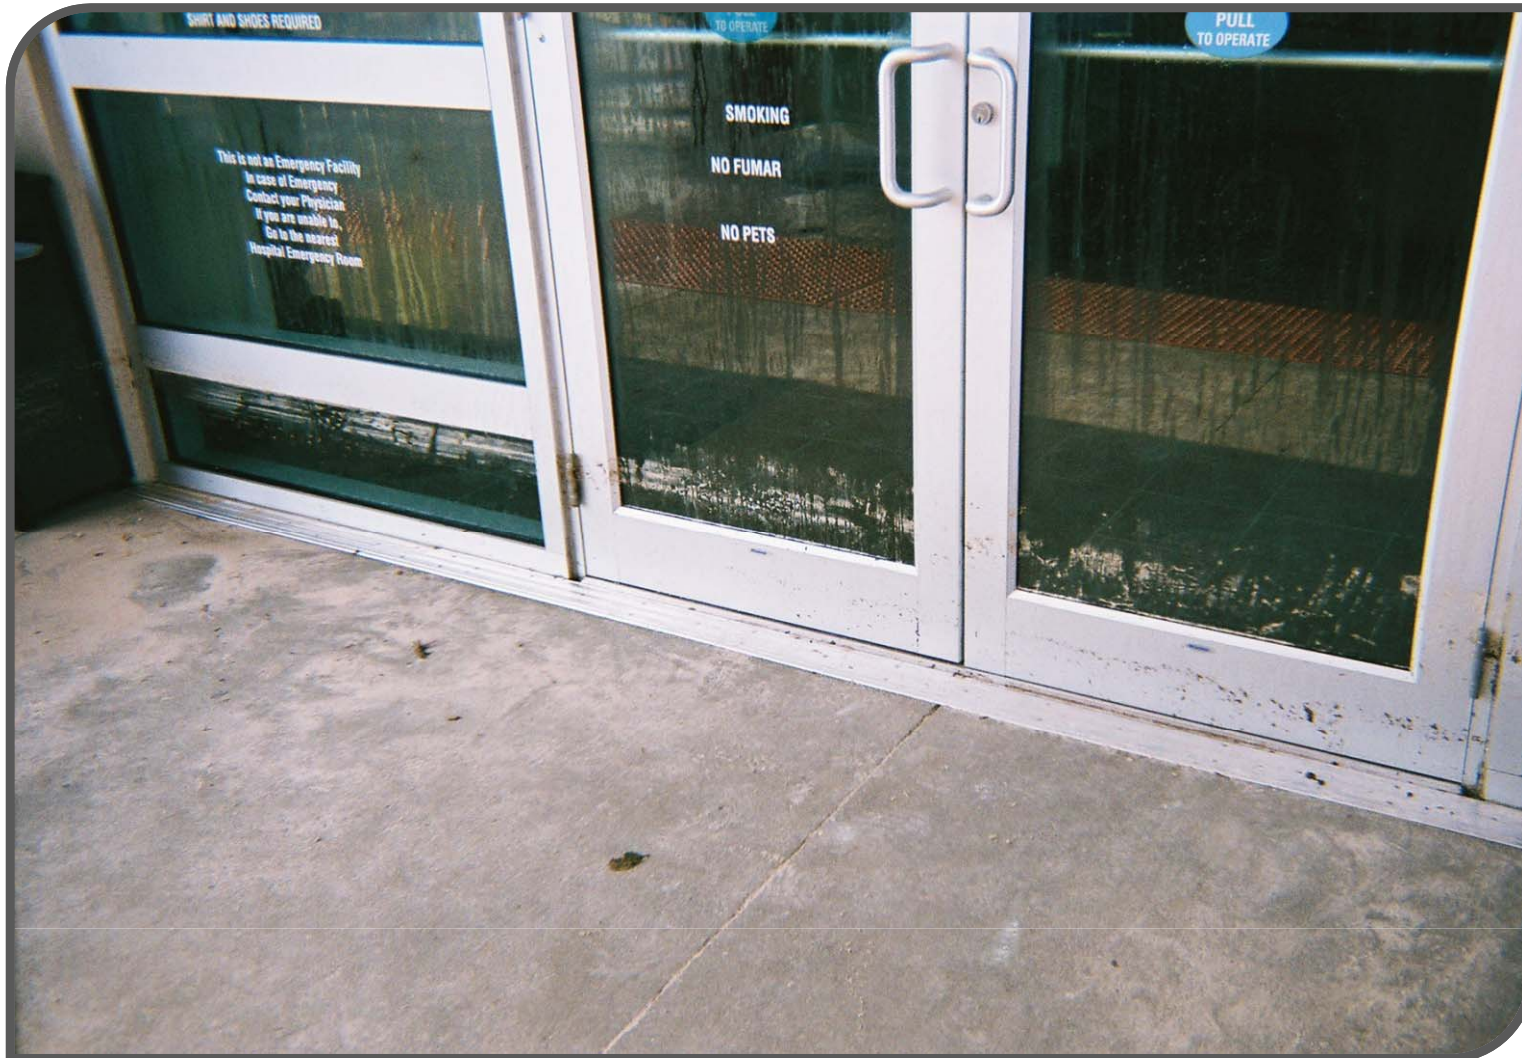
Orange City Medical Office

Shows Water Stains 8 Inches High At Main Entrance

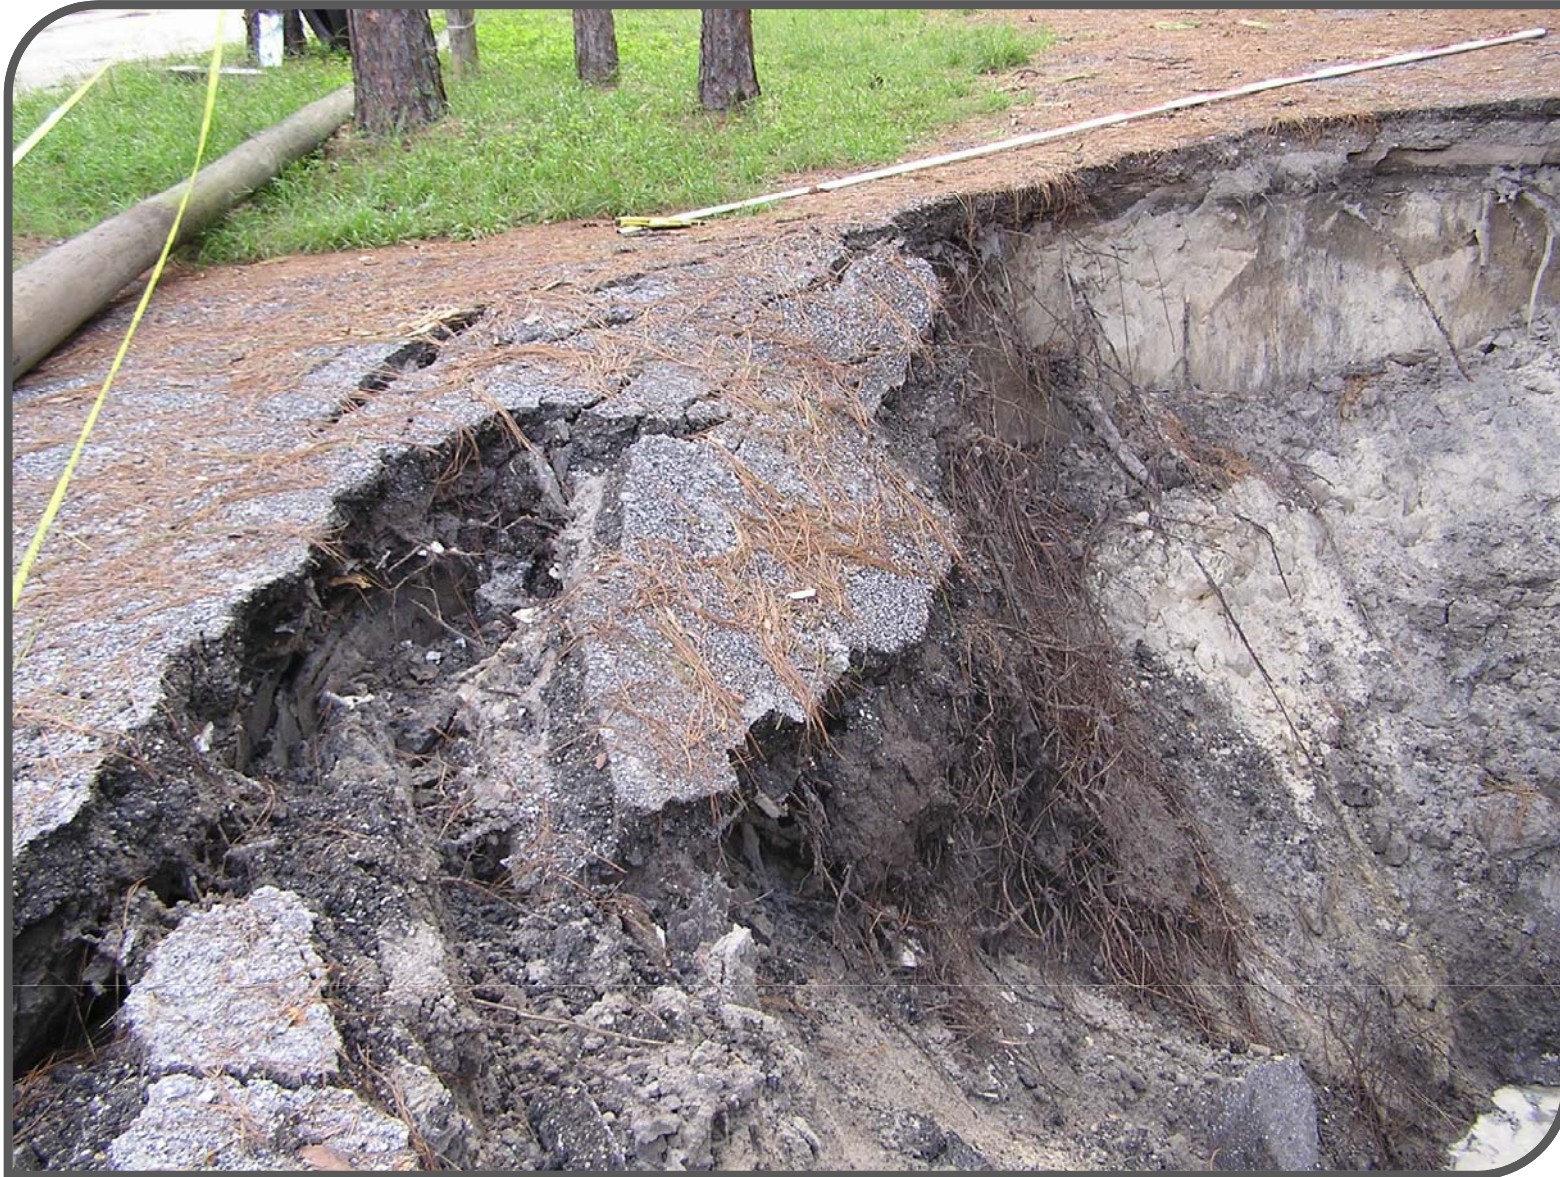
Photo 1 of 7

Deroose Nursery - Rock Springs

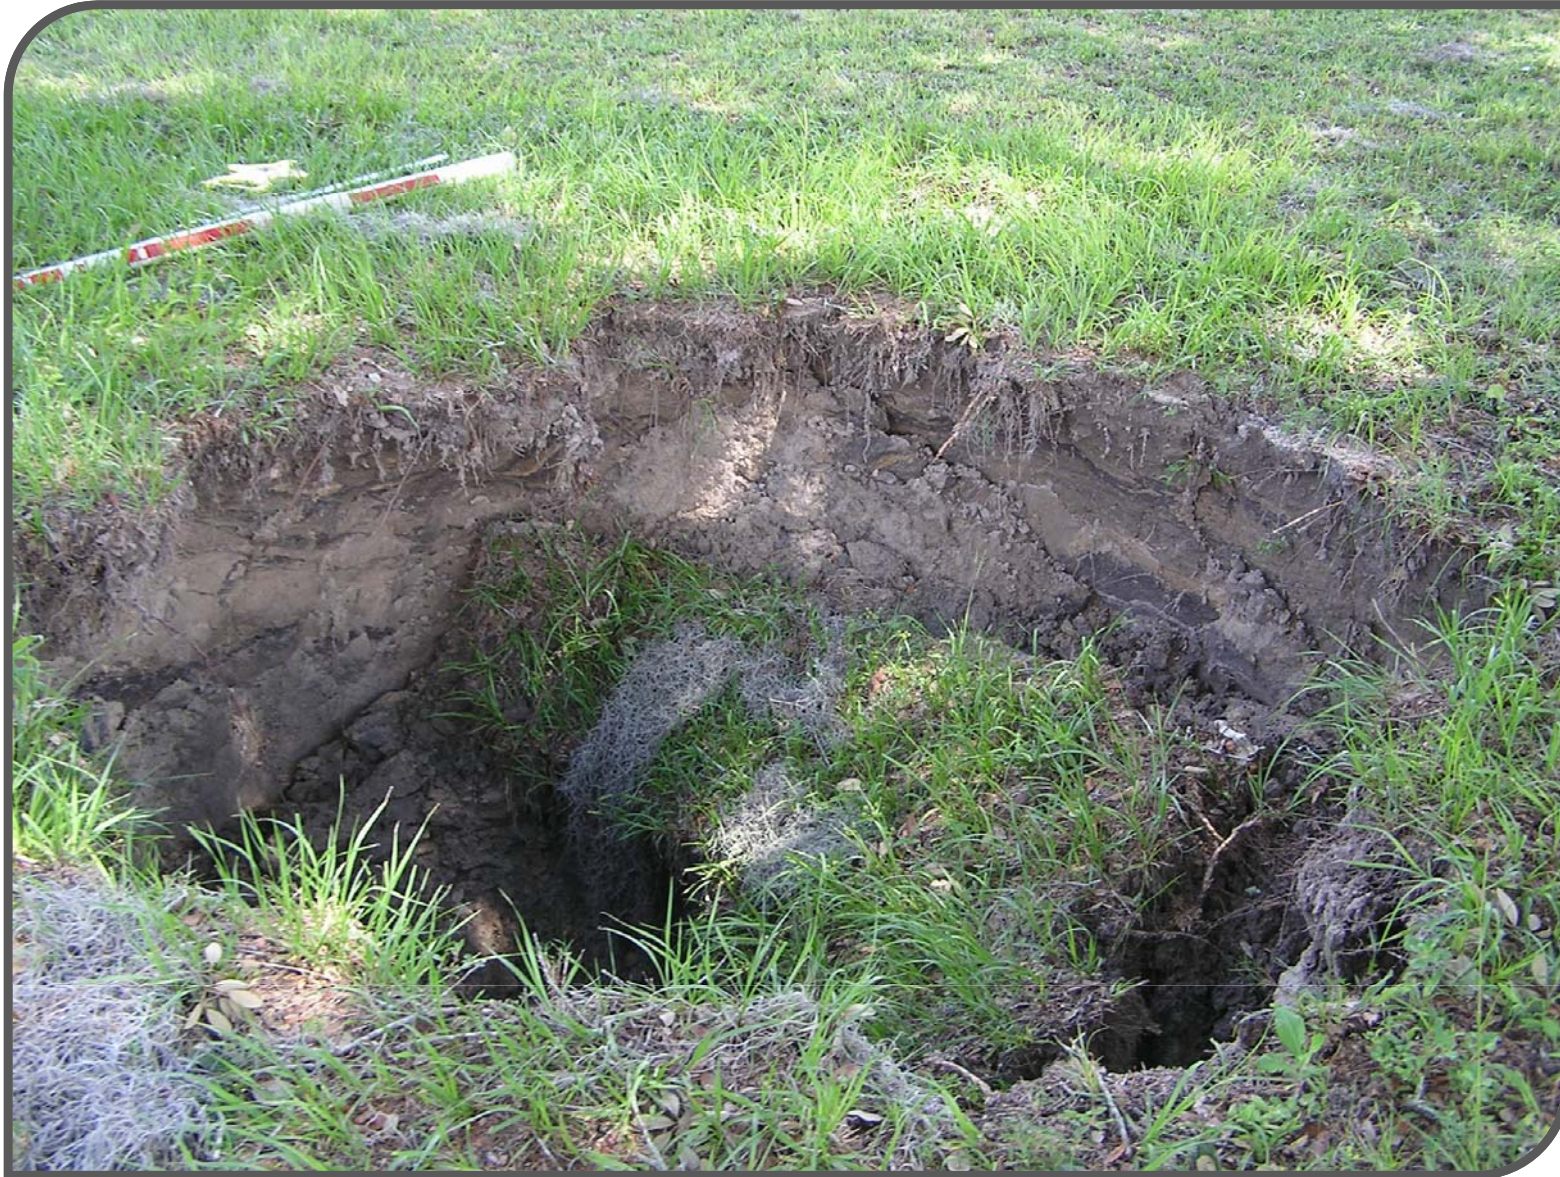
Photo 6 of 7

Deroose Nursery - Rock Springs

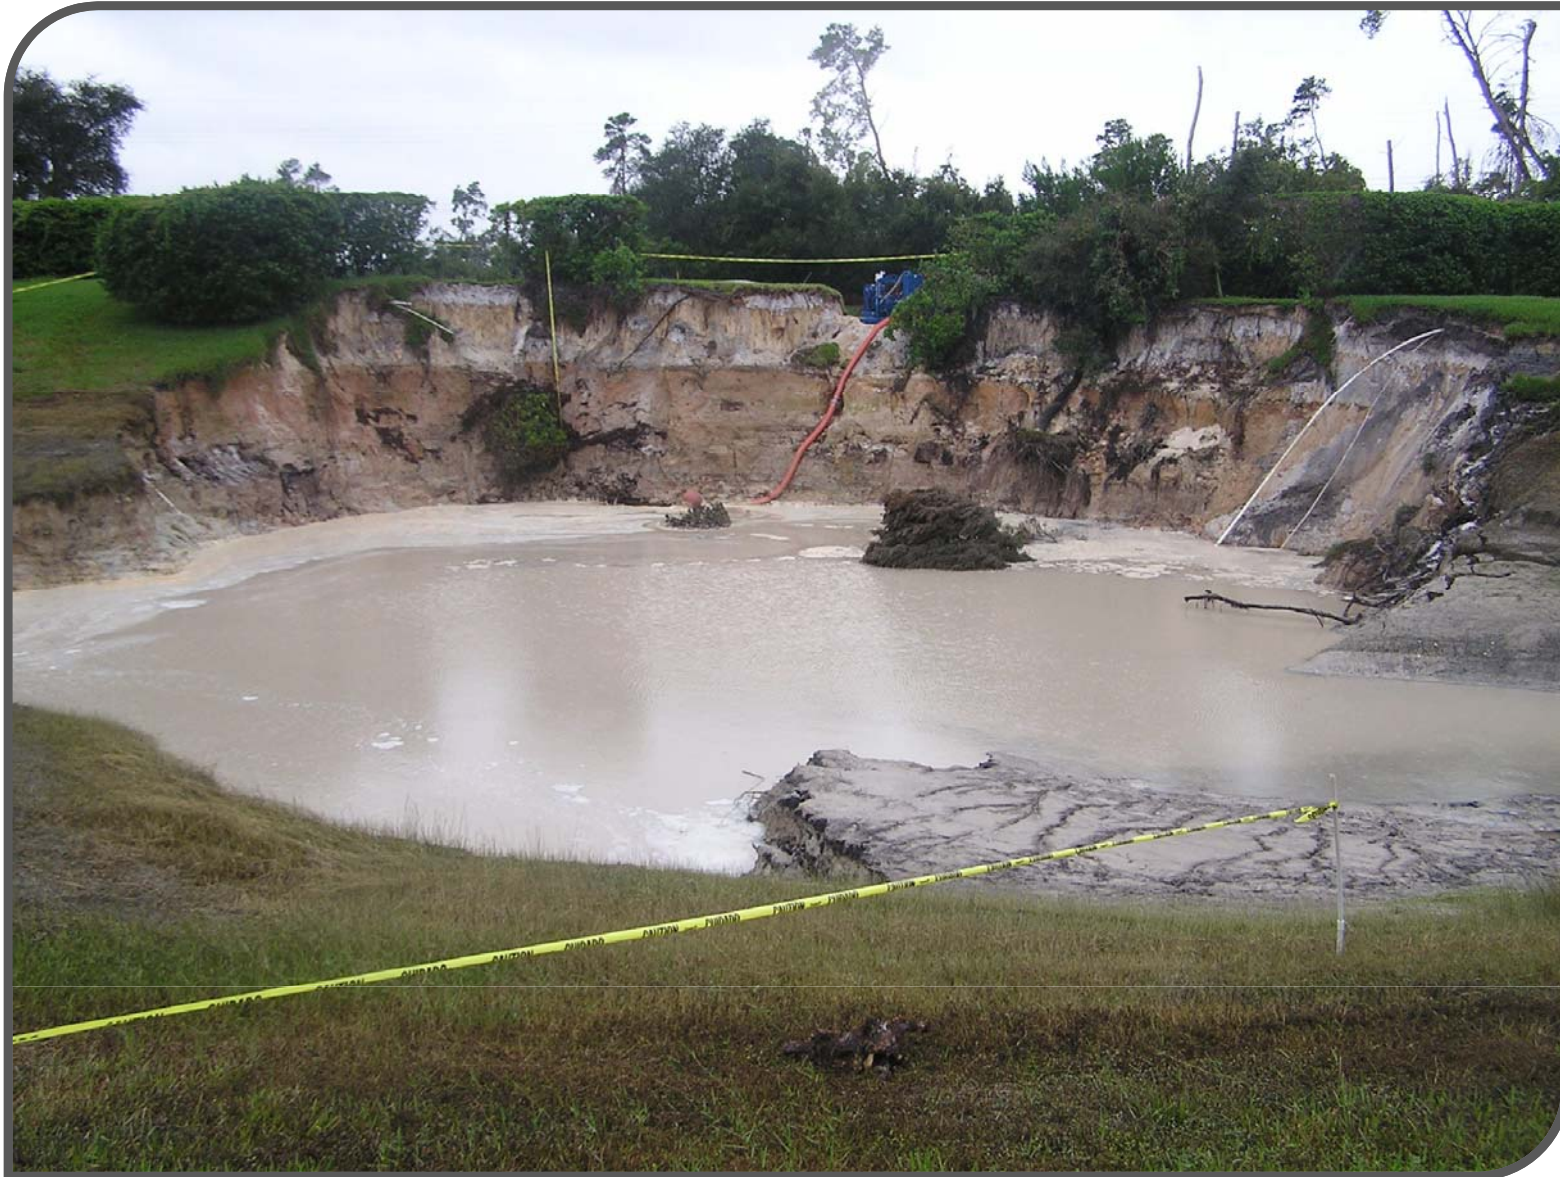
Photo 2 of 7

Donald E. Smith Blvd

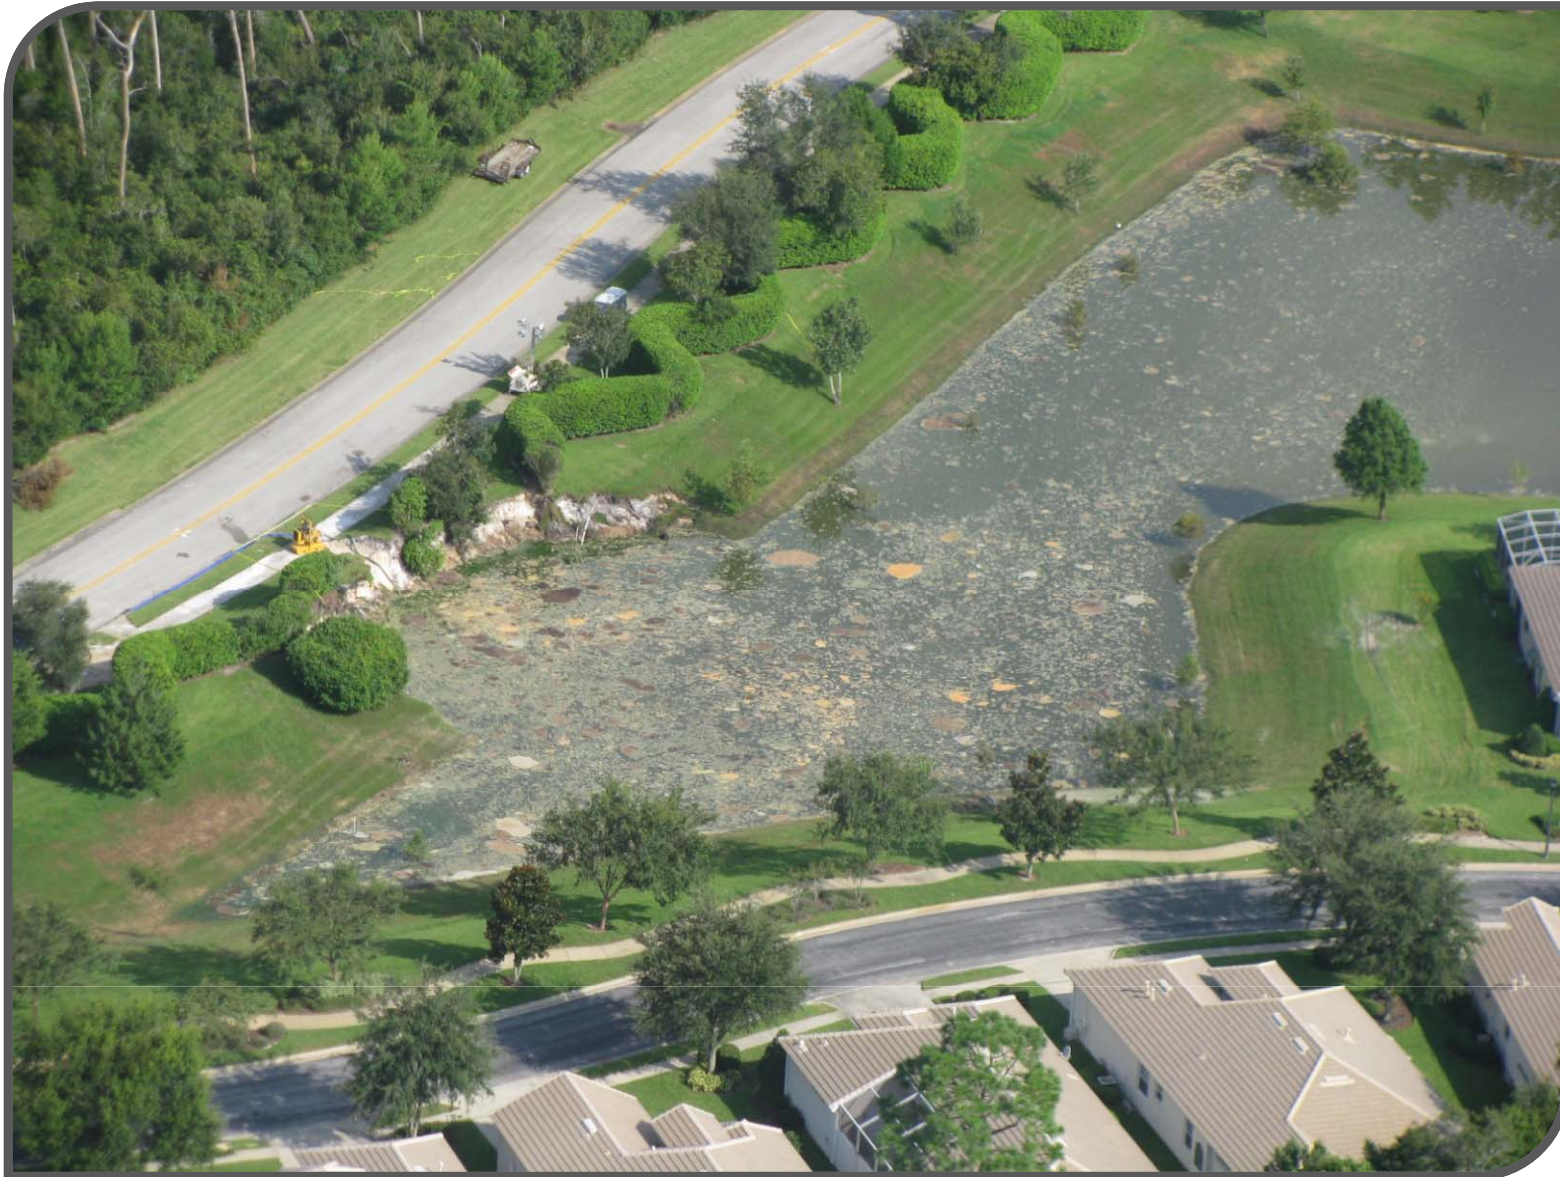
Photo 3 of 7

Donald E. Smith Blvd

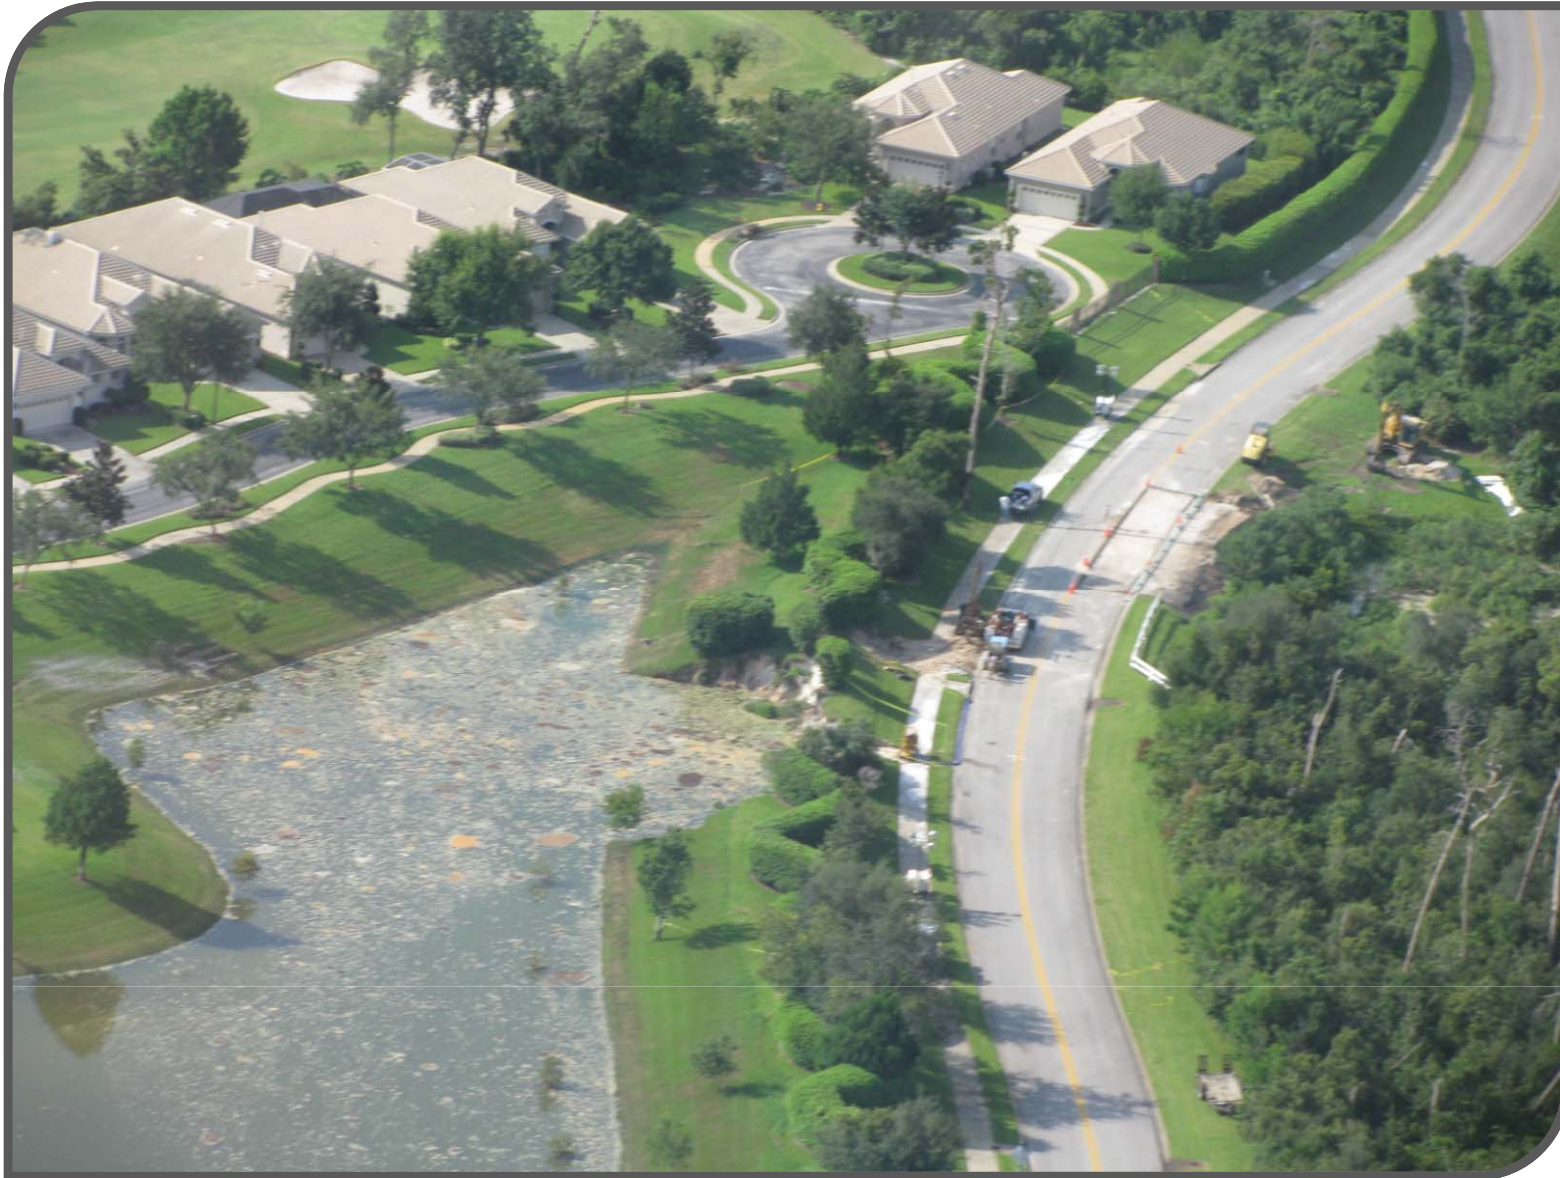
Photo 4 of 7

Donald E. Smith Blvd

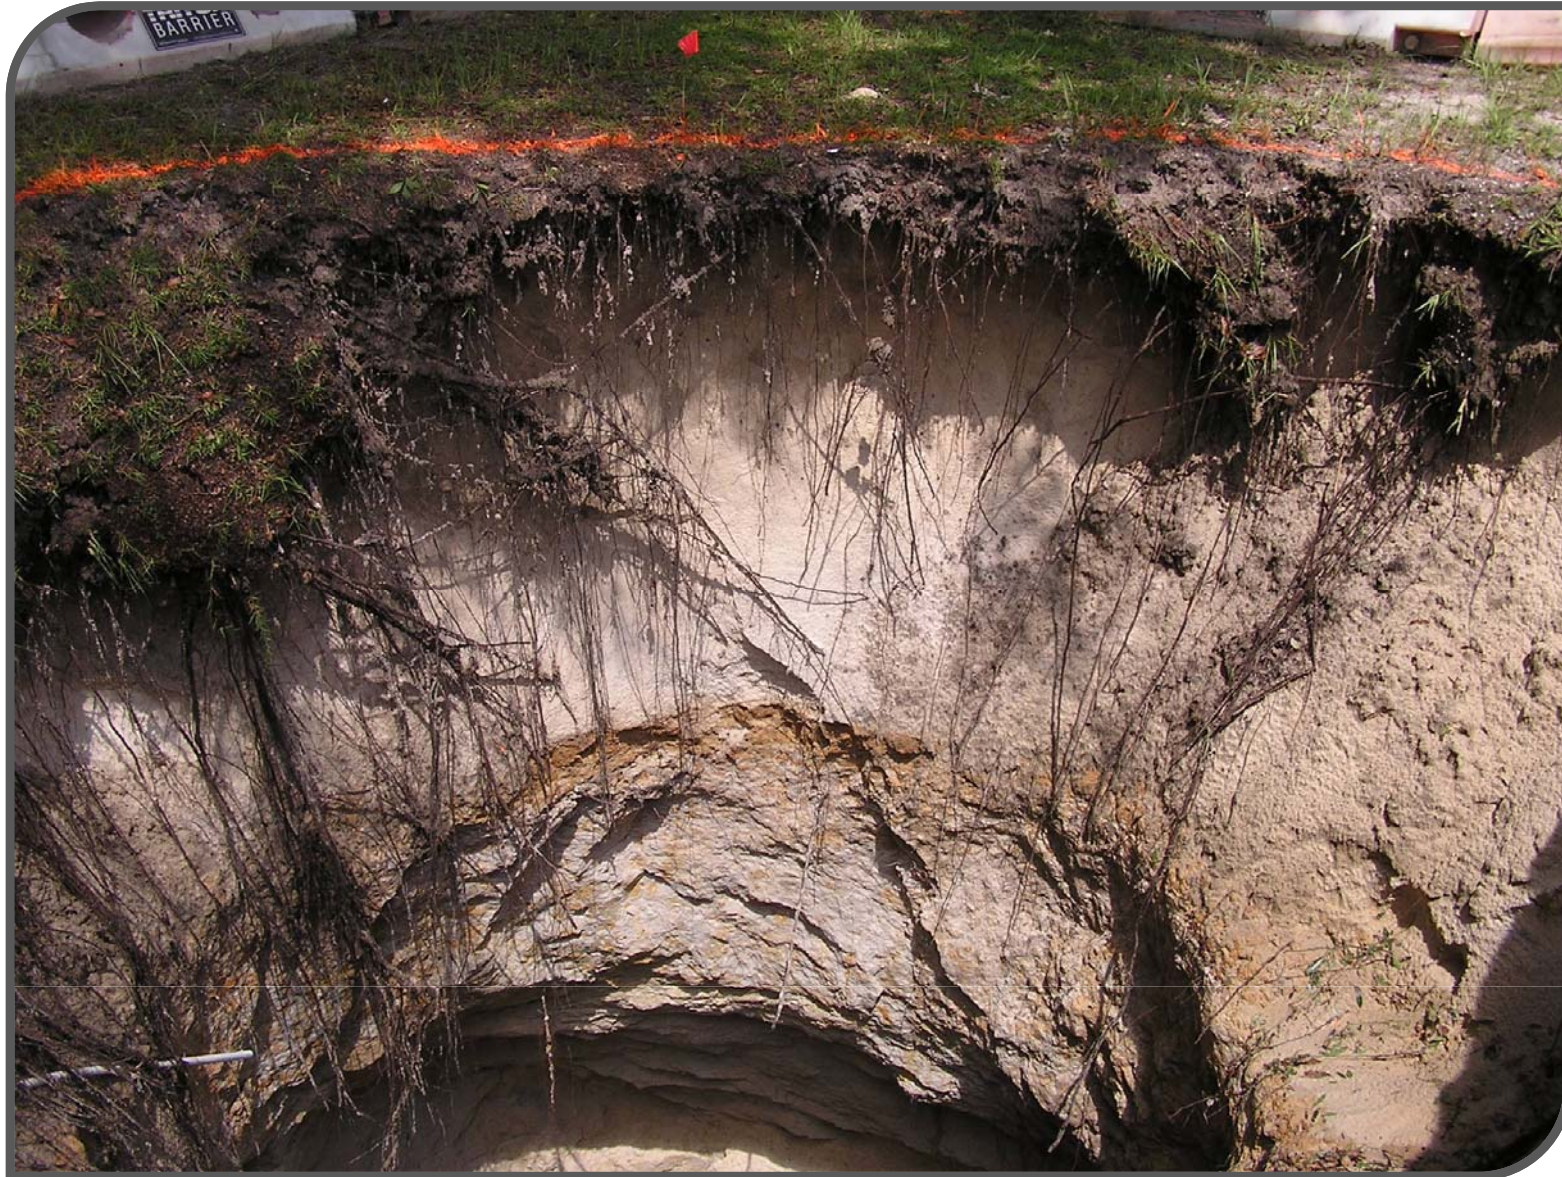
Photo 3 of 3

Fox Lake Drive Sinkholes - Rock Springs

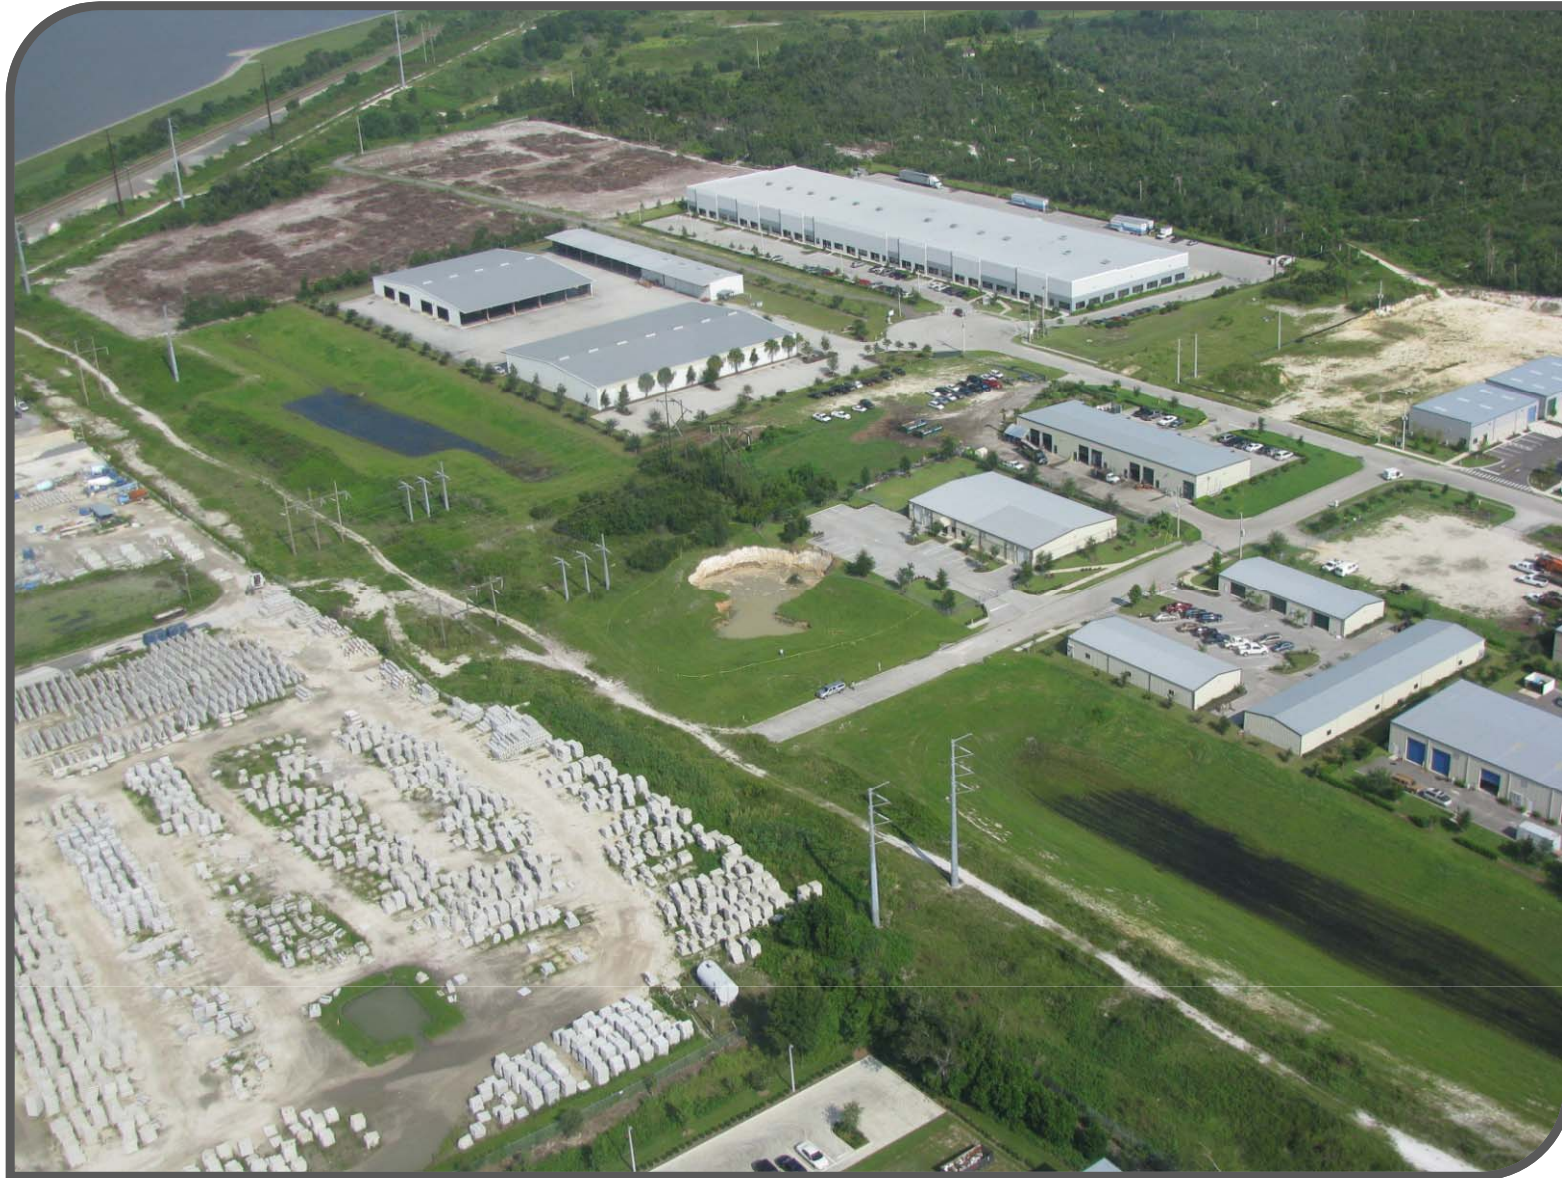
Photo 1 of 5

Integrated Court

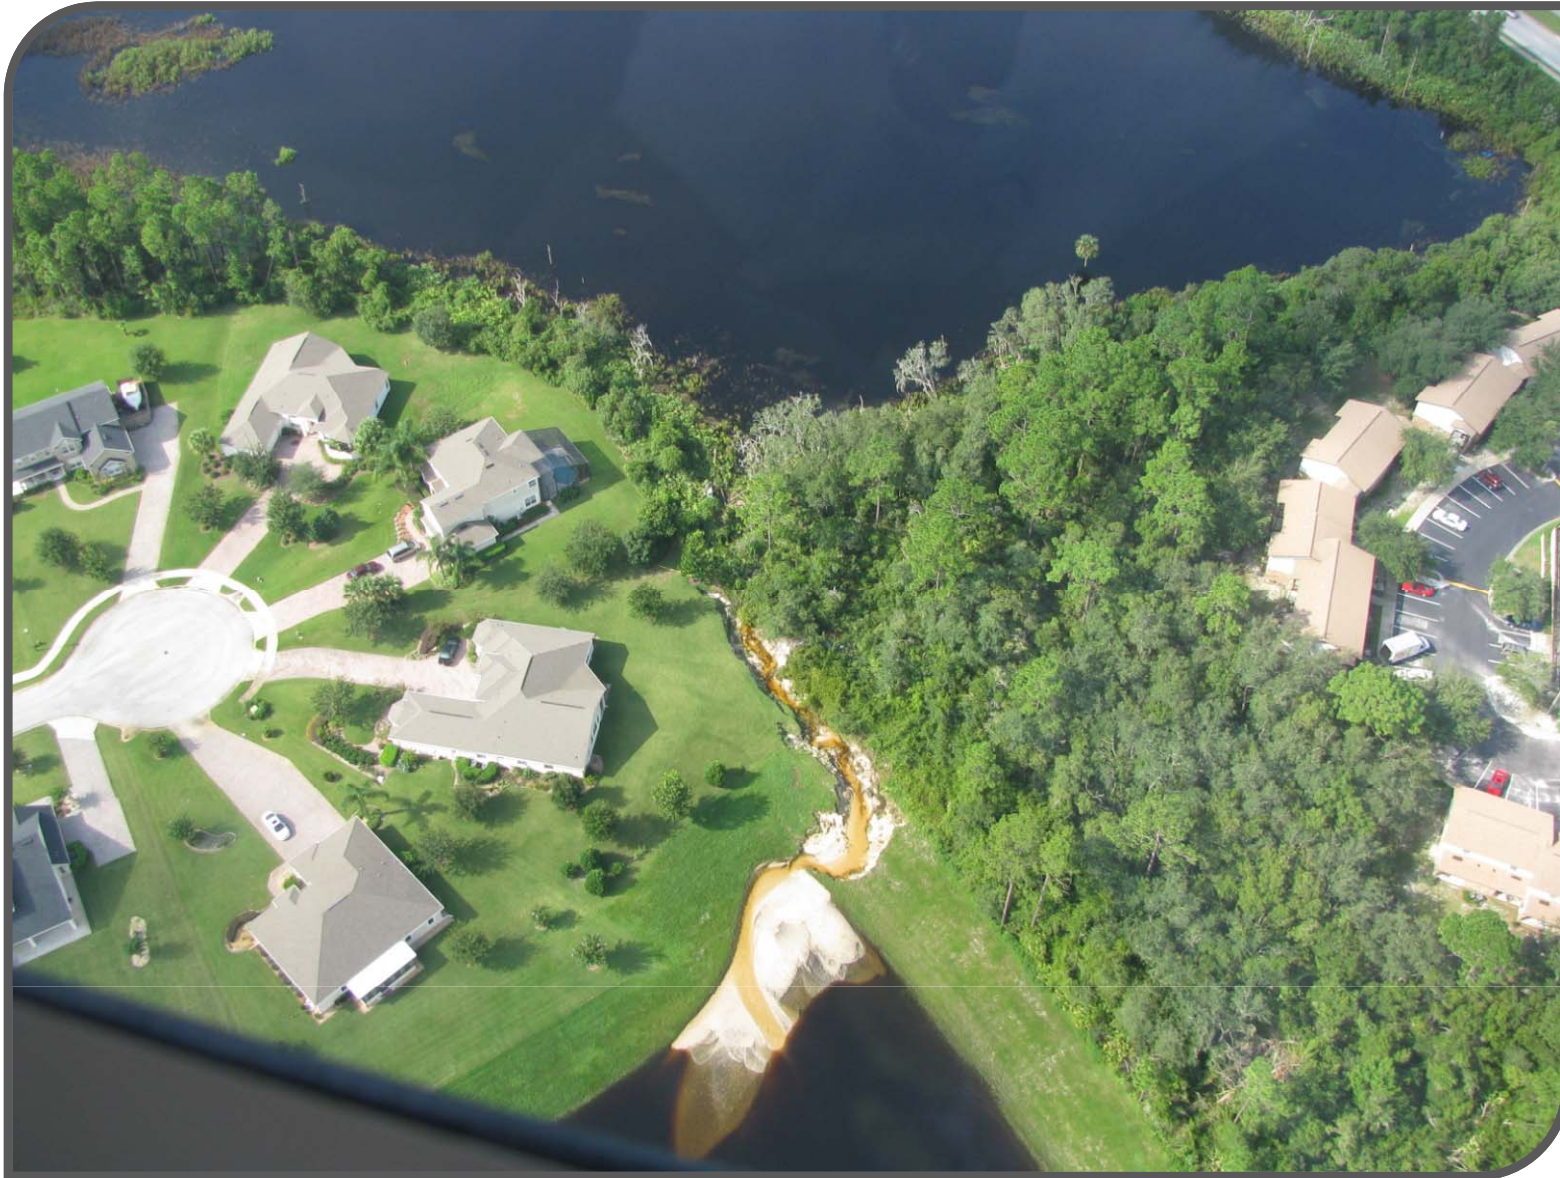
Photo 1 of 4

Glen Club Drive Pond Berm Failure

1. The modes of stormwater pond berm failures were similar in all instances.
2. The pond slope failures were not due to conventional slope stability but overtopping and then washing out of the weak spot in the fill section.
3. The sinkhole collapses, as is typical, occurred when the surficial aquifer water level or pond head rose and aggravated internal erosion, exposing the buried karstic cavities. The Rock Springs Sinkholes were classic cover collapse features which we only see in thinly mantled karst.
4. A “dam breach” analysis is sometimes needed to assess impact to downstream conveyance systems which can potentially impact structures.

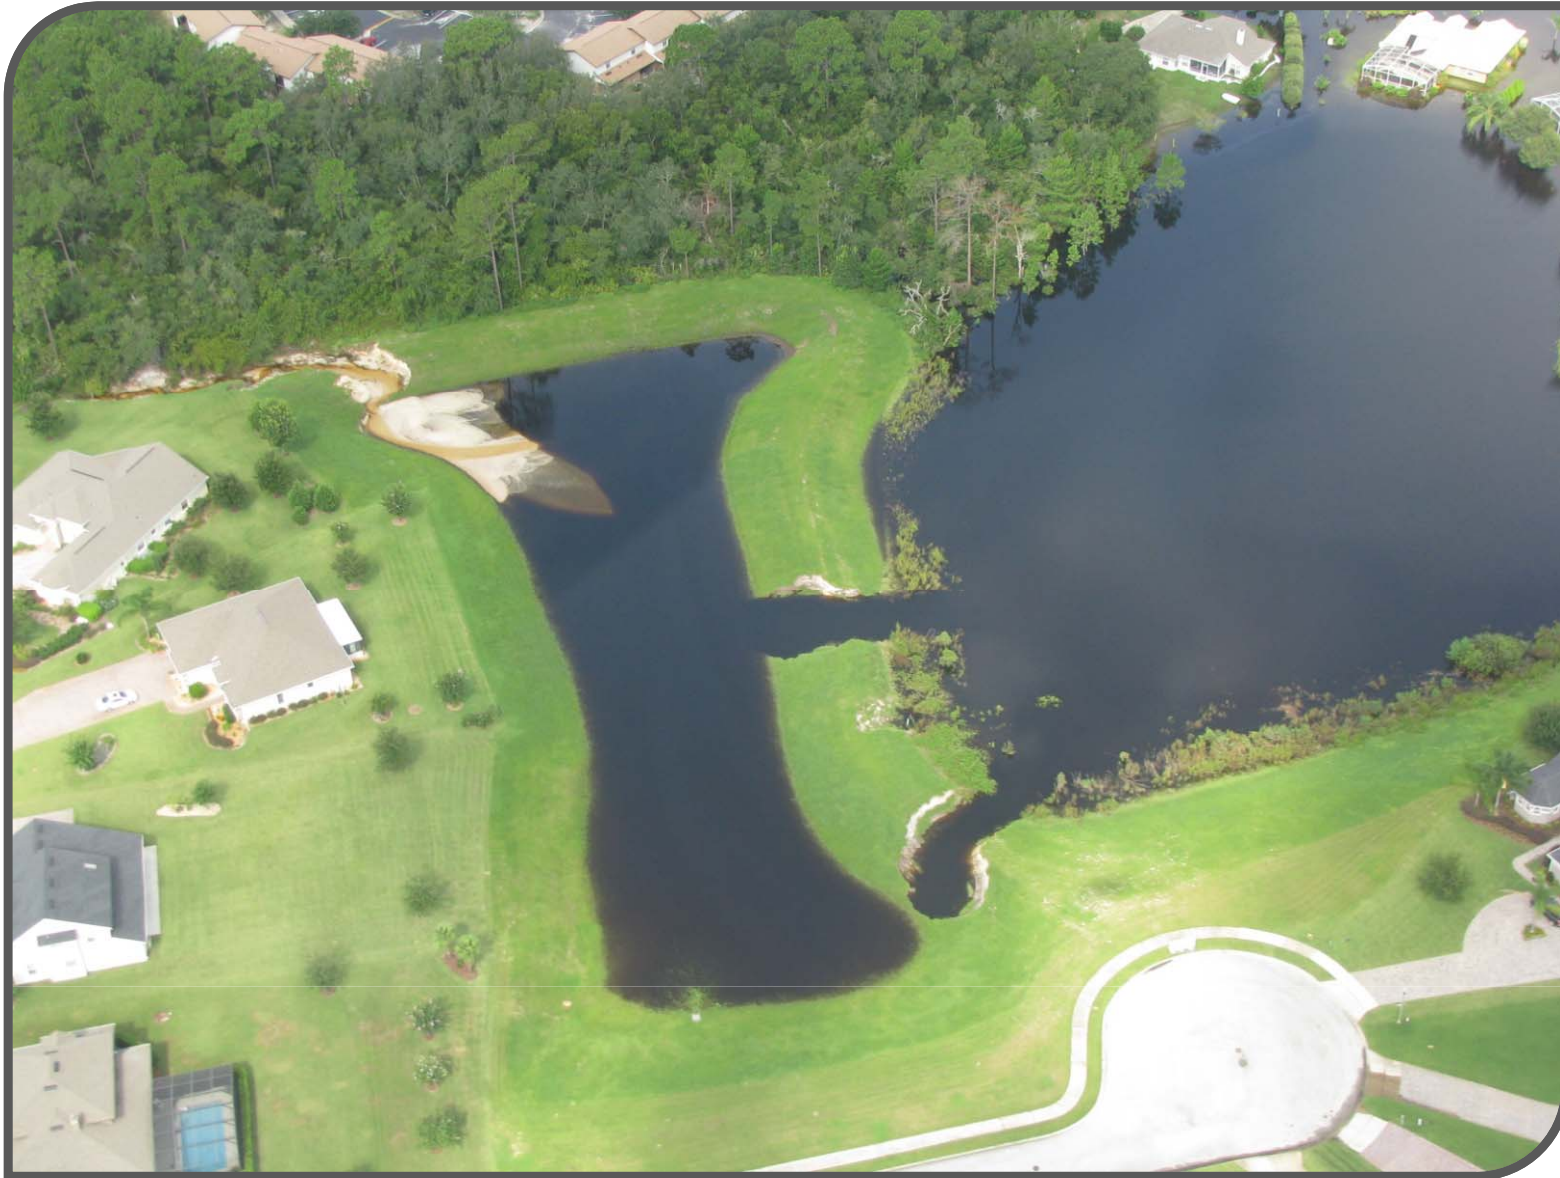
Photo 2 of 4

Glen Club Drive Pond Berm Failure

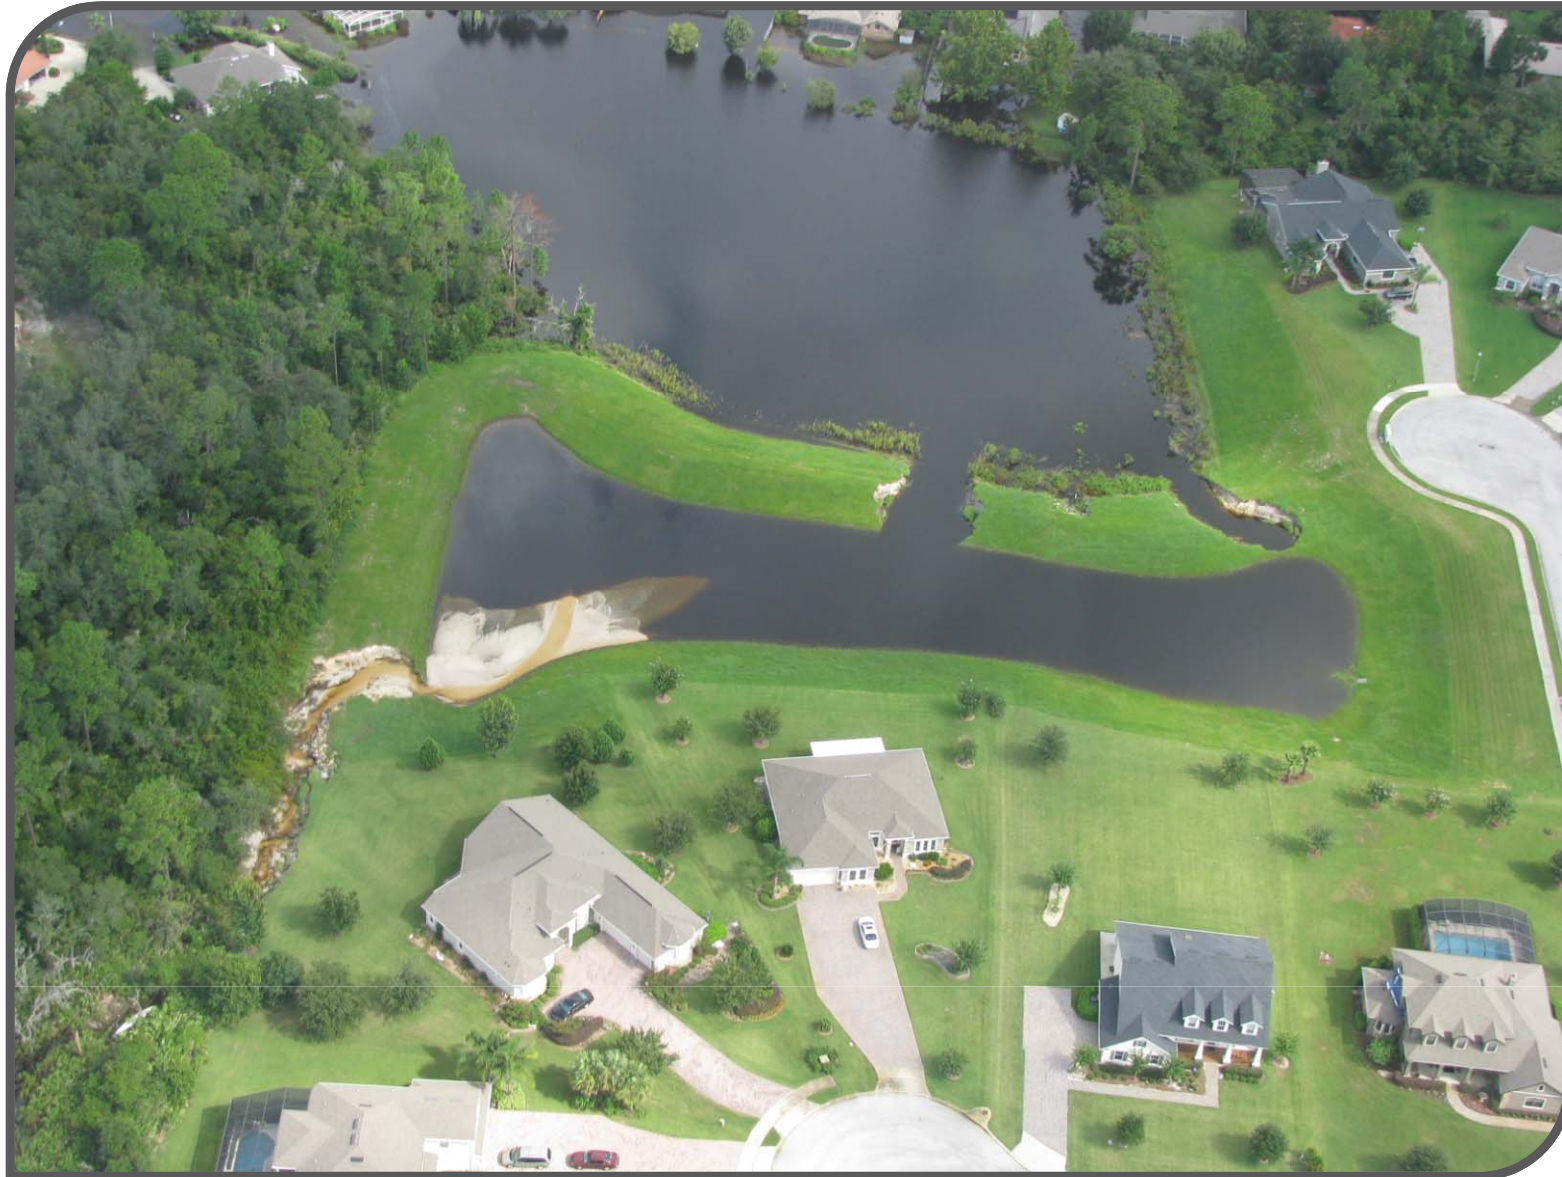
Photo 3 of 4

Glen Club Drive Pond Berm Failure

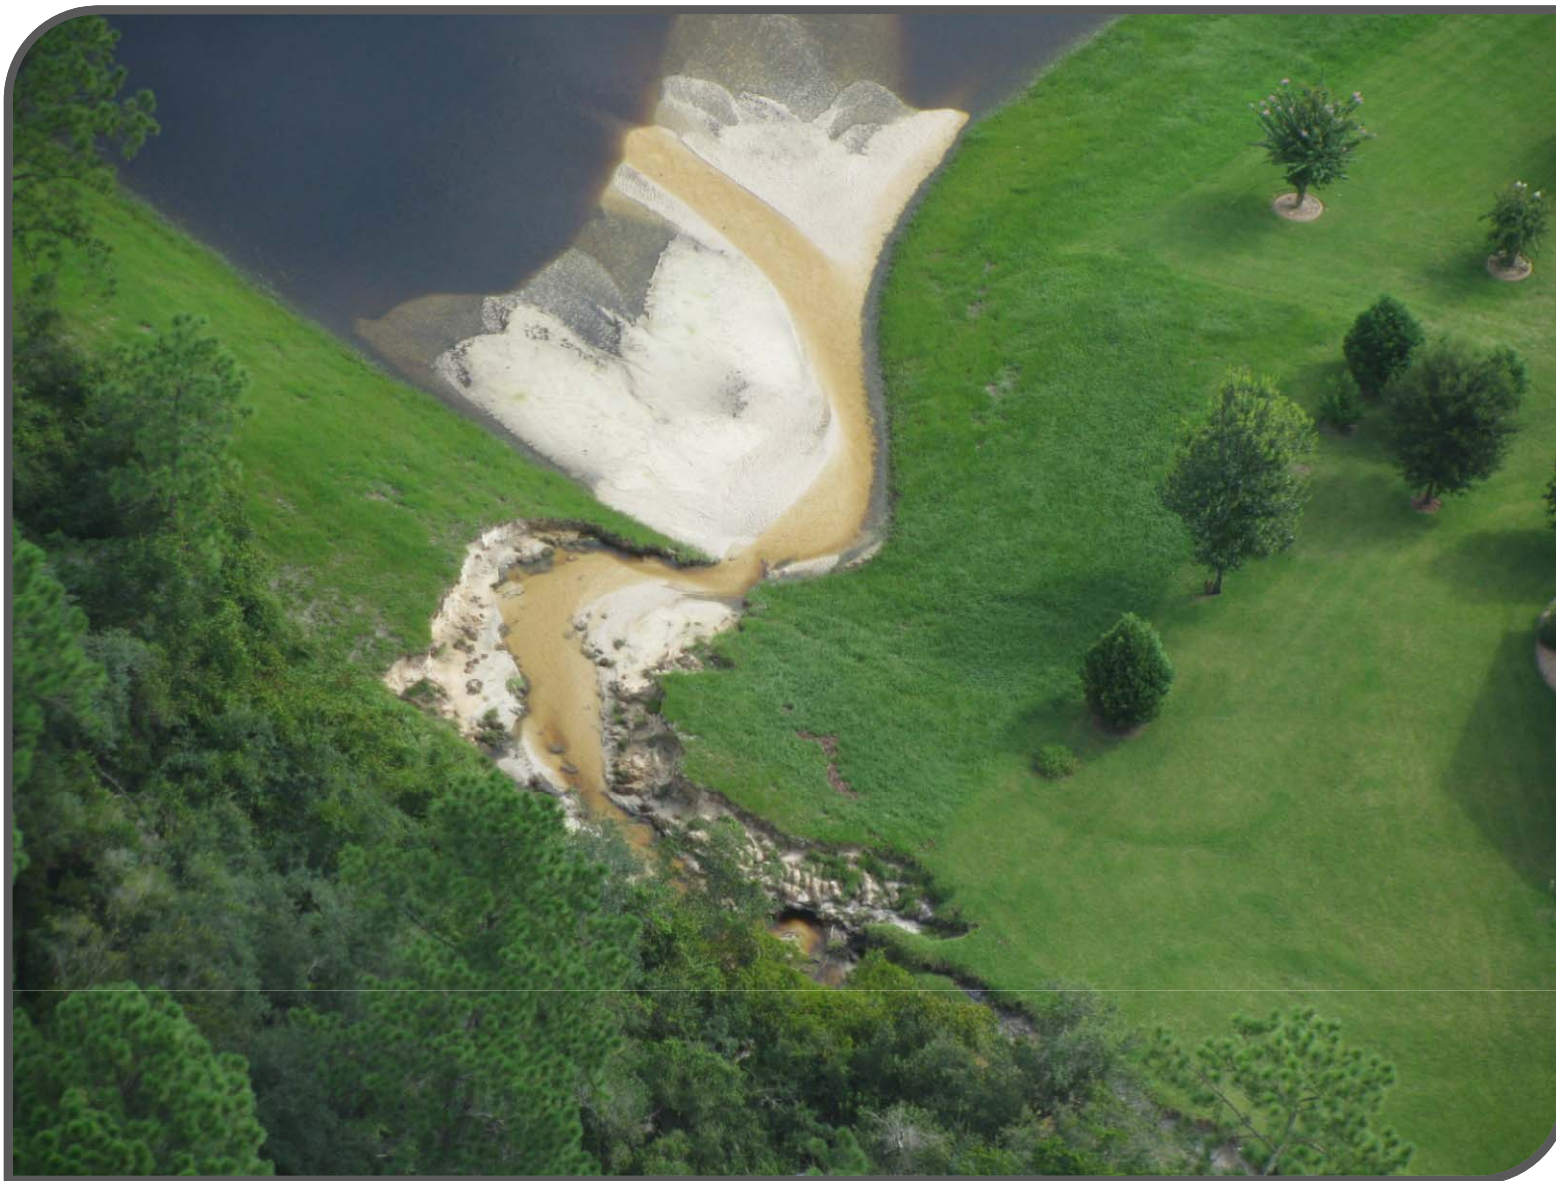
Photo 4 of 4

Glen Club Drive Pond Berm Failure
