2009 GMEC Conference

Dr. Devo Seereeram, Ph.D., P.E.,
Devo Engineering

Major Geotechnical Failures As a Result of Tropical Storm Fay
(With a Focus on DeBary, Orange City, and Rock Springs Localities in Central Florida)

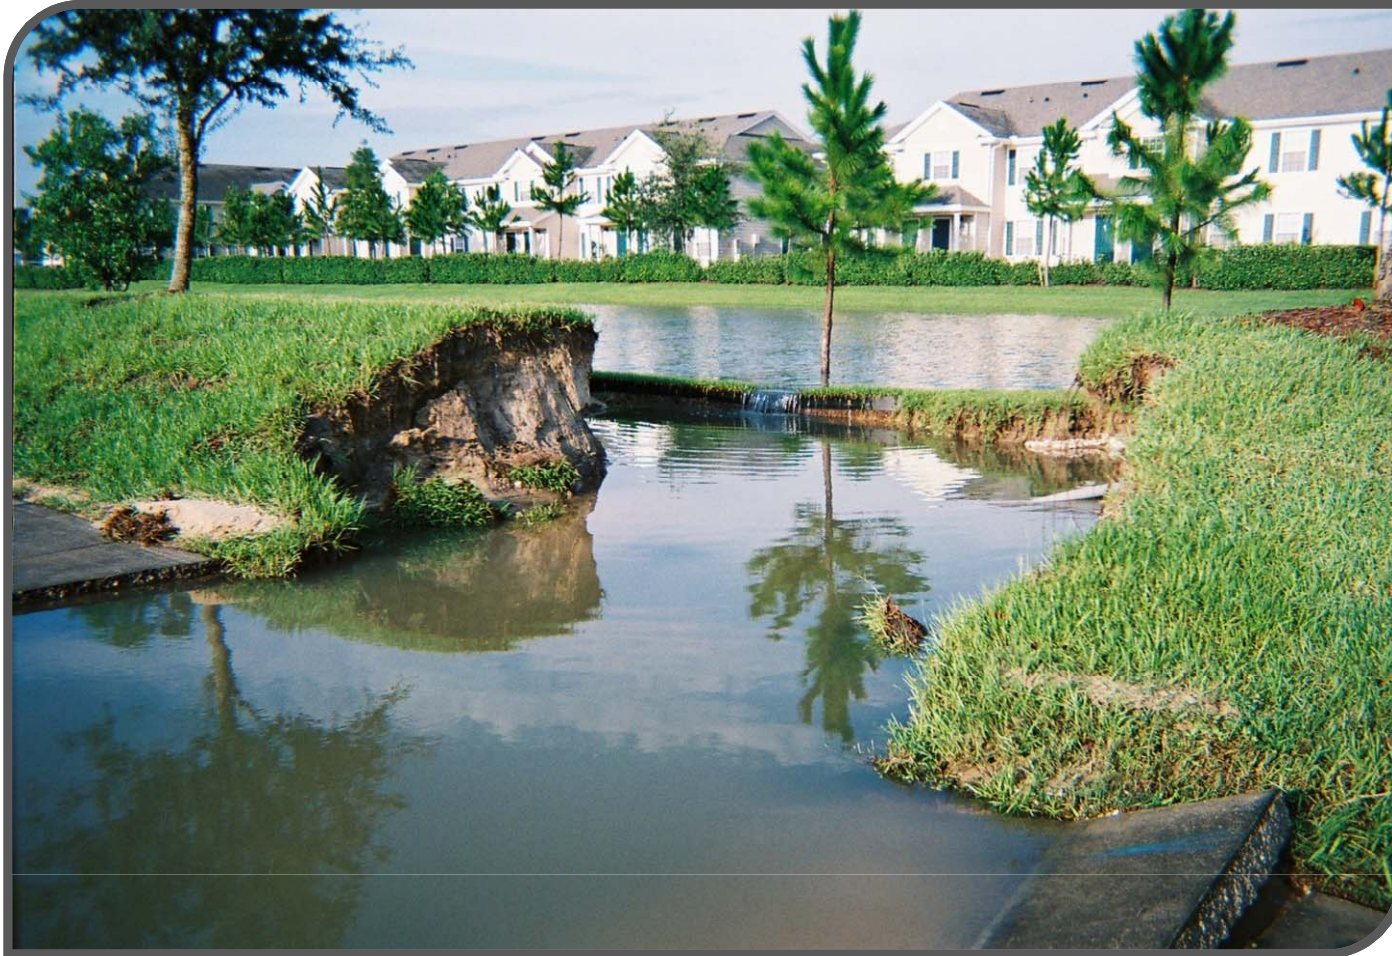
Photo 4 of 6

Saxon Trace Apartments
