ORANGE COUNTY'S FLORIDAN AQUIFER DRAINAGE WELLS

Recent Experience & Proactive Rehabilitation Program

Water Resources
Technical Group
Luncheon

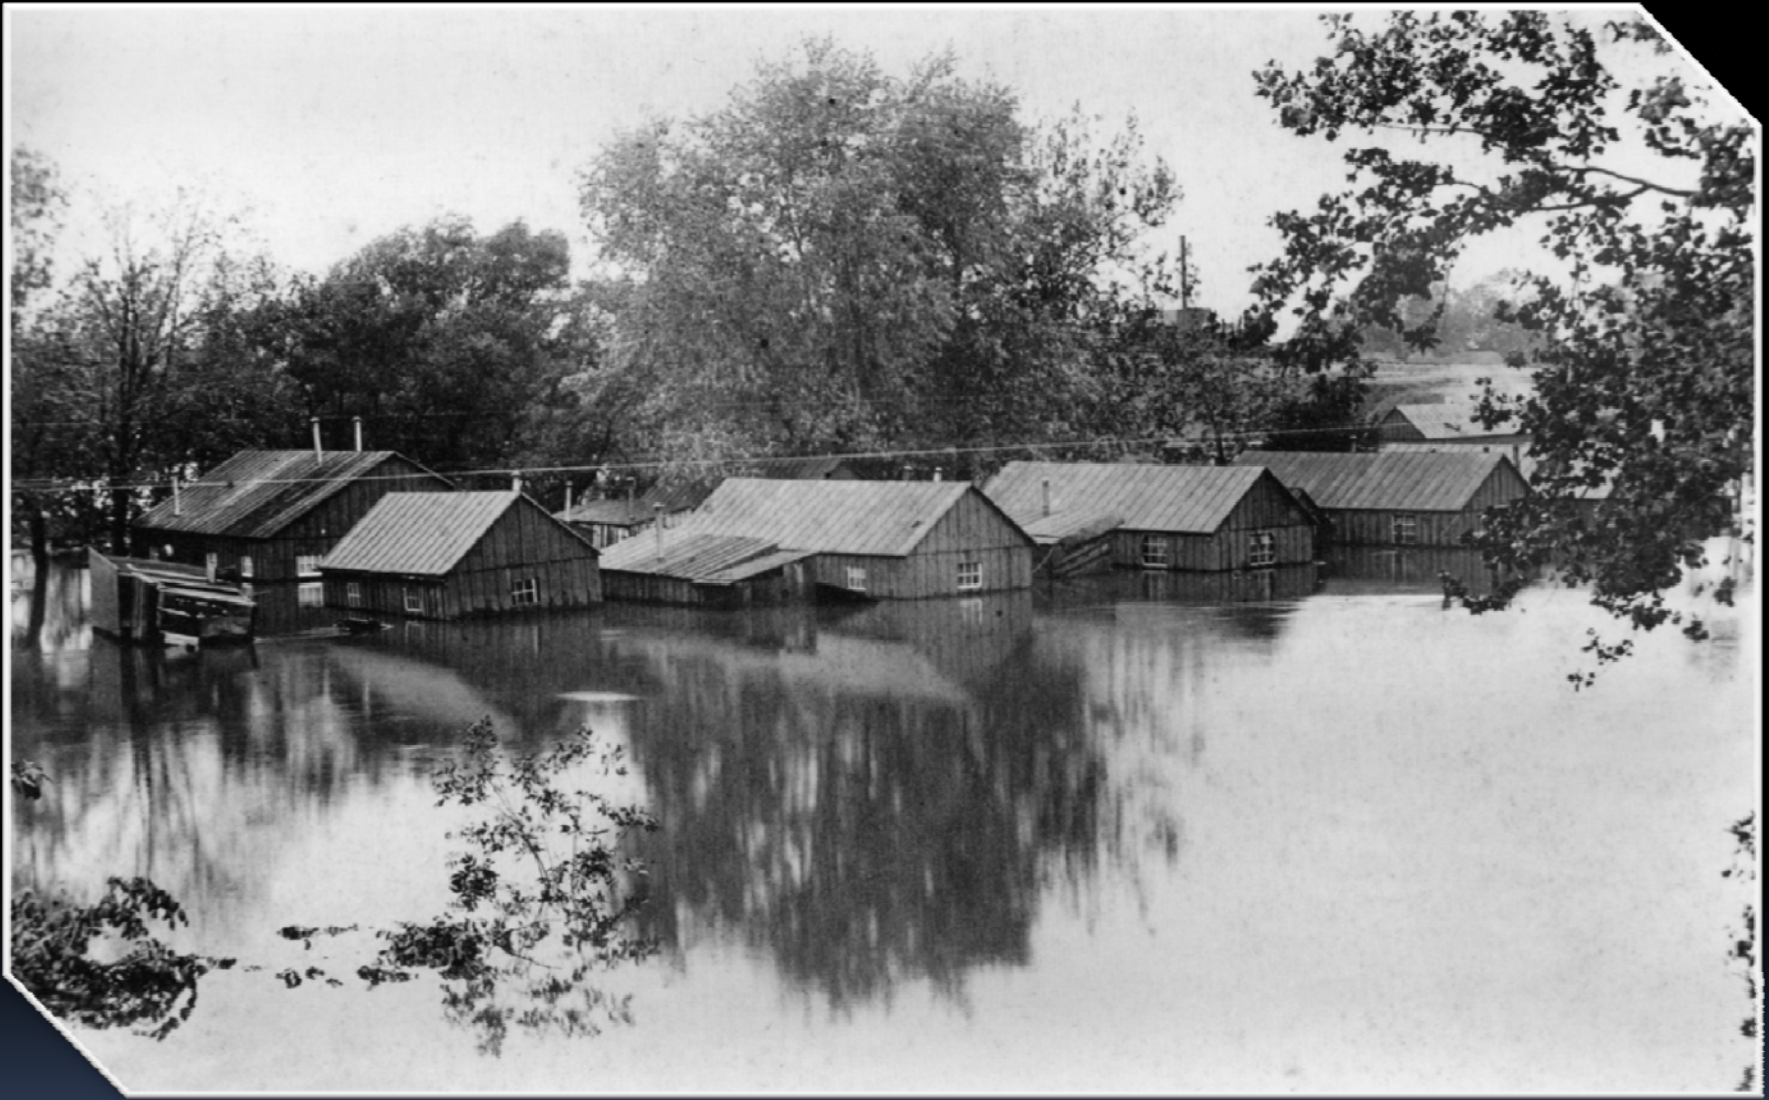
Photographer H. A. Abercromby recorded this flooded section of Orlando sometime in the **1880's** and **1890's**, according to Florida State Archives records. During heavy rains, the area near Greenwood Cemetery and the black community of Jonestown, east of downtown Orlando, was especially prone to flooding.

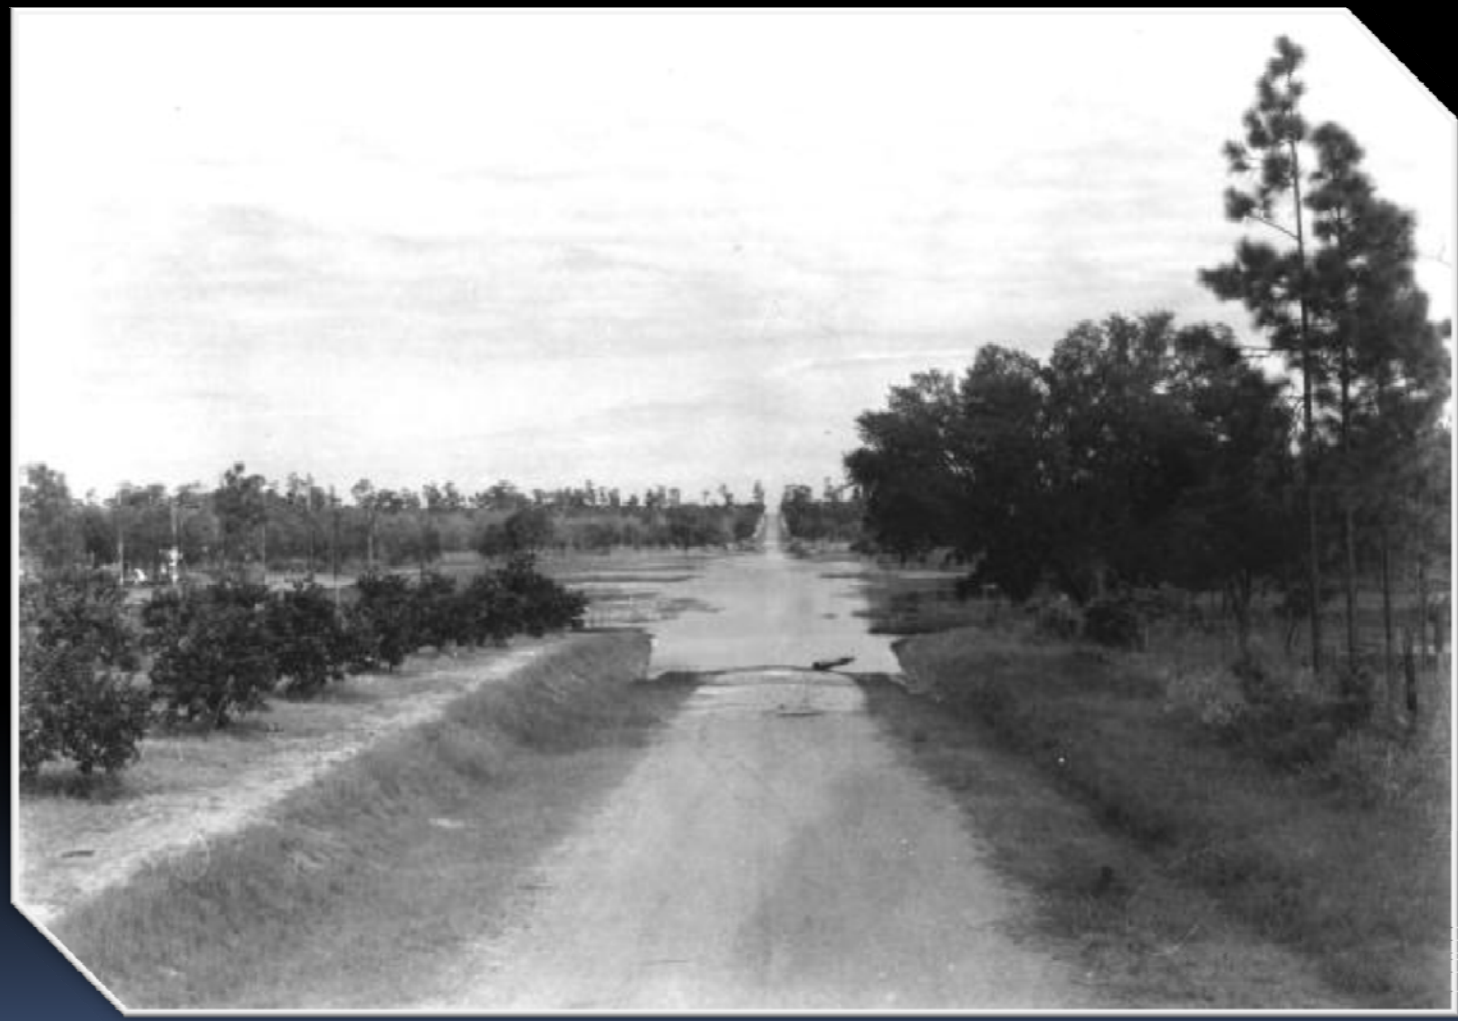
Flooded Hiawassee Road from heavy rainfall and ineffectiveness of drainage well 1930

This photo was taken before Hiawassee Rd was realigned

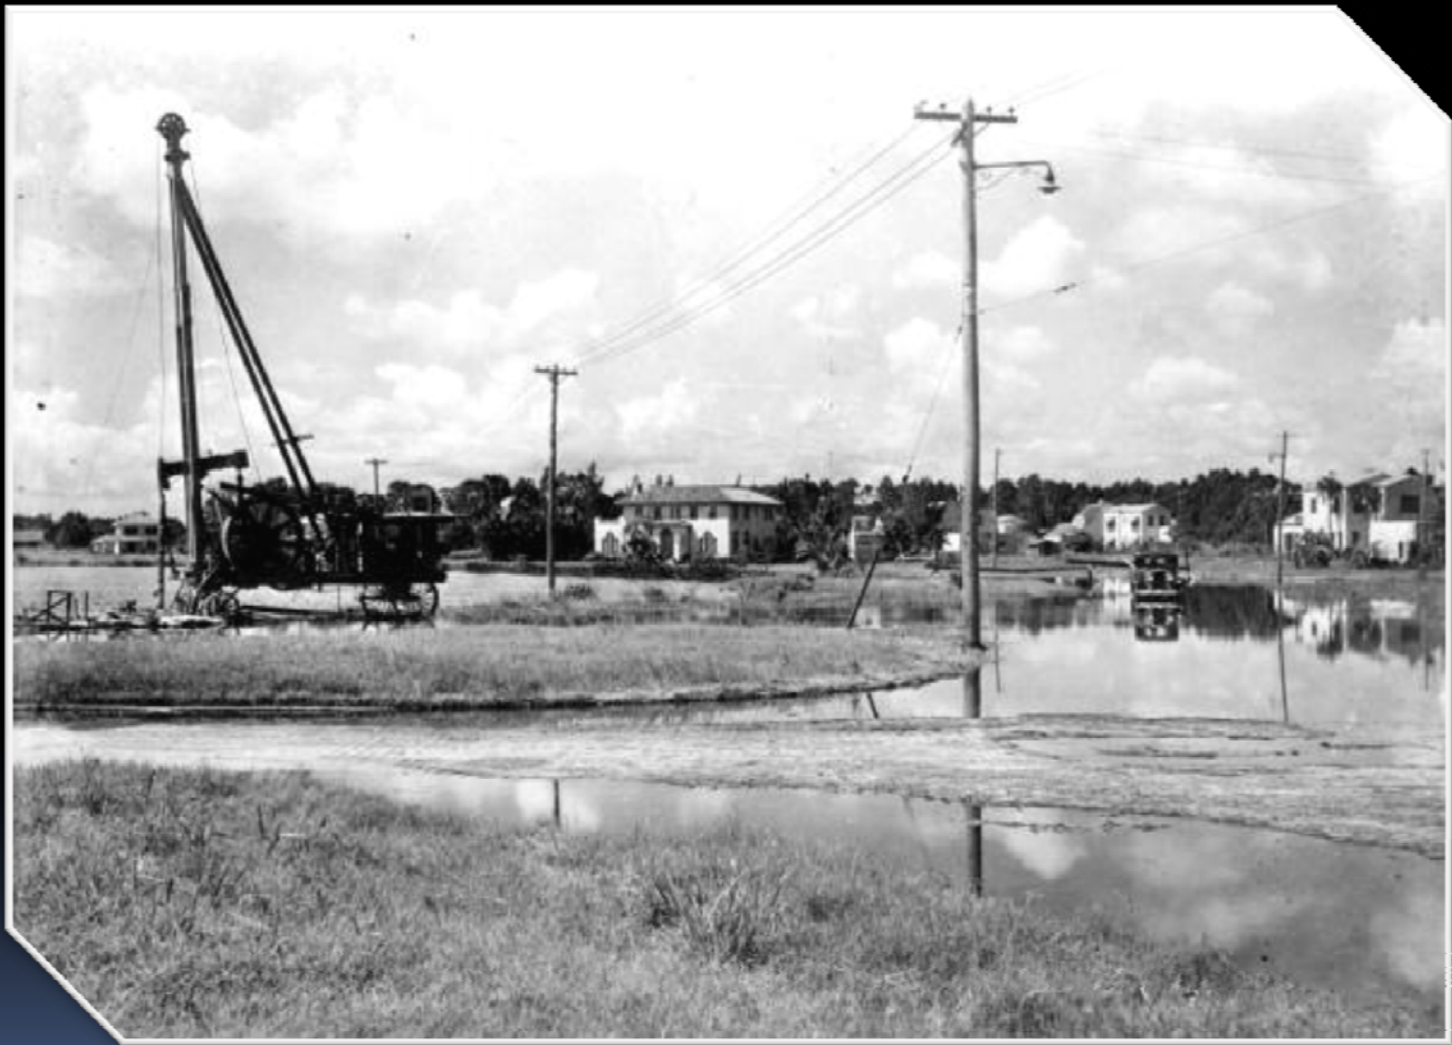
Lake Davis in southwest section of Orlando seen flooded after heavy rain 1930

Rig in photograph was used to drill deeper drainage well

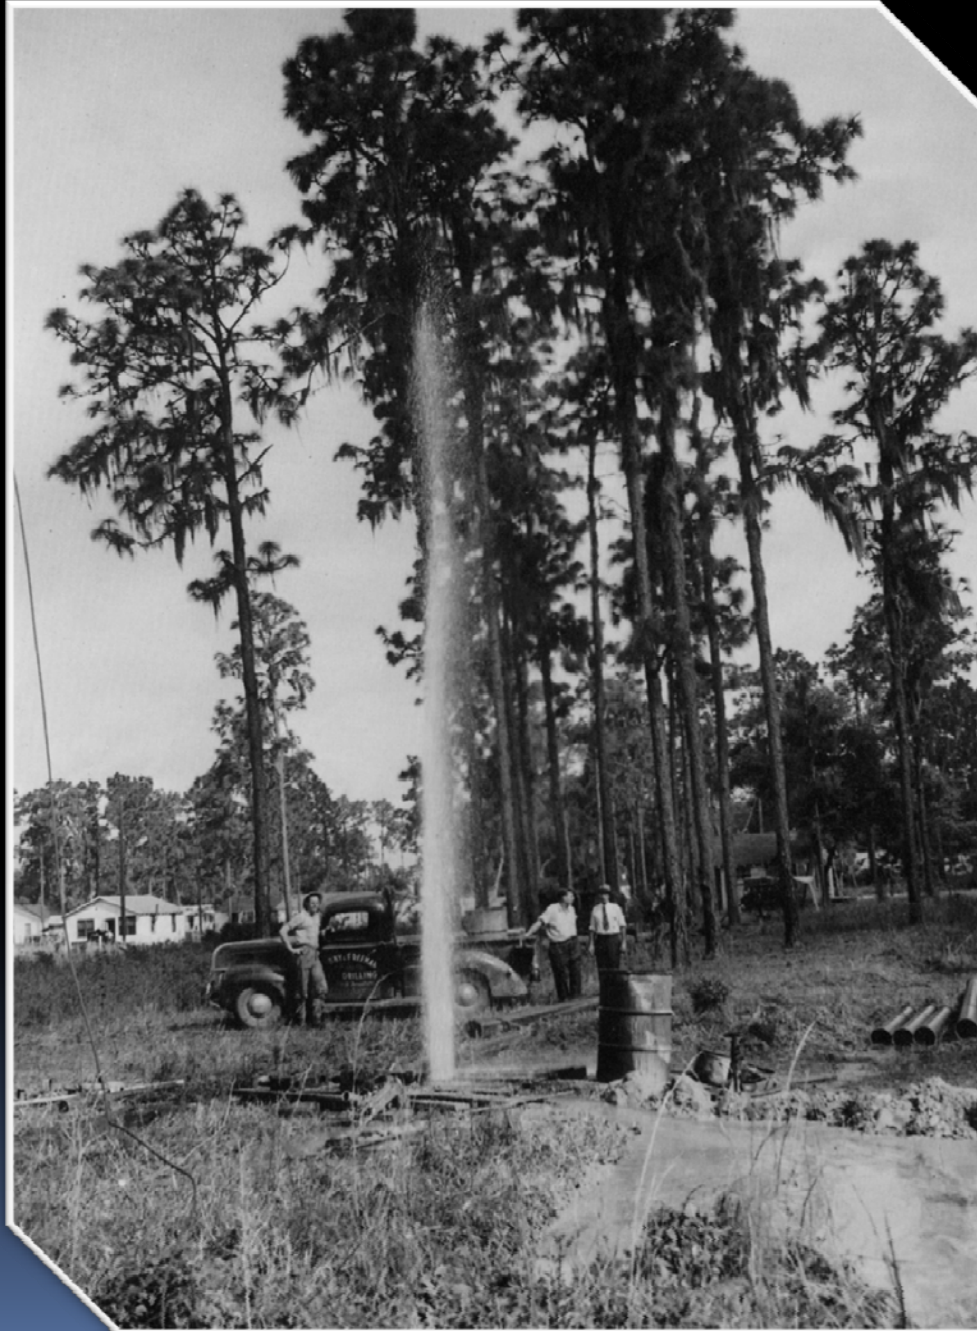
Methane gas burning from newly drilled drainage well

Height of flame is between 80 and 100 ft. at 9:00 a.m., Friday, , March 12, **1948**. Gas flowed at a land surface depth of 100 ft.

Located on 31st and S. Westmoreland.

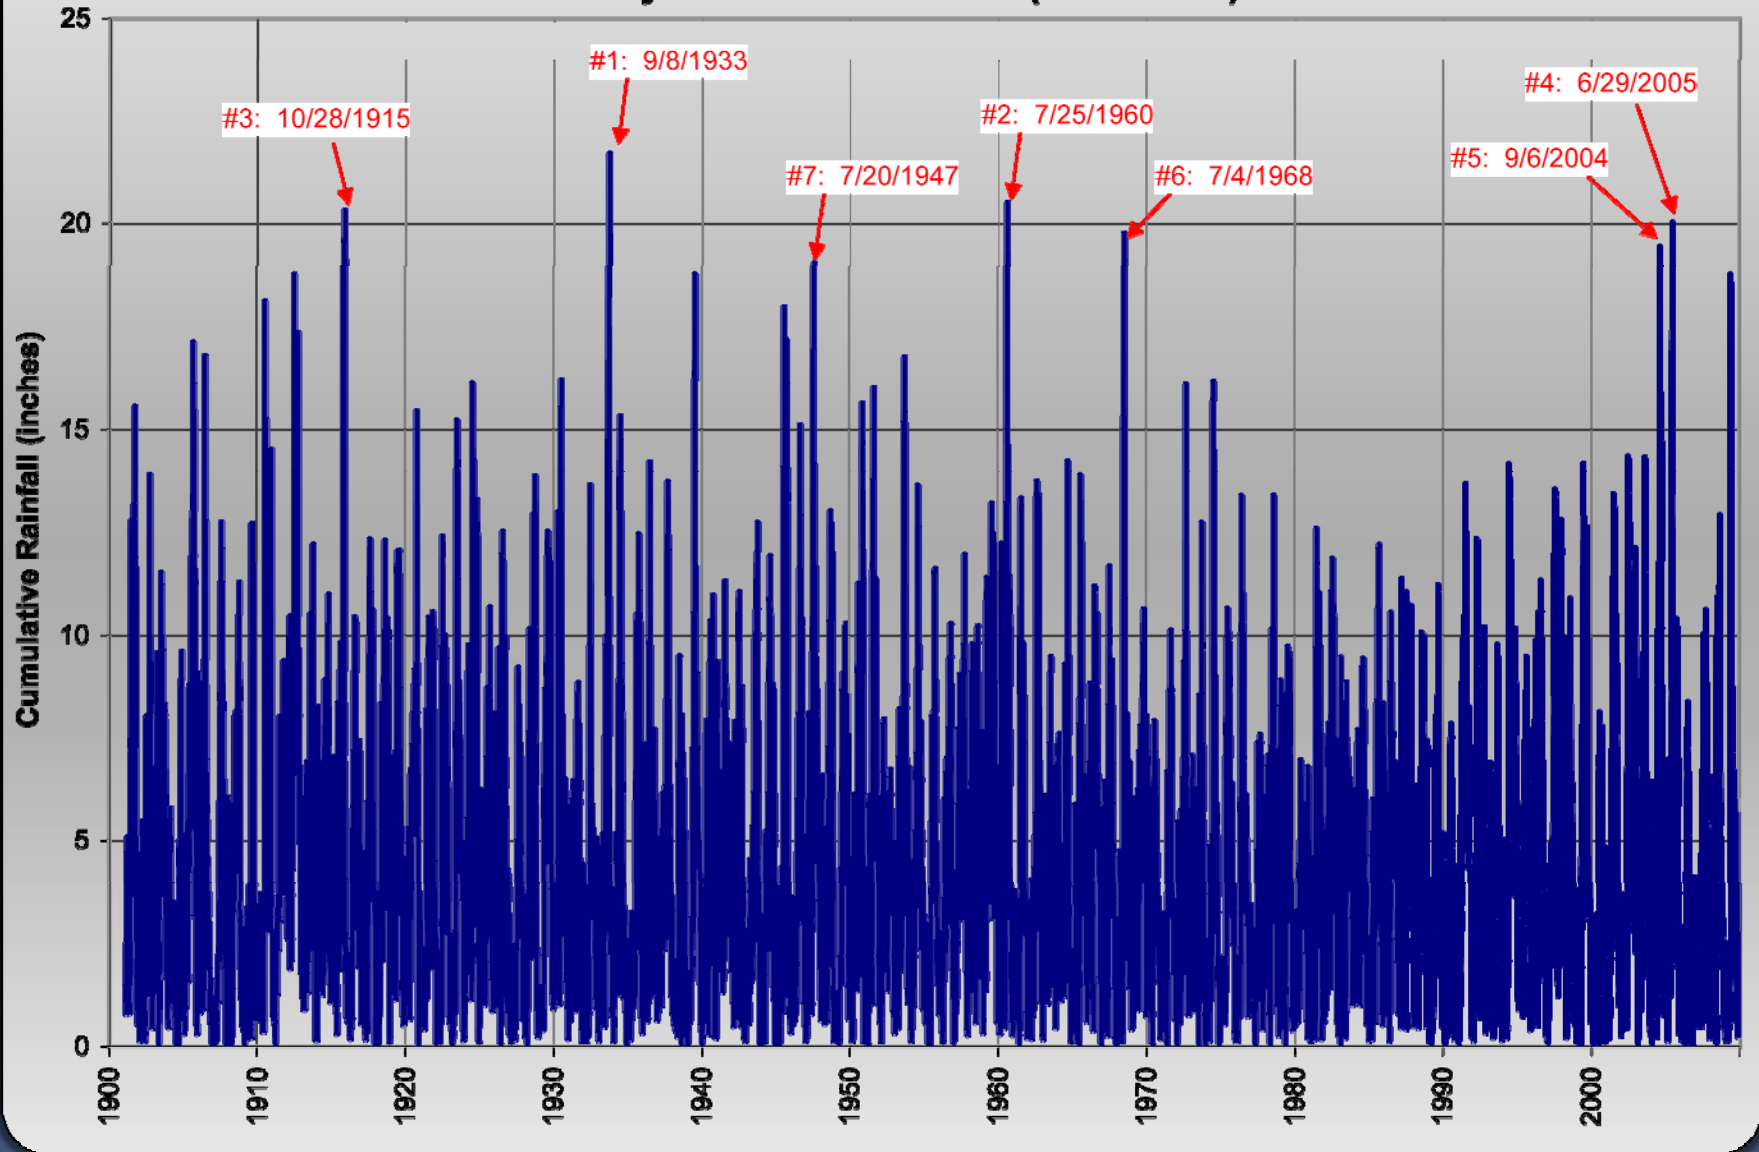
31 Day Antecedent Rainfall (ORLANDO)

Orlando Rainfall Peaks Coincide with Active Drainage well Construction – Monthly Peaks

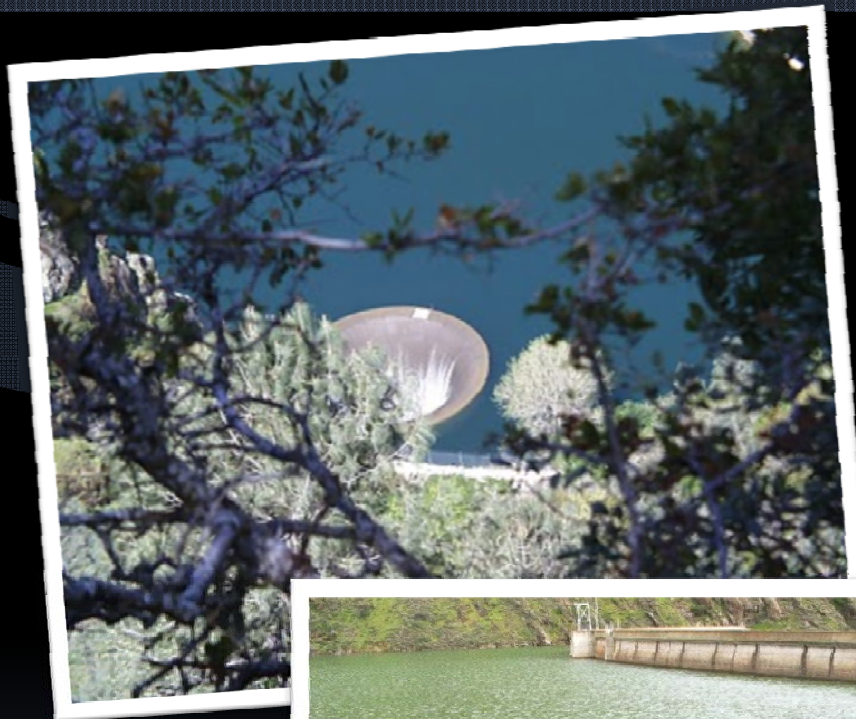
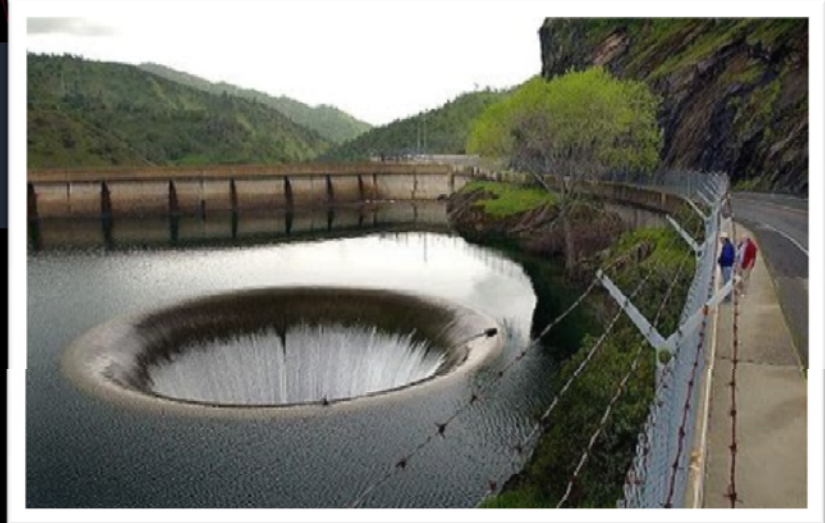
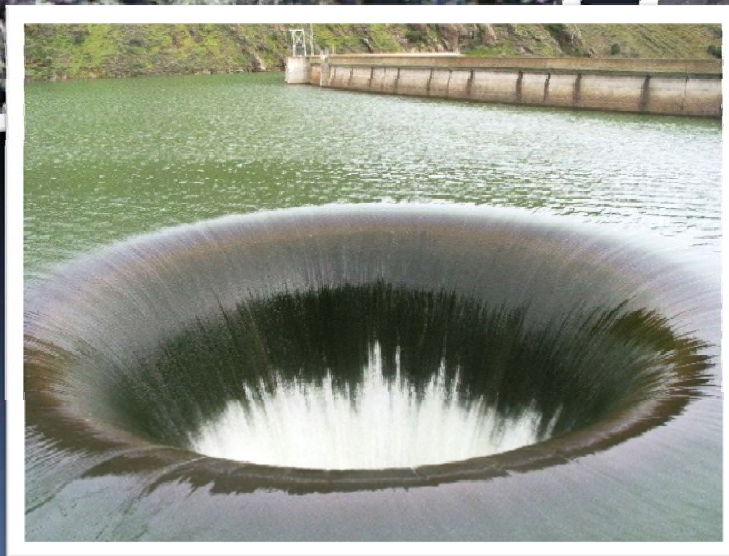
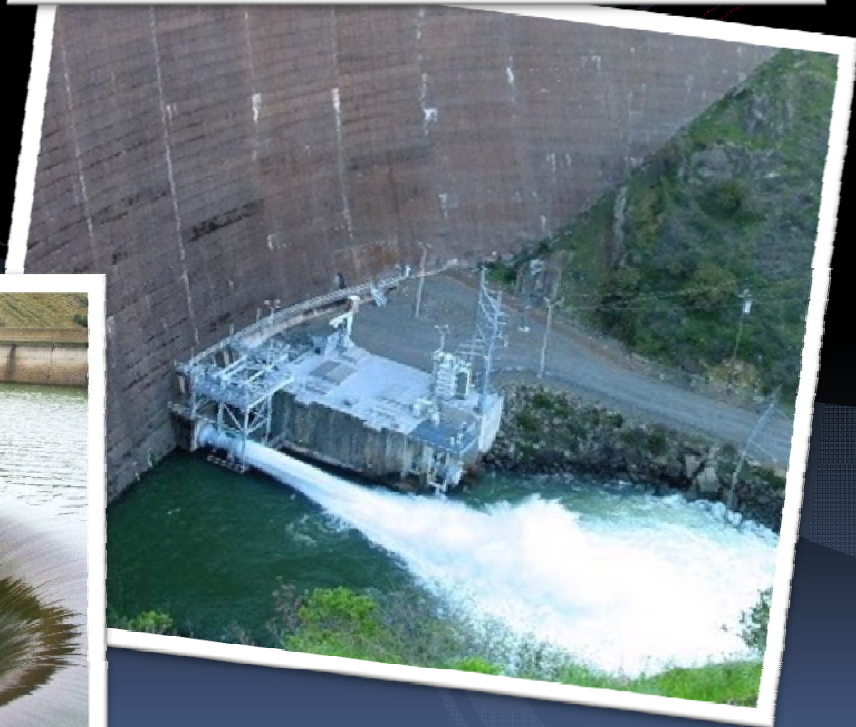
View of Morning Glory Spillway

Values of Theoretical Acceptance Rates for Drainage Wells (Morning Glory Hydraulics):

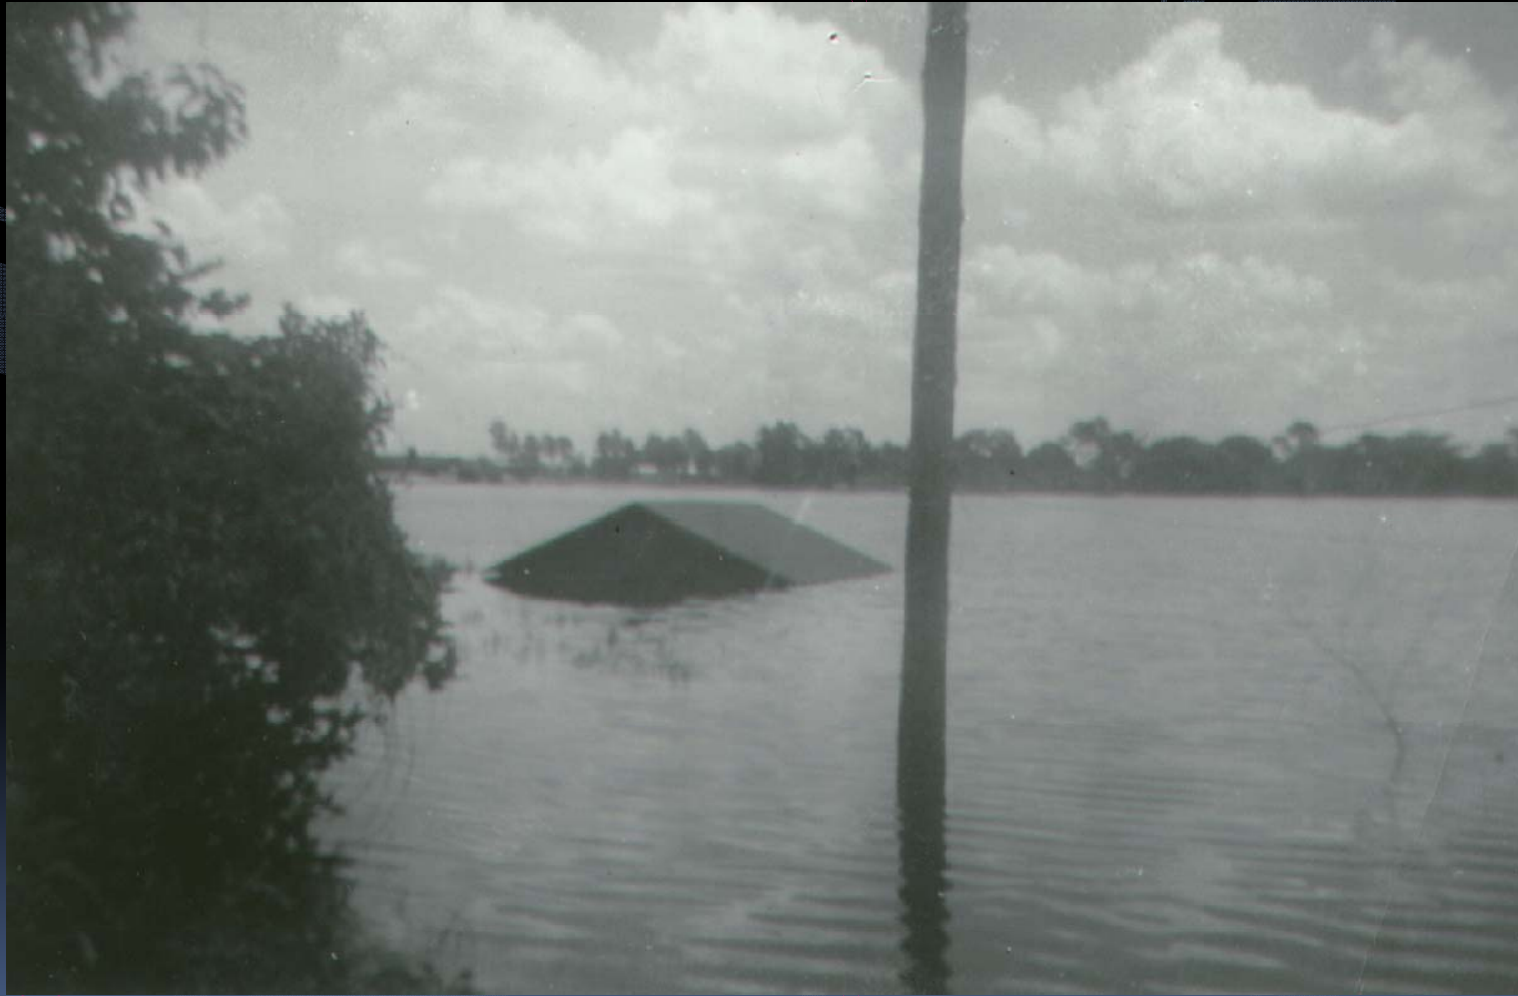
Lake Johio (lake contamination)

Pump House on Barnett Property During High Water Stage A Few Days Before Hurricane Donna in 1960 - Source: Ms. Pat Barnett

- **1998:** Lake Johio (Ocoee) - during high flow following El Nino storms in 1998, there was lake debris entering the well and impacting nearby residential wells. The subject drainwell was apparently blocked by Orange County sometime in the past (prior to 1980) due to complaints of "muddy water" from the nearby residents. The fitting that was used to block the flow into the drainwell apparently deteriorated and the well started flowing when the El-Nino rains hit early in 1998. complaints of air, lake vegetation debris, etc. the problem did not occur during low flow conditions or when a bleed-down was installed.

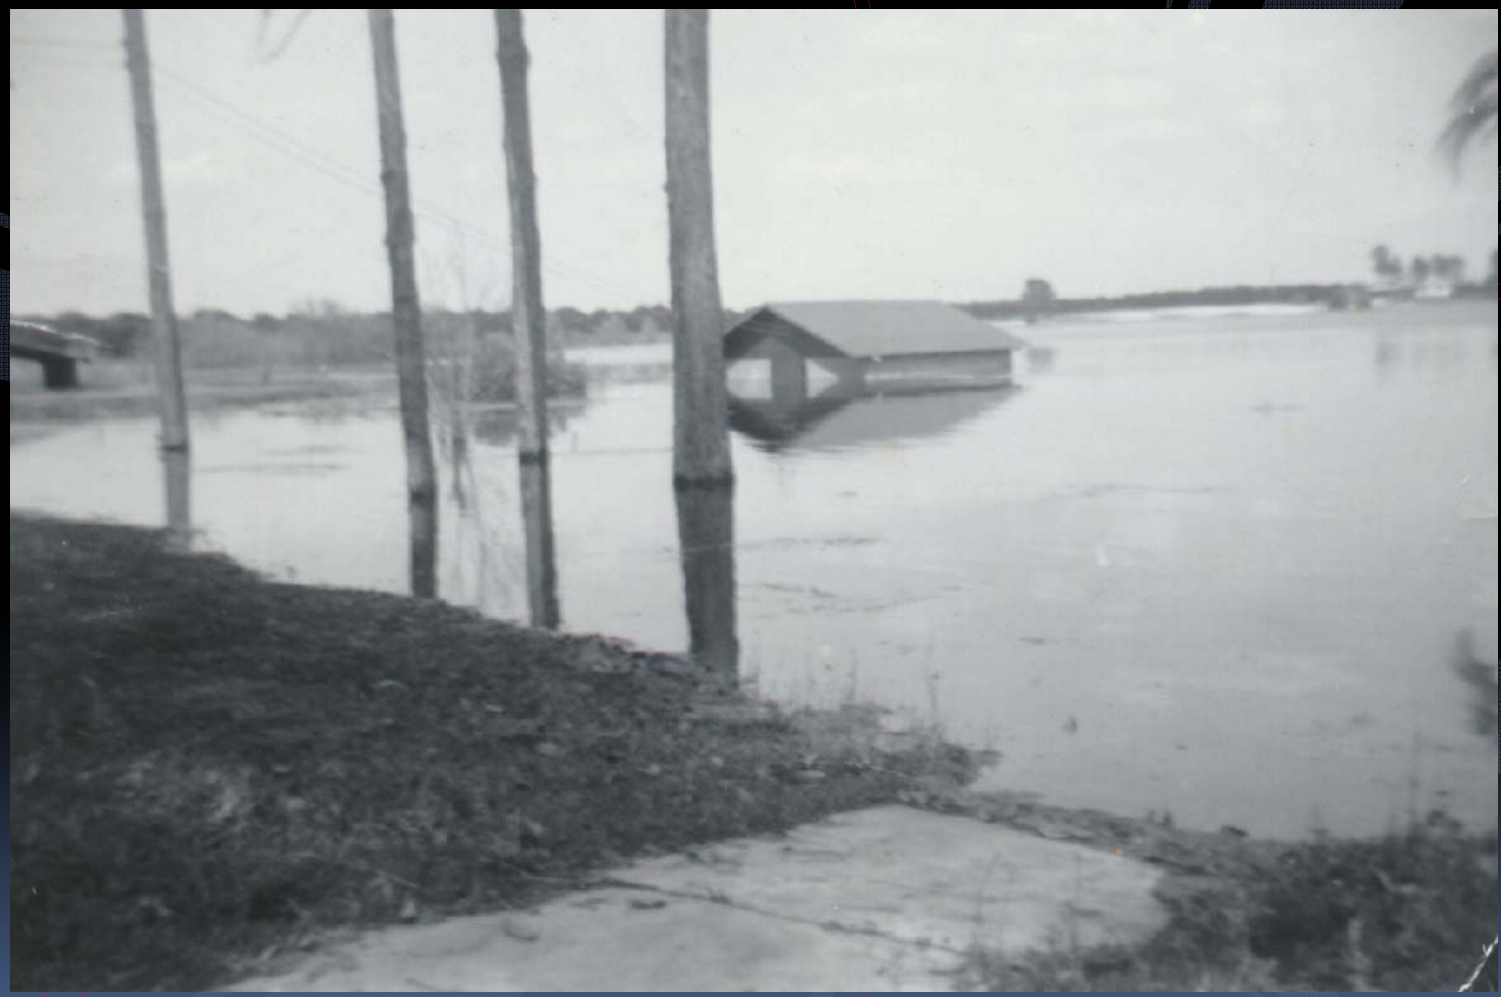
Lake Johio (lake contamination)

Pump House on Barnett Property During High Water Stage (Not Peak) A Few Days Before Hurricane Donna in 1960 - Source: Ms. Pat Barnett

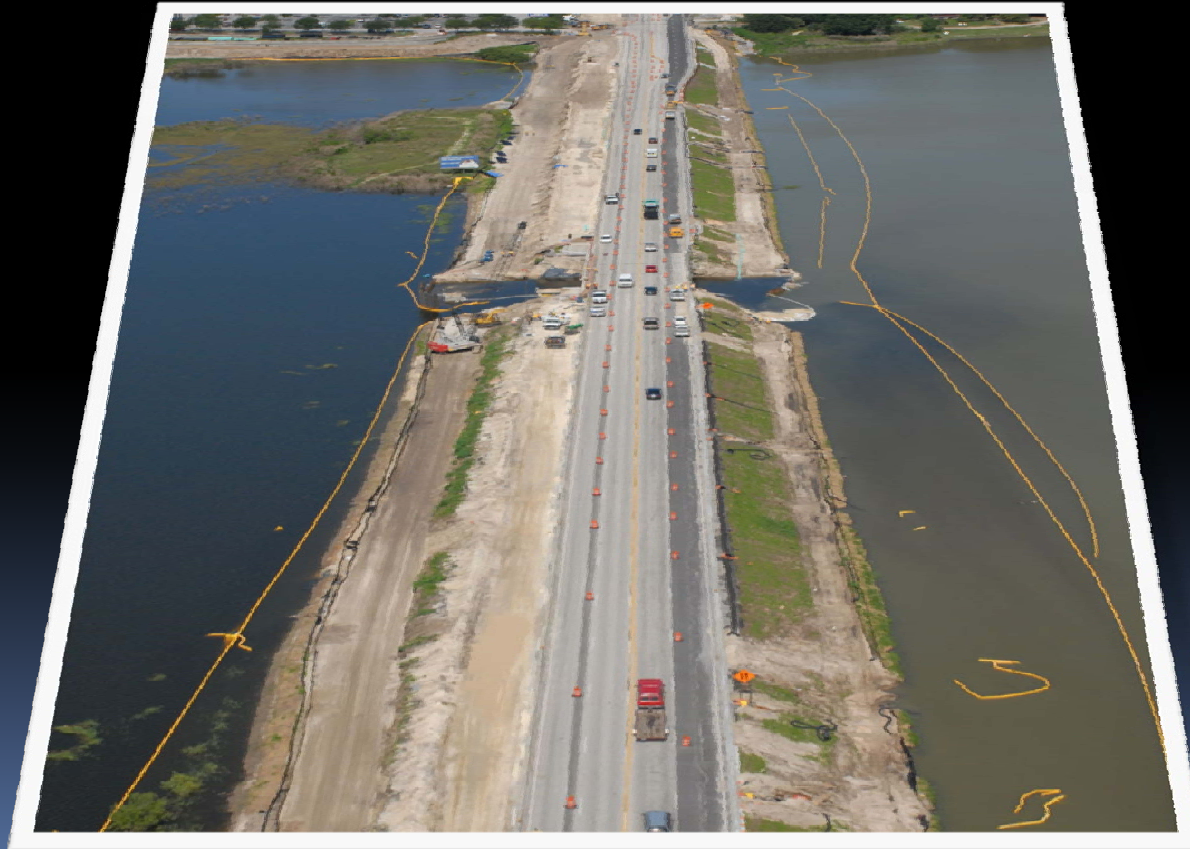
Lake Sherwood's Watershed Limits

Following the 2004 Hurricanes, the lake level rose again and an emergency permit from the FDEP was sought and approved to replace this well since it was in a difficult location to maintain and there was evidence of holes in the well casing. The 24-inch diameter well was replaced with four (4) 12-inch diameter wells at a location approximately 2,500 feet southeast of the existing well.

These replacement wells came online in July 2005.

The replacement wells were tested during the storm of May 2009 (i.e., Gulf Gale).

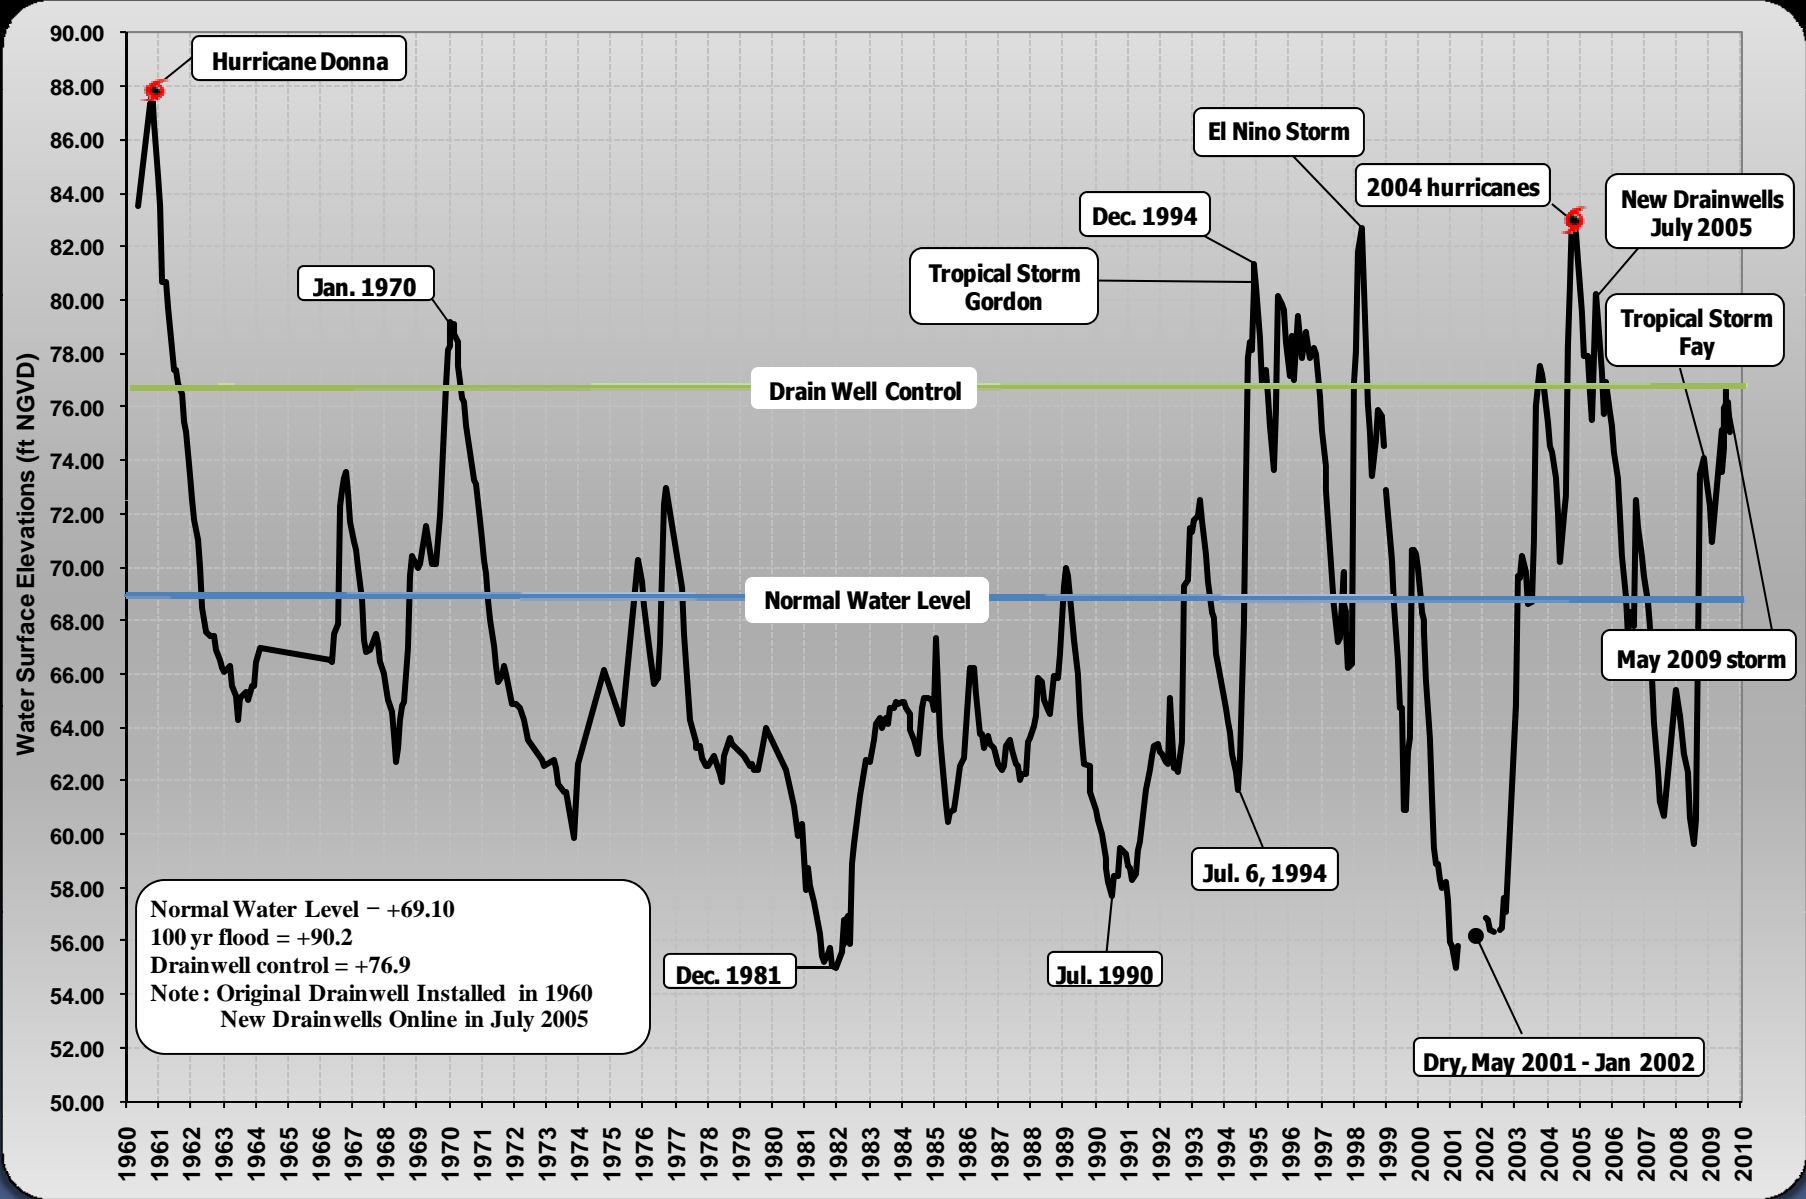
Lake Sherwood - Lake Level Plot (1960 to Sept 2009)

The lake level rose 6 ft over the 3 days May 19 to May 21 and caused a cofferdam failure which led to the shut down of a lane on State Road 50 due to undermining.

The wells kicked in and performed a remarkable job of controlling the lake level. see video and chart.

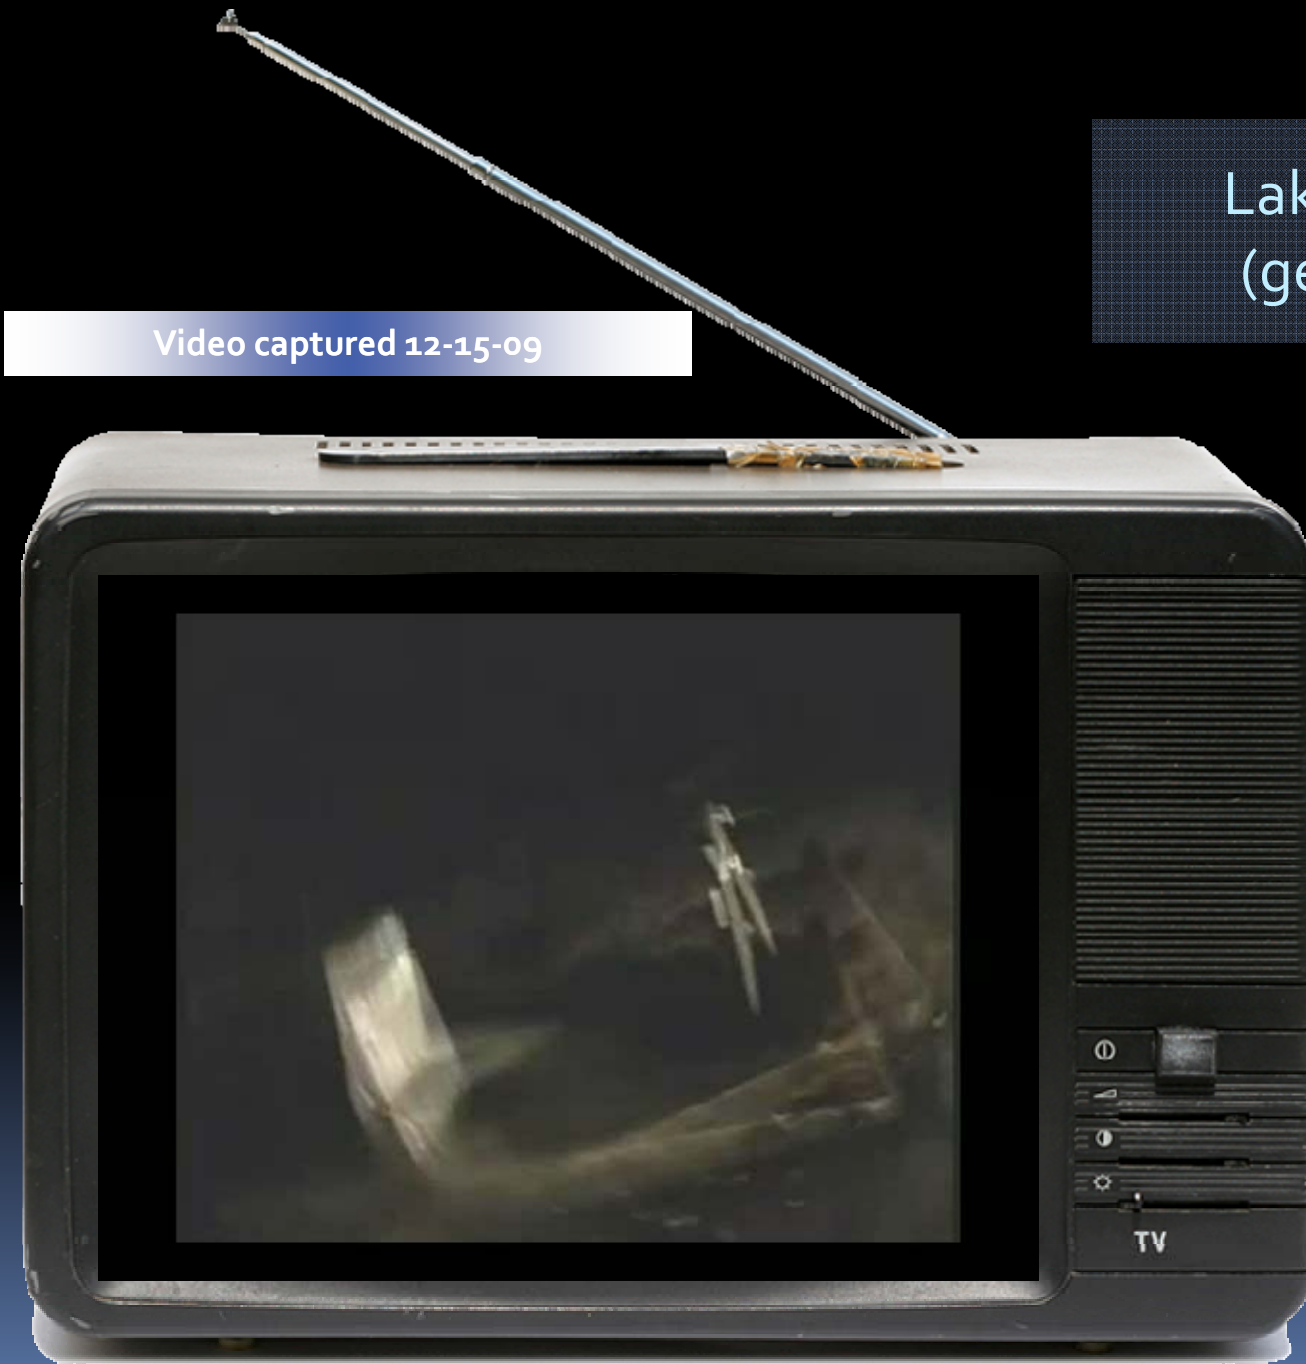
Lake Holden (geysering)

Video captured 12-15-09

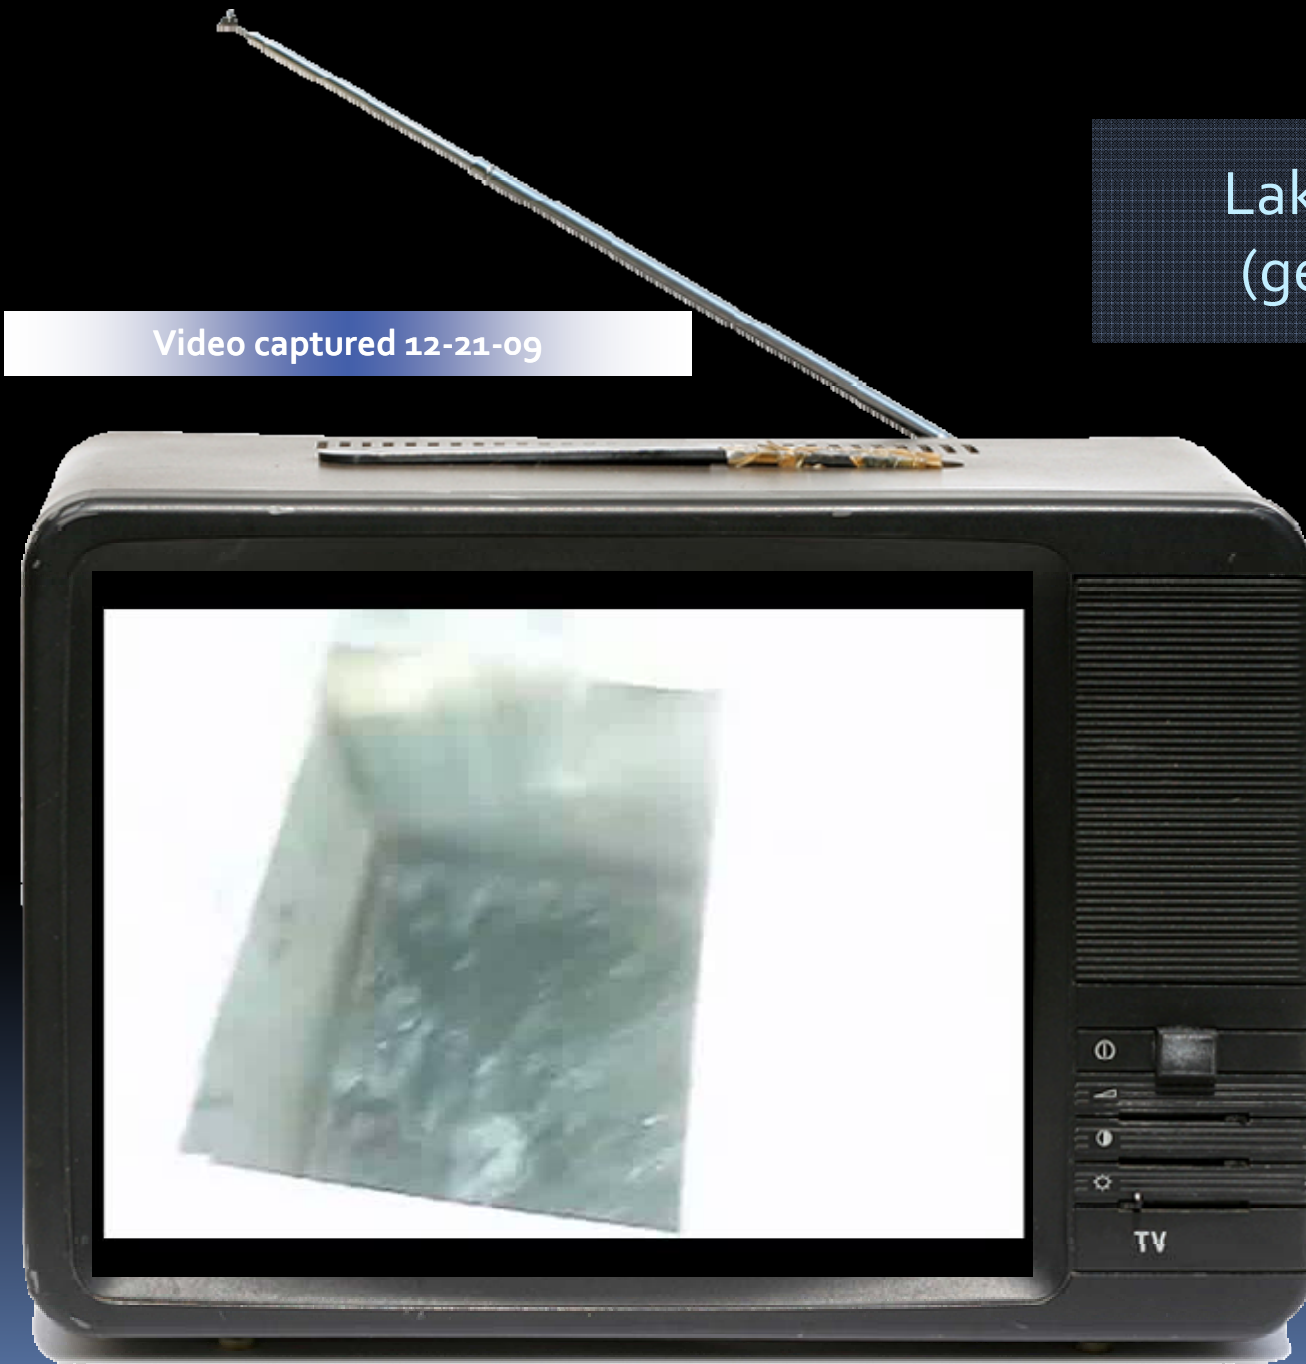
Lake Holden
(geysering)

Video captured 12-21-09

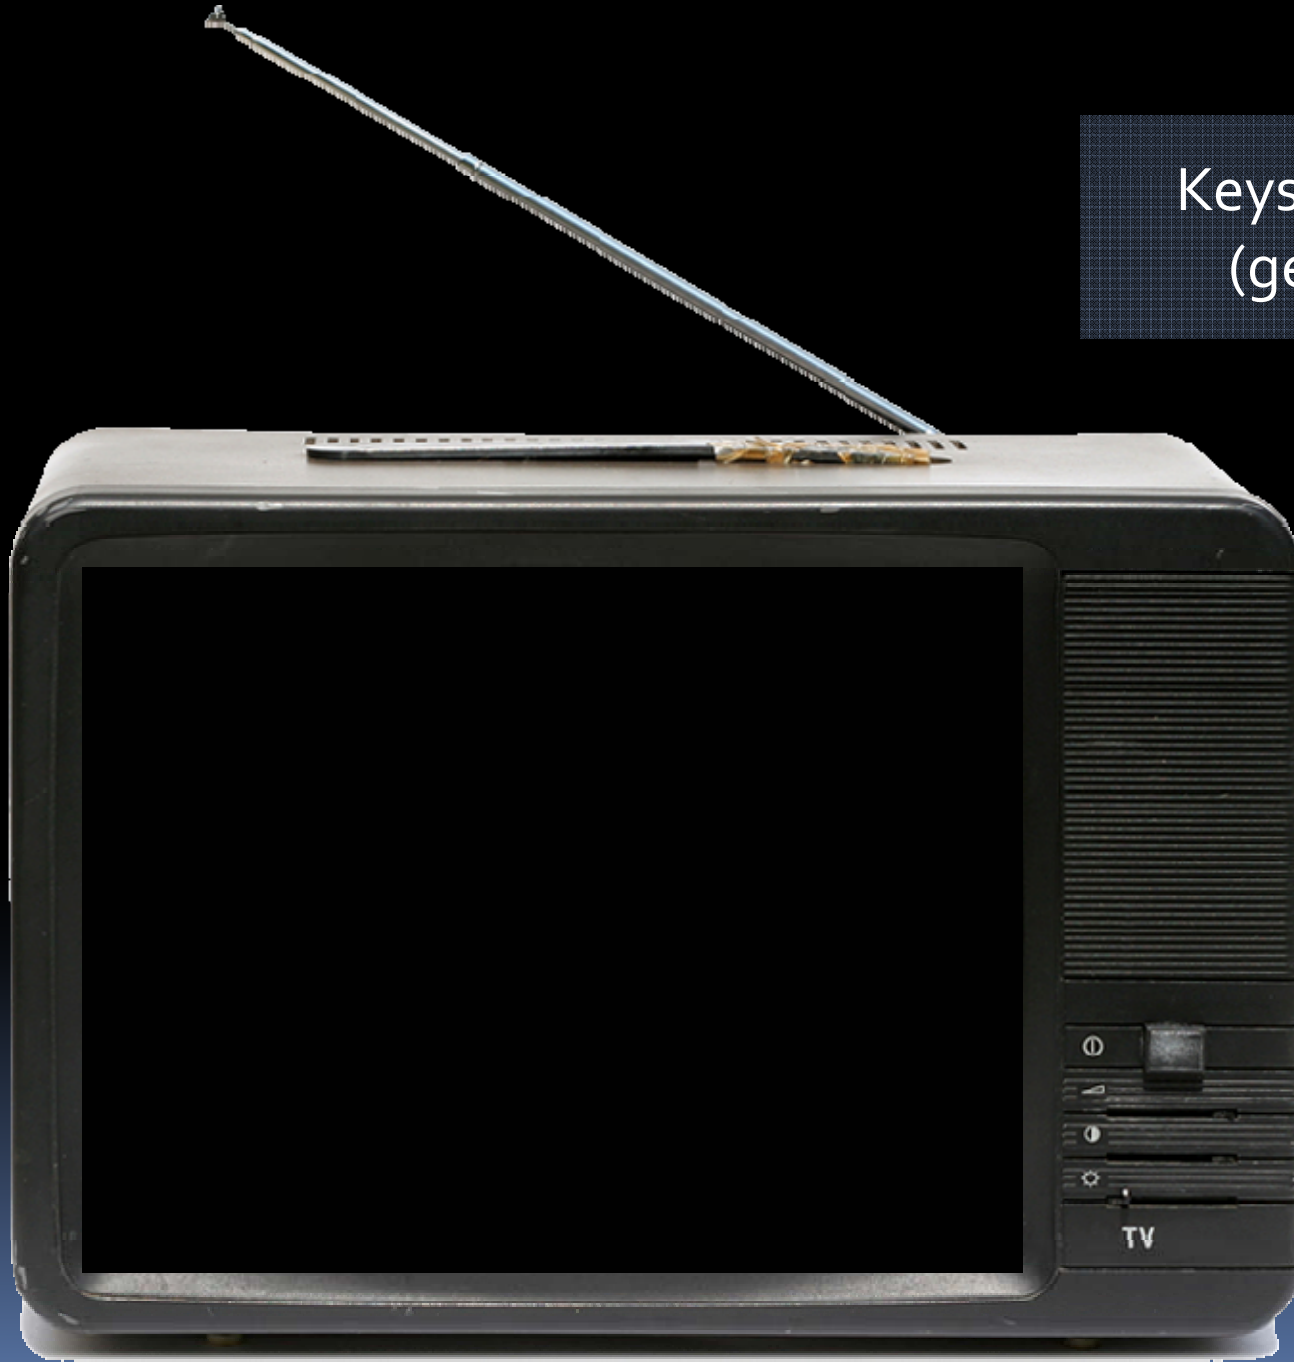
Case Study # 4
Keystone Drive/
Lake Pineloch
(Geysering)

Keystone Drive
(geysering)
