ORANGE COUNTY'S FLORIDAN AQUIFER DRAINAGE WELLS

Recent Experience & Proactive Rehabilitation Program

Water Resources
Technical Group
Luncheon

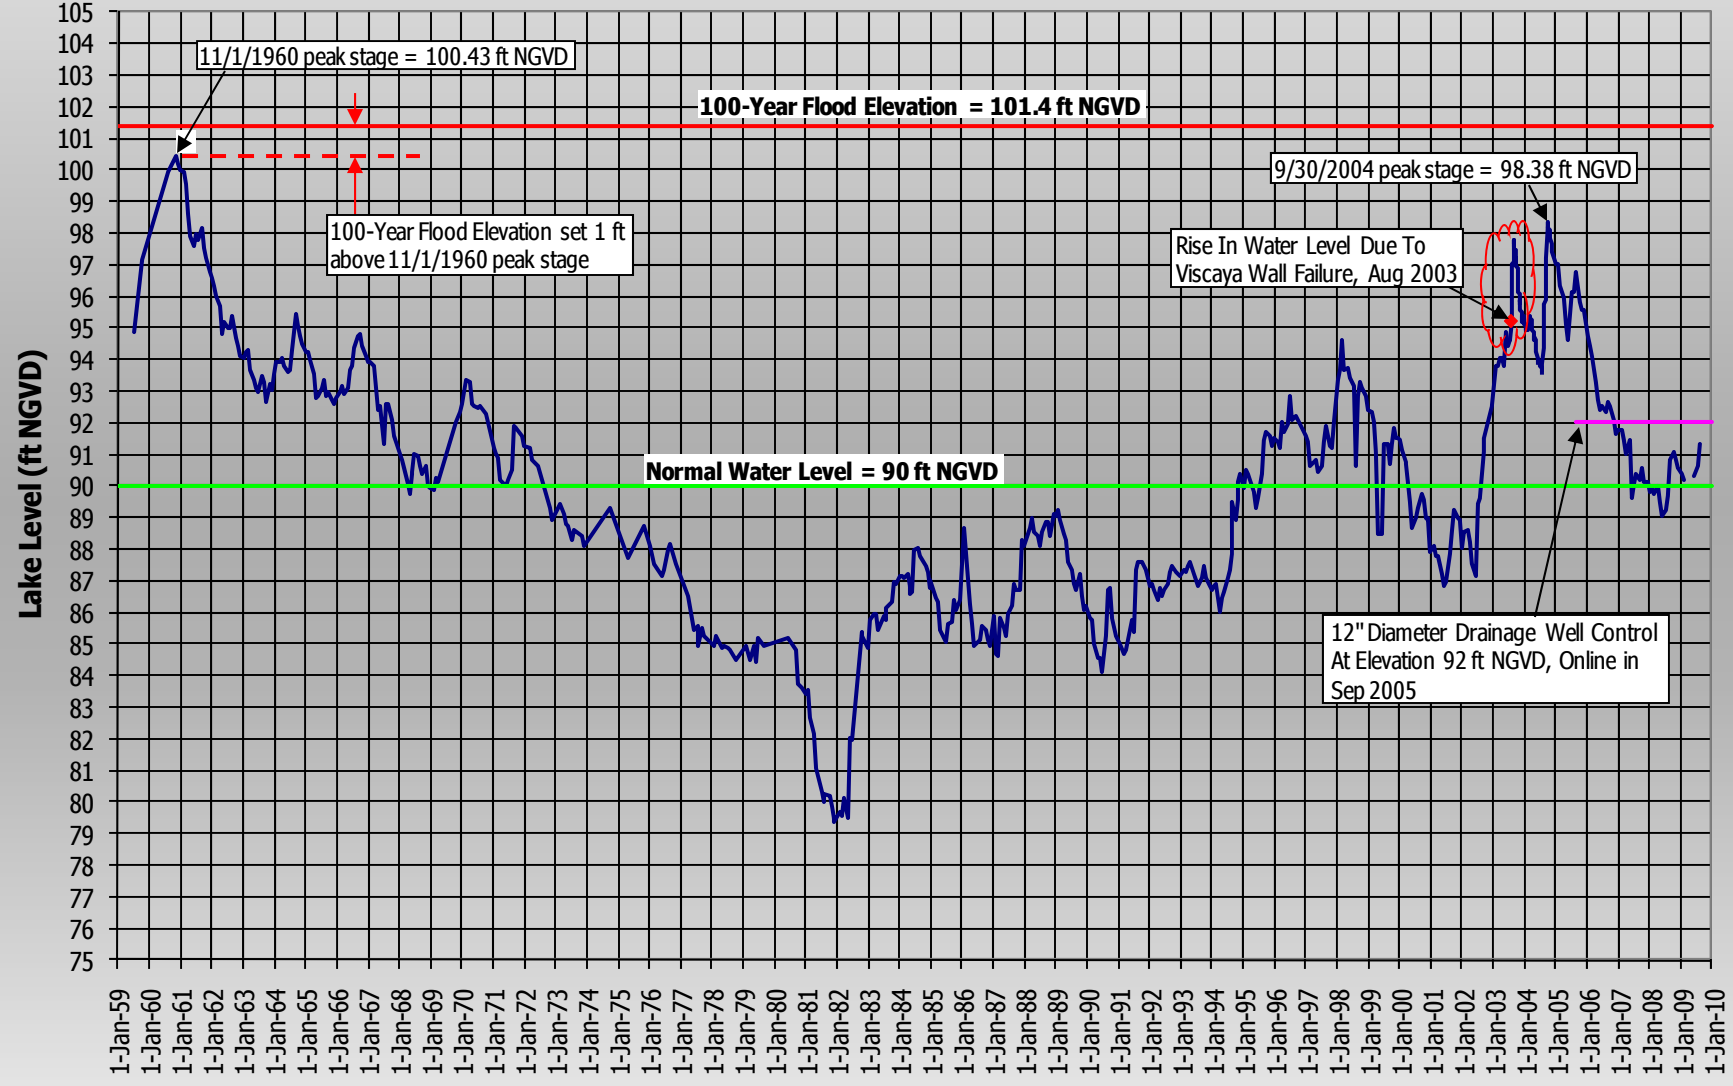
Lake Level For Big Sand Lake (7/1/1959 to 8/19/2009)

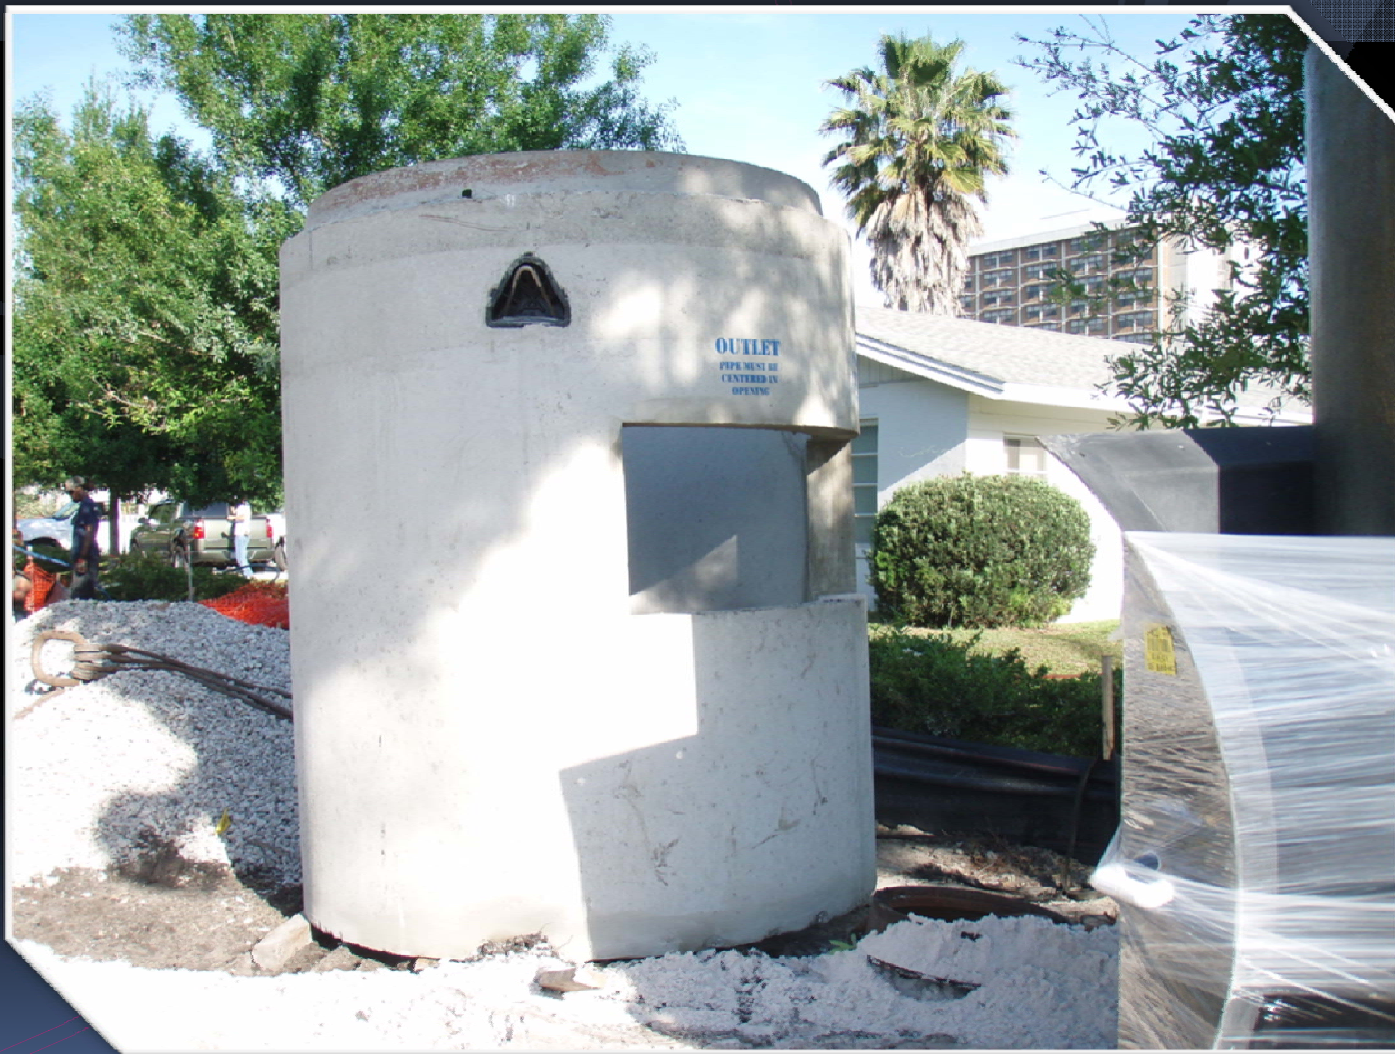
Example of Street Level Control Well – Clay St. (1 of 4)

Clay Street - CDS stormwater treatment unit prior to installation.

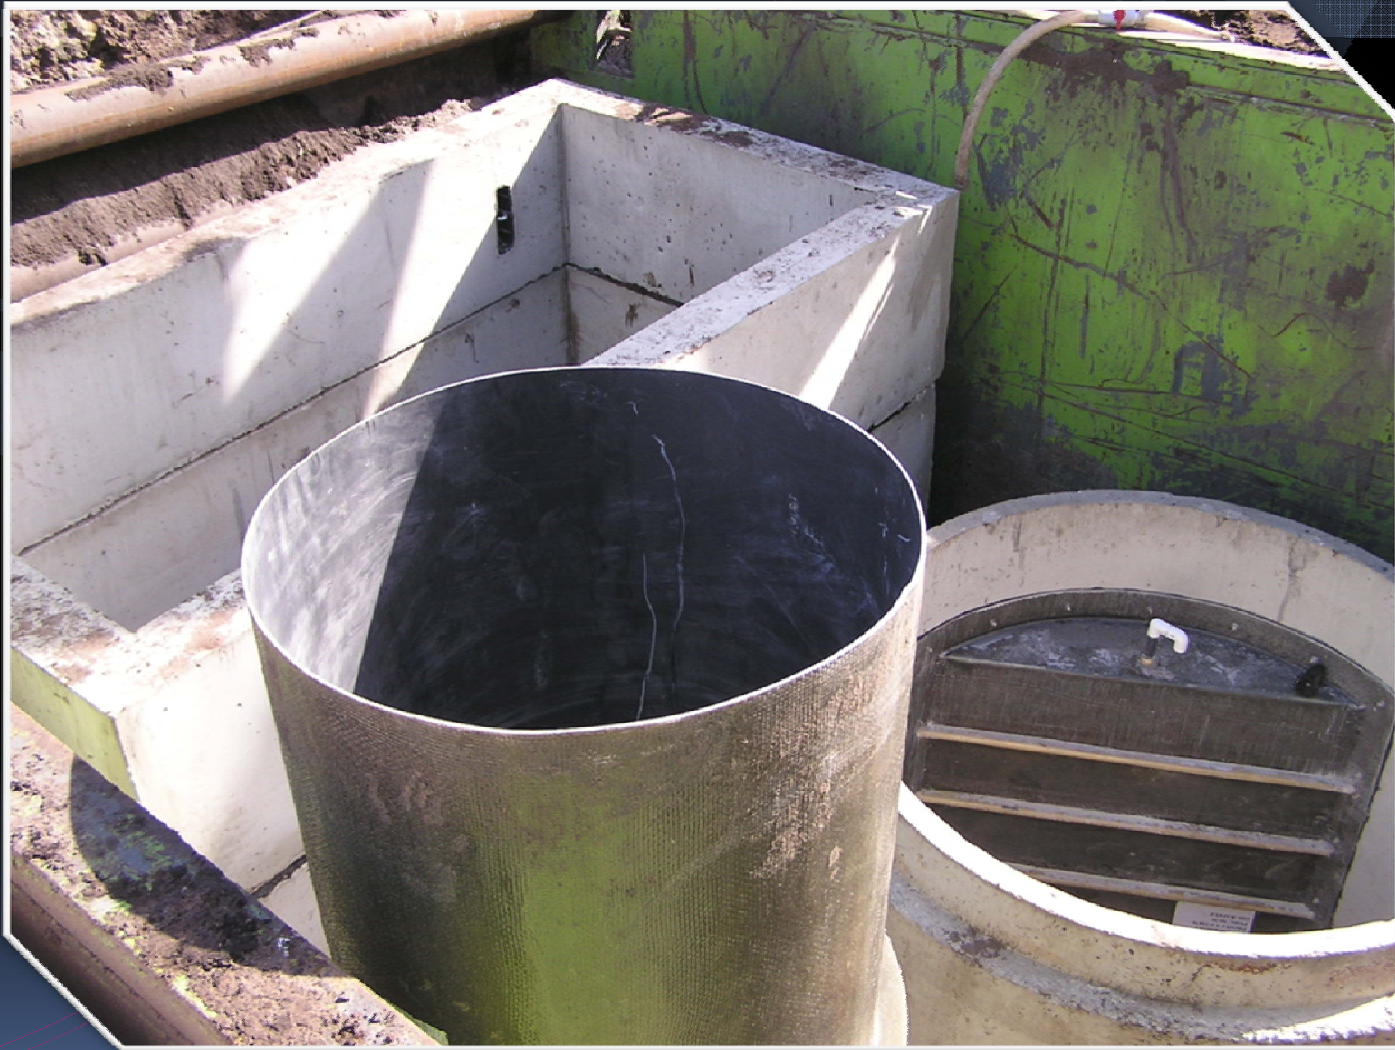
Example of Street Level Control Well – Clay St. (2 of 4)

Clay Street - Additional view of CDS and drainage well structures.

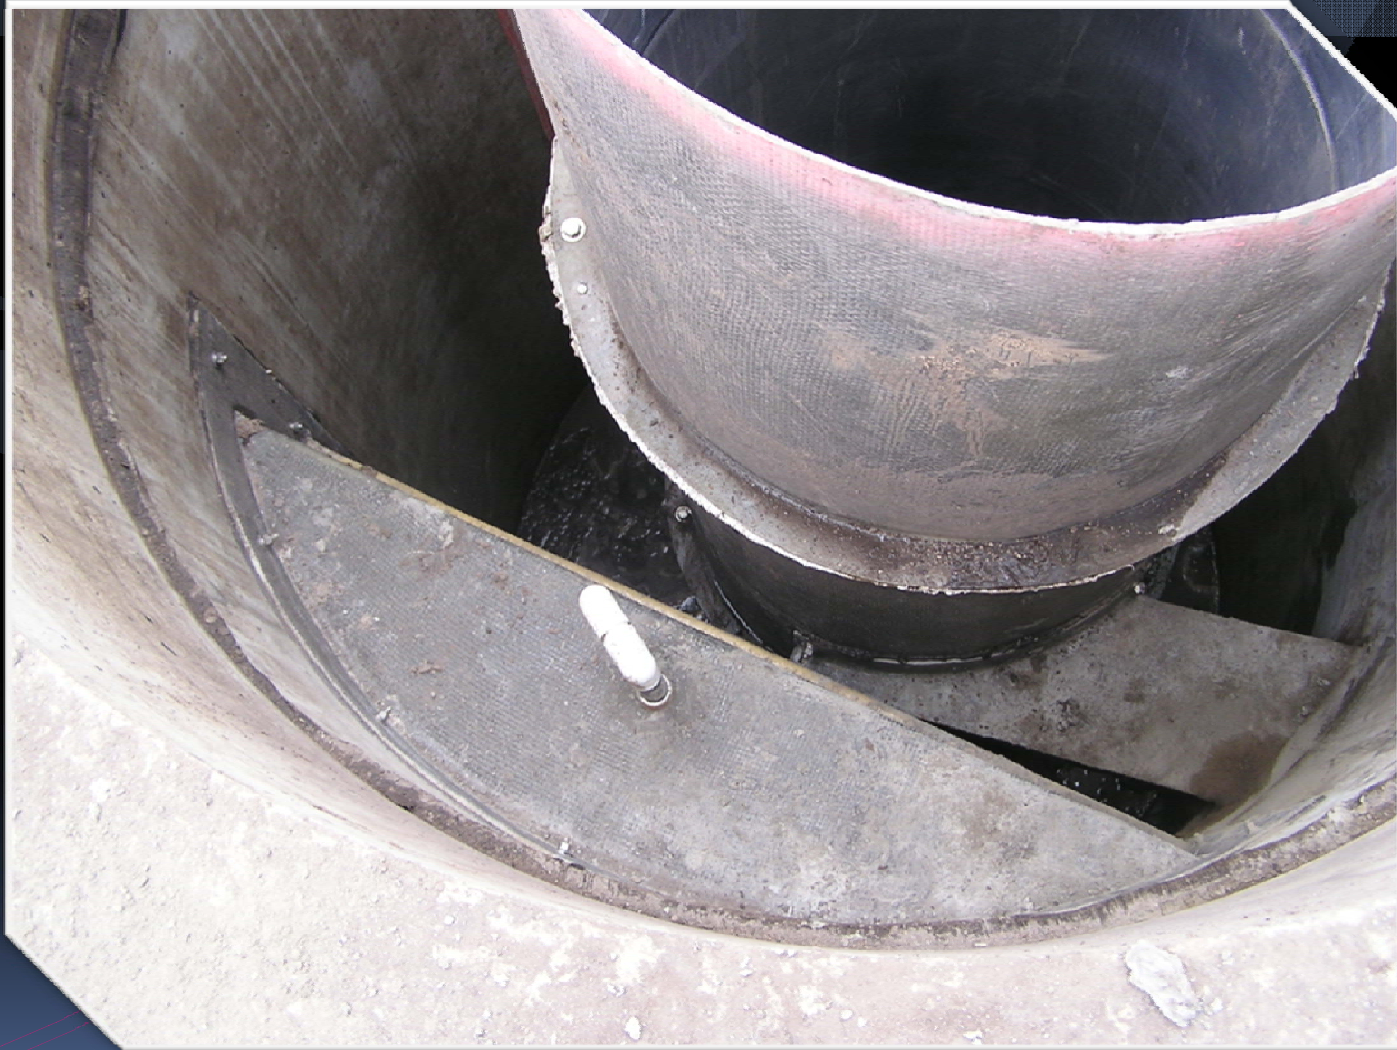
Example of Street Level Control Well – Clay St. (3 of 4)

Clay Street - Oil baffle and separation screen within CDS structure.

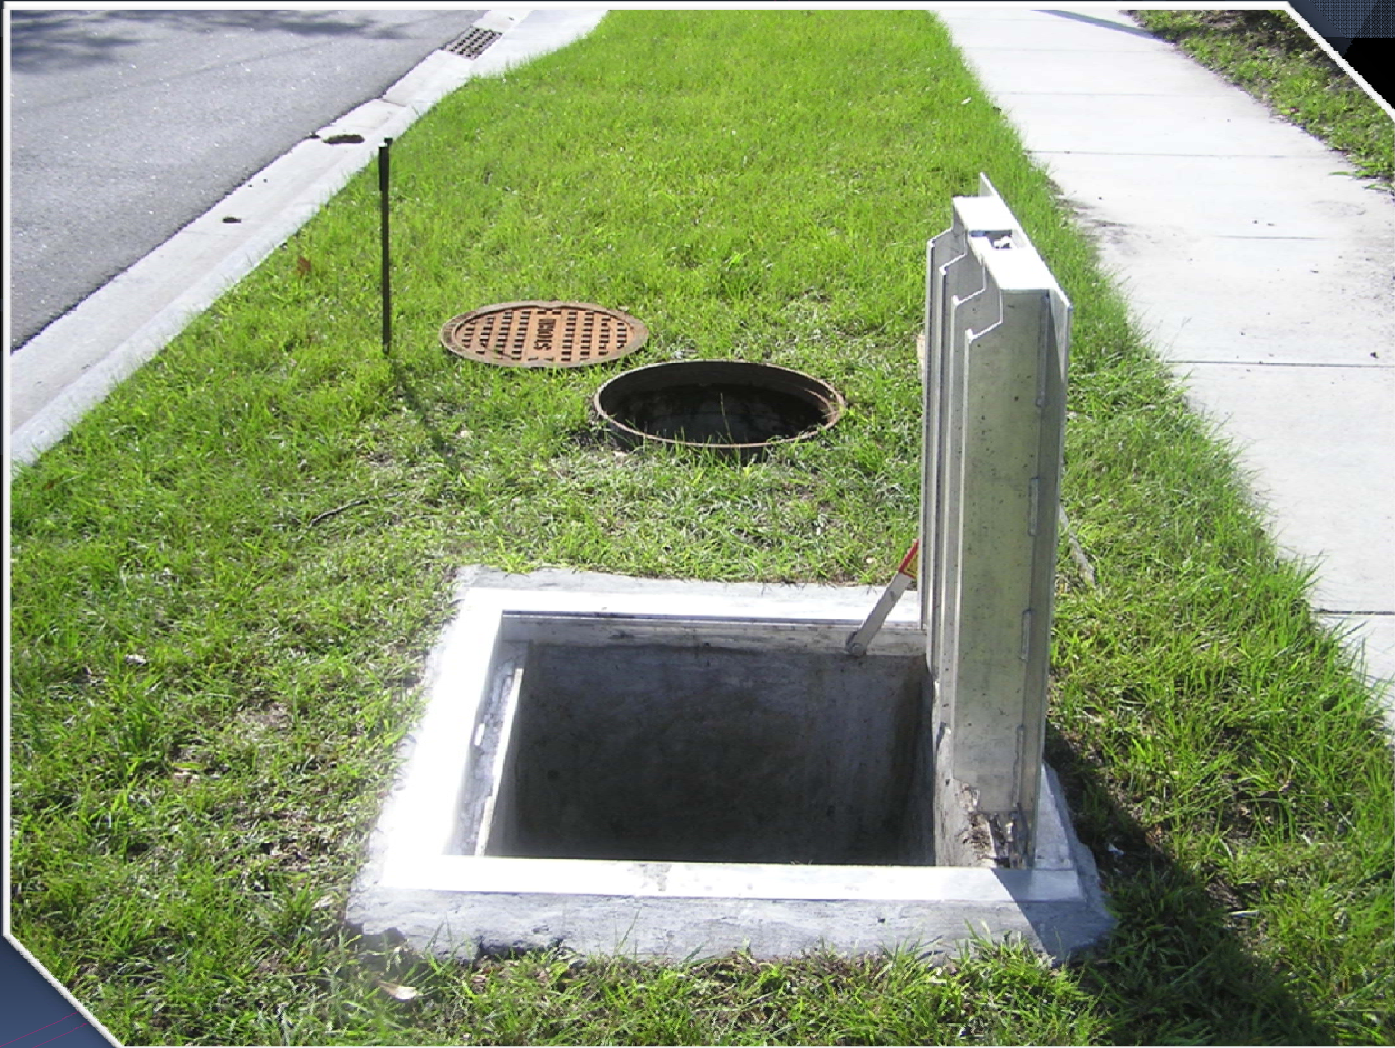
Example of Street Level Control Well – Clay St. (4 of 4)

Clay Street - Access hatch and manhole cover for drainage well and weir structure.

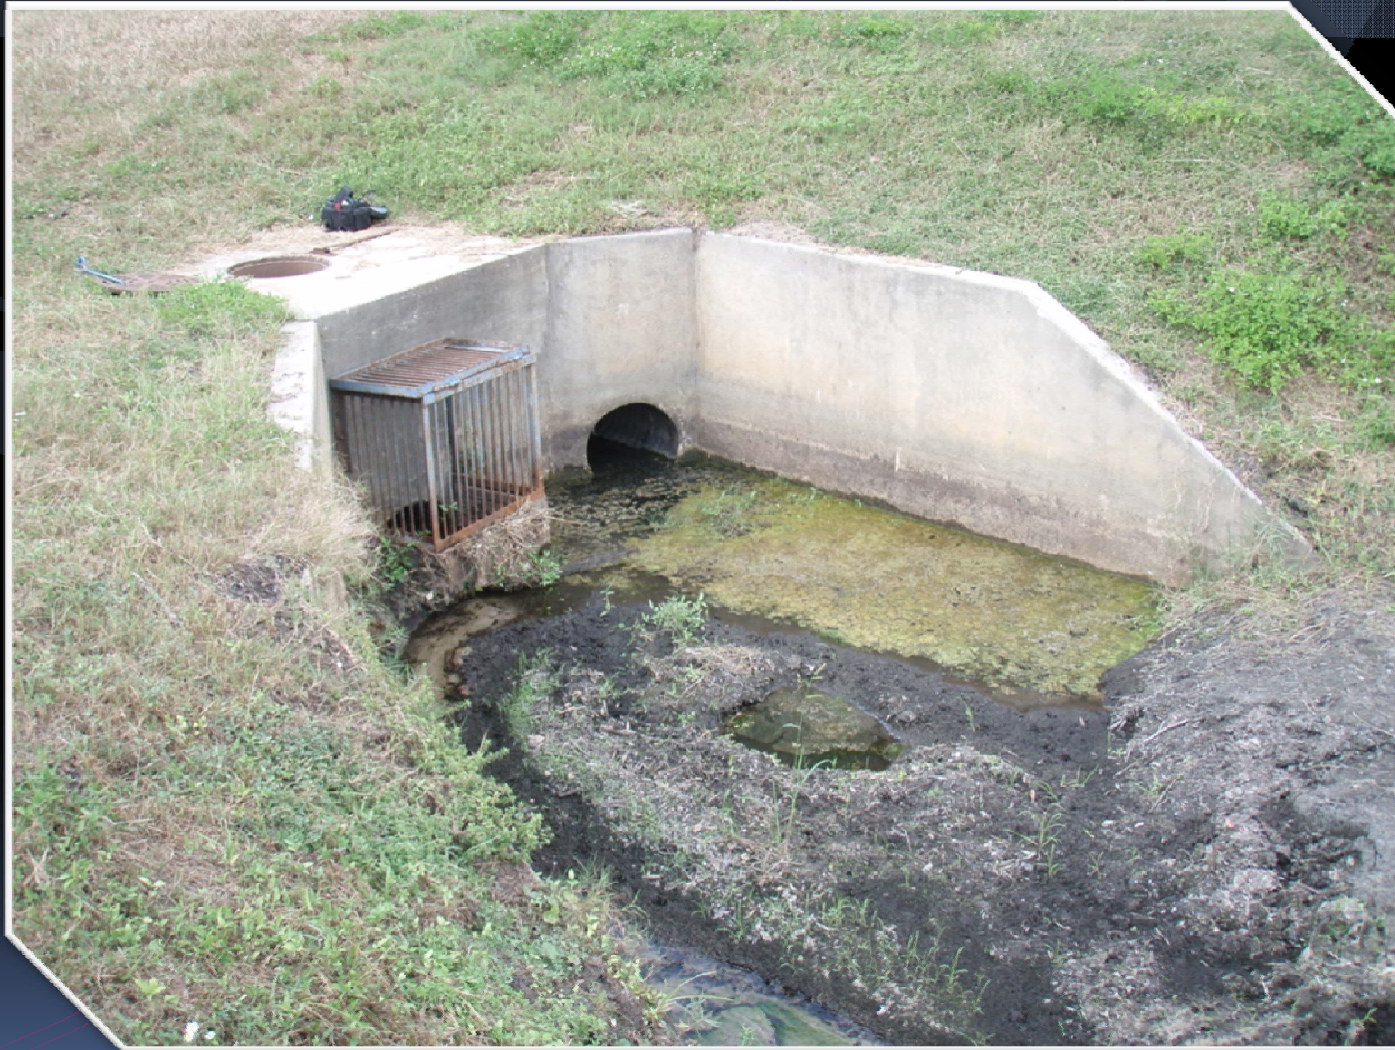
Example of Canal Level Control Well – Goddard Ave. (1 of 5)

Goddard Avenue - Old headwall structure showing well intake (L) and roadway discharge (R)

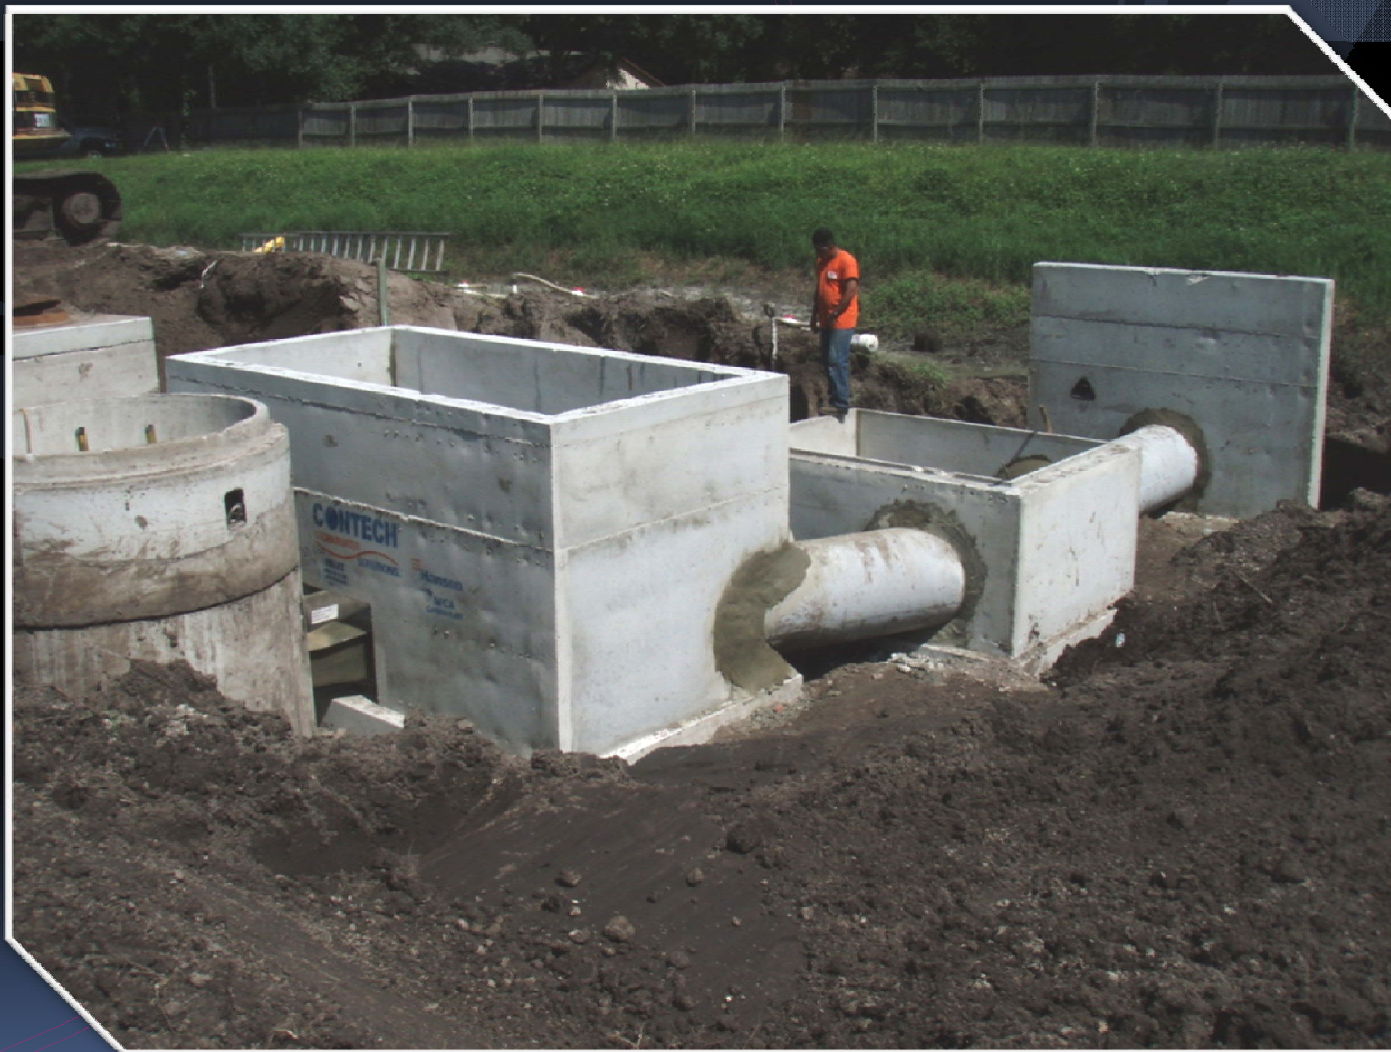
Example of Canal Level Control Well – Goddard Ave. (2 of 5)

Goddard Avenue - Structure and pipe installations prior to backfilling.

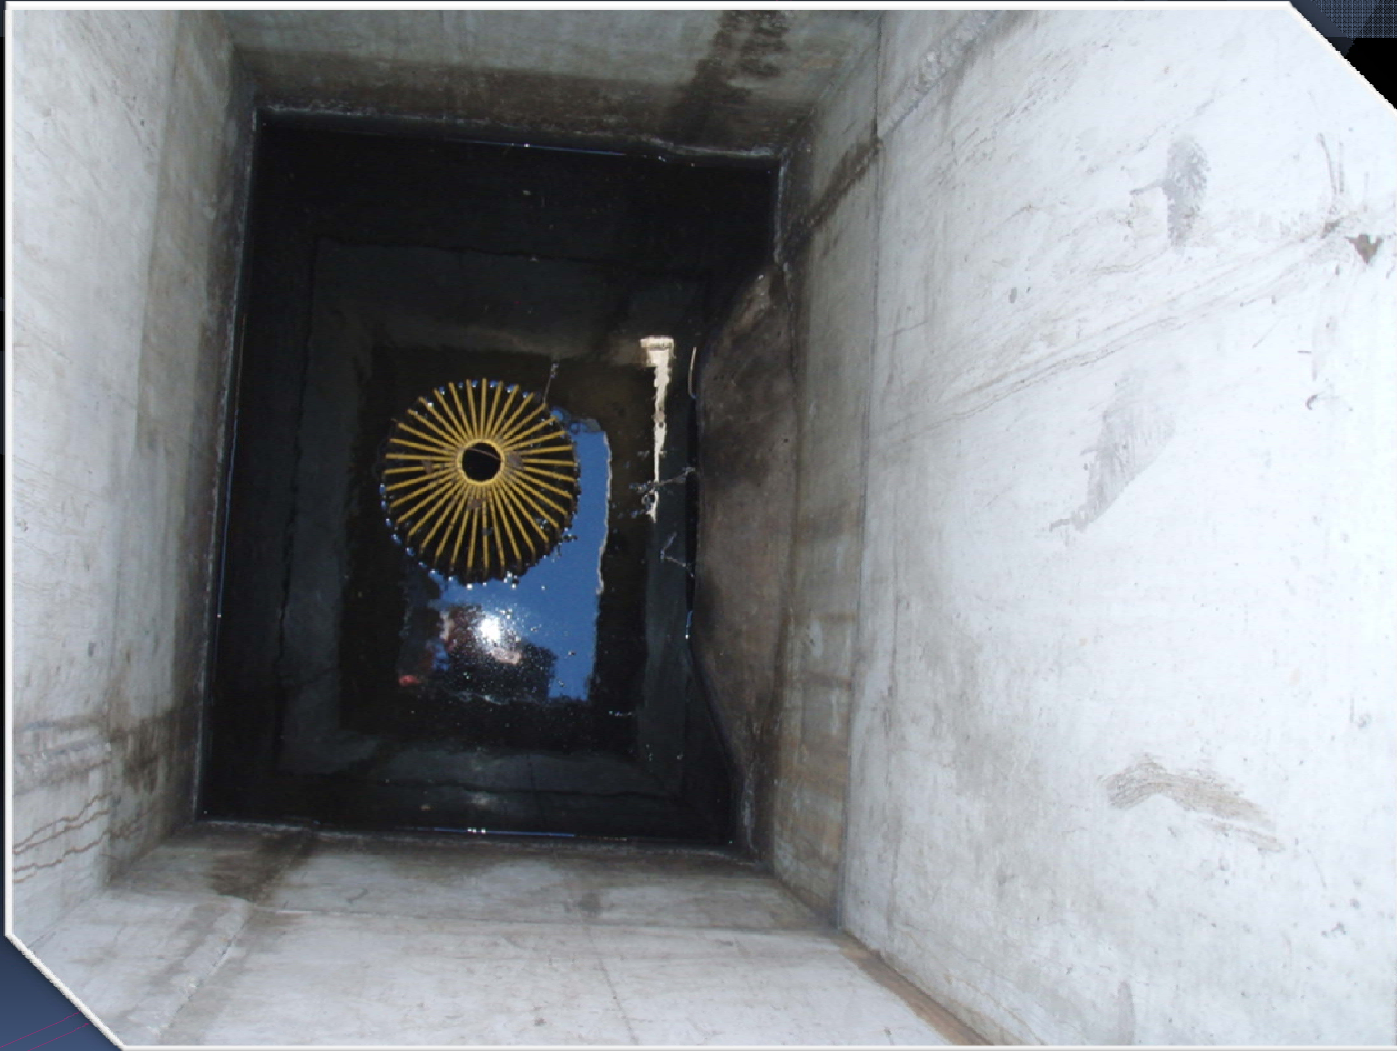
Example of Canal Level Control Well – Goddard Ave. (3 of 5)

Goddard Avenue - Interior of DW-031 well structure.

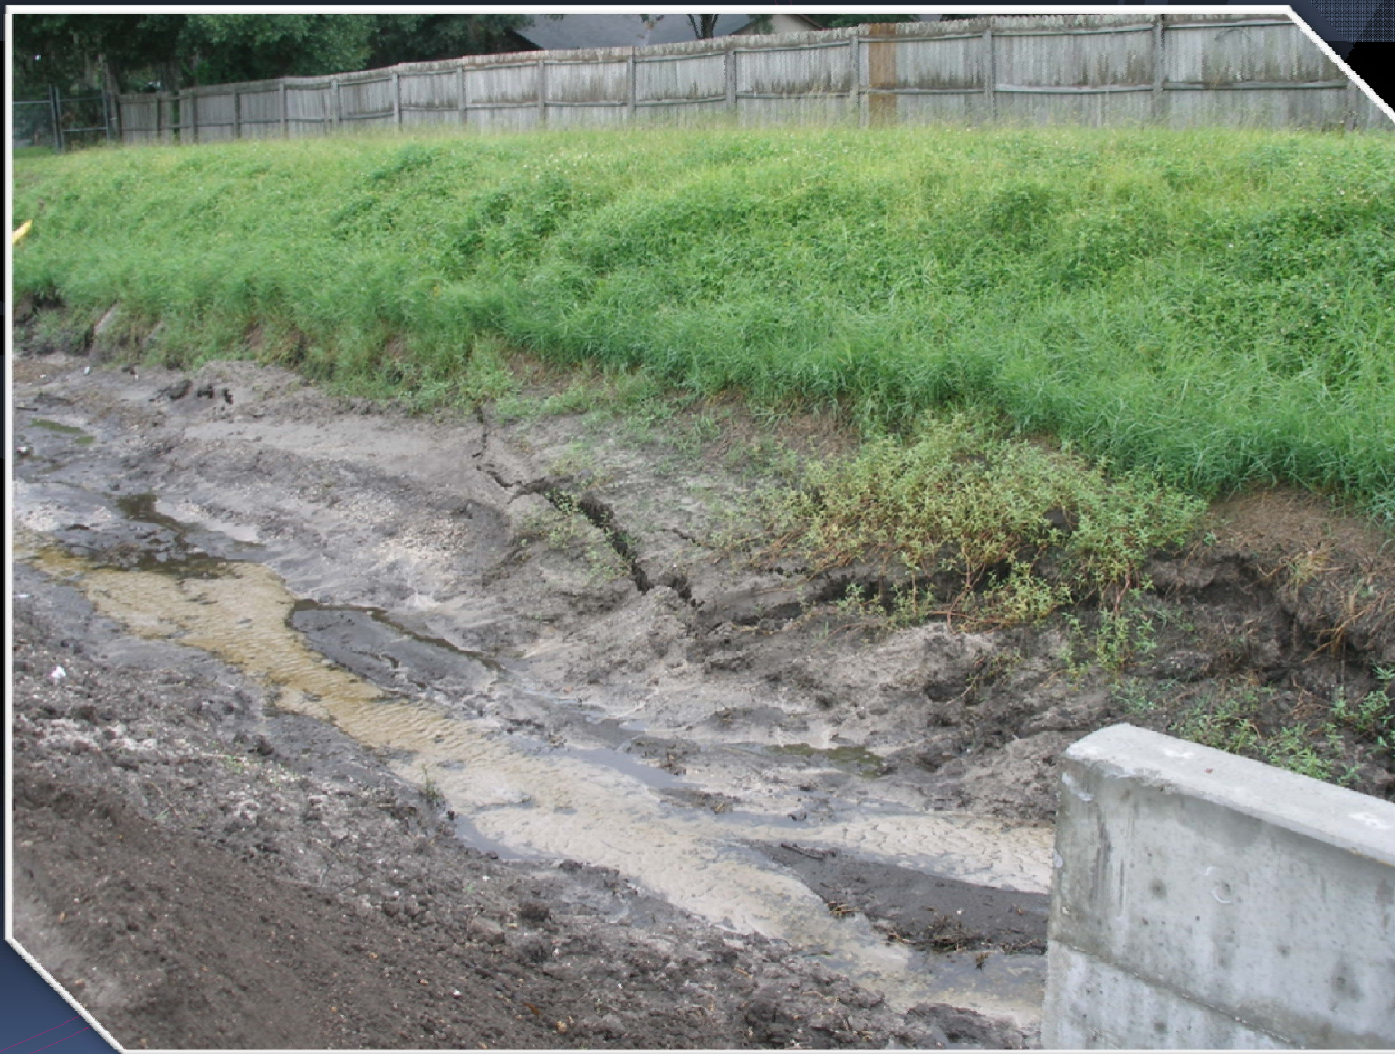
Example of Canal Level Control Well – Goddard Ave. (4 of 5)

Goddard Avenue - Unstable ditch sideslope - note soil cracking.

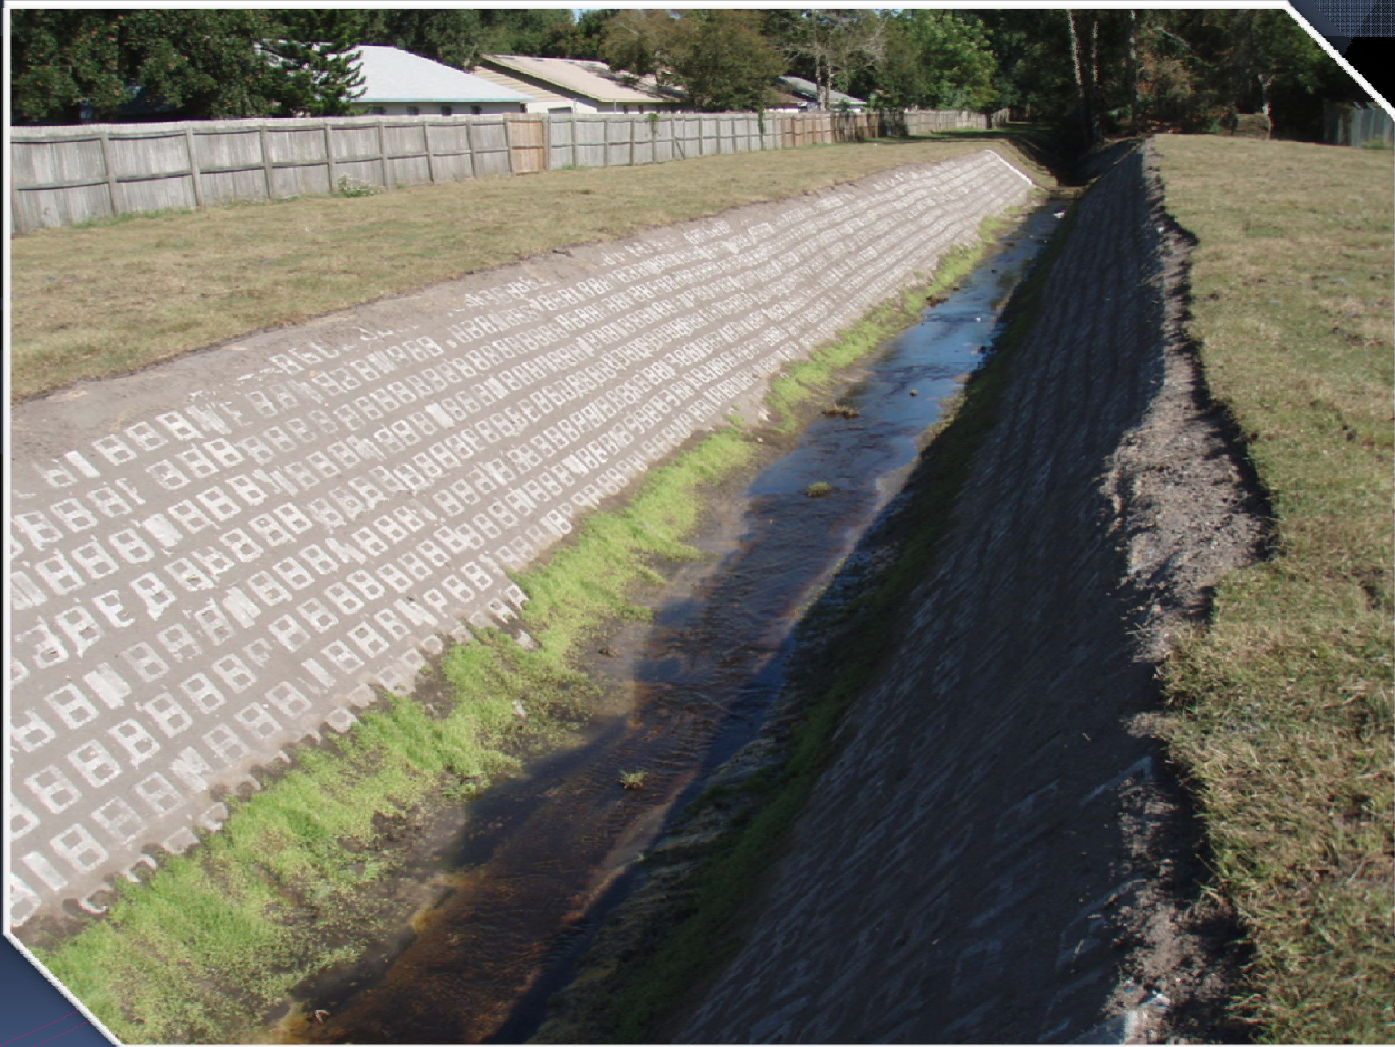
Example of Canal Level Control Well – Goddard Ave. (5 of 5)

Goddard Avenue - Cable concrete ditch enhancement installed by Orange County personnel.

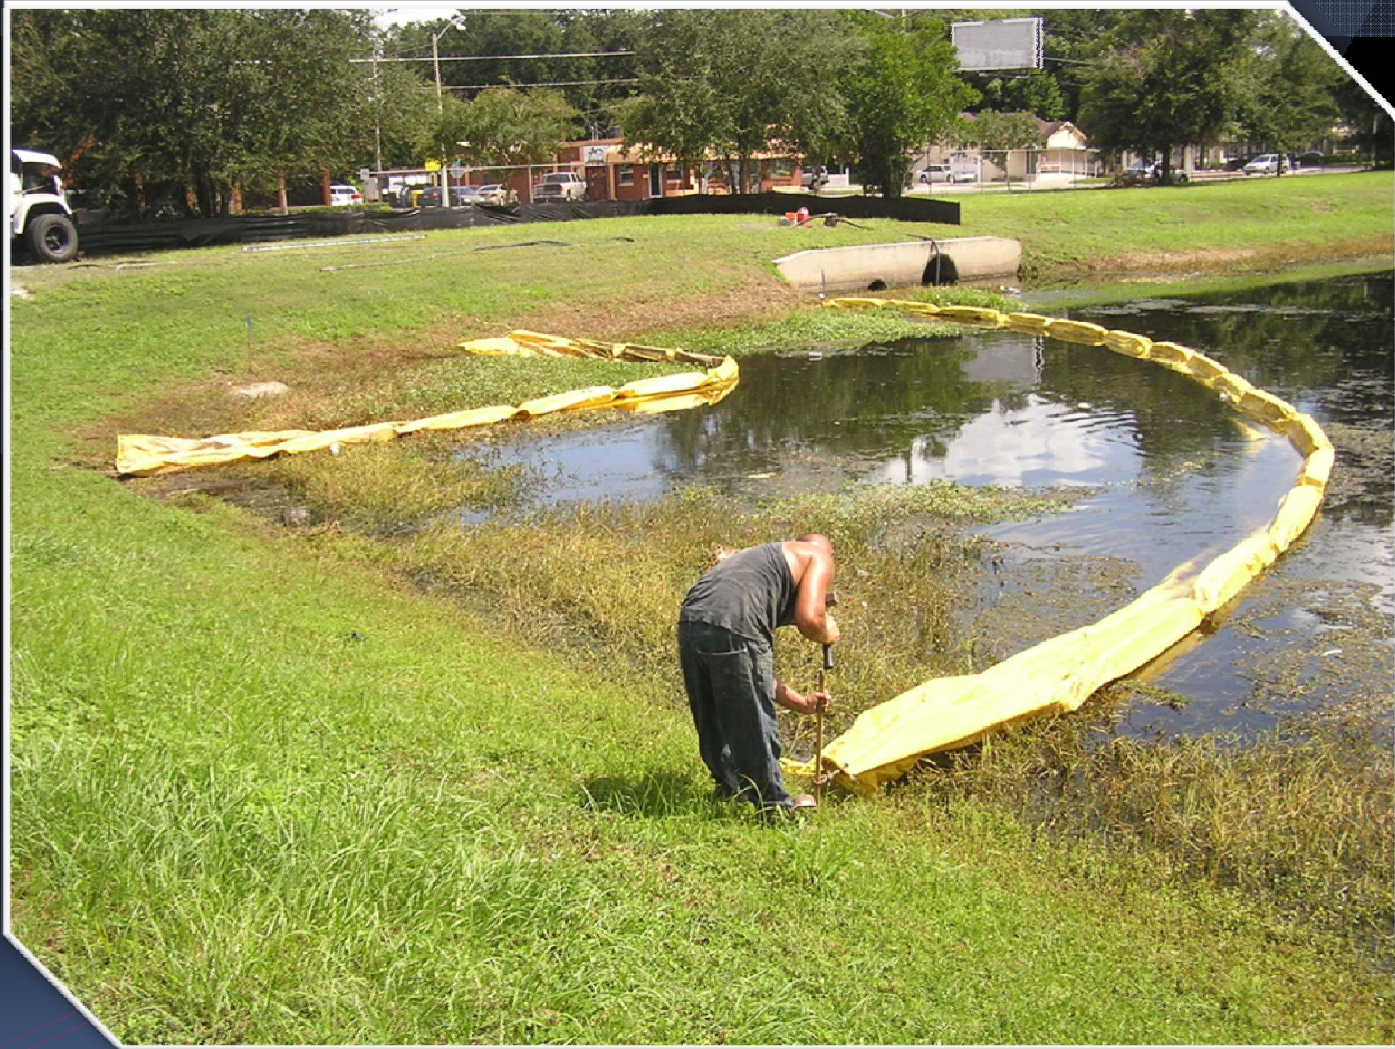
Example of Pond Level Control Well – Bumby Ave. (1 of 3)

Bumby Avenue - Turbidity barriers being set up prior to construction activities.

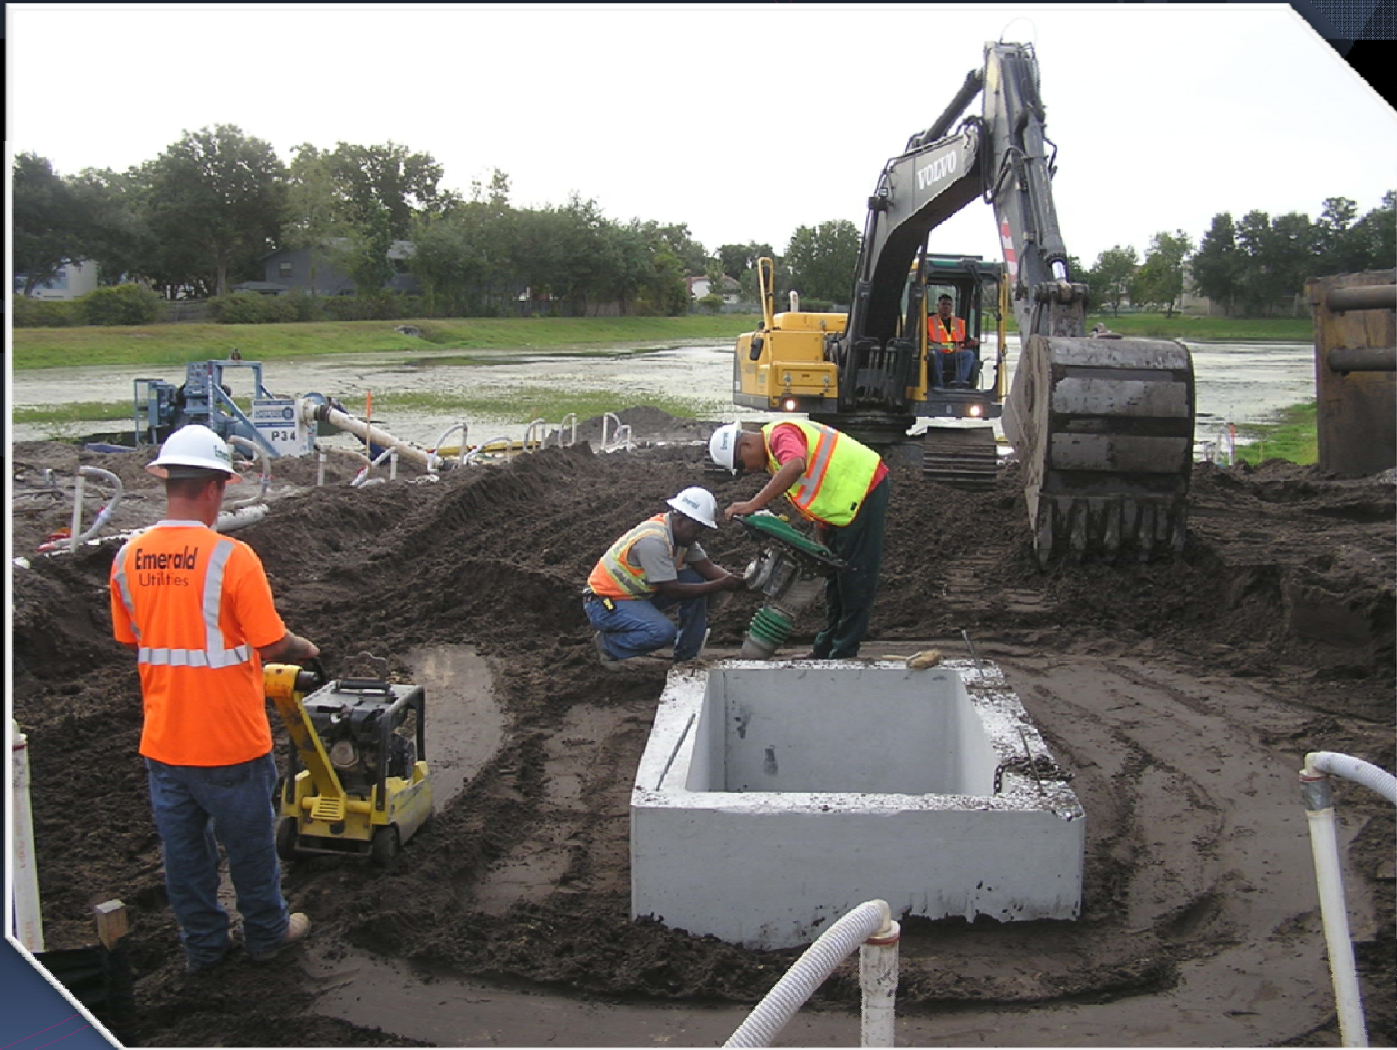
Example of Pond Level Control Well – Bumby Ave. (2 of 3)

Bumby Avenue - Backfilling and compacting area around new well enclosure.

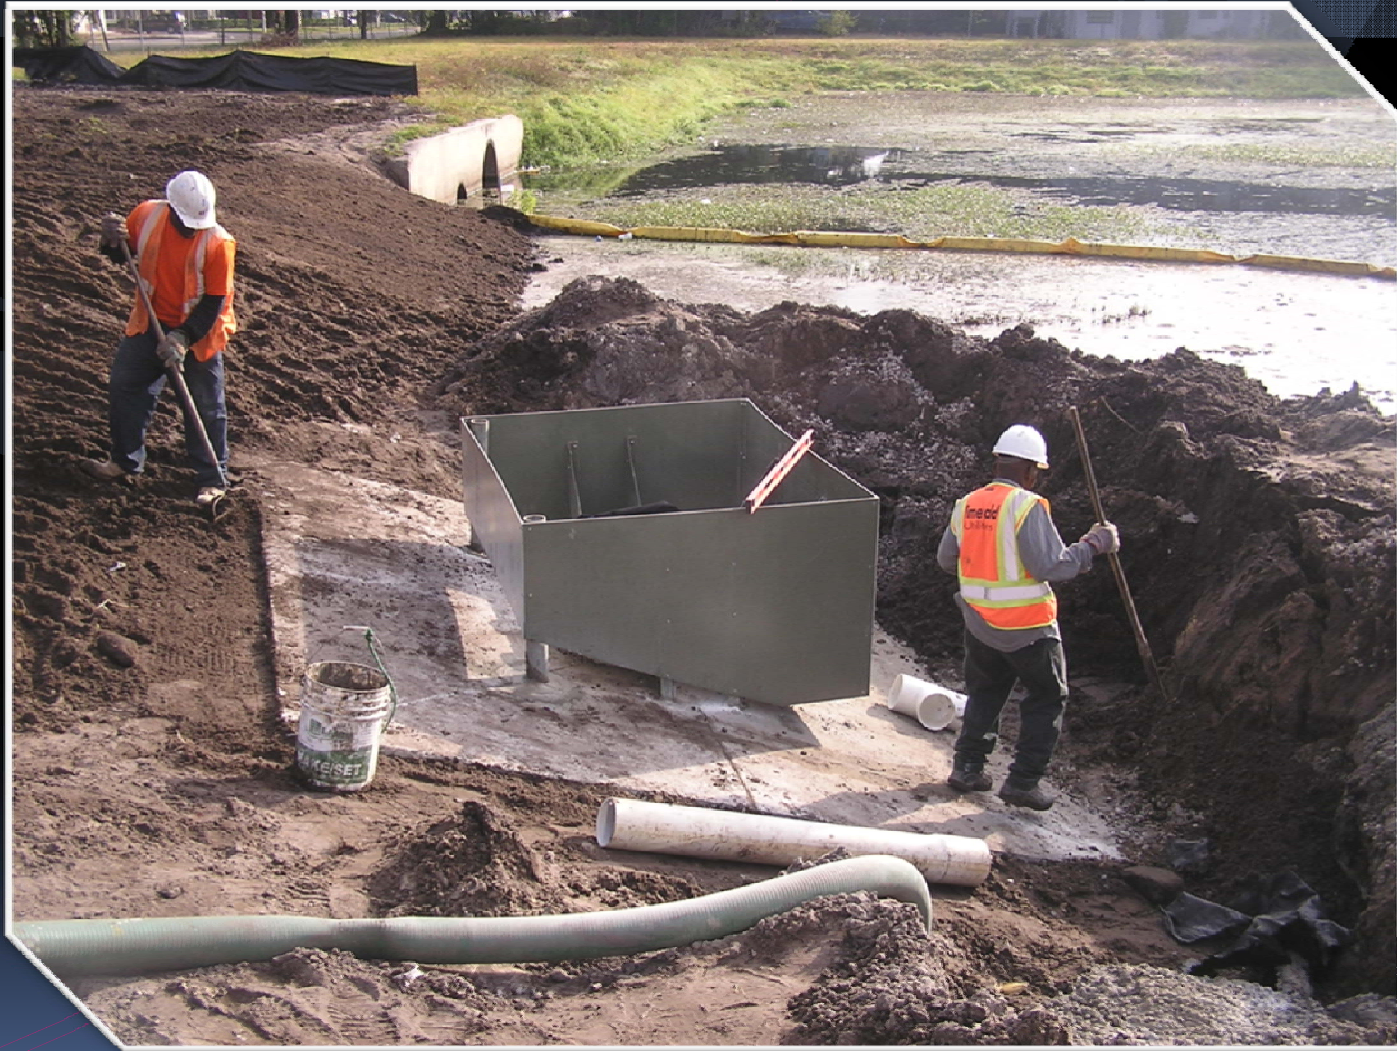
Example of Pond Level Control Well – Bumby Ave. (3 of 3)

Bumby Avenue - Fiberglass skimmer being set into position on inflow structure.

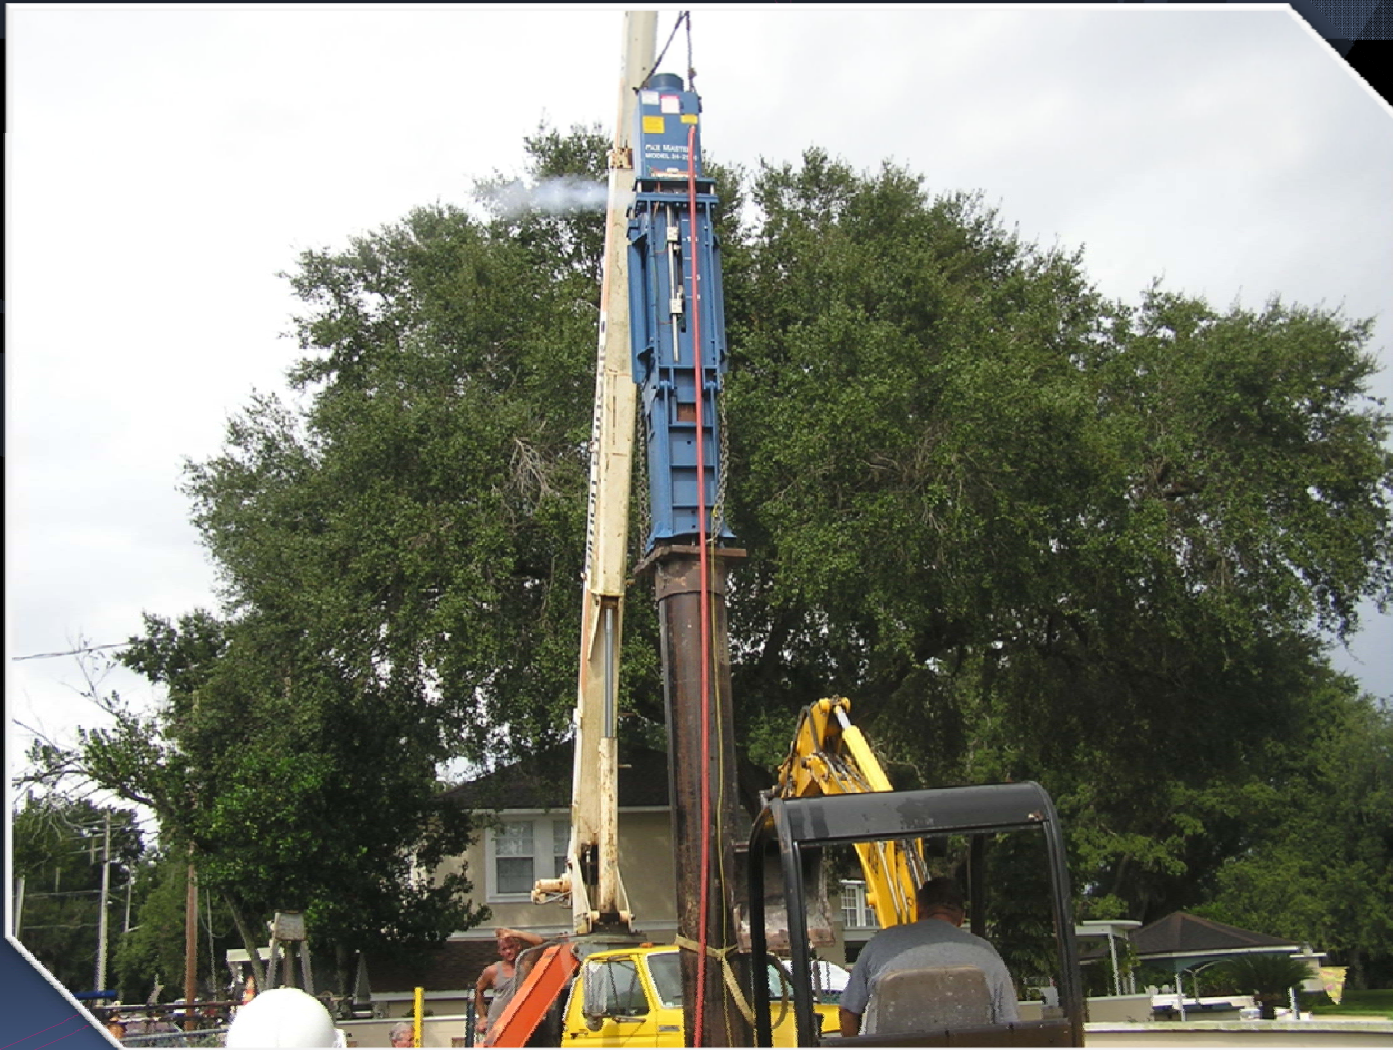
Example of Lake Level Control Well – Bass Lake (1 of 4)

Bass Lake - View of 18-inch diameter surface casing being driven to depth using a pneumatic hammer.

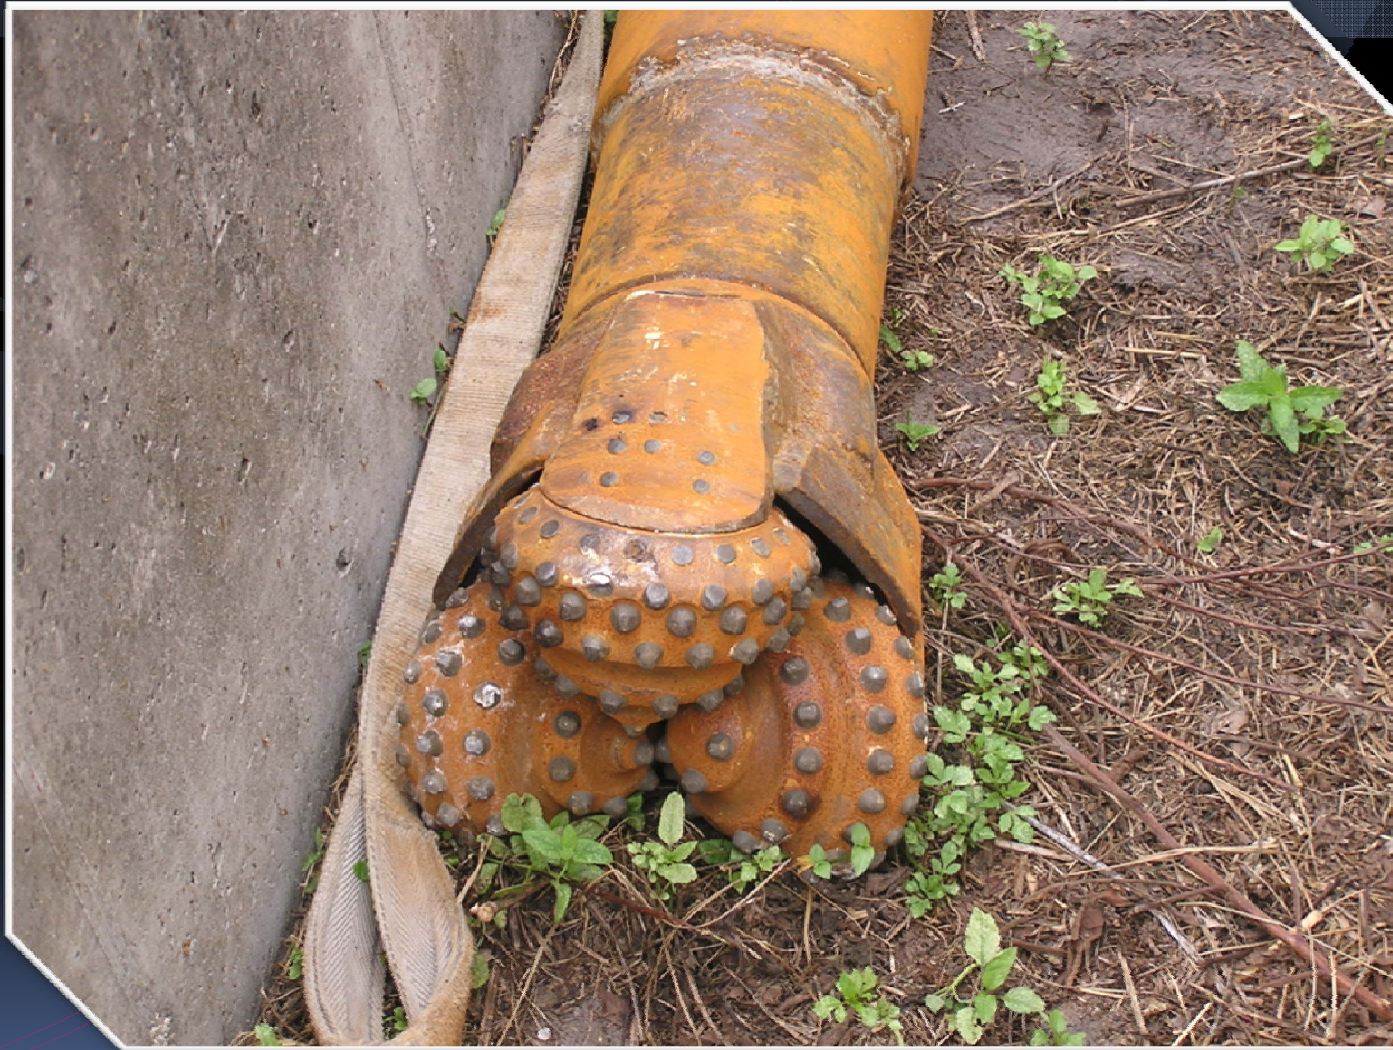
Example of Lake Level Control Well – Bass Lake (1 of 4)

Bass Lake - Closeup view of 12-inch diameter drill bit.
