ORANGE COUNTY'S FLORIDAN AQUIFER DRAINAGE WELLS

Recent Experience & Proactive Rehabilitation Program

Water Resources
Technical Group
Luncheon

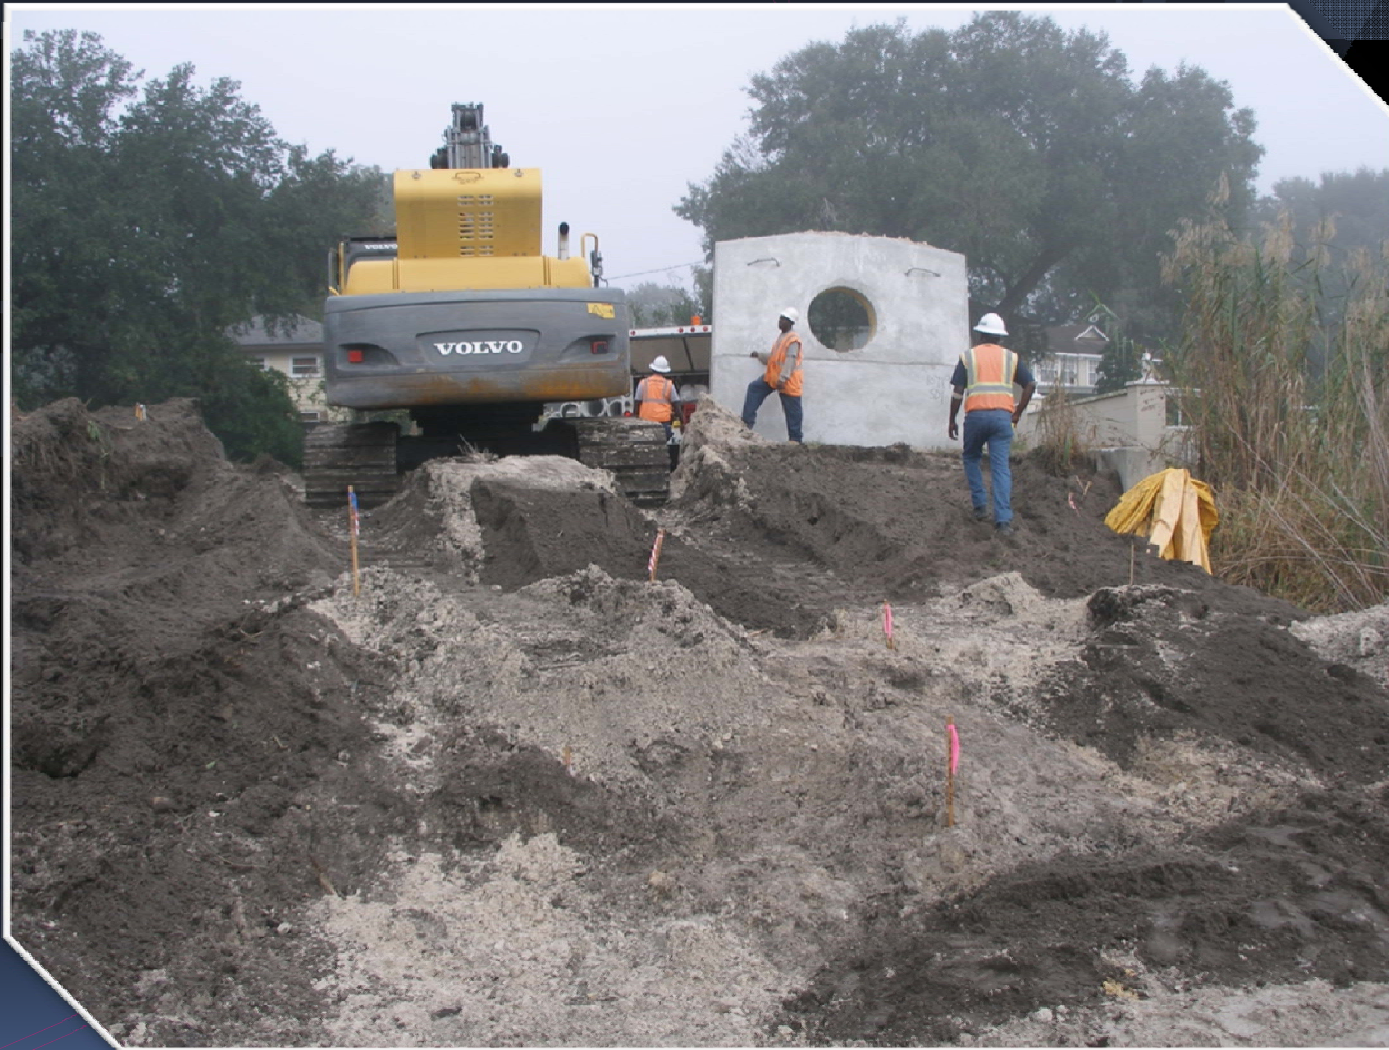
Example of Lake Level Control Well – Bass Lake (1 of 4)

Bass Lake - View of headwall during installation activities.

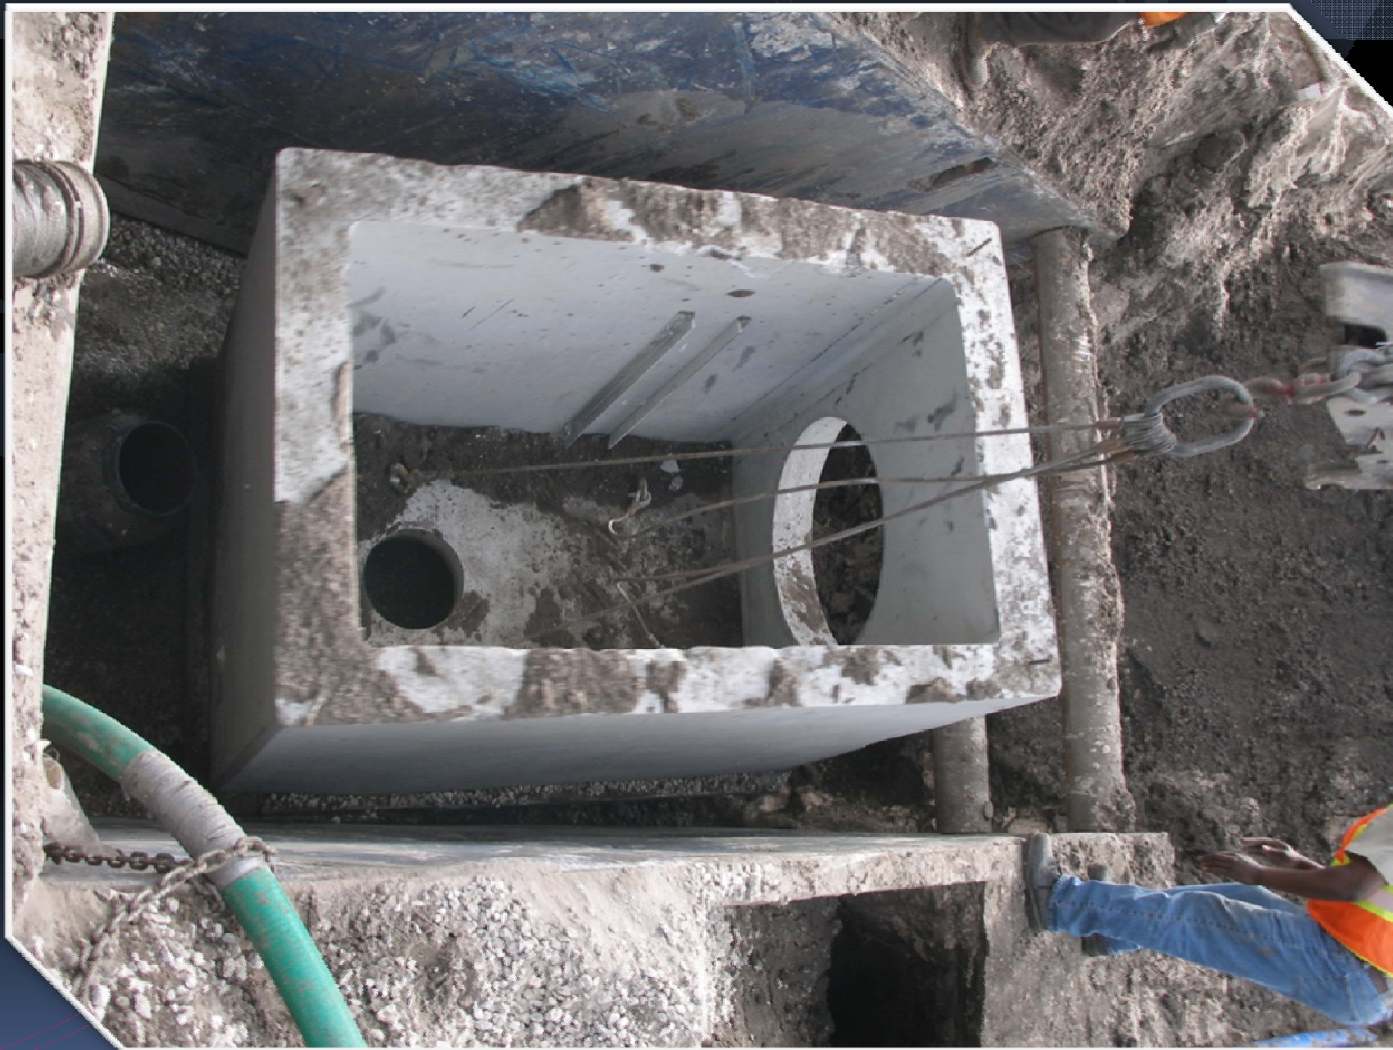
Example of Lake Level Control Well – Bass Lake (1 of 4)

Bass Lake - View of enclosure being installed.

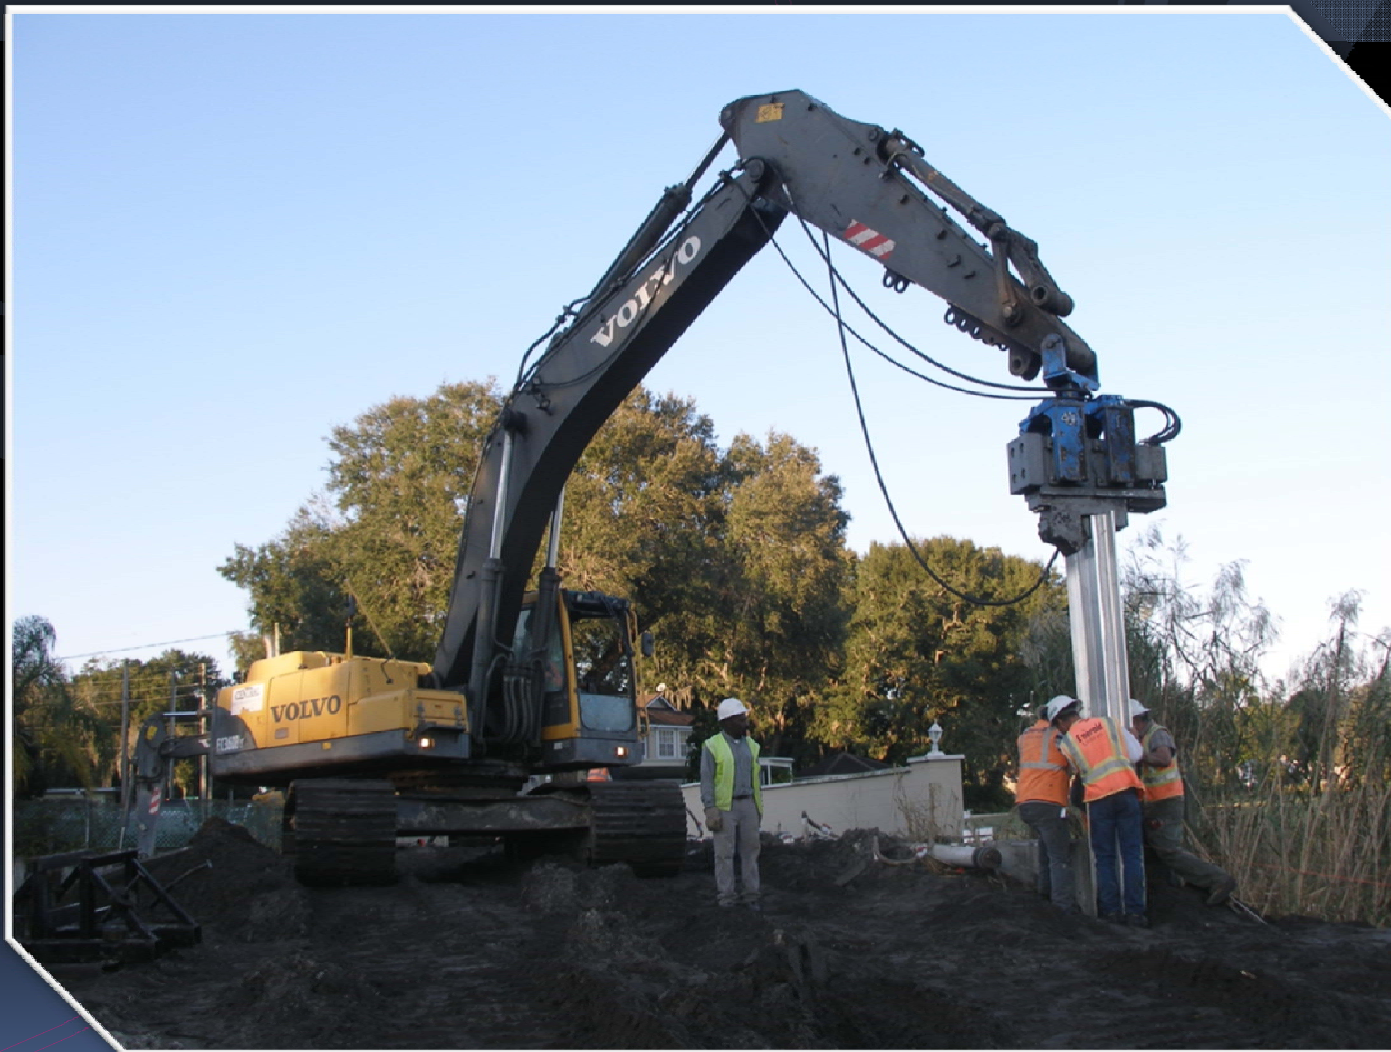
Example of Lake Level Control Well – Bass Lake (1 of 4)

Bass Lake - View of trackhoe-mounted hammer during sheet pile wall installation.

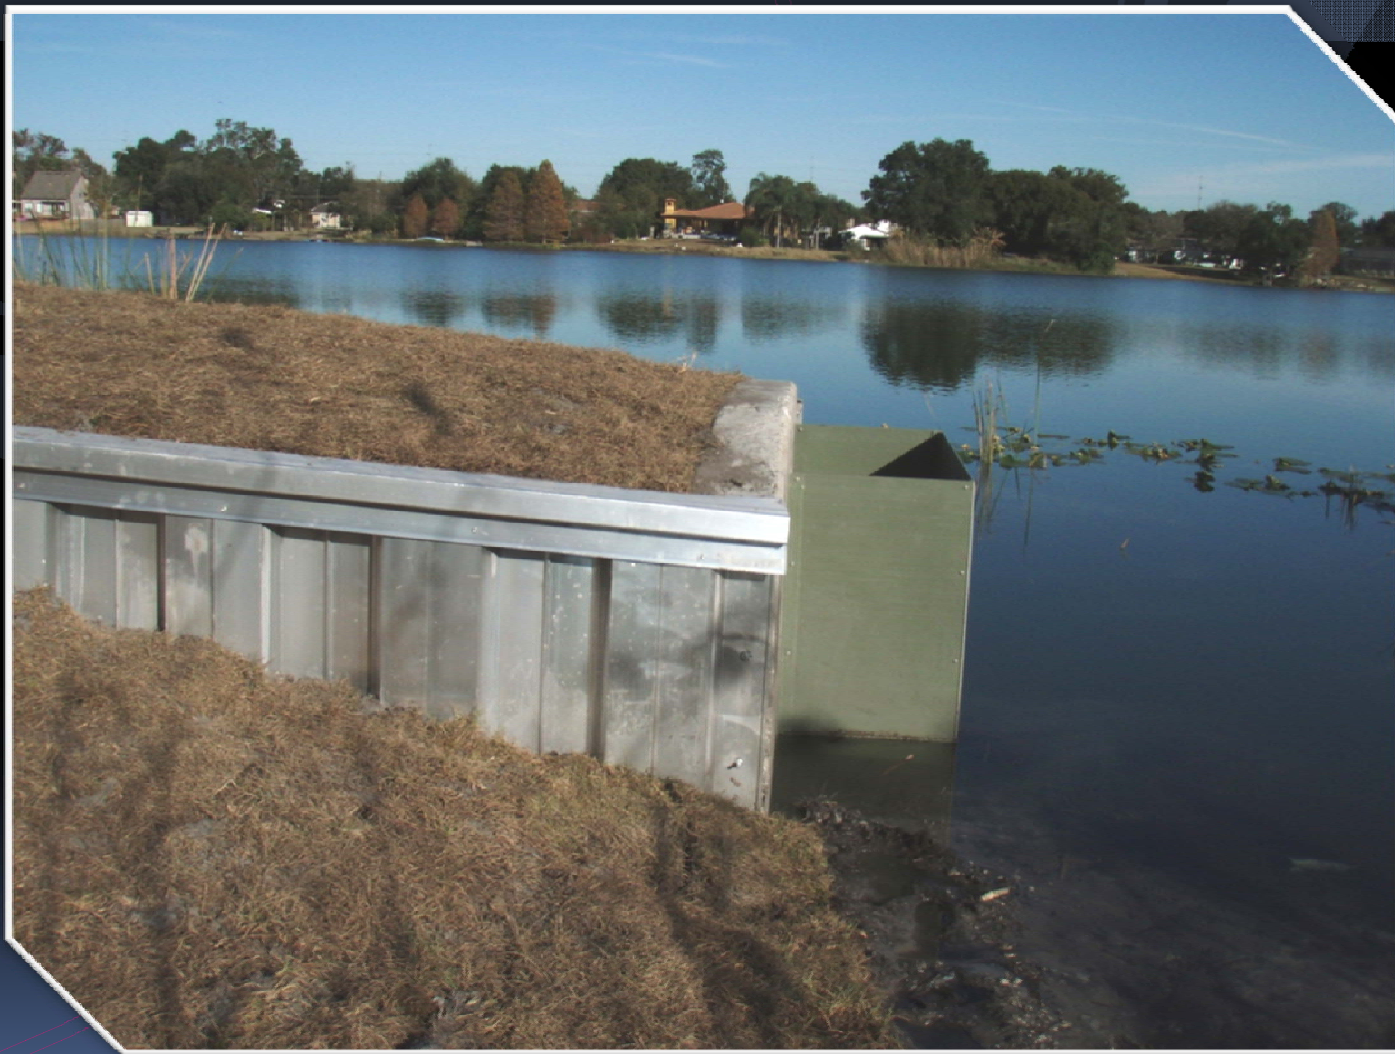
Example of Lake Level Control Well – Bass Lake (1 of 4)

Bass Lake - Complete sheetpile wall with end wall and skimmer

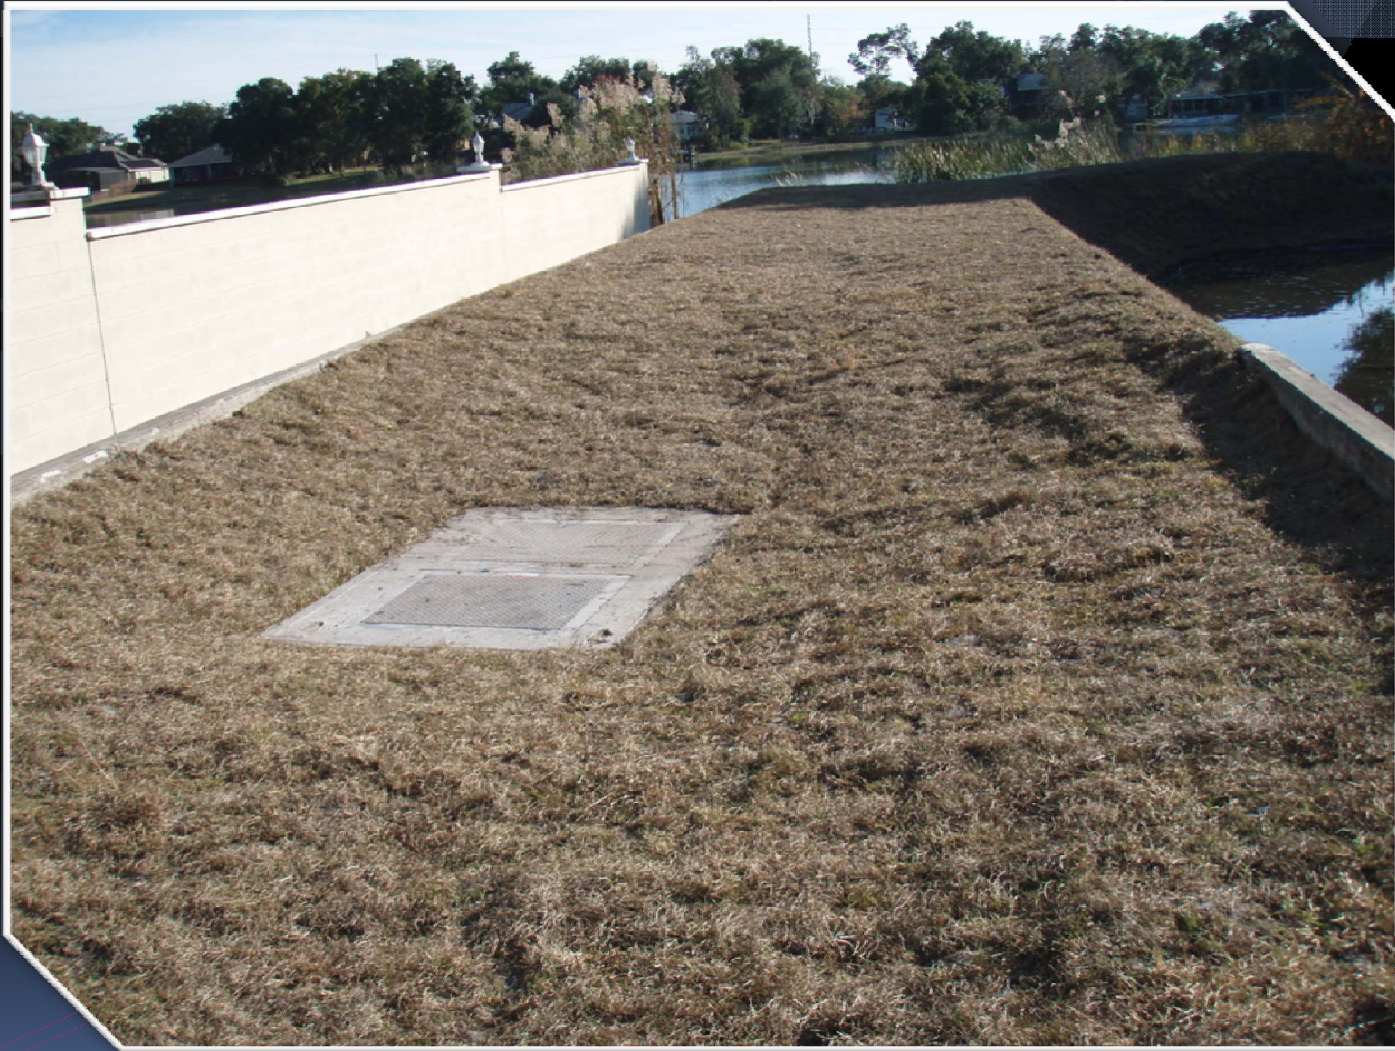
Example of Lake Level Control Well – Bass Lake (2 of 4)

Bass Lake - View showing enclosure with aluminum hatch at new well.
