CLERMONT CHAIN OF LAKES

1- Description of Study Area

2- Statement of Problems

3- Objectives of Study

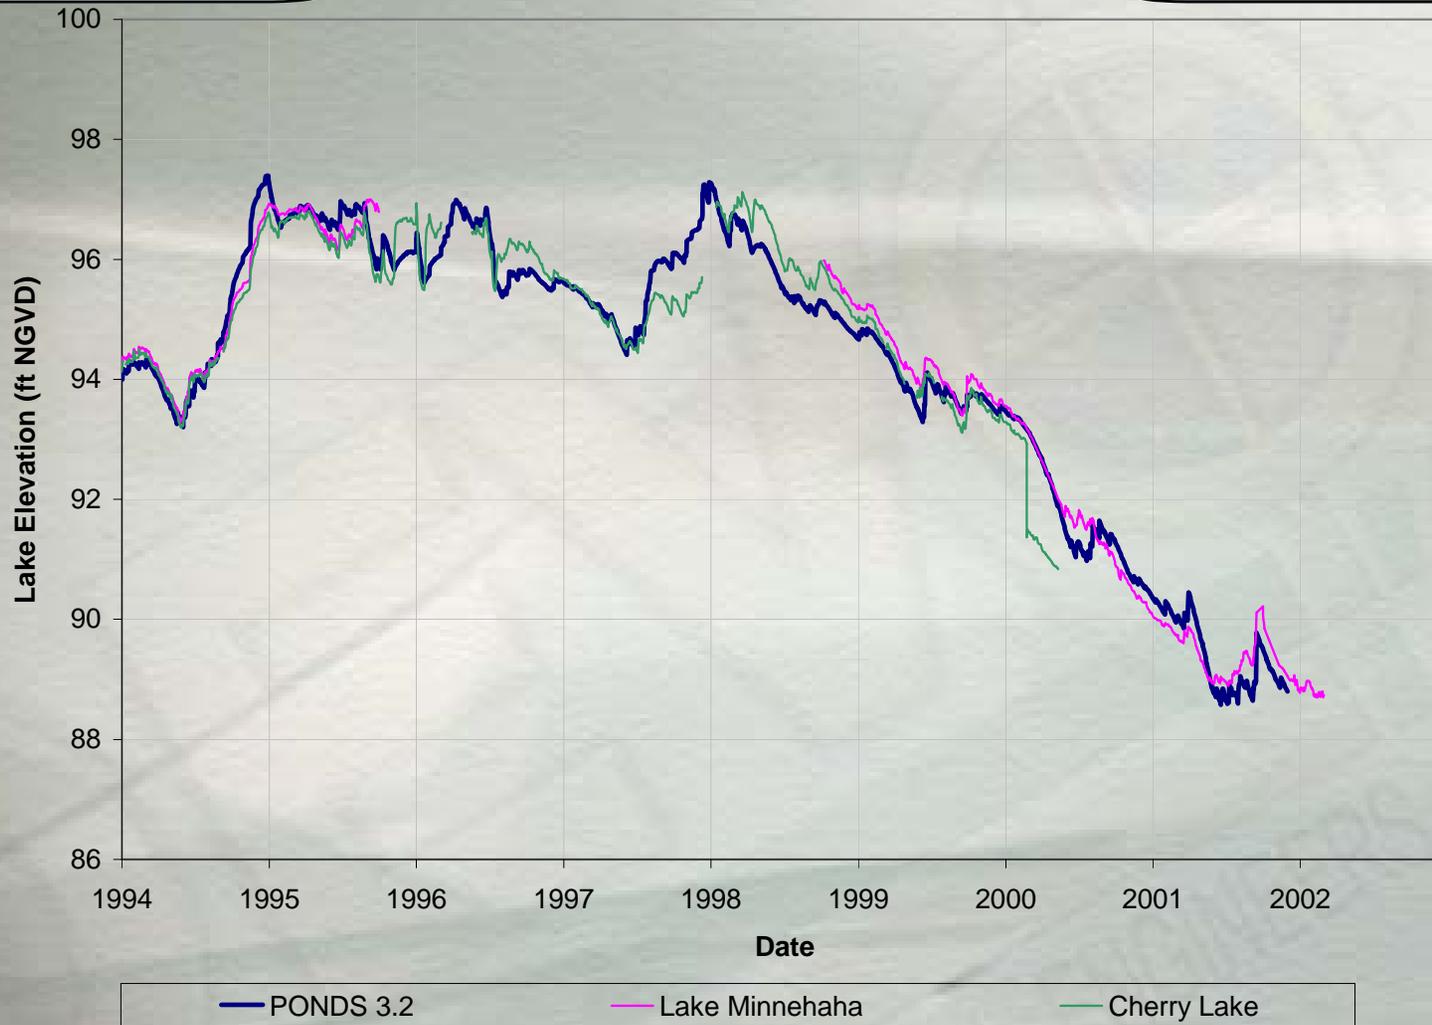
Measured and Predicted Lake Levels

Model Period: January 1, 1994 through November 30, 2001.

The beginning of the modeling period was chosen such that the long term behavior of the model could be assessed. The end of the modeling period corresponds to the most recent data obtained for Clermont 7 S weather station.

Total net loss represents a drop in lake levels from +94 ft at beginning of simulation to +89.12ft. at and of simulation.

- * Leakage rate between surficial aquifer and Upper Floridan aquifer is on the order of 5 to 6.5 inches/year
- * Lakes in the Clermont Chain do not appear to be well connected to the upper Floridan aquifer
- * Big Creek and Little Creek are the main sources of surface water inflow
- * The recent drop in lake levels appear to be caused by the recent severe deficit in rainfall, and subsequent lack of stream inflow from Big Creek and Little Creek

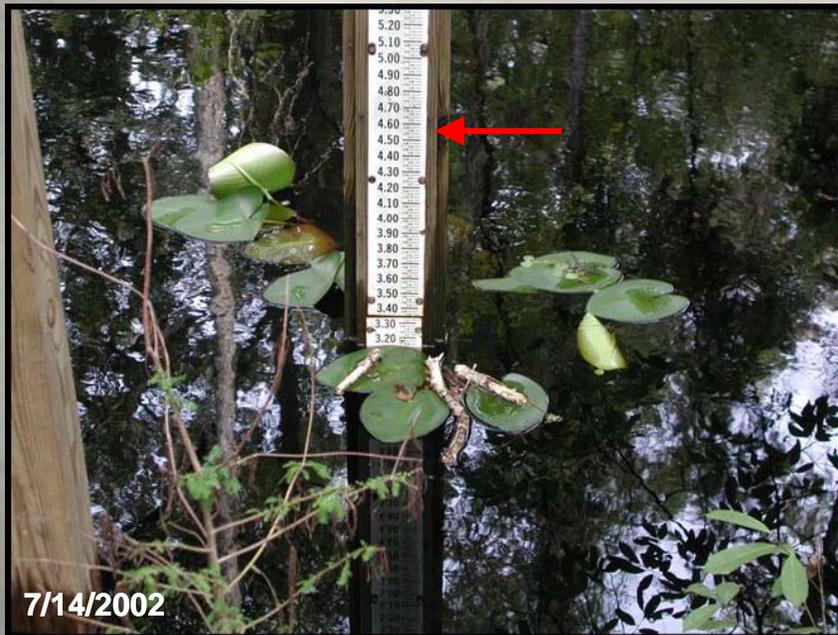
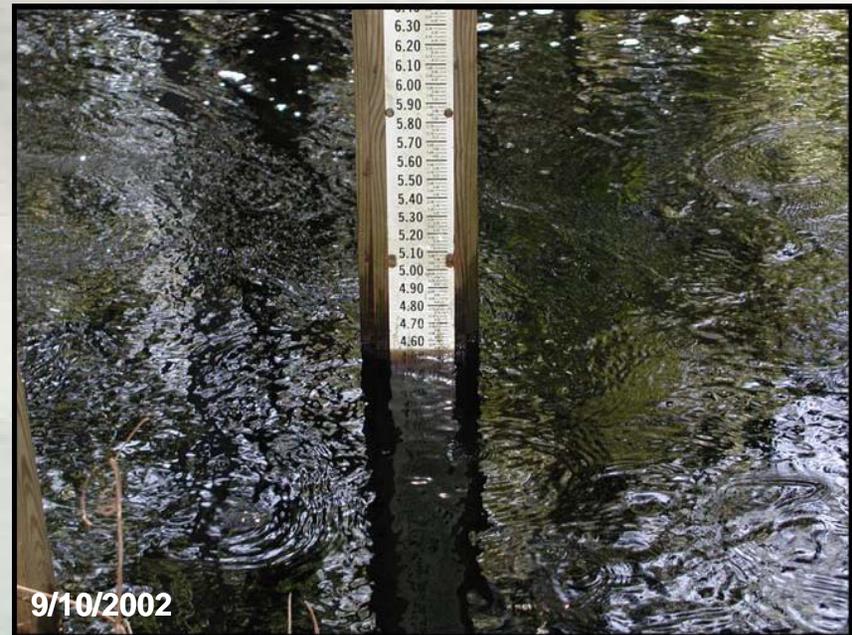
Big Creek Gaging Station

Gage up from about 3.15 to 4.55

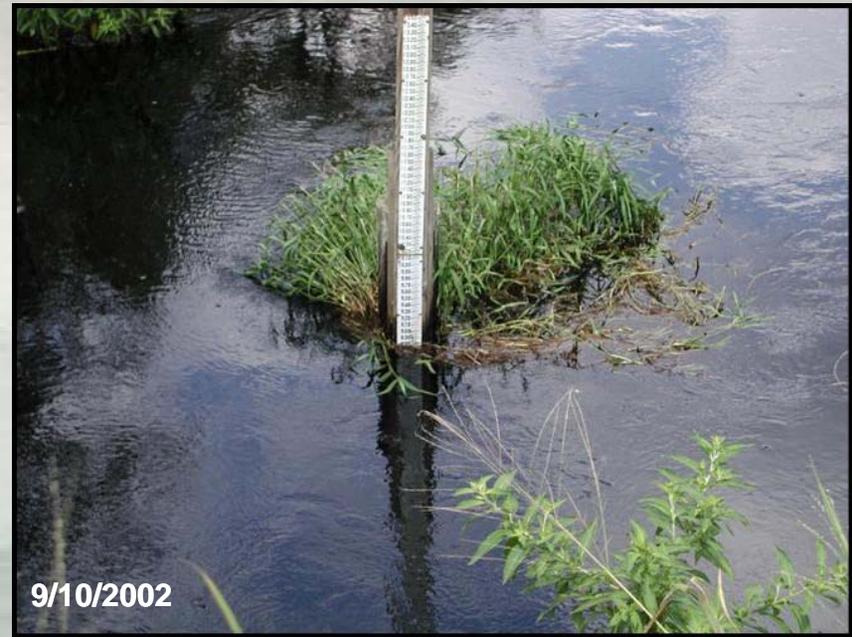
Little Creek Gaging Station

Gage up from 7.8 to 8.75
