**Current Issues in  
Storm Water  
Regulation in Florida**

**29th Annual ASCE-  
EWRI Water Resources  
Seminar**

**Speaker: Devo Seereeram Ph.D., P.E.**

**Topic: Litigation Prone Areas of  
Stormwater Management With  
Illustrated Case Studies**

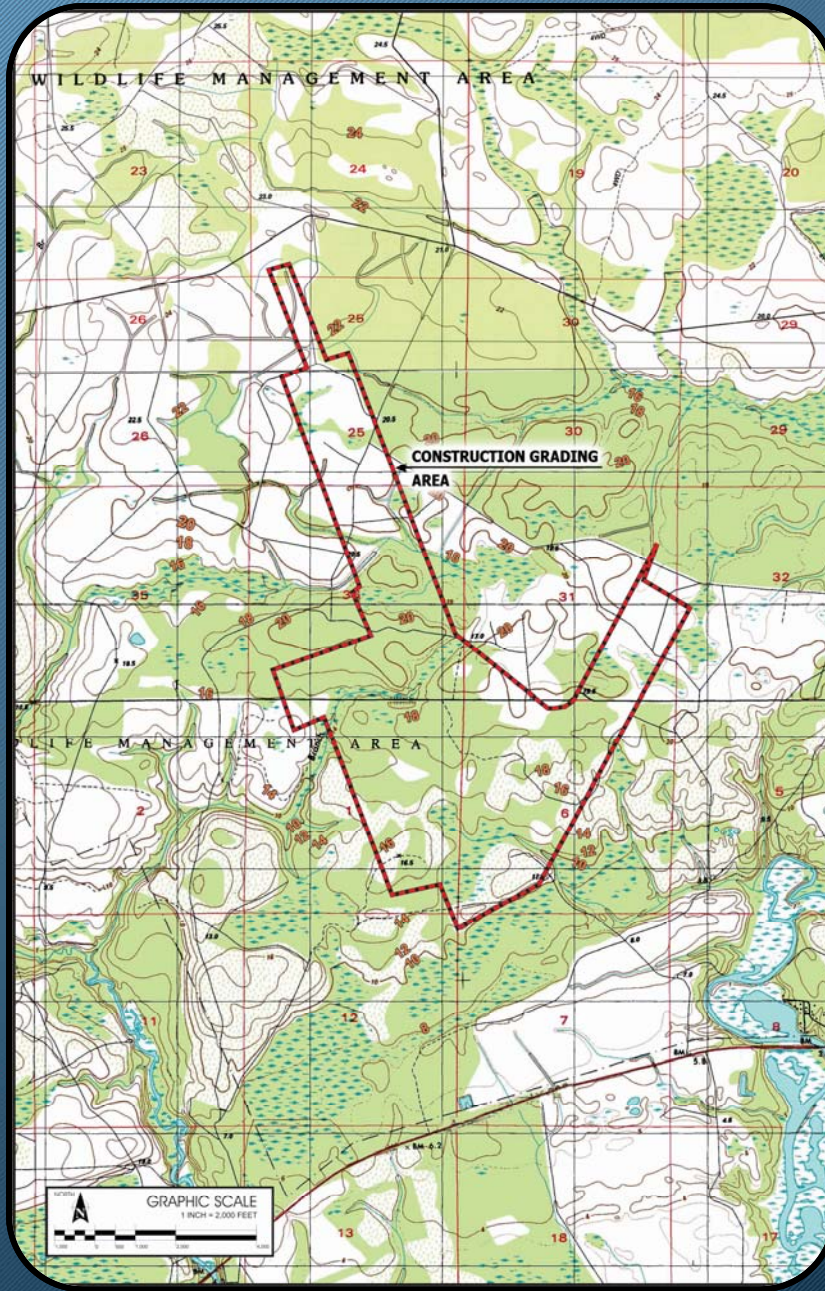
## Obstruction of Natural Drainage Flow Path During Construction

**Topic #1:** First, during construction, the contractor may not have considered the natural flow paths for stormwater runoff through his work site with the result that some flow lines are obstructed leading to upstream blockages and impoundments, some of which may fail with a “tidal wave” effect. These failures cause significant erosion and environmental damage since they release a lot of sediment-laden water.

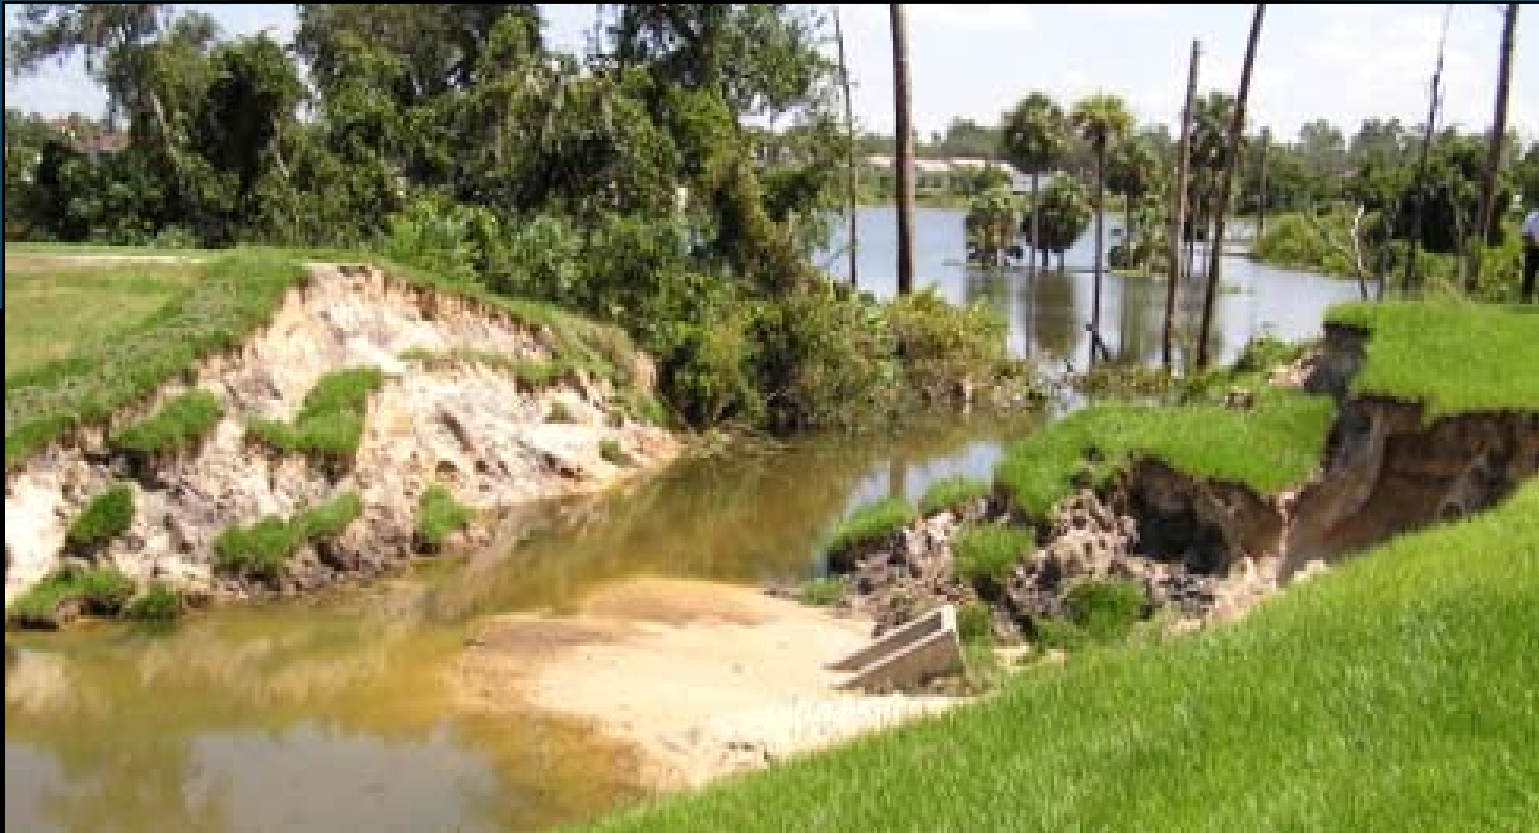
## **Berm Failure**

**During the early days of Tropical Storm Fay, Project X stormwater pond experienced a berm failure as a result of uncontrolled discharge over the berm**

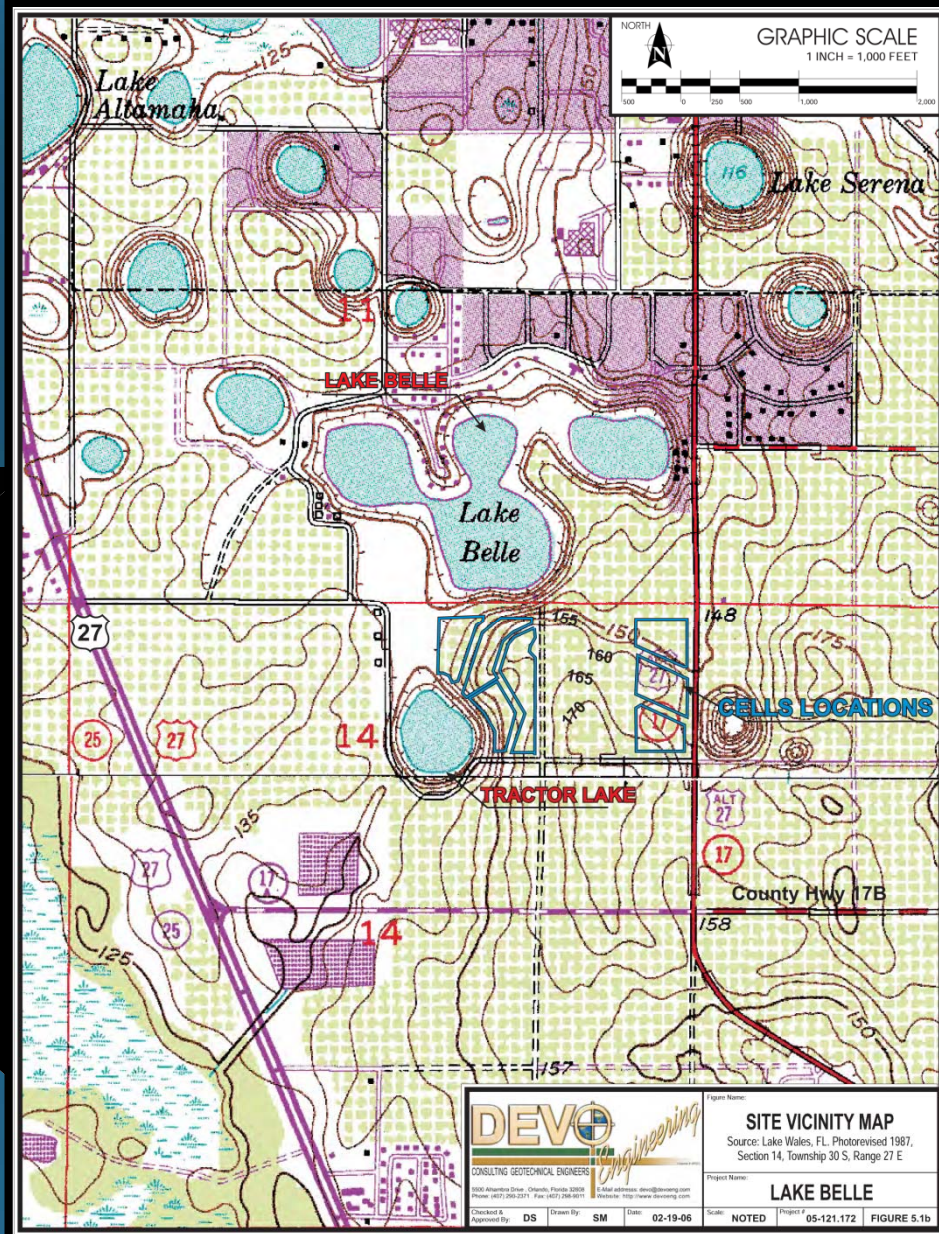
Figure 2.1  
Lake Levels for Lake Belle  
Period of Record: 5/16/1992 to 11/7/2005

**Topic #28:** Impact of Rapid-Rate Artificial  
Recharge Basins on Hydroperiod of  
Adjacent Lake

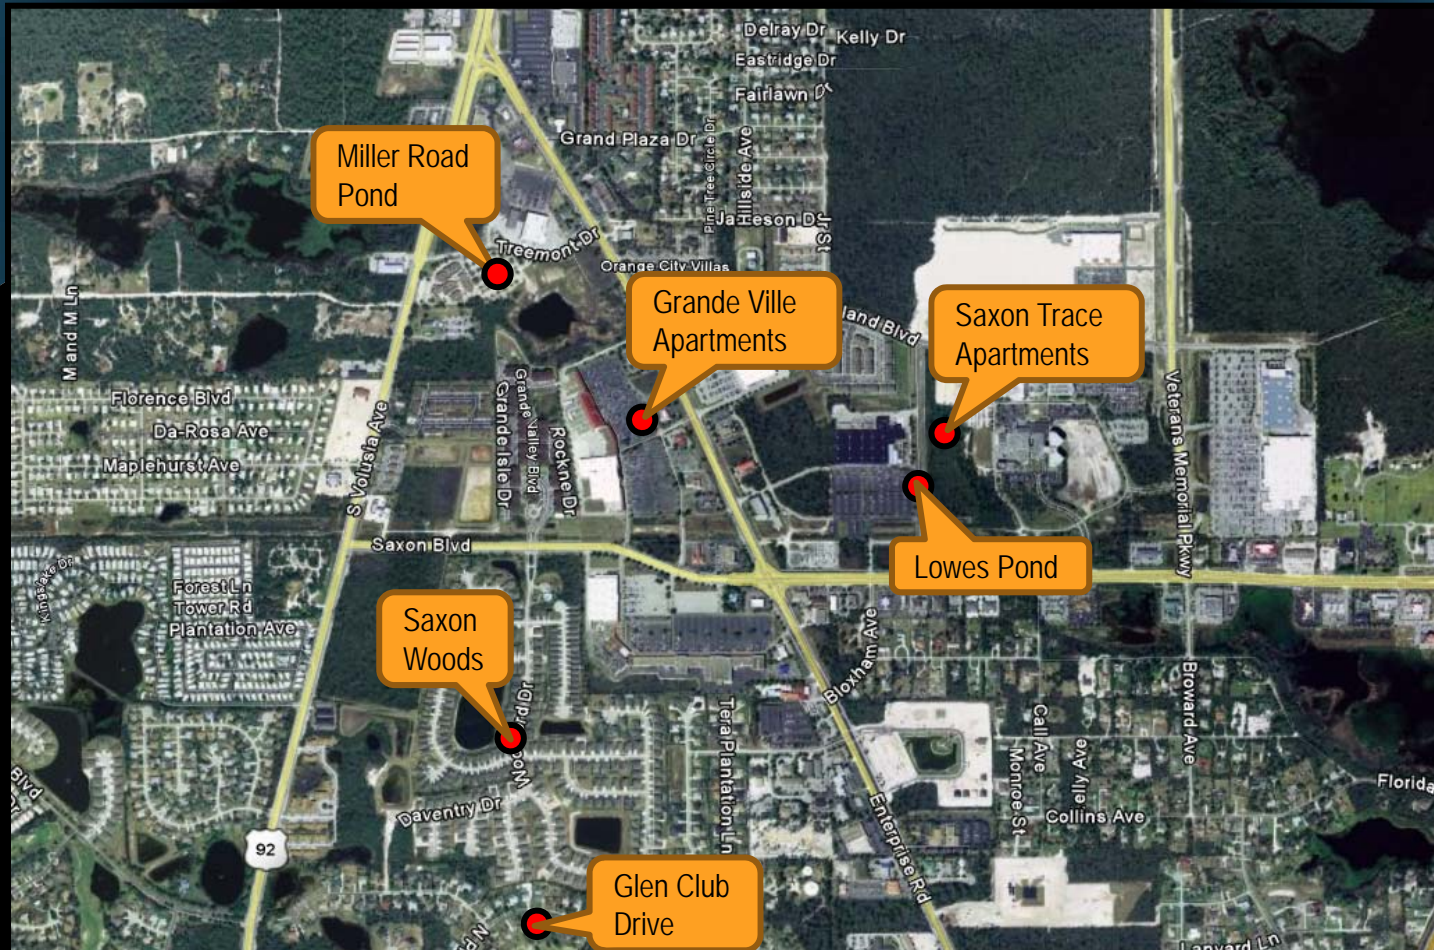
## Pond Berms Failures (Tropical Storm Fay)

**Topic #4:** Stormwater impoundment failures leading to sudden releases of stormwater causing flooding and damage to downstream properties.

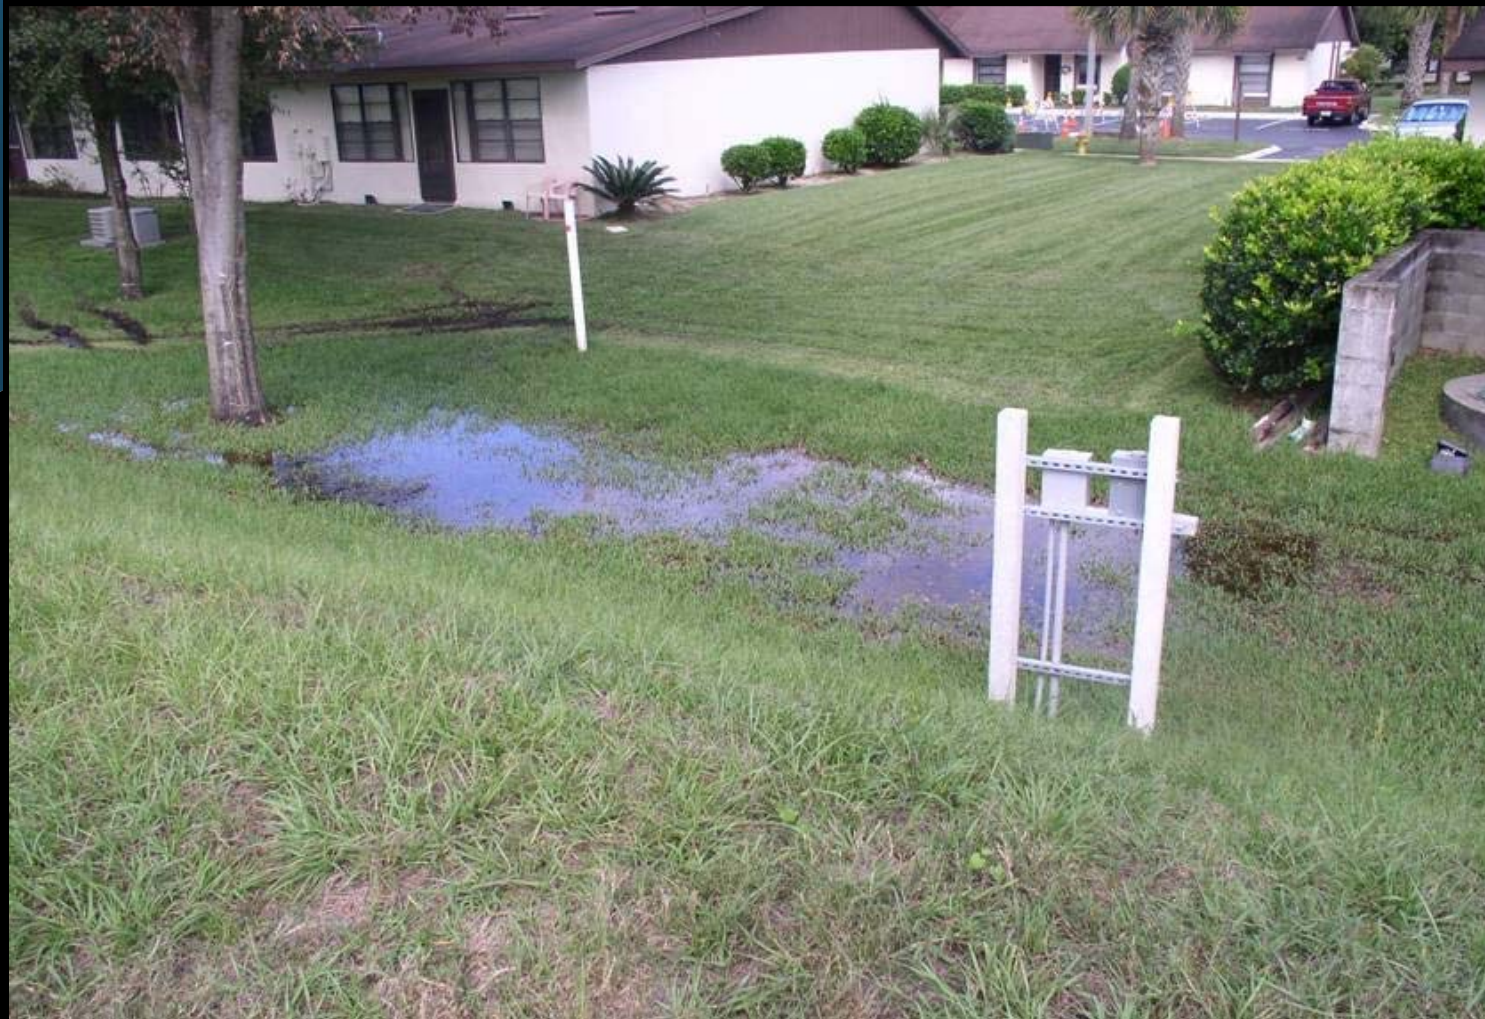
**FDOT Saxon Pond**  
(Photo date: 2002)

**Topic #5:** Seepage through pond berms or an artificial rise in the water table in the locality of a stormwater storage system which causes nuisance flooding or chronic wetness/seepage/flooding to adjacent land owners. Some lake level modification projects which raise lake levels can impact lakeshore residents, especially those on septic tanks.

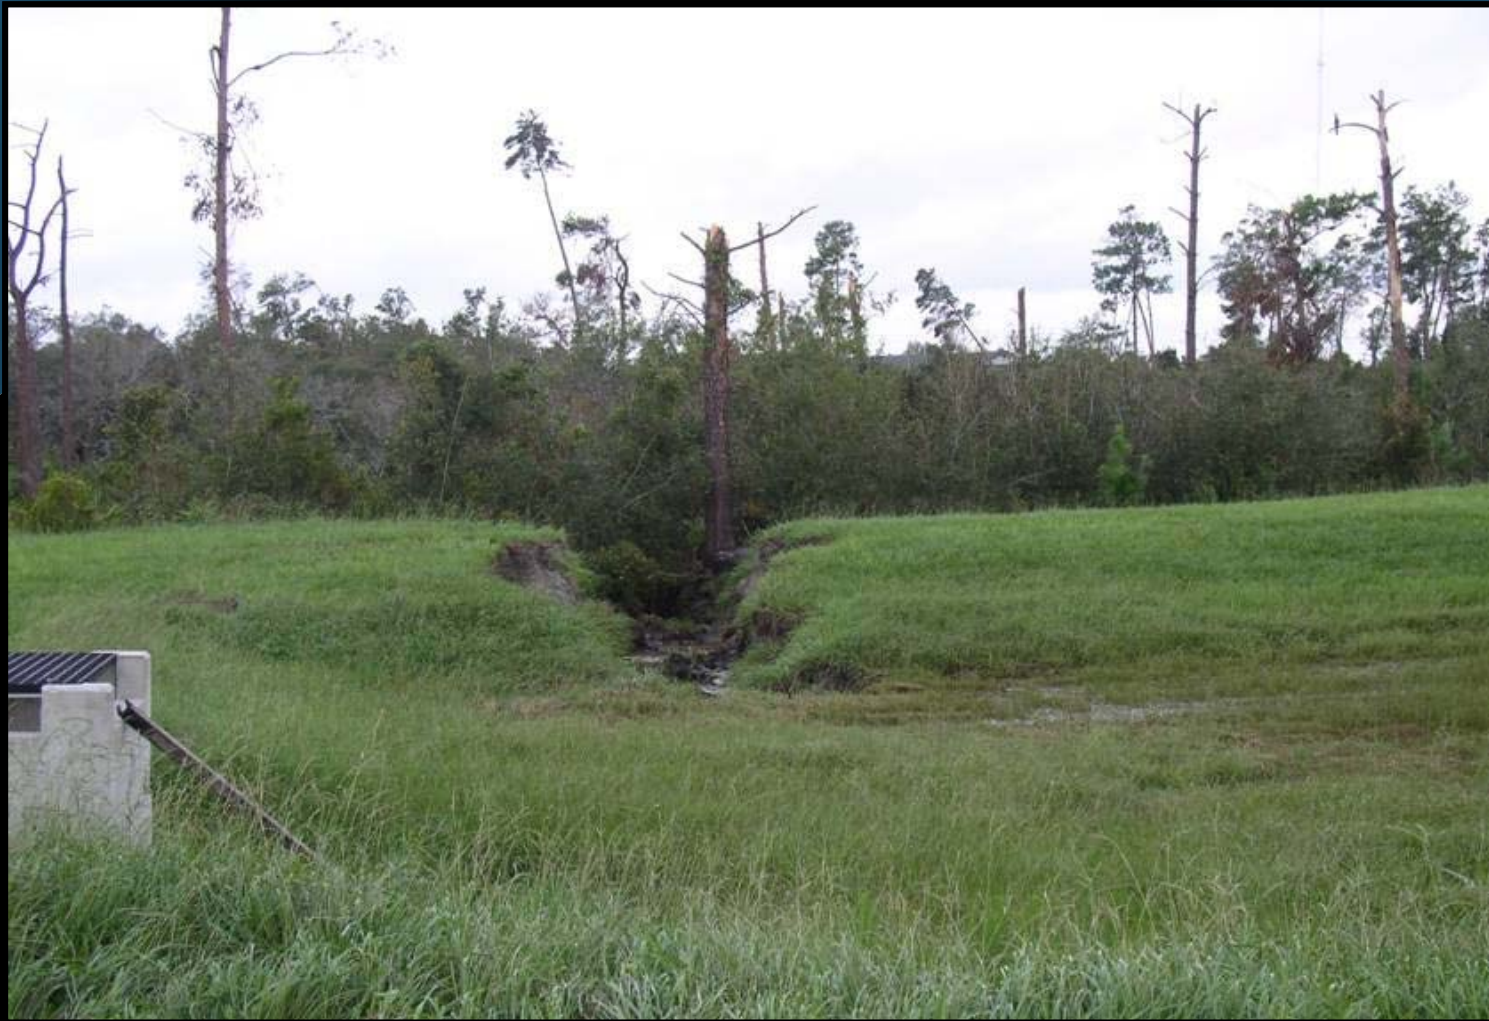
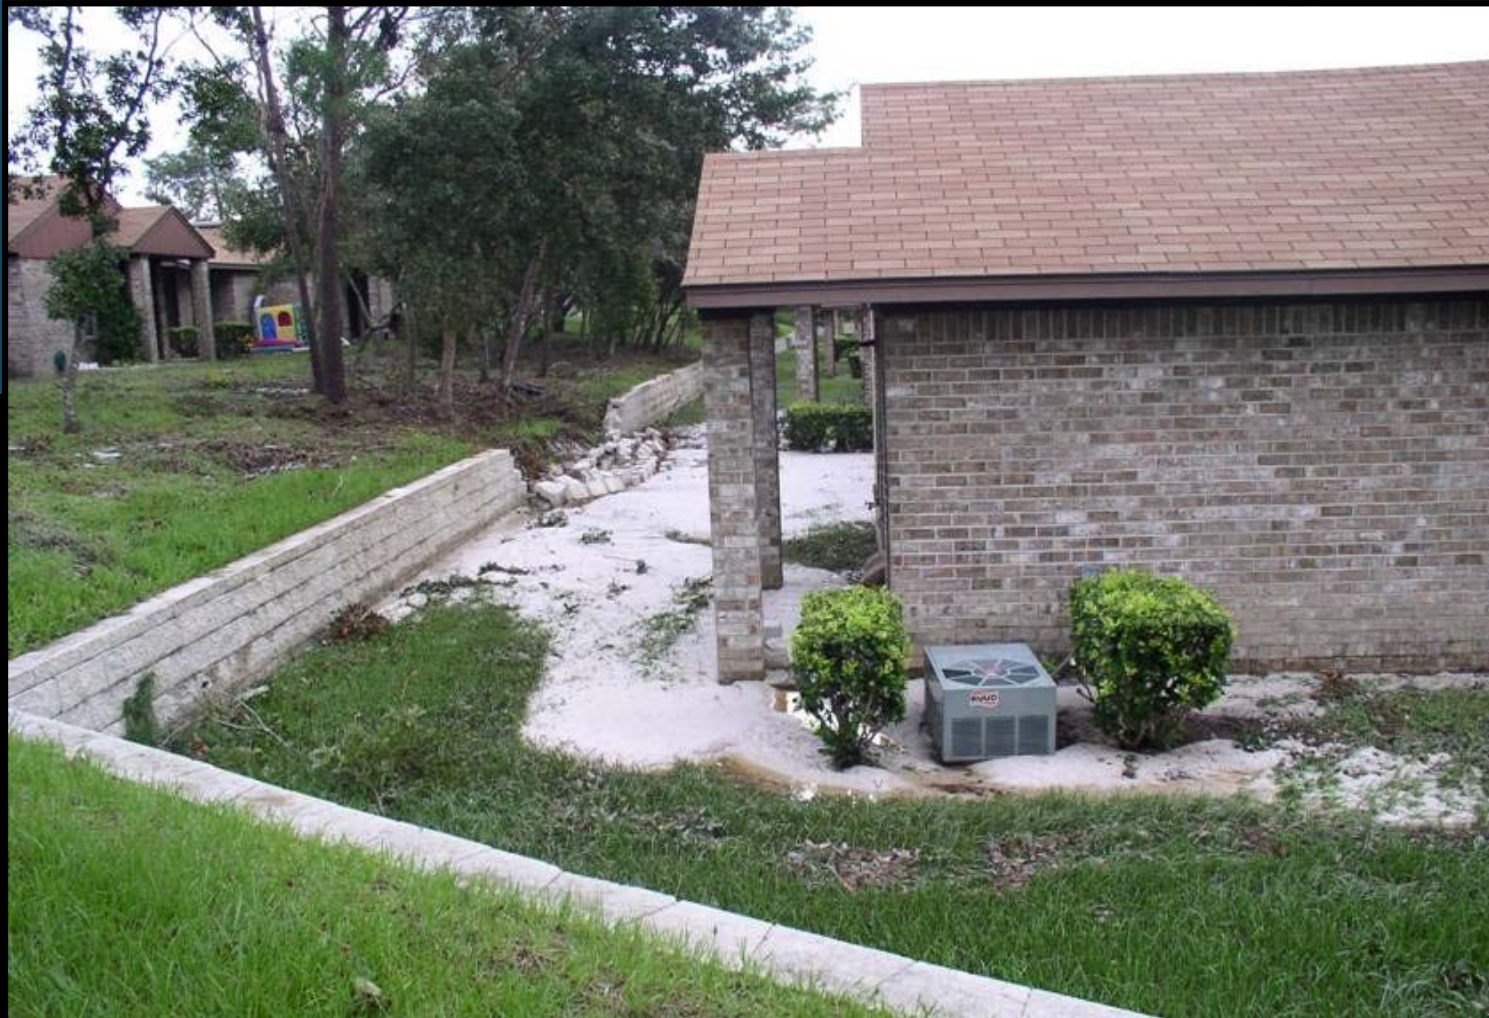
**Site in Debary**  
(Photo date: 2004)

**Topic #6:** Construction errors such as improper sand in filter systems, incorrect elevations for berms (too low), dumping debris in fill berms, no seepage collars on pipes to prevent blow-outs, etc.

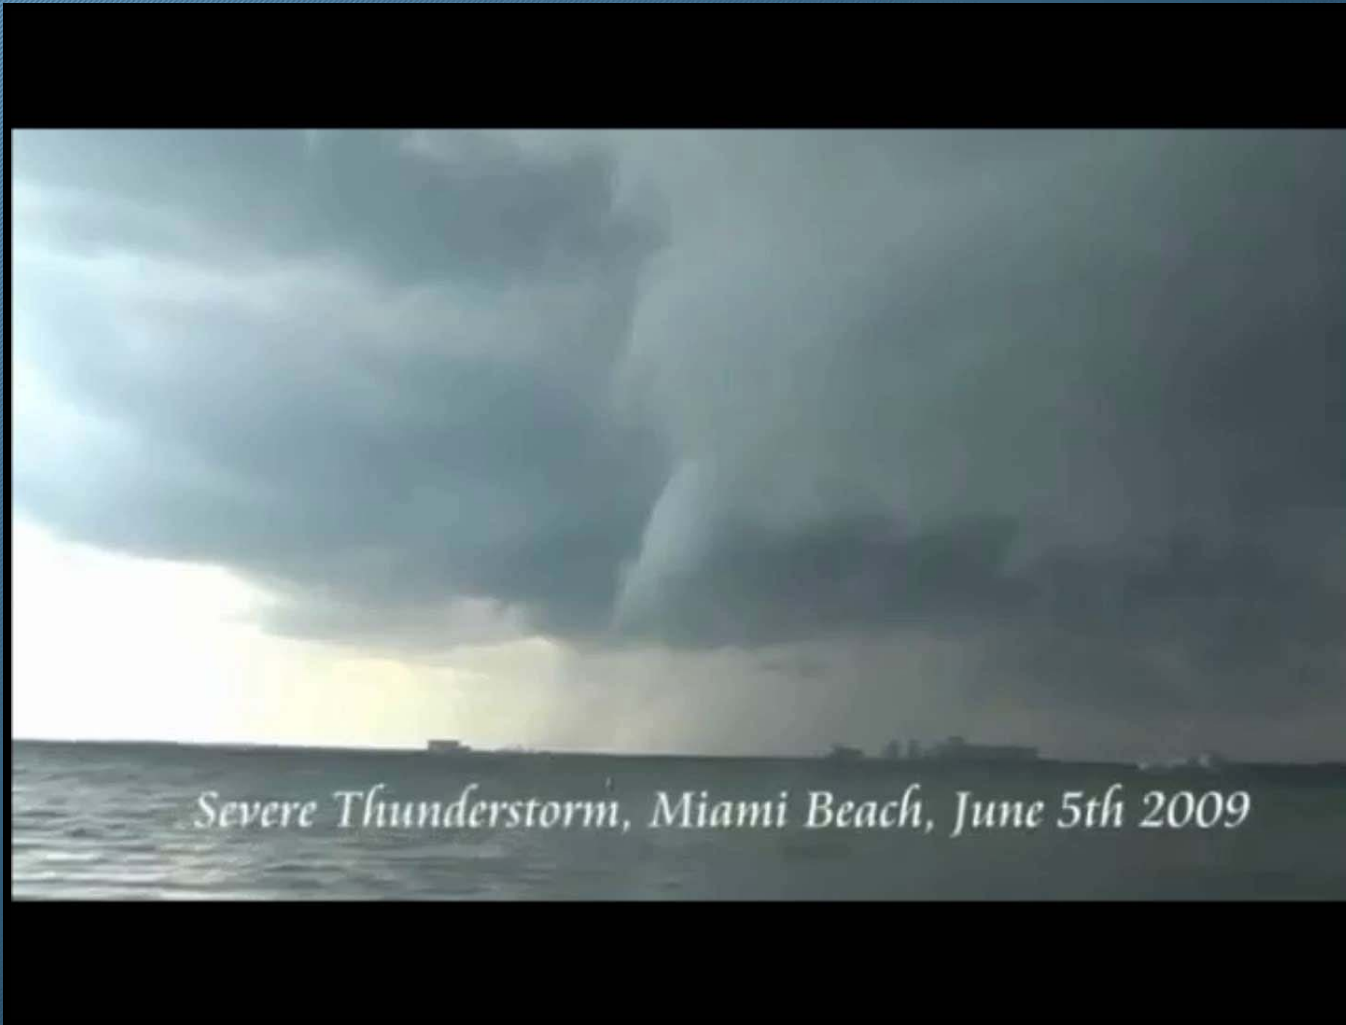
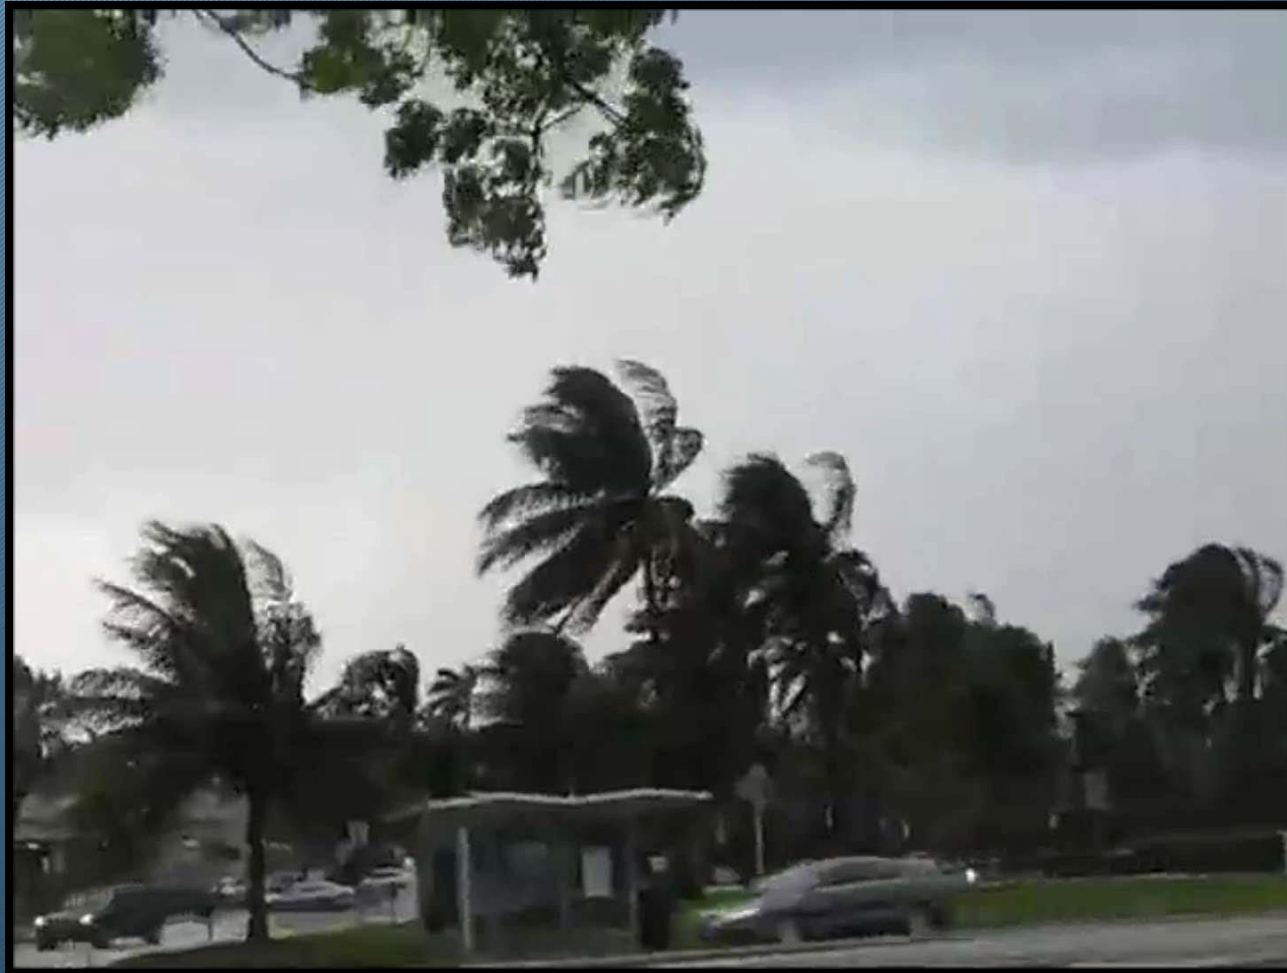
**South Beach (FL) Storm of  
June 5, 2009**

- Date: Friday, June 5, 2009
- Started at 3:30 p.m.
- Ended at 6:00 p.m.
- 9.88 inches of rain recorded (Miami Beach City Hall rain gauge)
- Recurrence Interval: approximately once every 800 years
- Tide Conditions during rain event: Mid-Low Tide increasing to High Tide (8:15 p.m.)

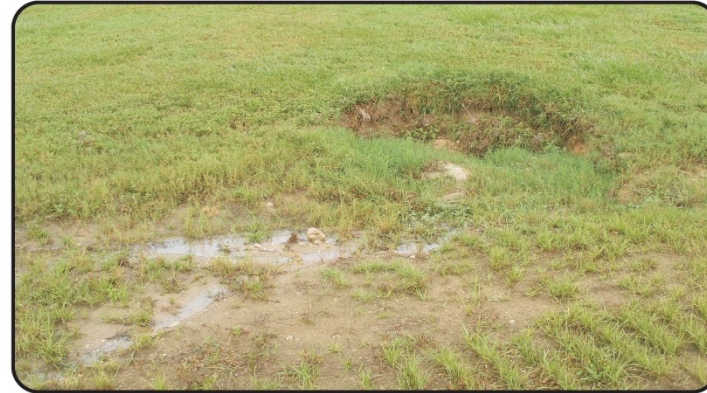
Photo 2. Shows Water Flowing Into The Sinkhole at the Toe of Slope on the Western Side of Pond SMF-1 on October 24, 2007

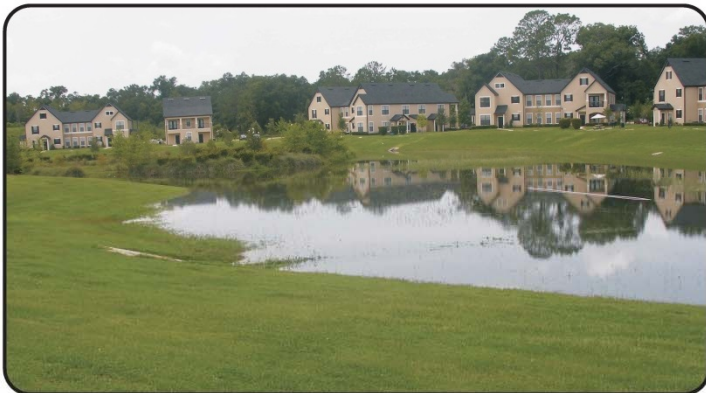
Photo 3. Shows Pond SMF-1 at its Highest Stage on July 9, 2008

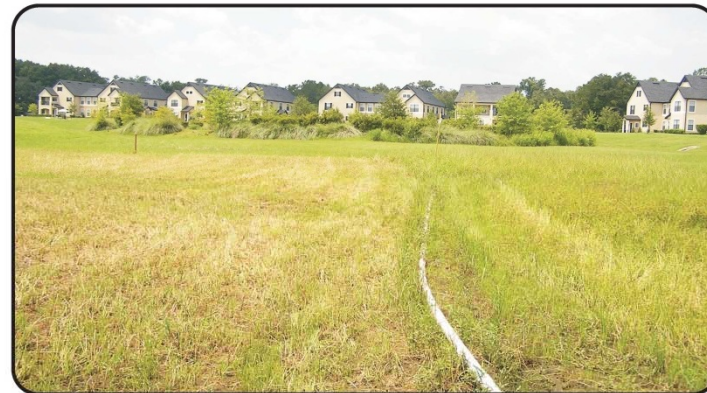
Photo 4. Shows Pond SMF-1 Practically Dry on August 9, 2008

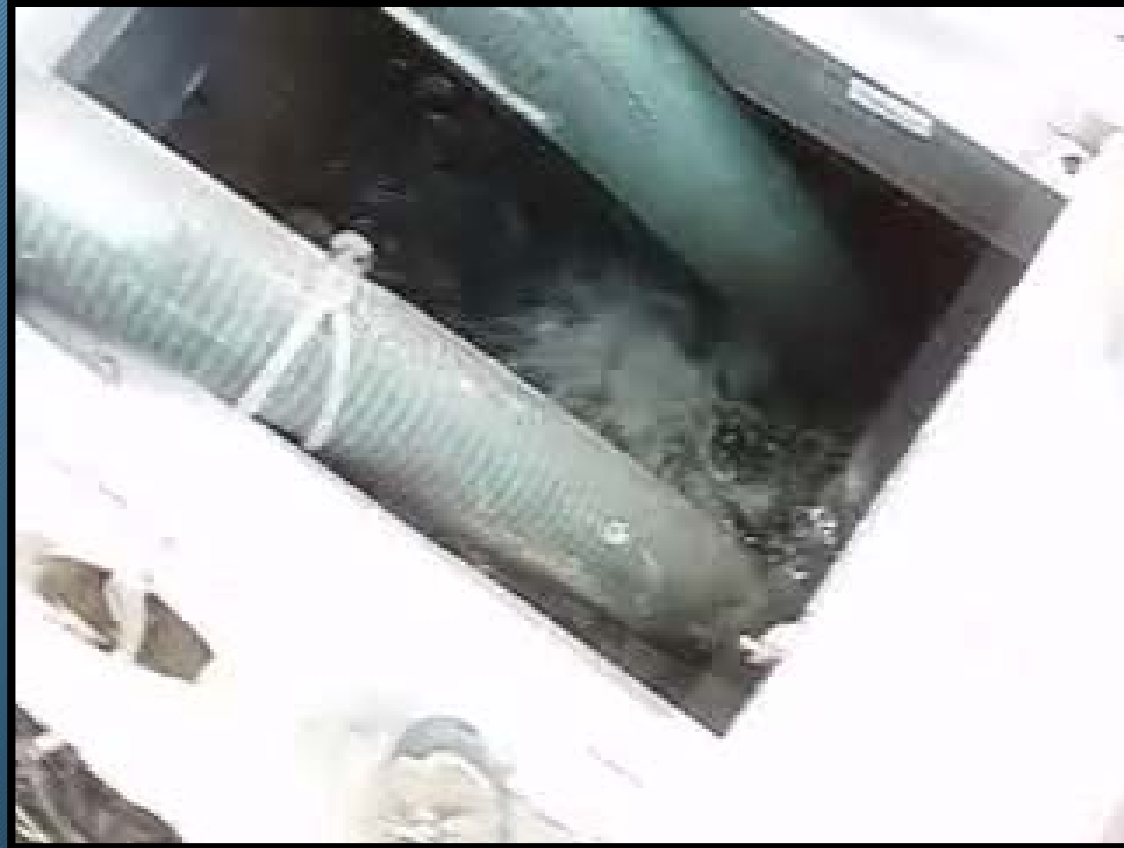
**Geyser**

## Drainage Failure

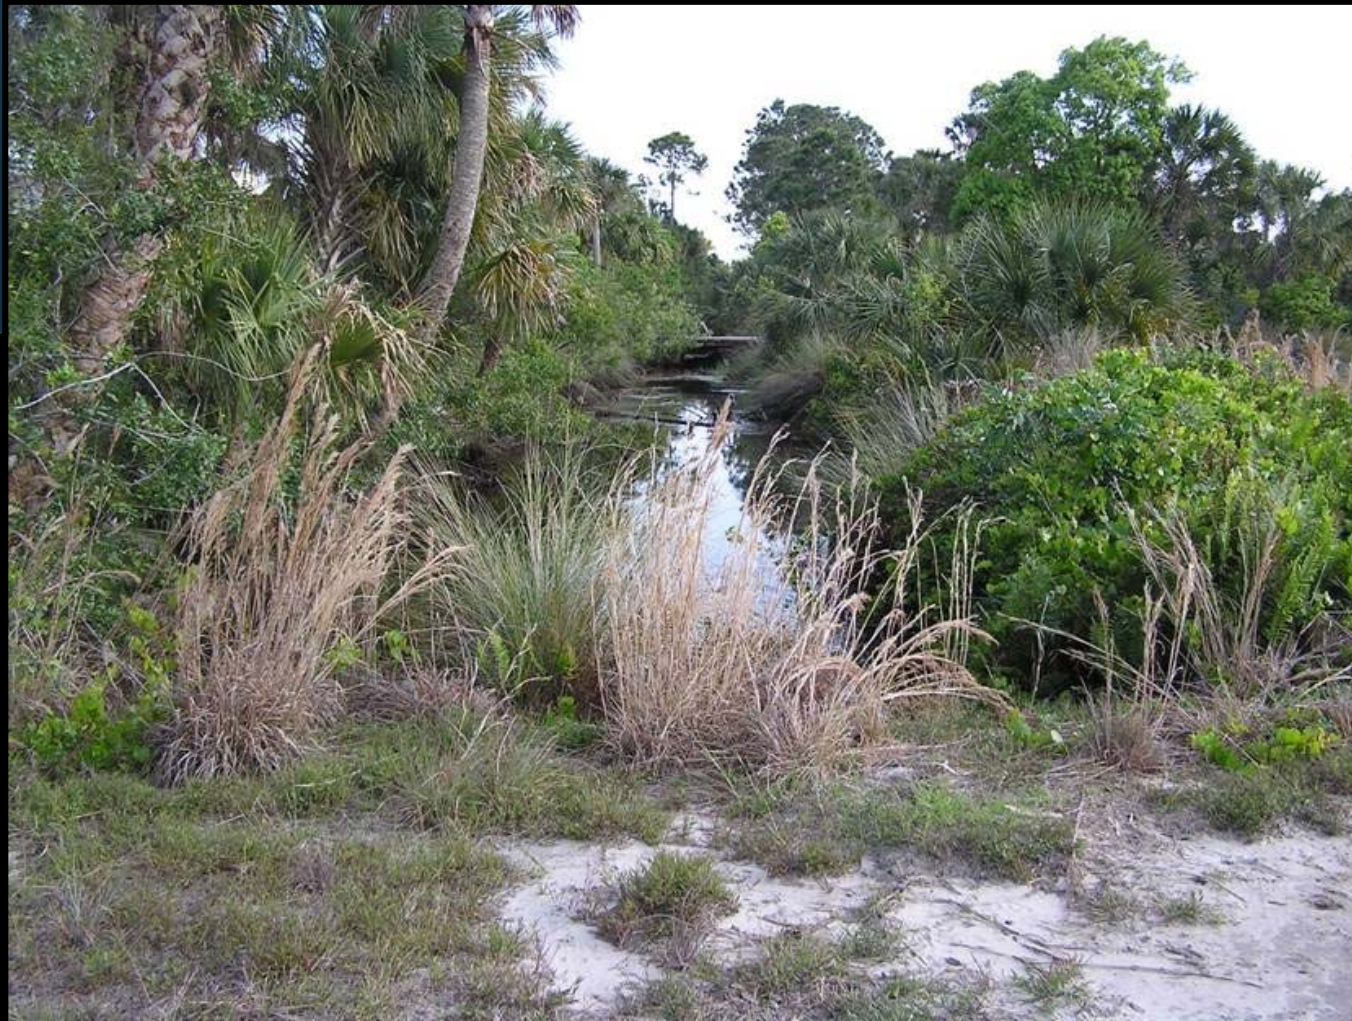
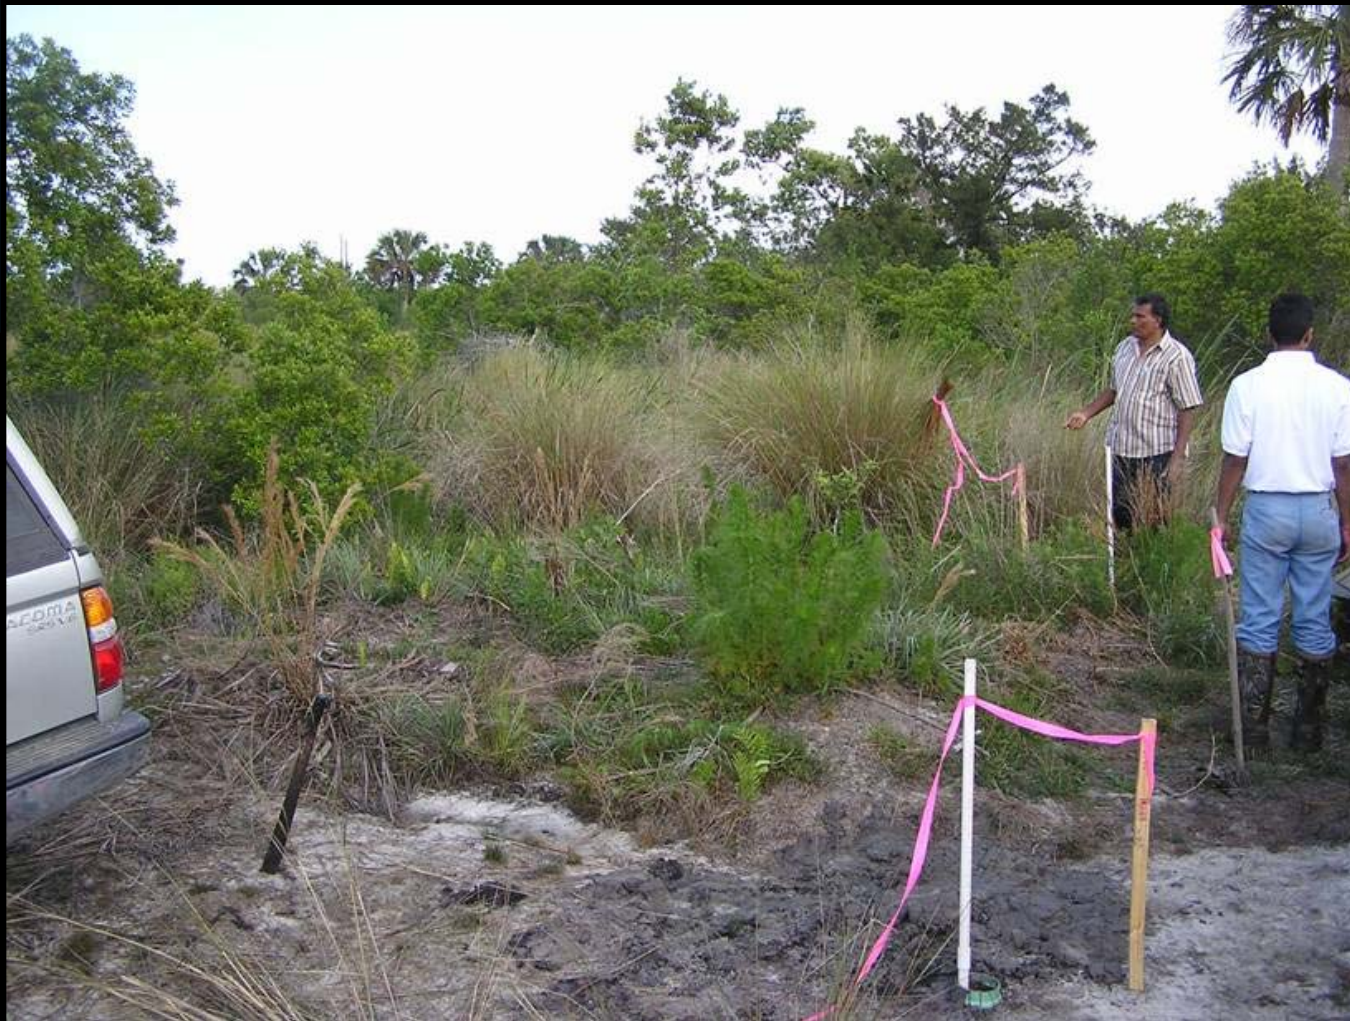
**Site in Brevard County**  
**Photo Date: 2005**

**Topic #19:** Claims that ditching (or adjustments to control levels on ditches) within agency property has effectively drawn down the water table for large distances from the bank of the edge, thus increasing the infiltration potential and reducing stormwater runoff.
