# ROADWAY PROJECTS WITH FOCUS ON SUBSURFACE / DRAINAGE & LITIGATION-RELATED ISSUES

## 2011 FACERS Annual Conference

- Devo Seereeram, Ph.D., P.E.  
Devo Engineering

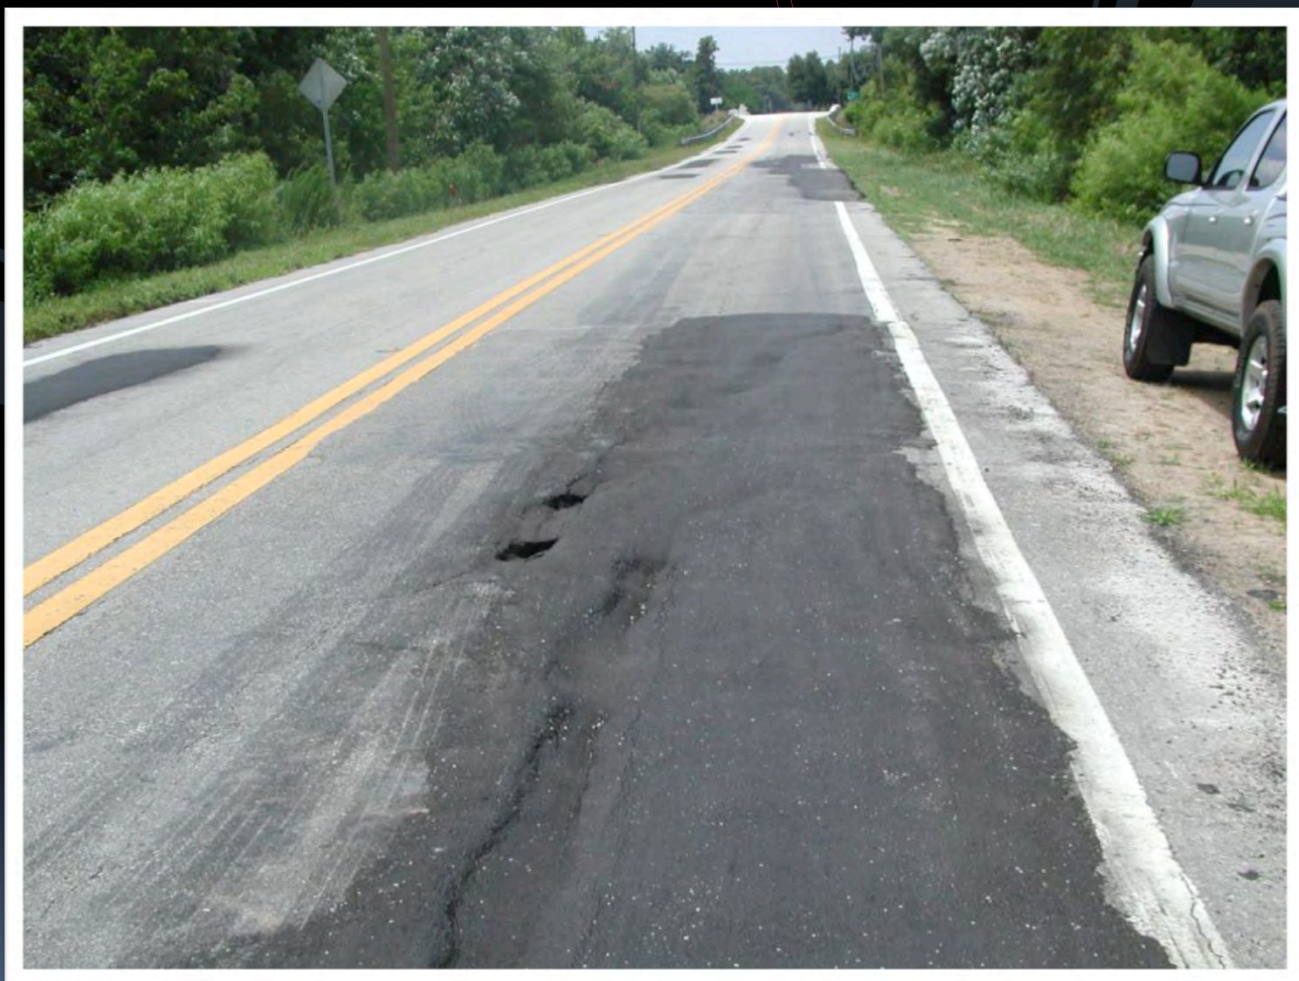
# Country Road 561

Continued pavement distress after patch

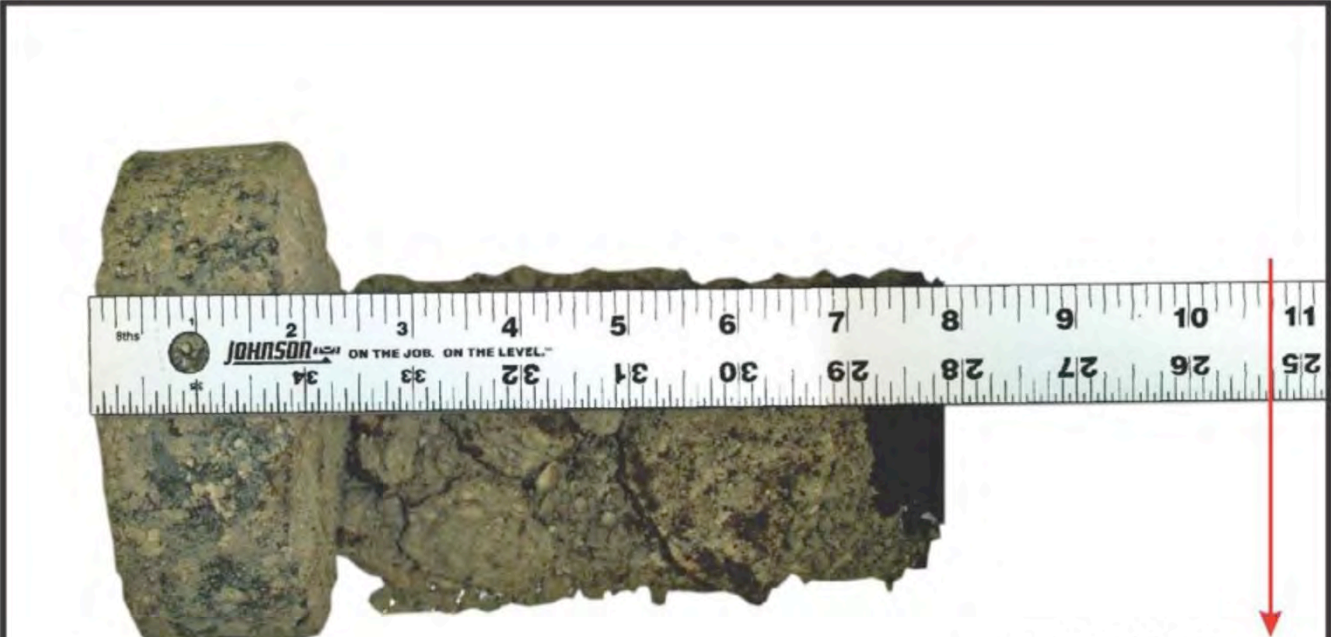
# Lake Underhill Road

# Corroding Sand-Shell-Cement Base

\* Portion of sample crumbled and unrecoverable during coring & extraction

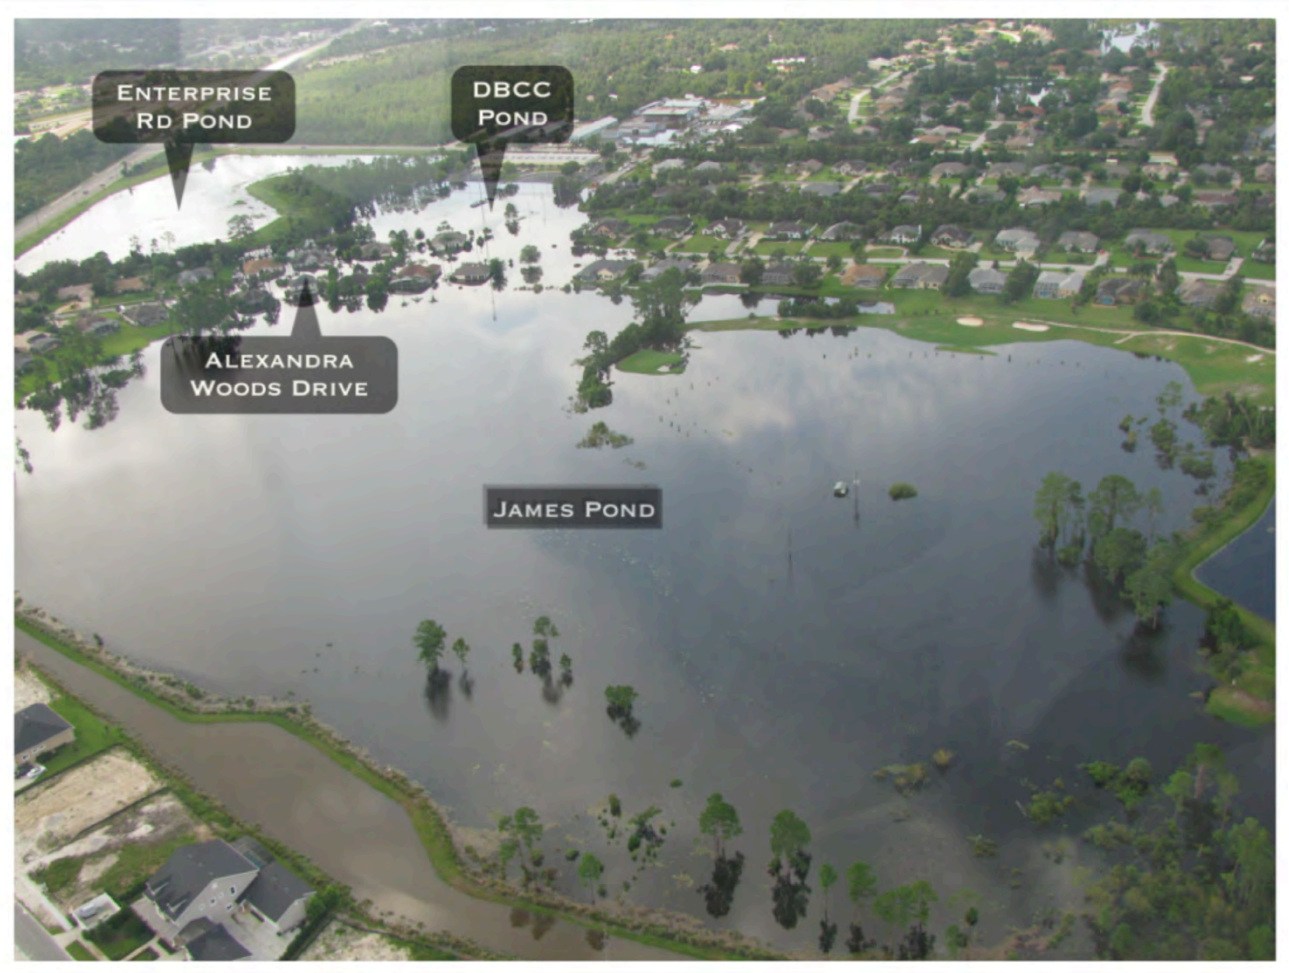
James Pond (9 structures flooded)

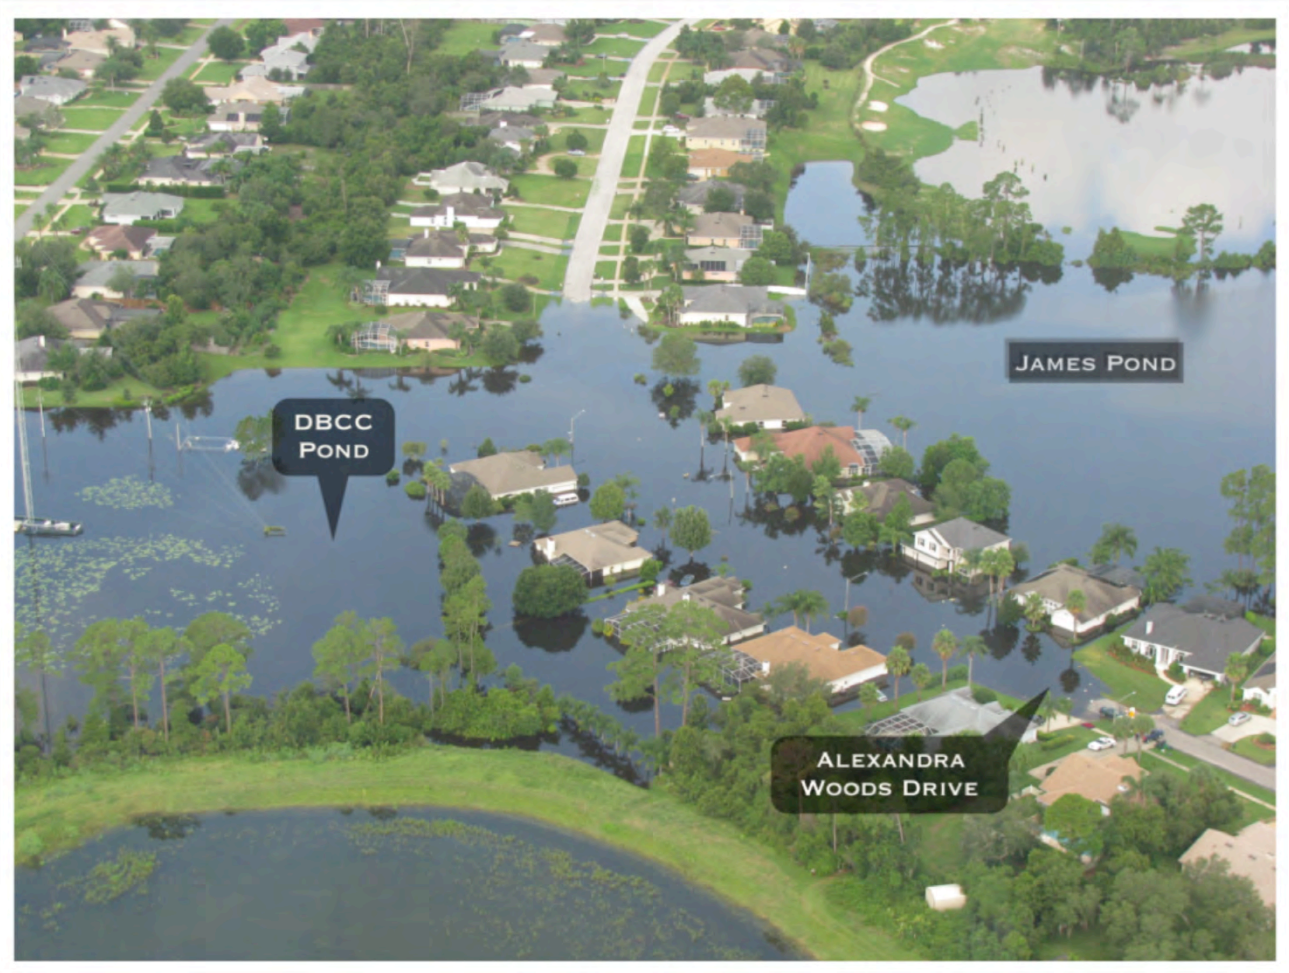
James Pond (9 structures flooded)

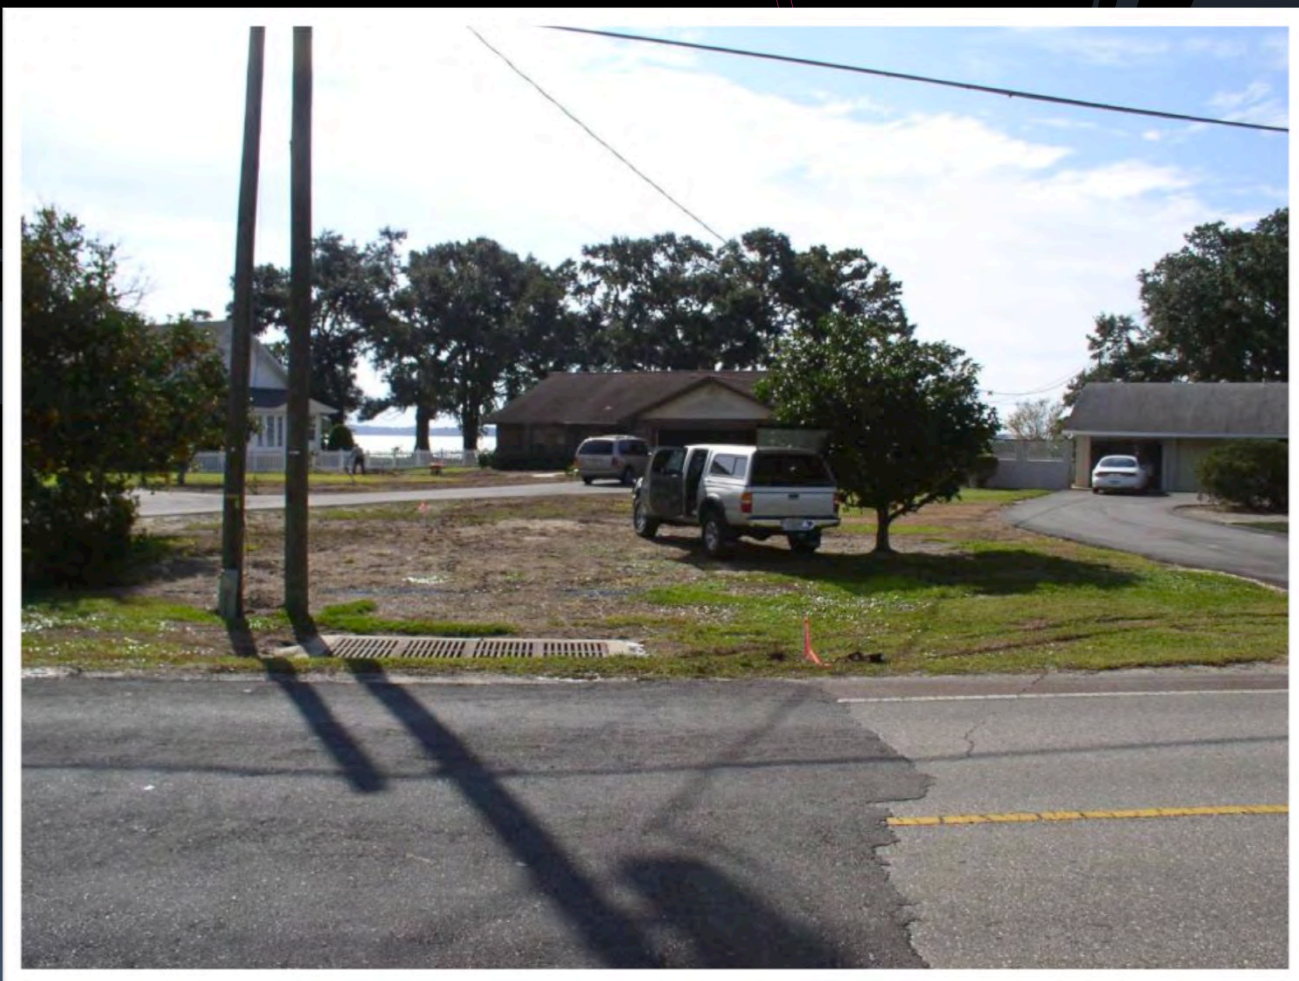
Loss of soil & settlement distress at pipe crossing

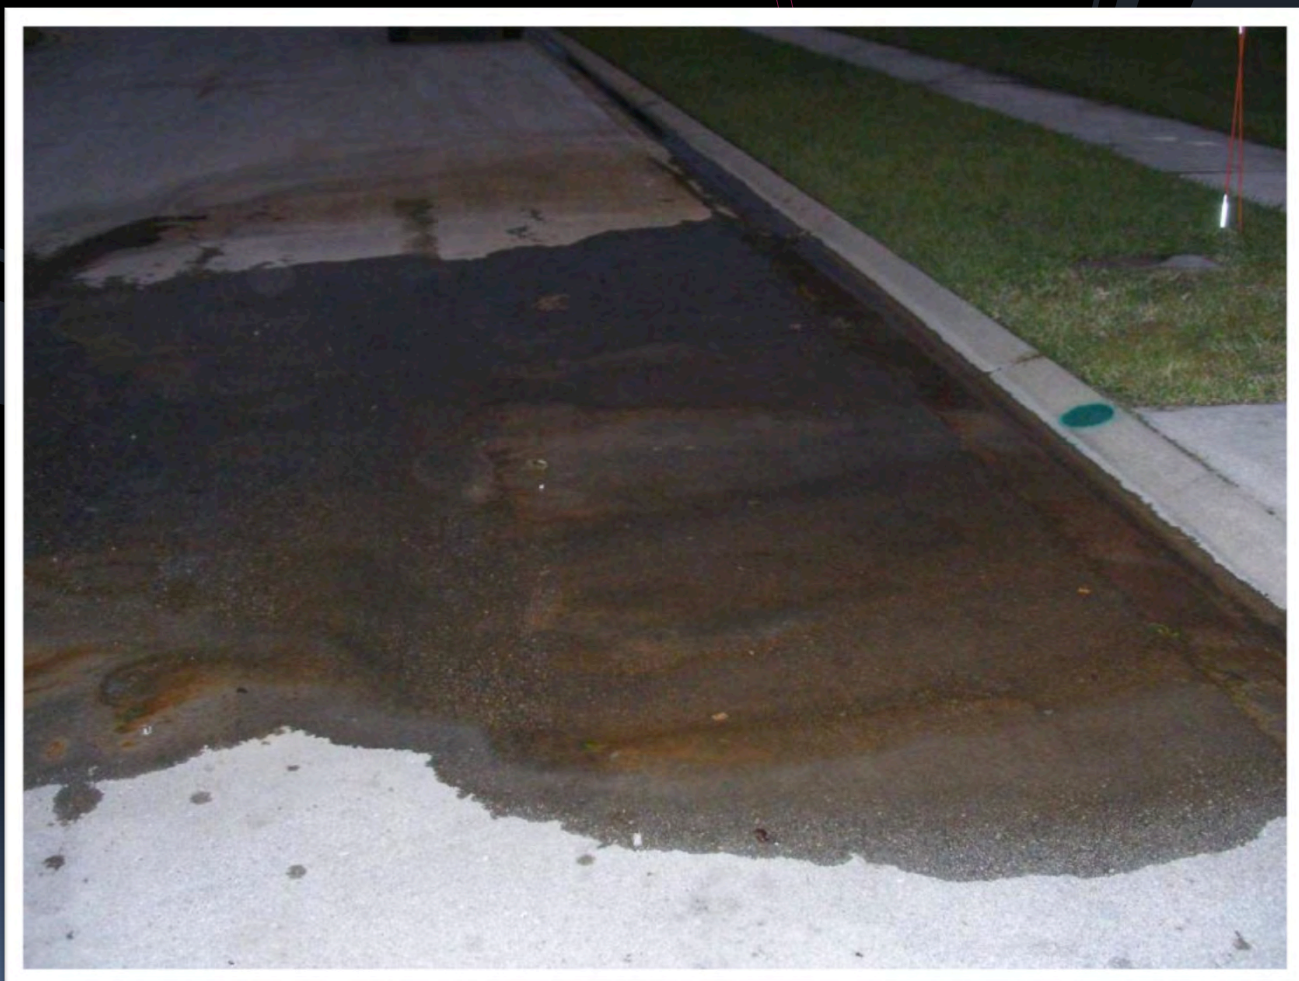
Upward Seepage Beneath Pavement

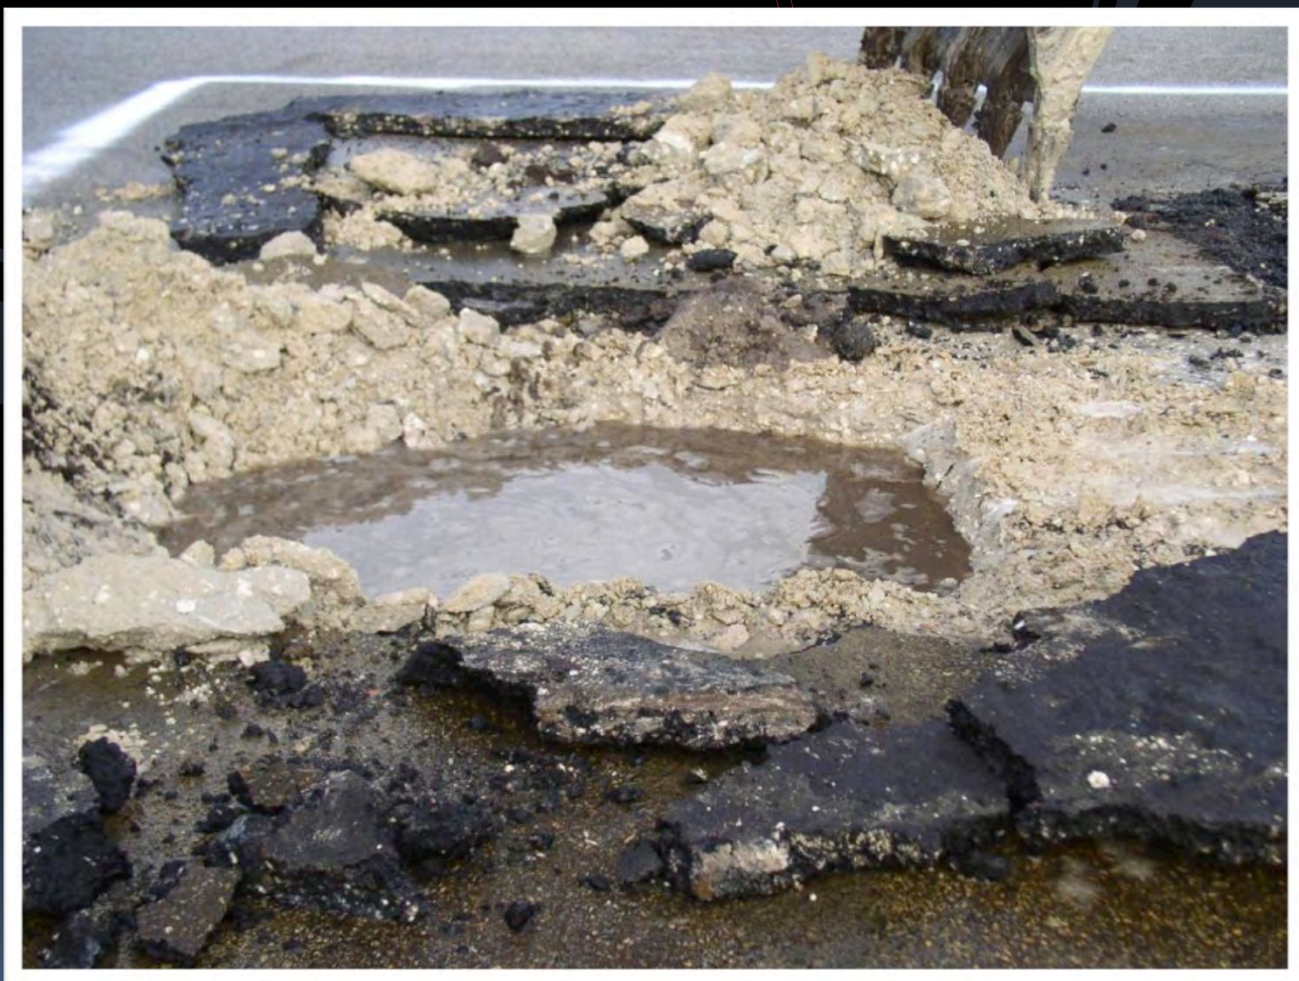
Field Investigation and Excavation

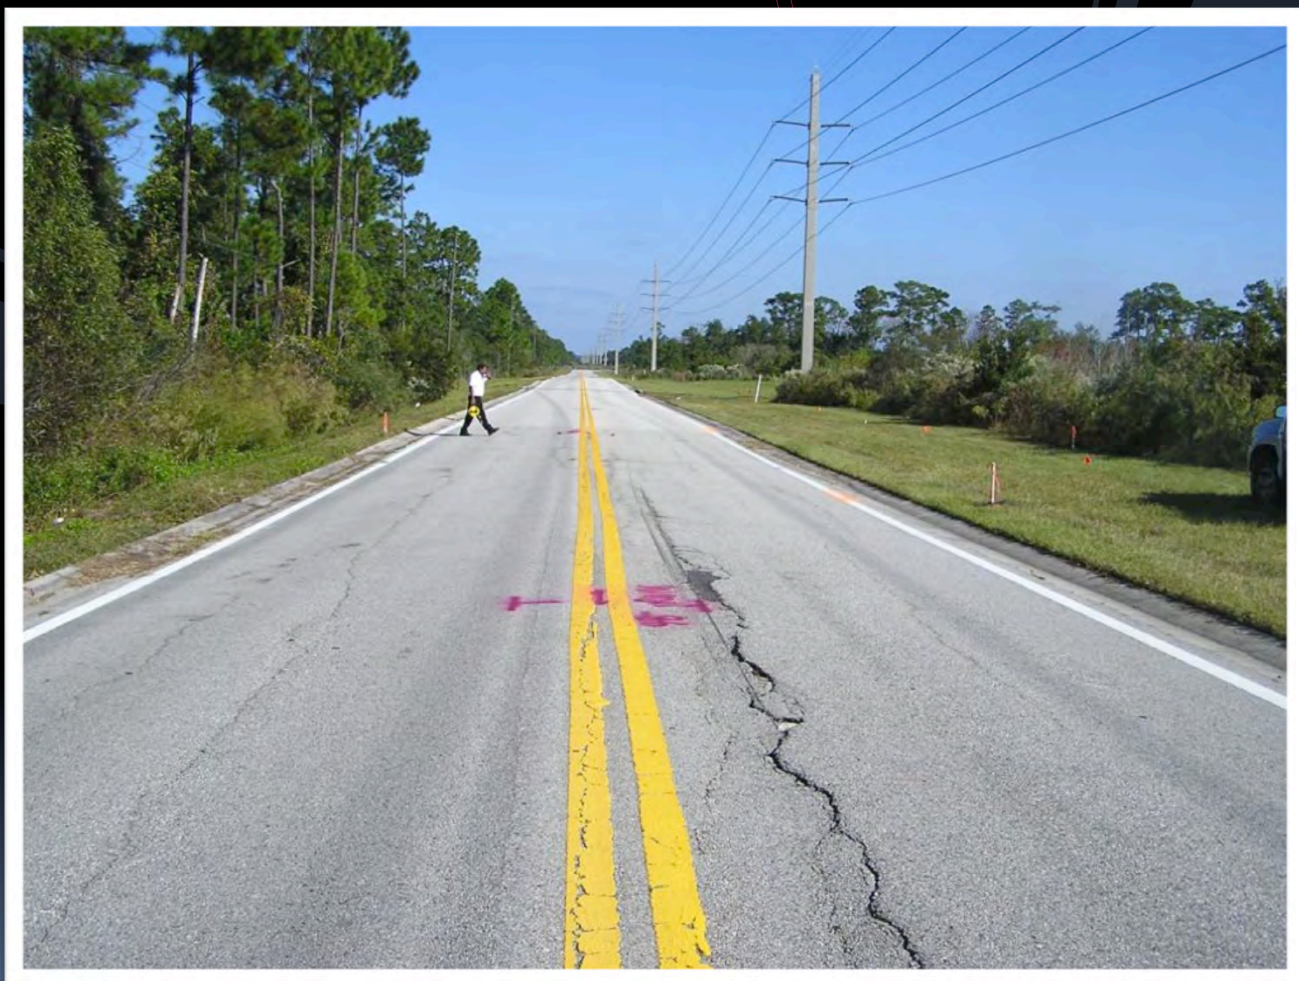
Photos of Distress

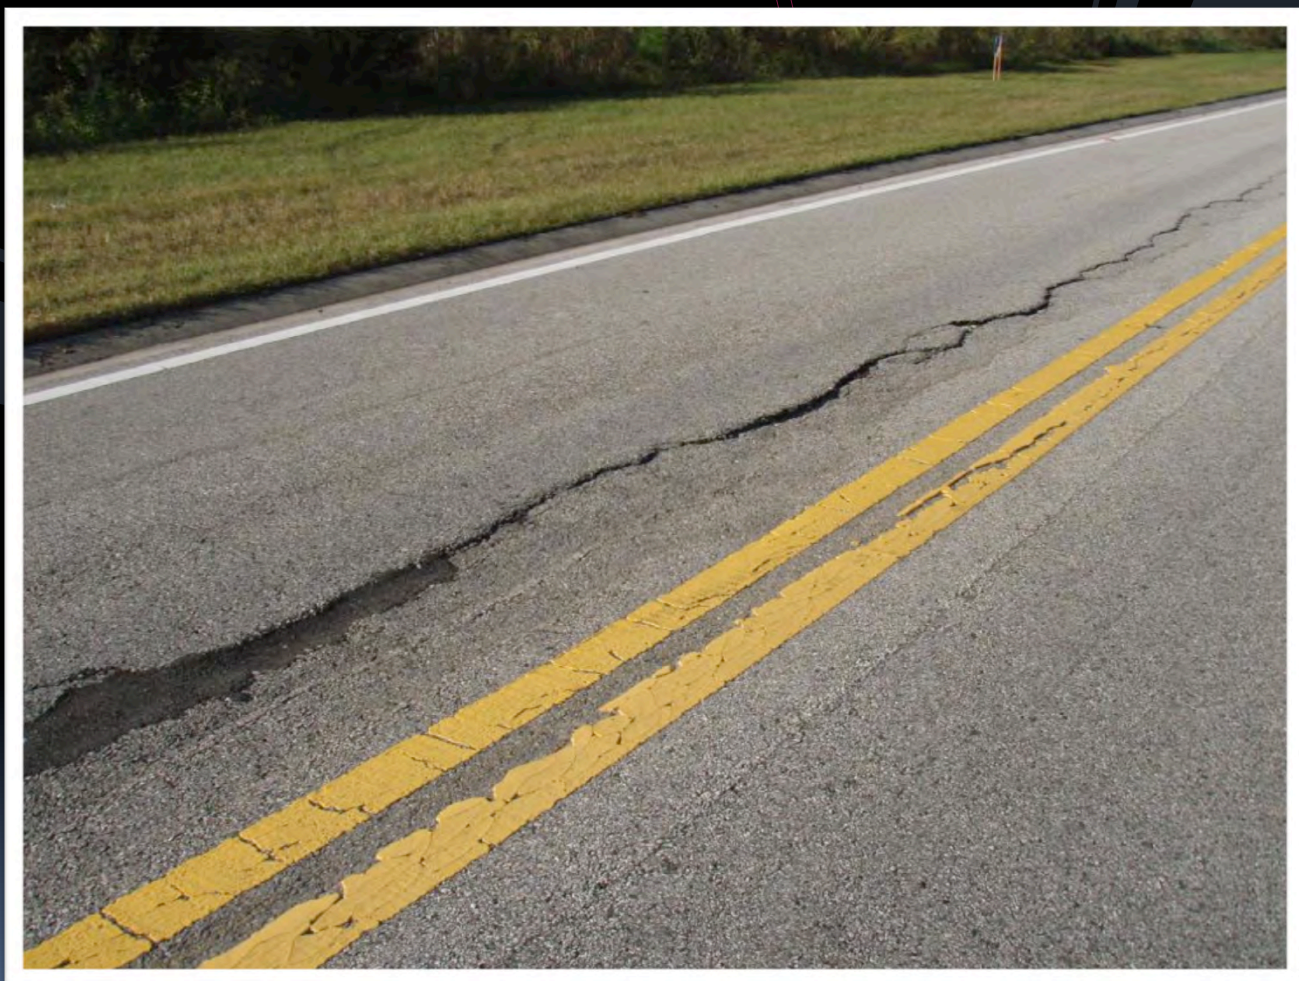
Photos of Distress

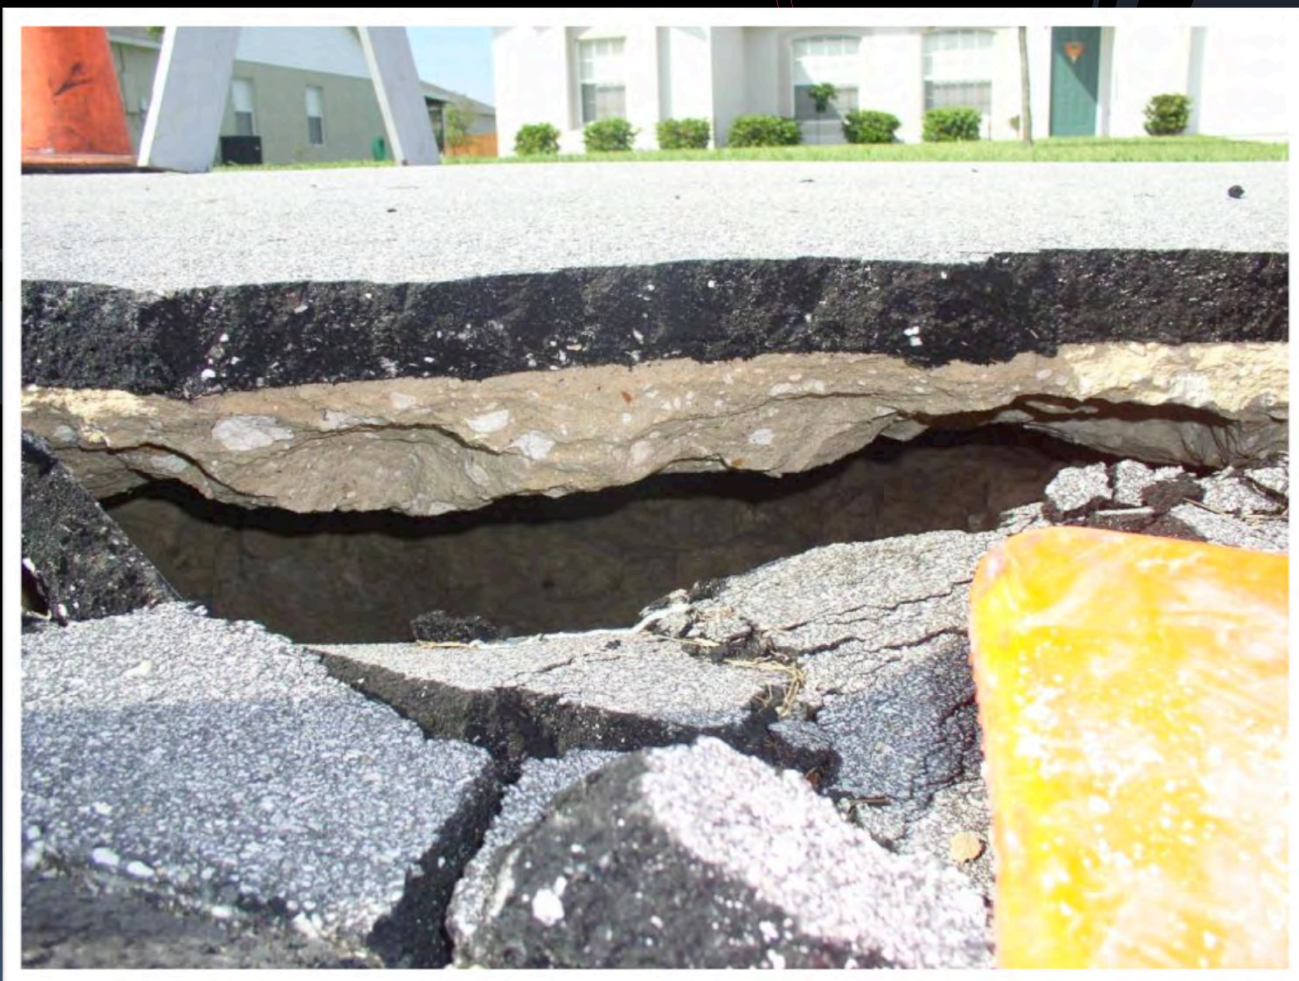
# Loss of soil around manholes - Lakeview Preserve

Close-up view of "sinkhole"

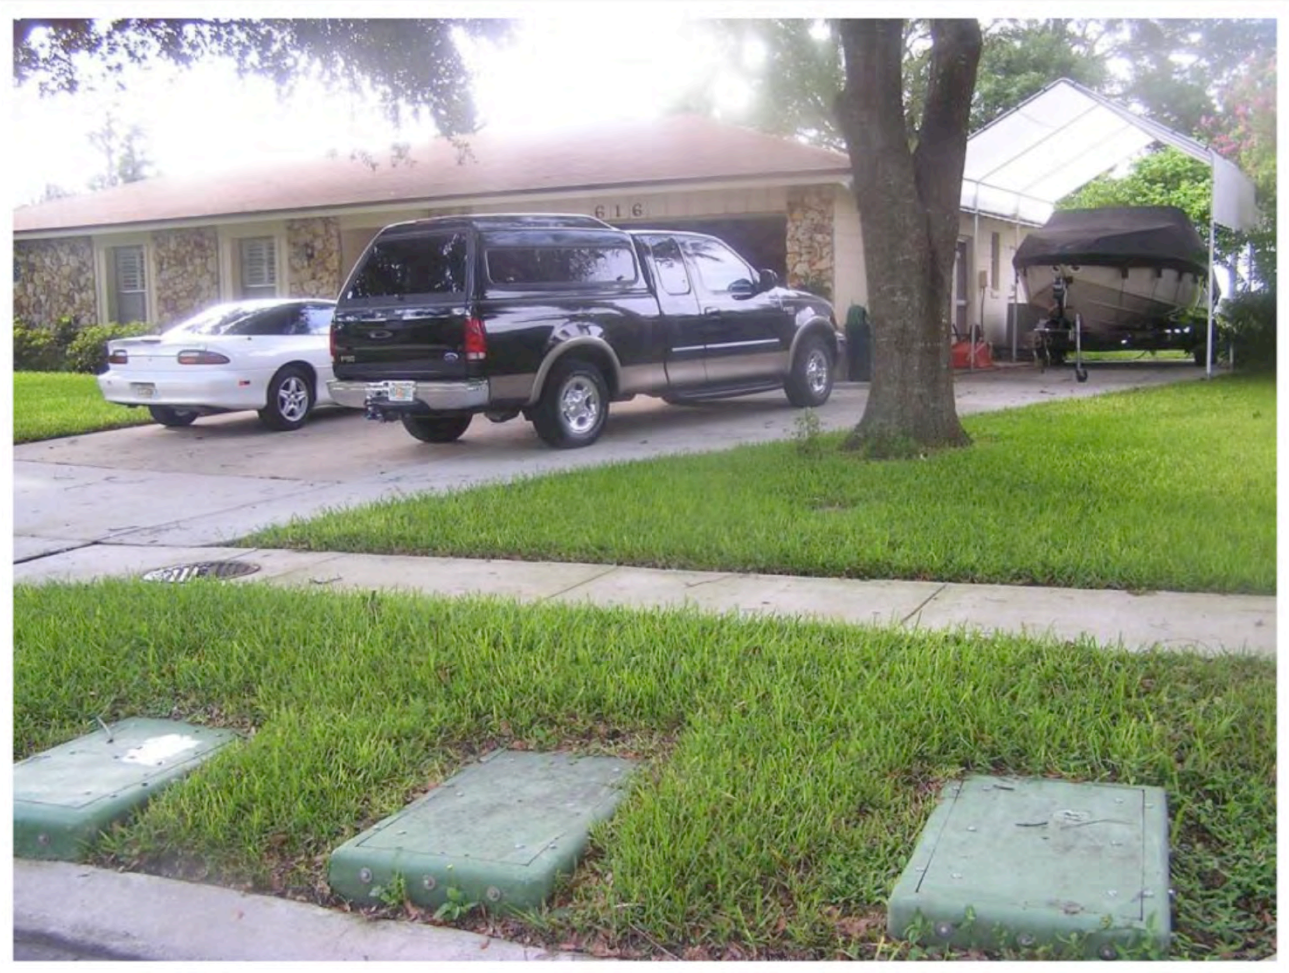
# Settlement of Loose Sand Backfill Around Sediment Removal Structure

Installed structure in landscape strip

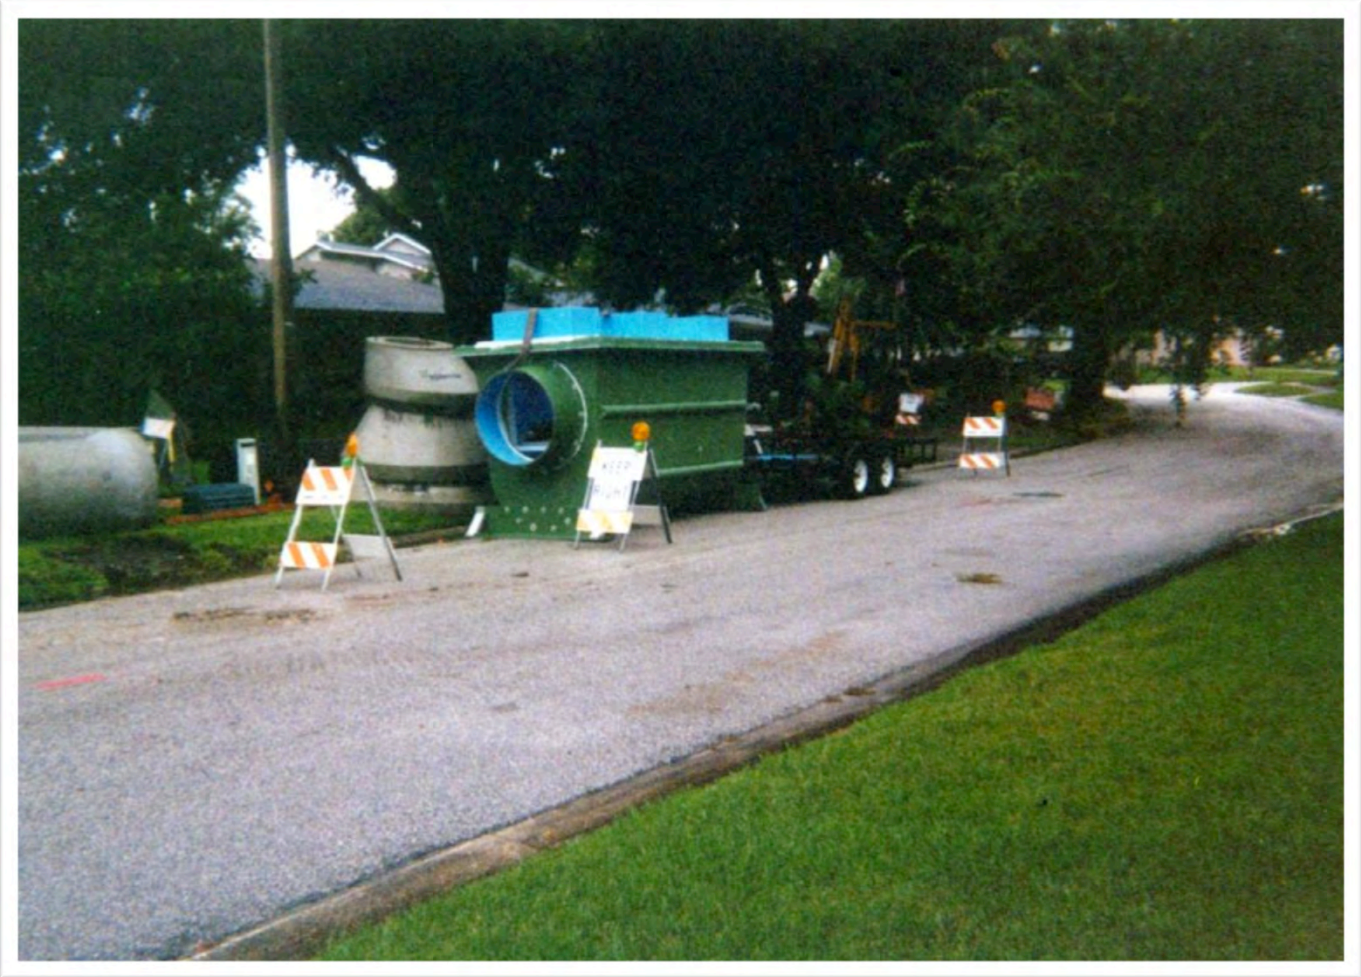
# Settlement of Loose Sand Backfill Around Sediment Removal Structure

Photos of installation

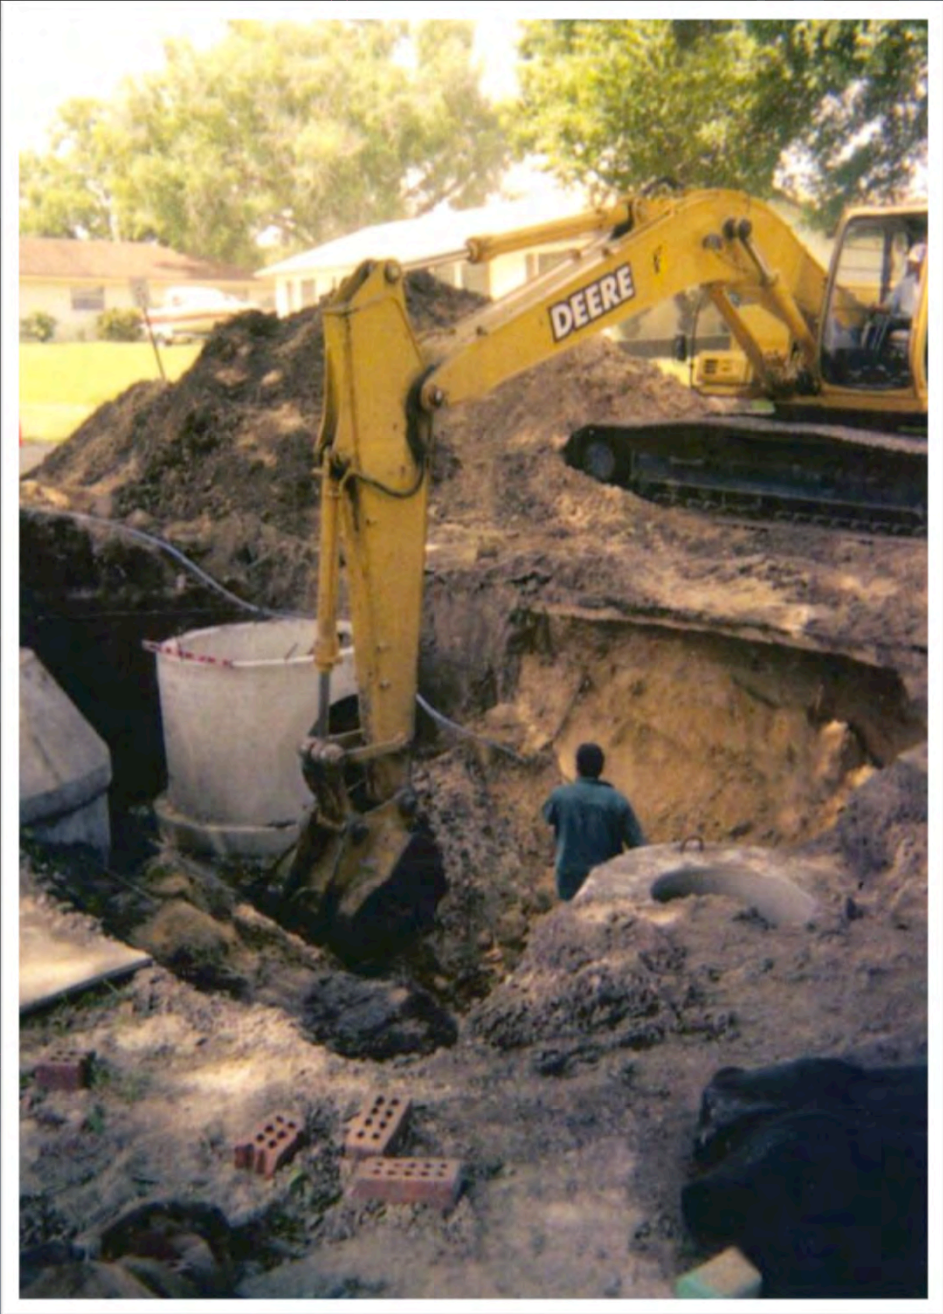
# Settlement of Loose Sand Backfill Around Sediment Removal Structure

Photos of installation
