CONSTRUCTION CONSIDERATIONS

PONDS WORKSHOP - SJRWMD

MAINTAINING LEAKINESS OF POND BOTTOM EXCAVATED IN CLAYEY SAND

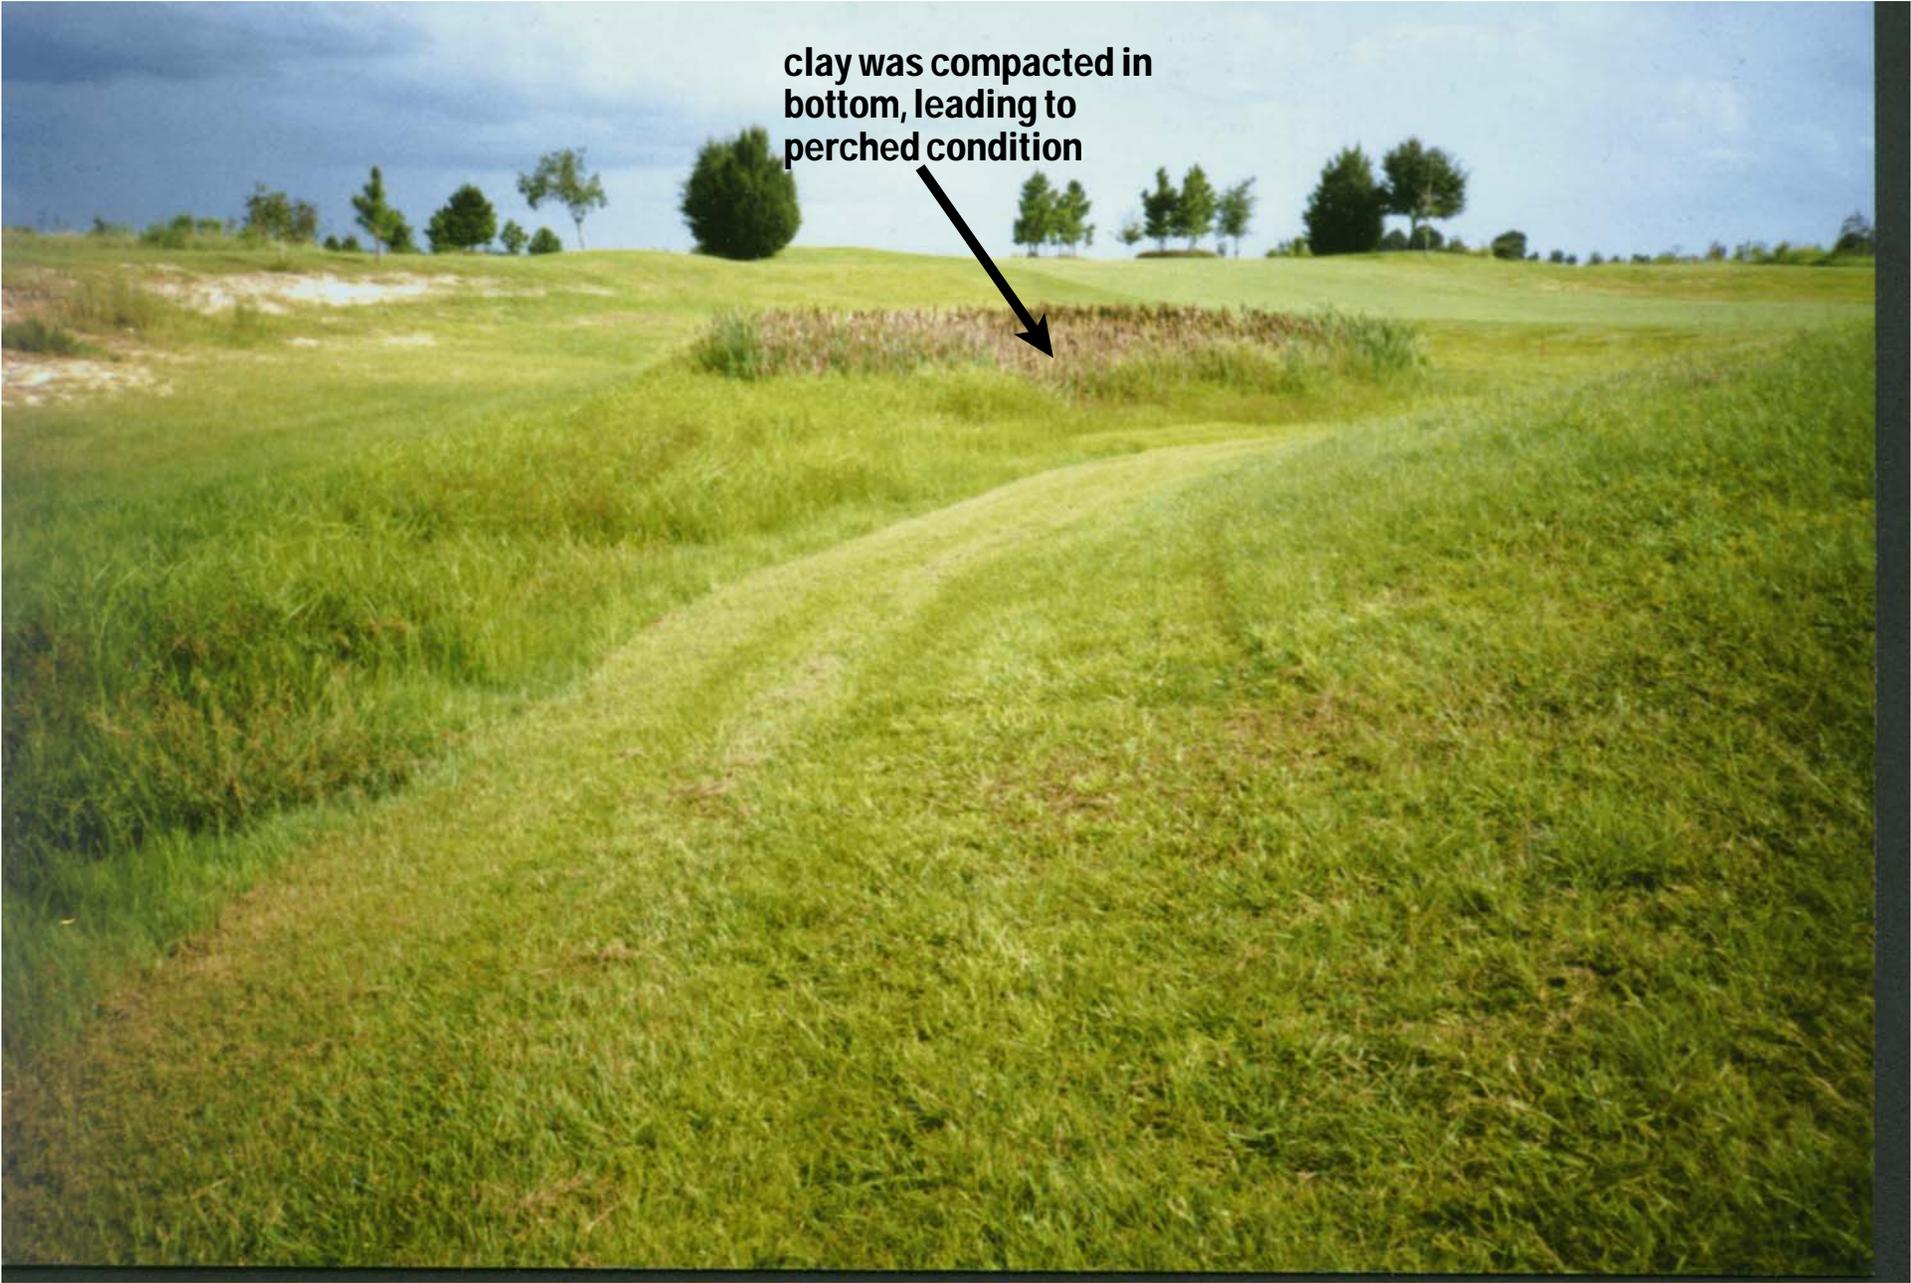
**clay was compacted in
bottom, leading to
perched condition**

- The clayey sands which comprise the lower part of the limestone overburden in most of Marion County & surrounding areas are relatively leaky and the water table level generally corresponds to the potentiometric surface of the Floridan aquifer. While the clayey sands can be relatively impermeable on a small scale (and when remolded/compacted), the unit as a whole is leaky due to micro-cracks and fissures which are vertically interconnected and extend into the limestone aquifer.

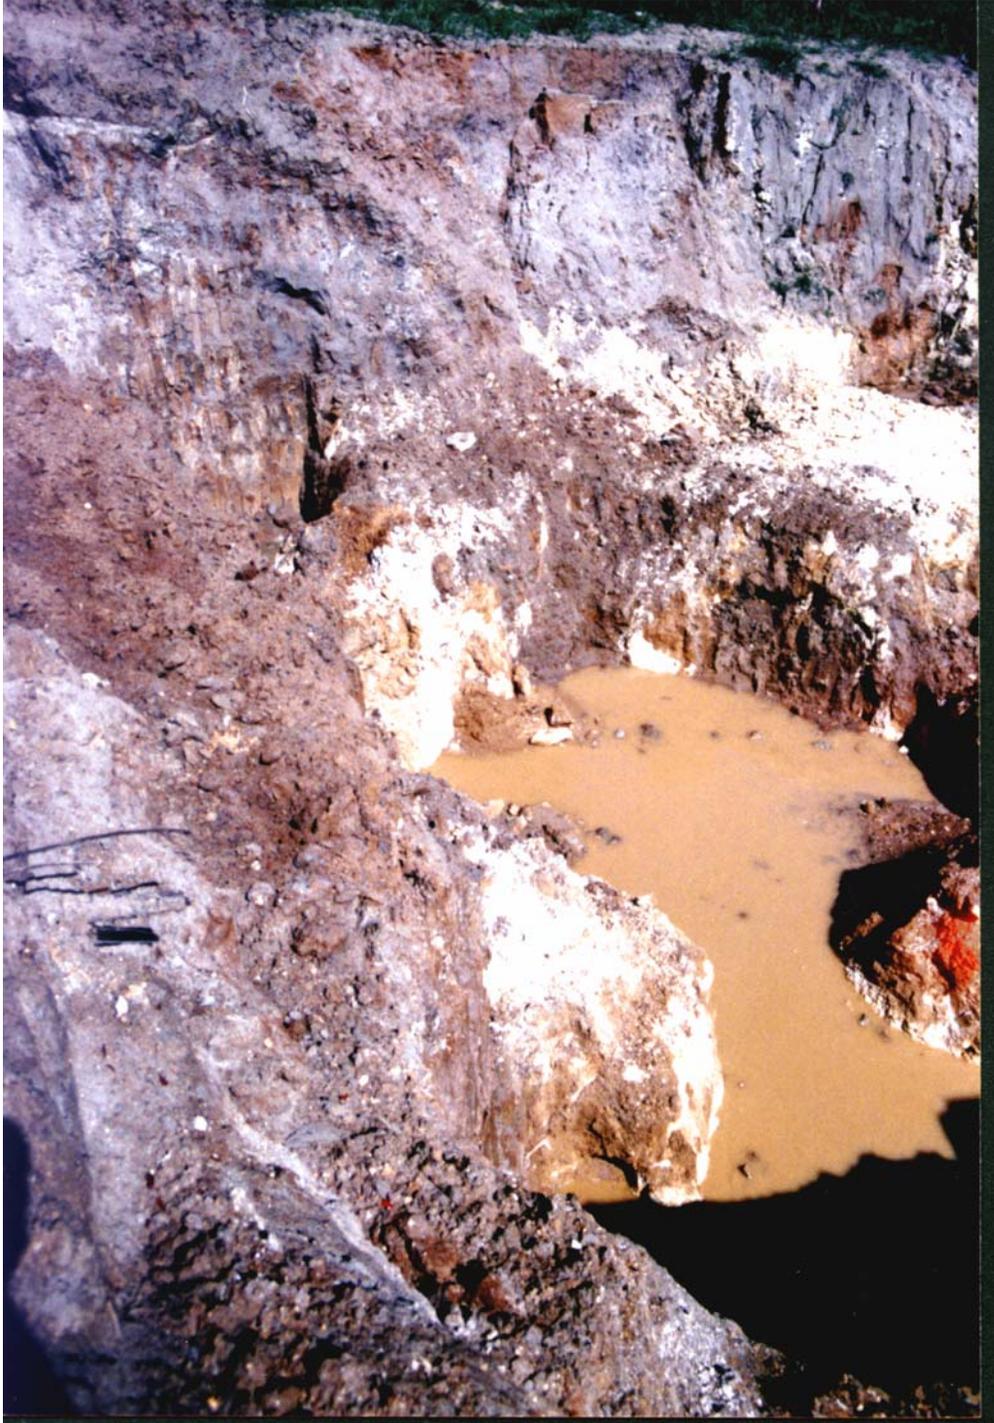
EXAMPLE OF A DEEP EXCAVATION FOR POND RETROFIT
