PART 2

STORMWATER PERMITTING BIG PICTURE ISSUES

STORMWATER 2005

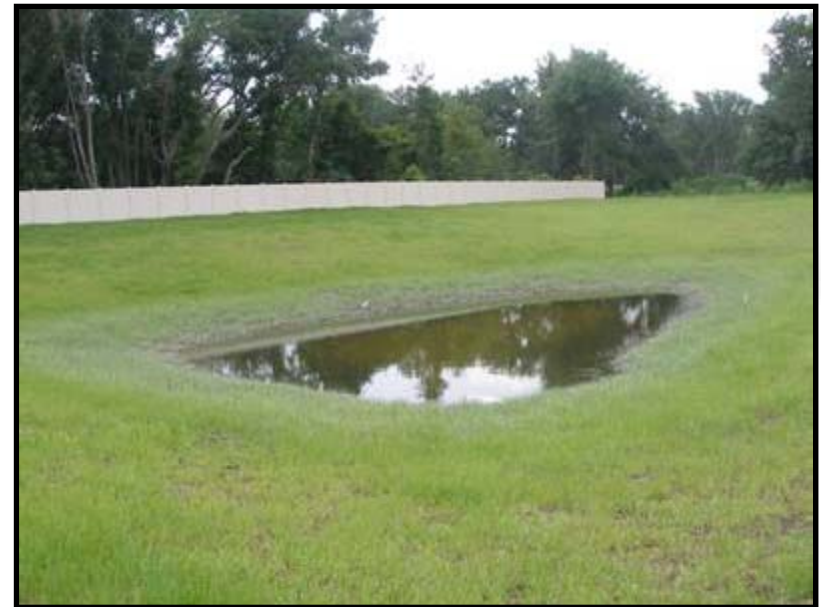
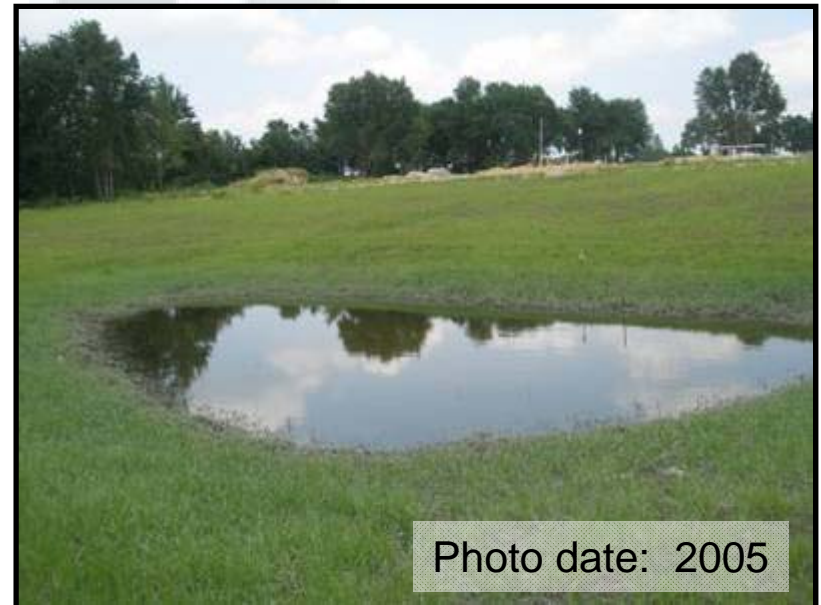
Wekiva Run – Pond 1

Dry Bottom Ponds Excavated into Clayey Soils

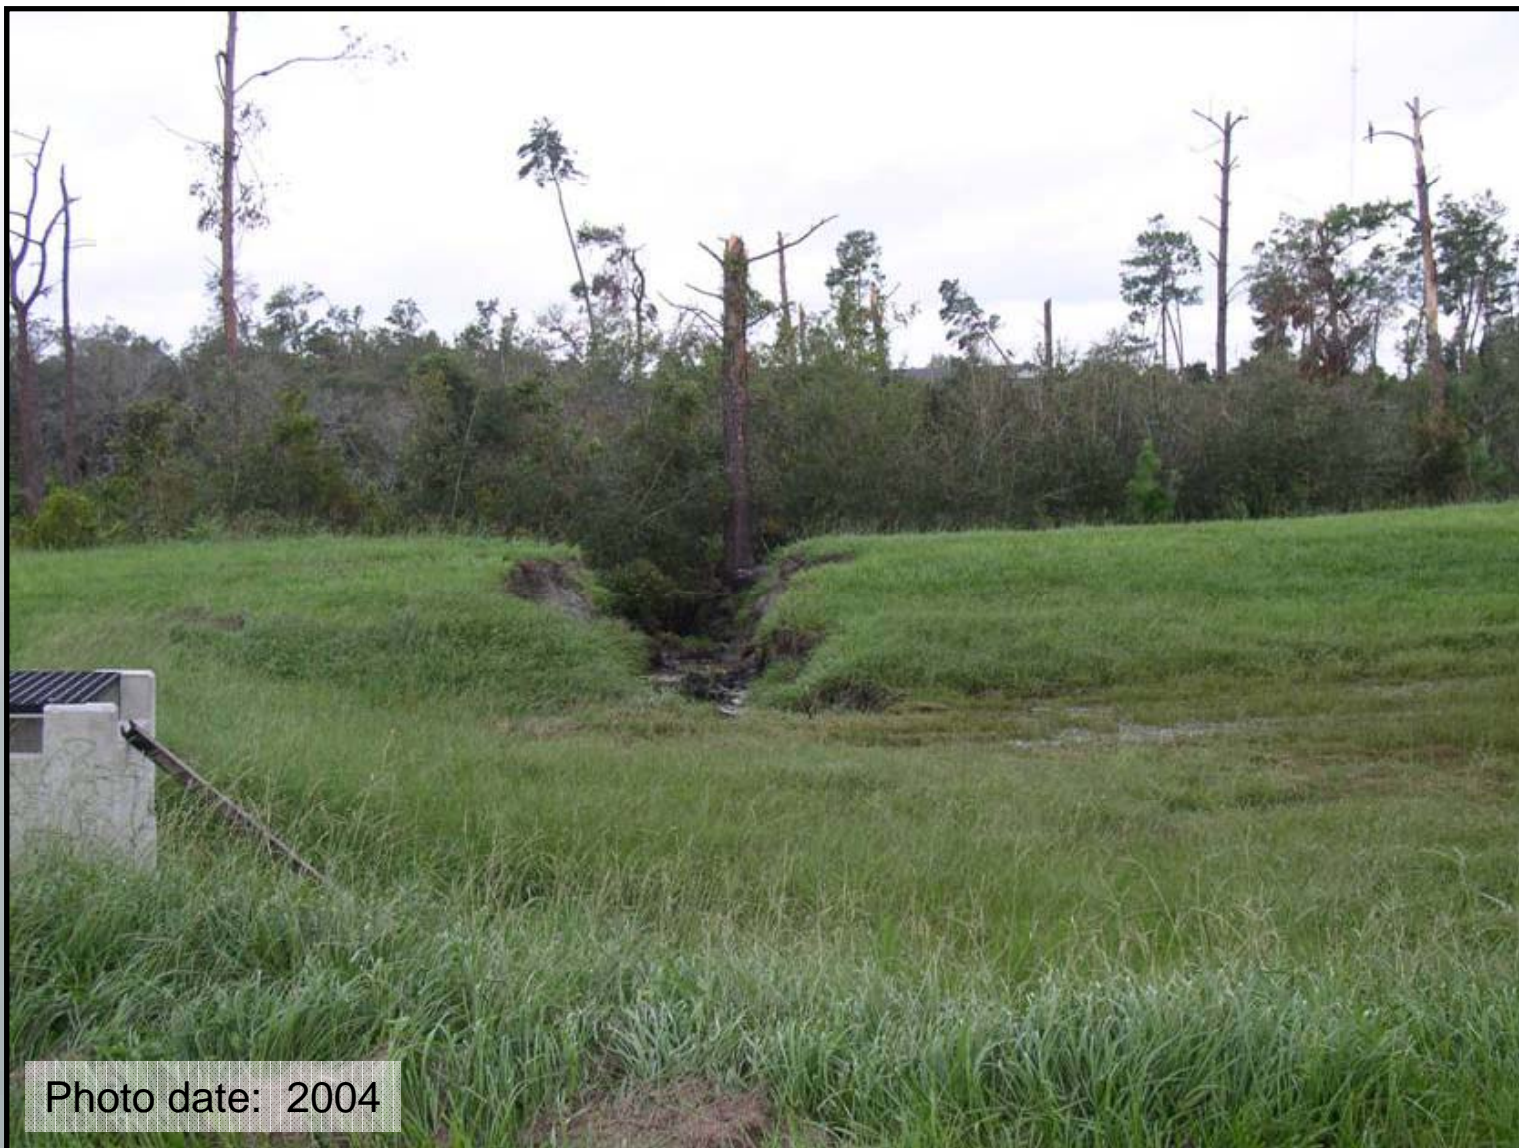
Site in Debarry

Pond Berm Failures & Flooding Consequences

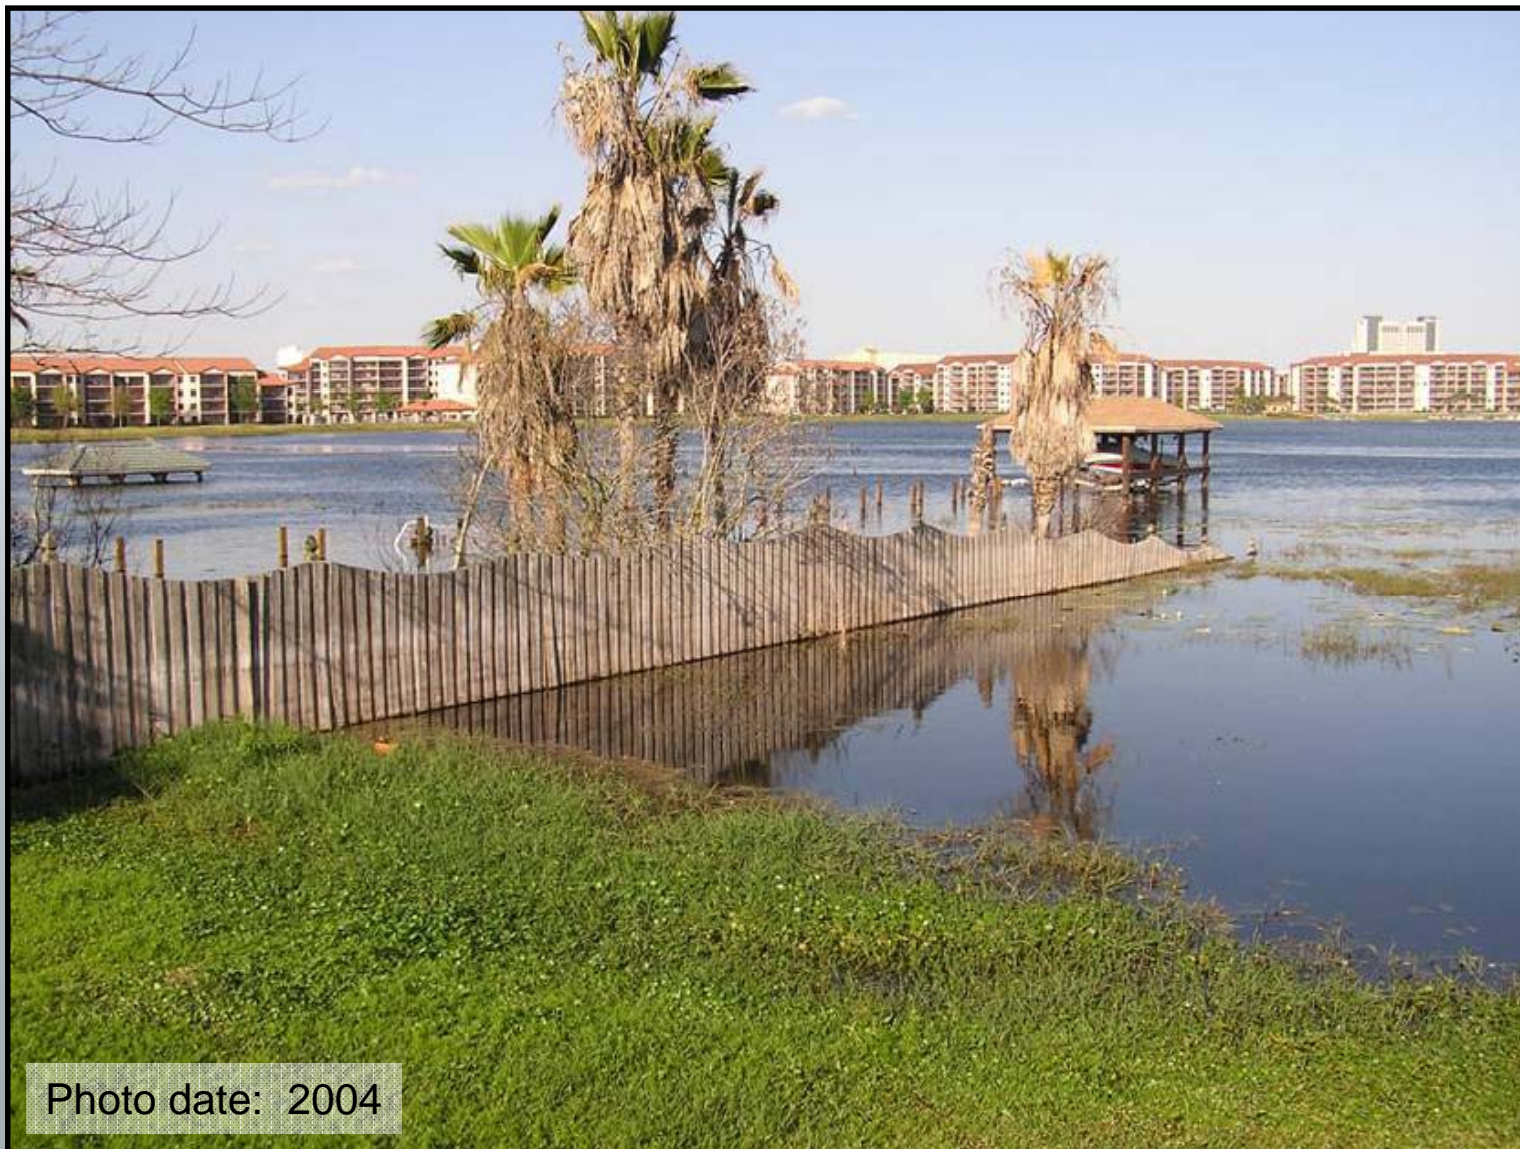
Big Sand Lake

Flooding of Land Locked Lakes

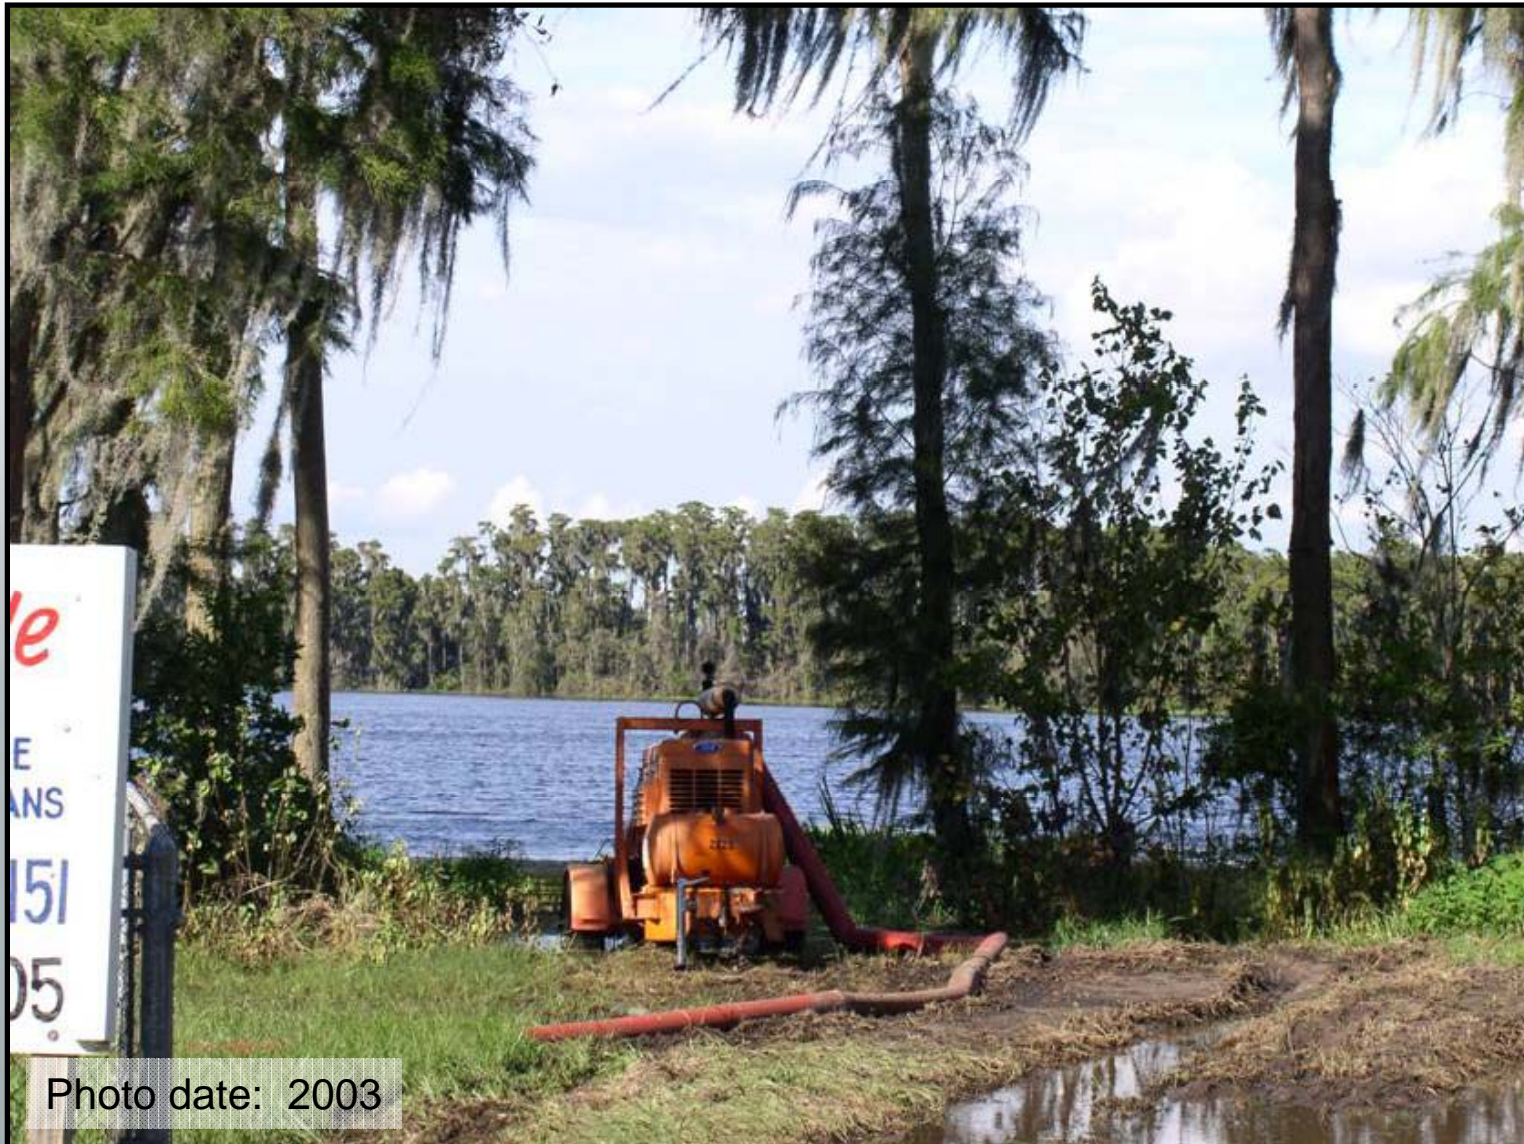
Lake Rexford and Lake Osage, Orange County

Land-Locked Basins Affected by Floridan Aquifer

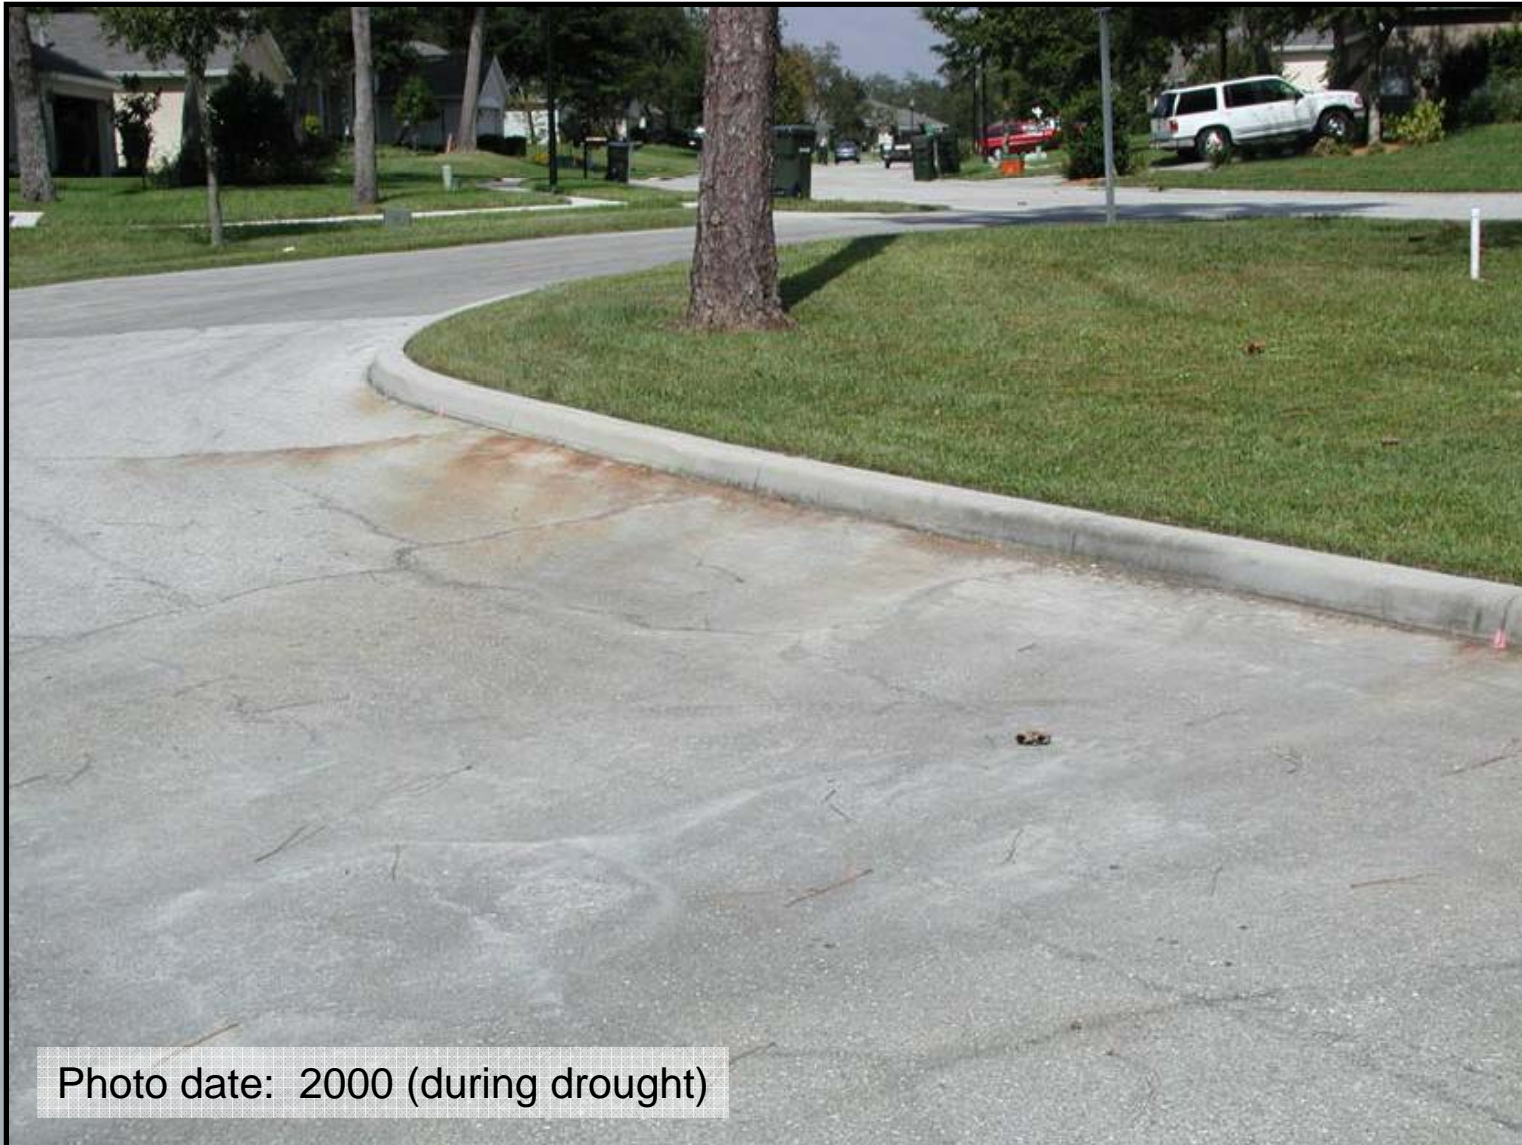
Community Area - Reflections Subdivision in Ocoee

Pavement Failure Due to Grades Cut into Water Table

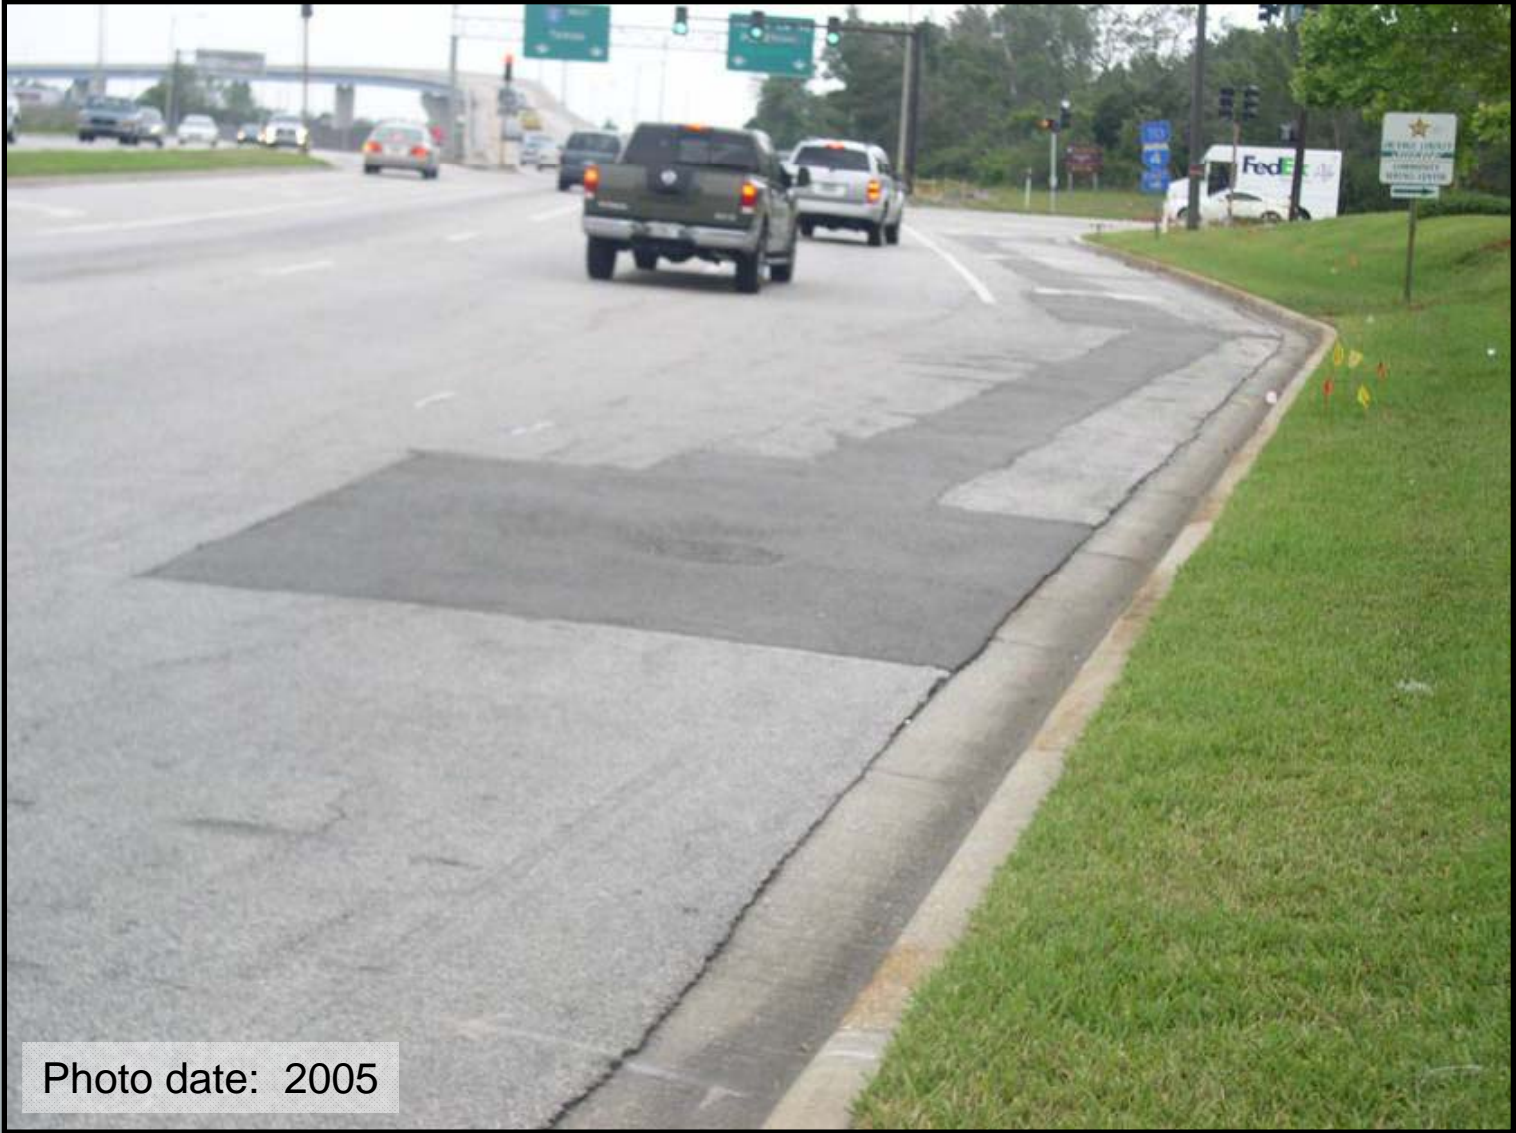
Central Florida Parkway

Pavement Failure Due to Over Irrigation of Landscape Areas

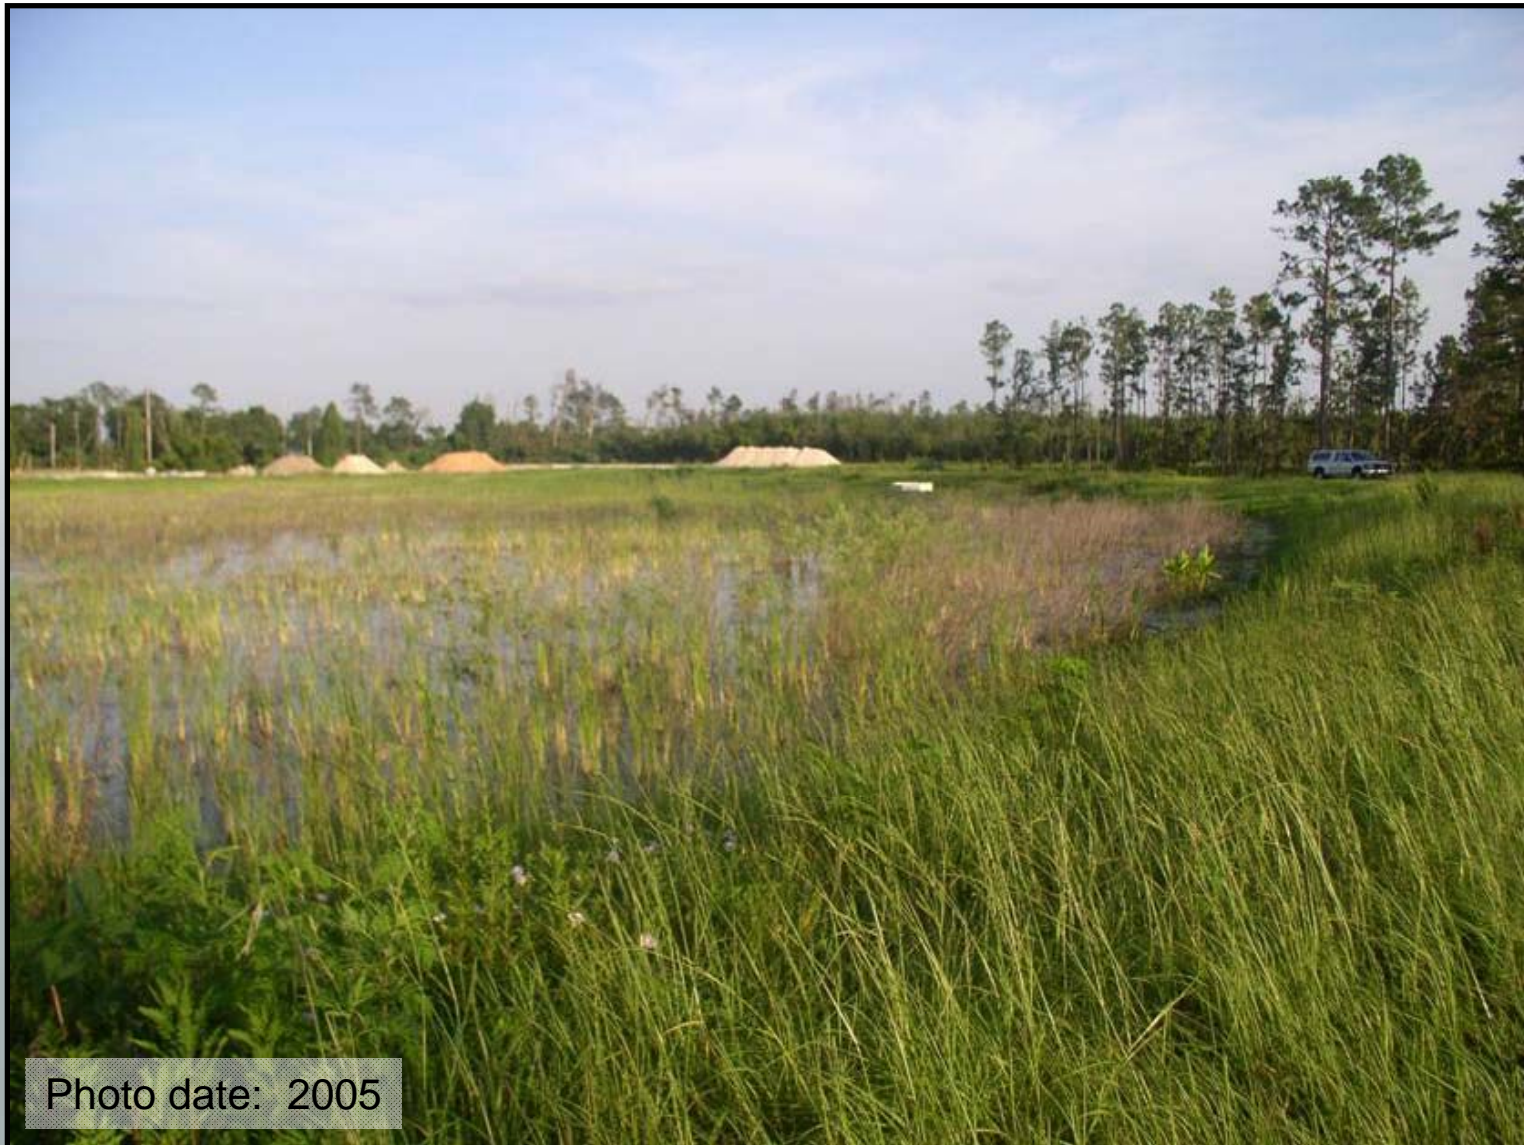
Highbanks and Enterprise Pond

Seepage Through Pond Berms

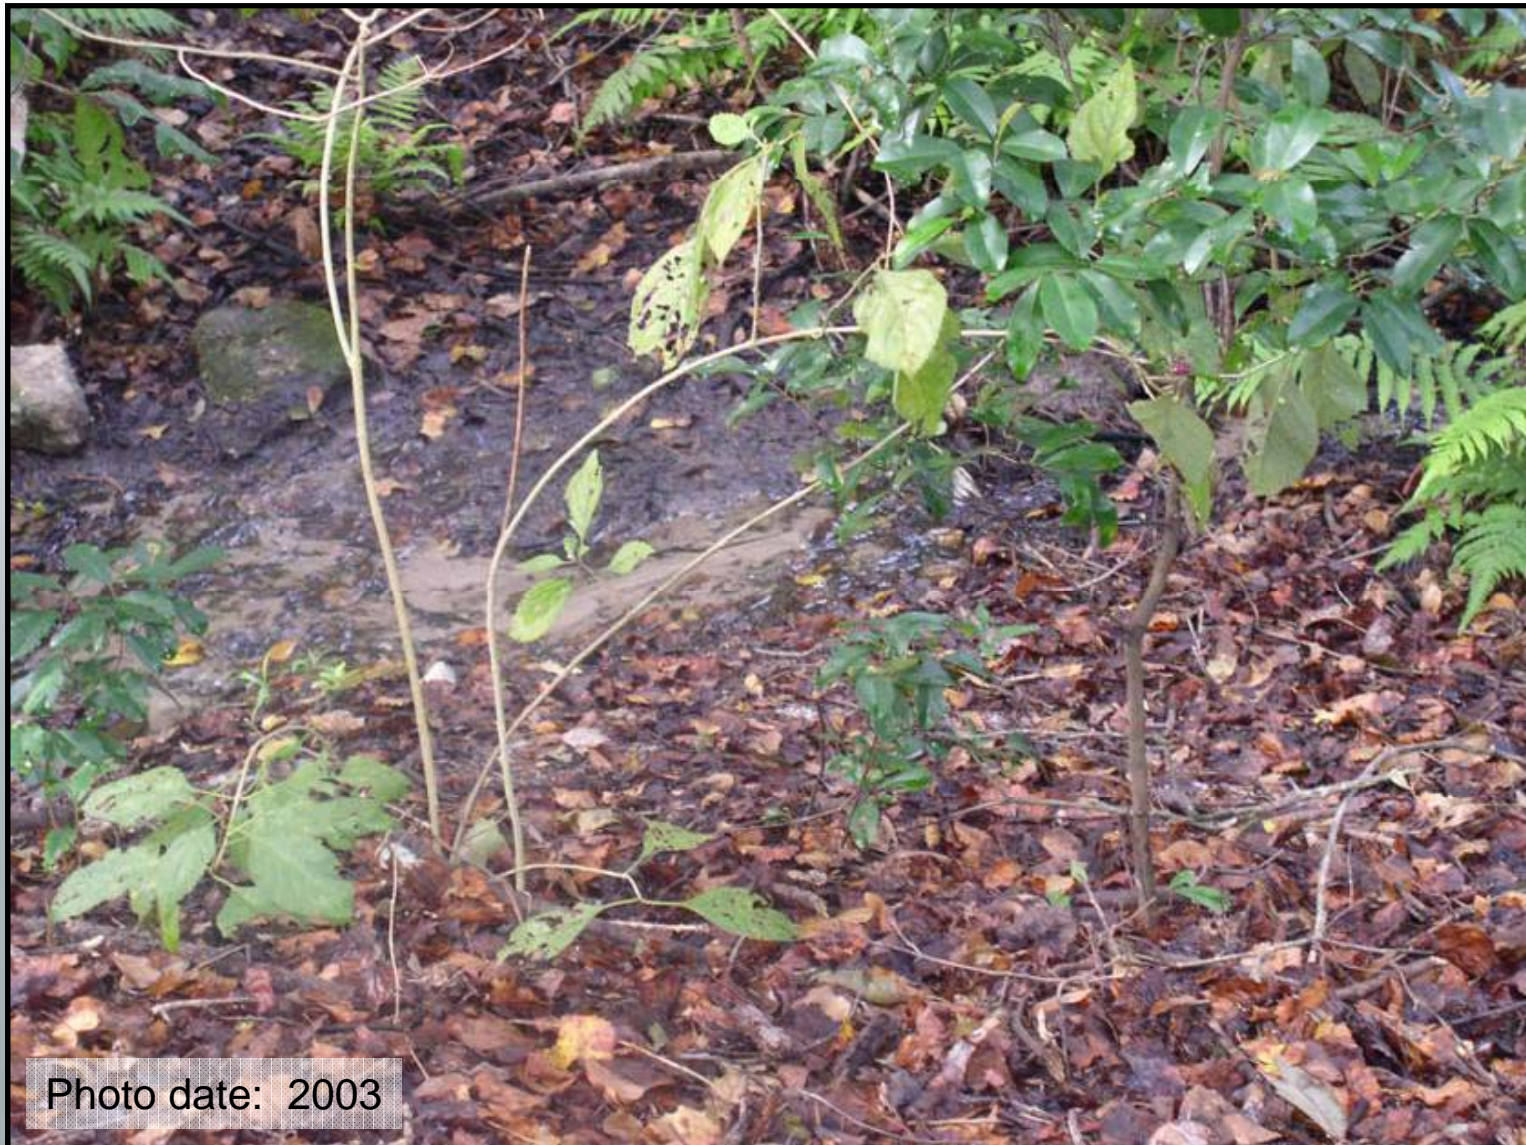
Seepage Faces

Steep upland adjacent to Lake Meadow in Ocoee

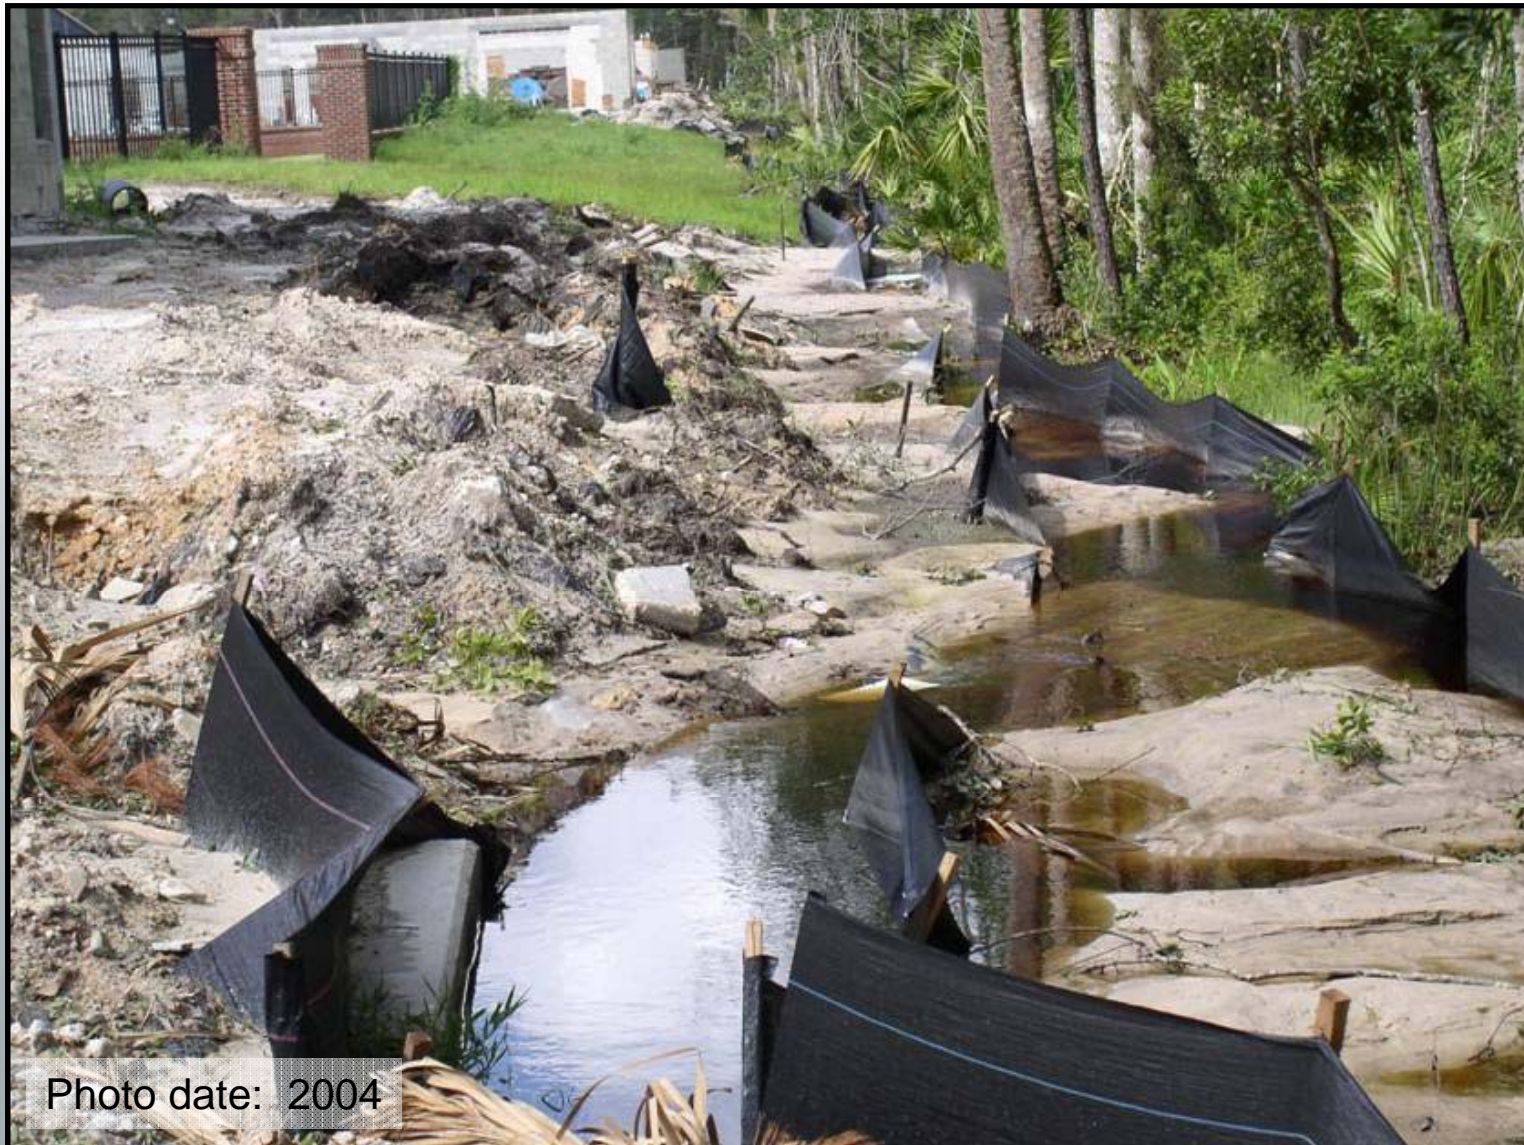
Site in Seminole County

Failure of Erosion Control Measures and Impact to Wetlands

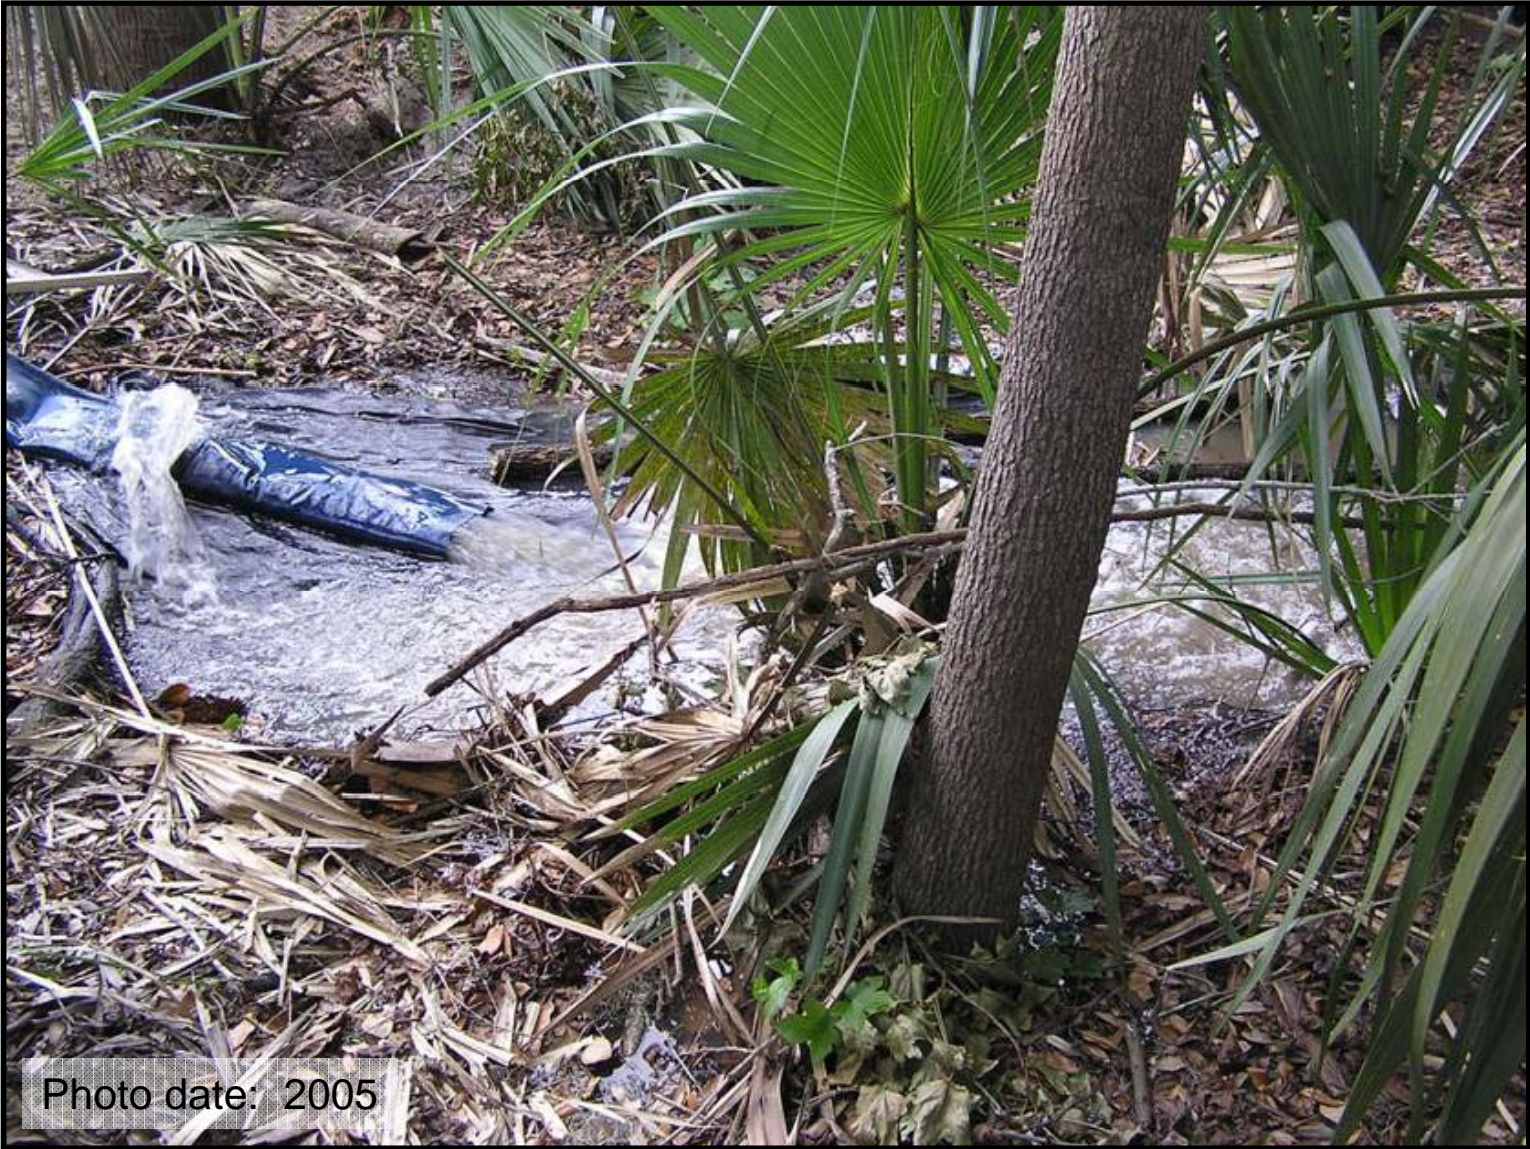
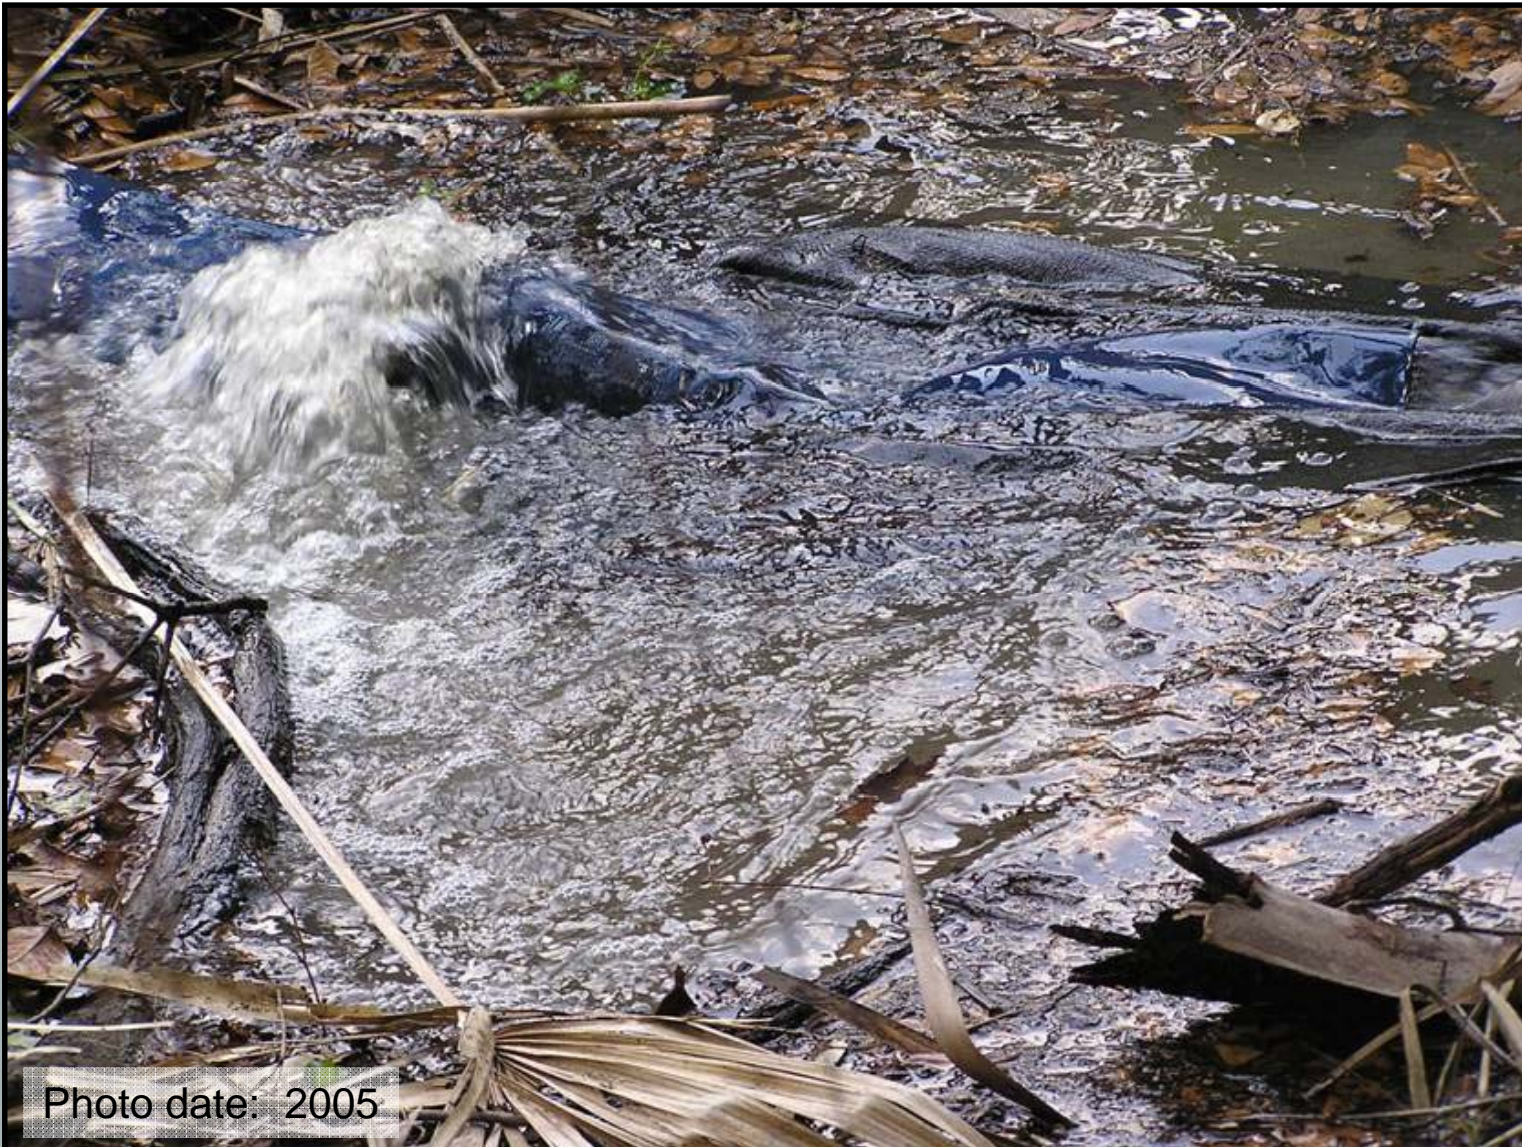
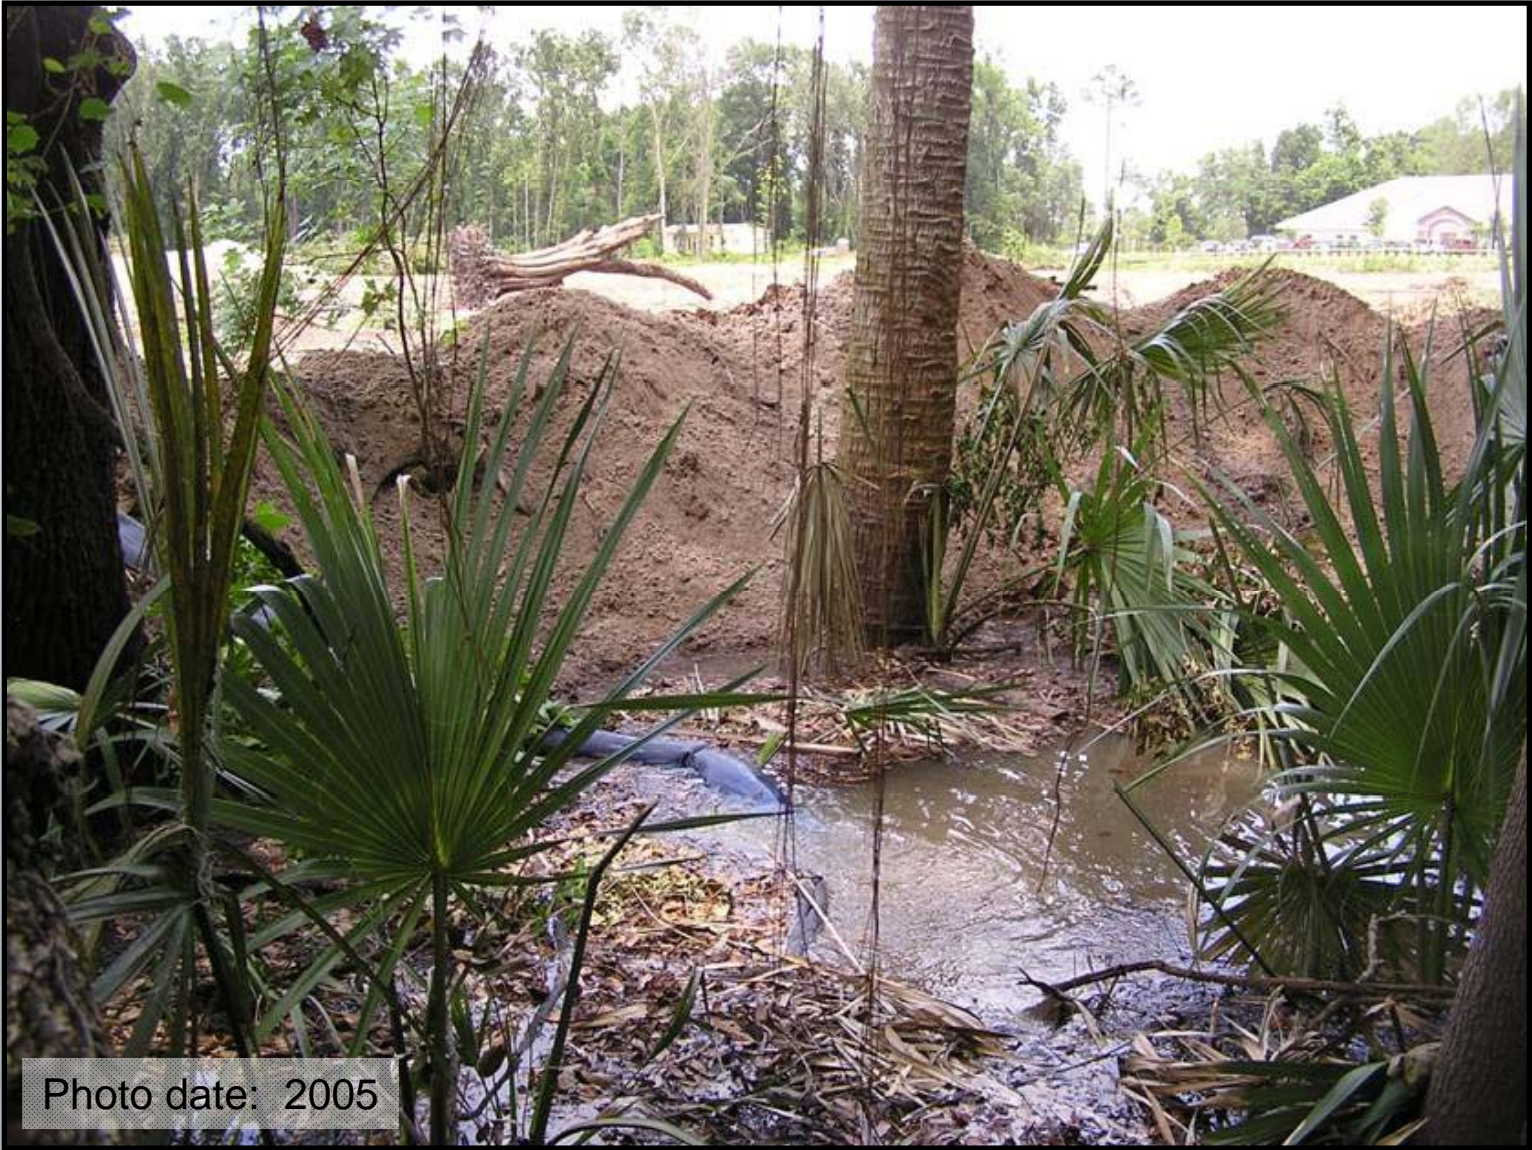
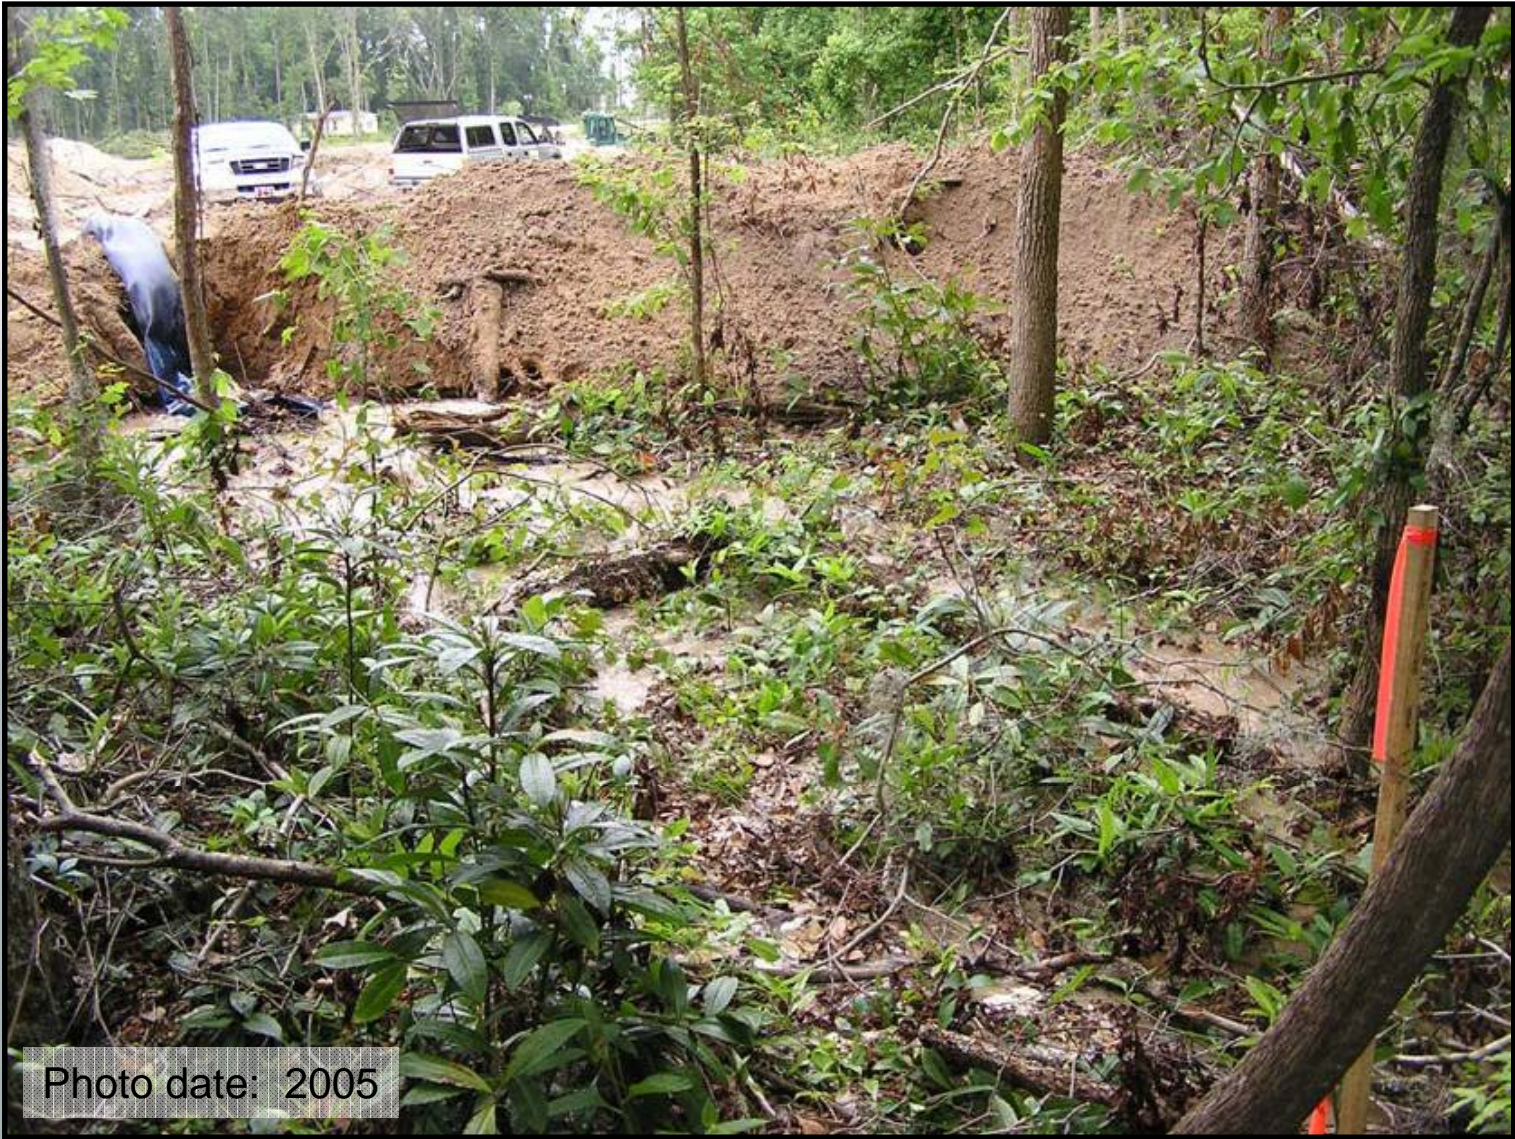
Deerwood Apts in Ocala – Sinkhole 1 Load Test

Load Testing of Natural Depressions
