PART 2

STORMWATER PERMITTING BIG PICTURE ISSUES

STORMWATER 2005

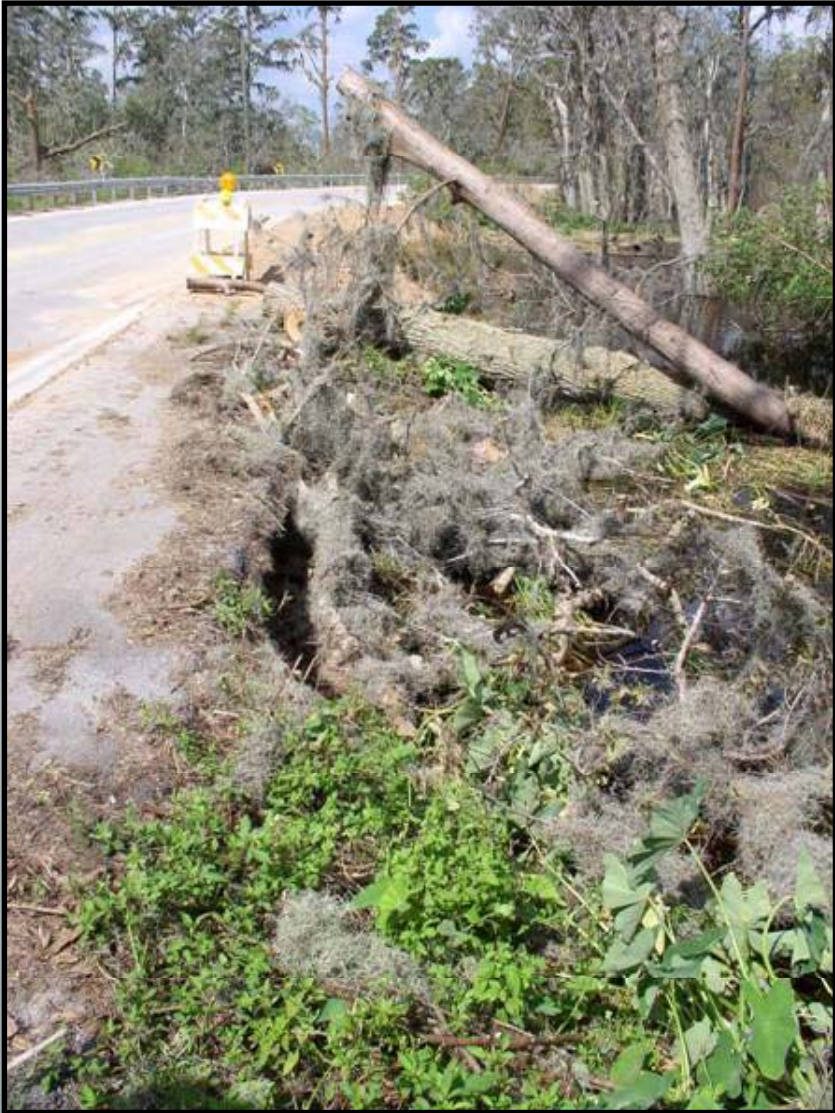
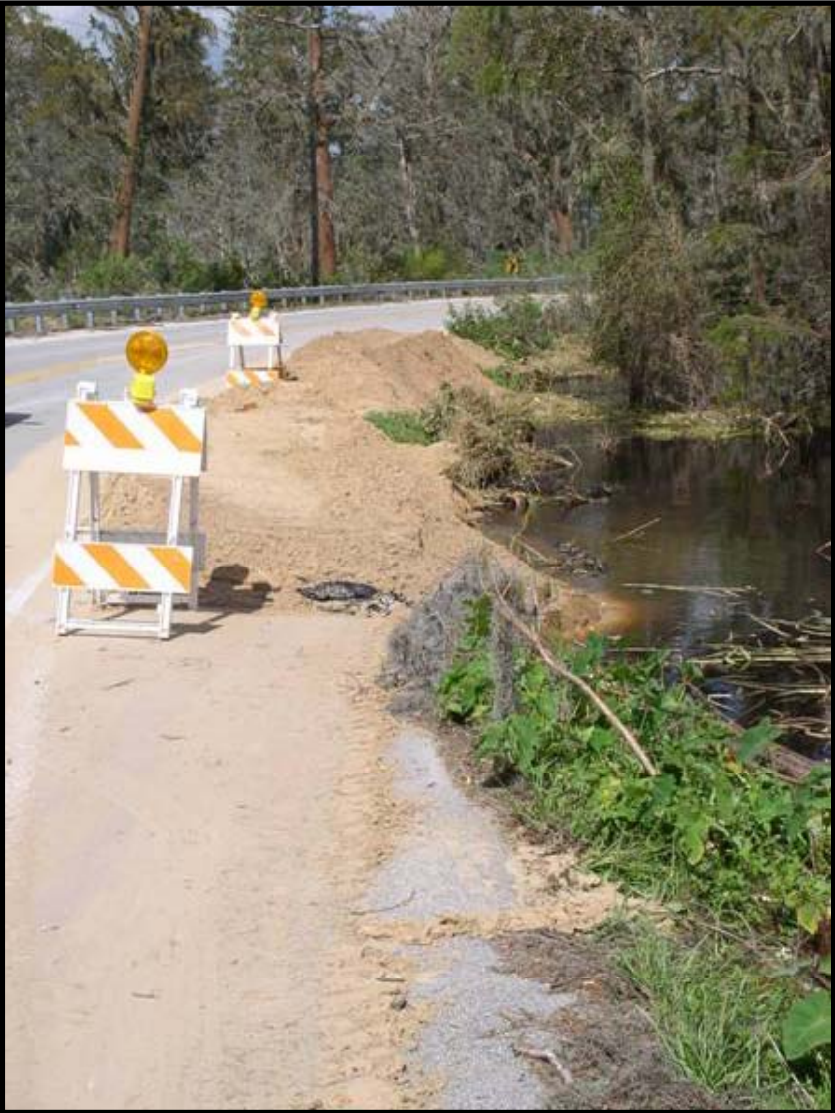
CR 561 Clermont

Side Slope Failures Due to Storm-Induced Wave Action

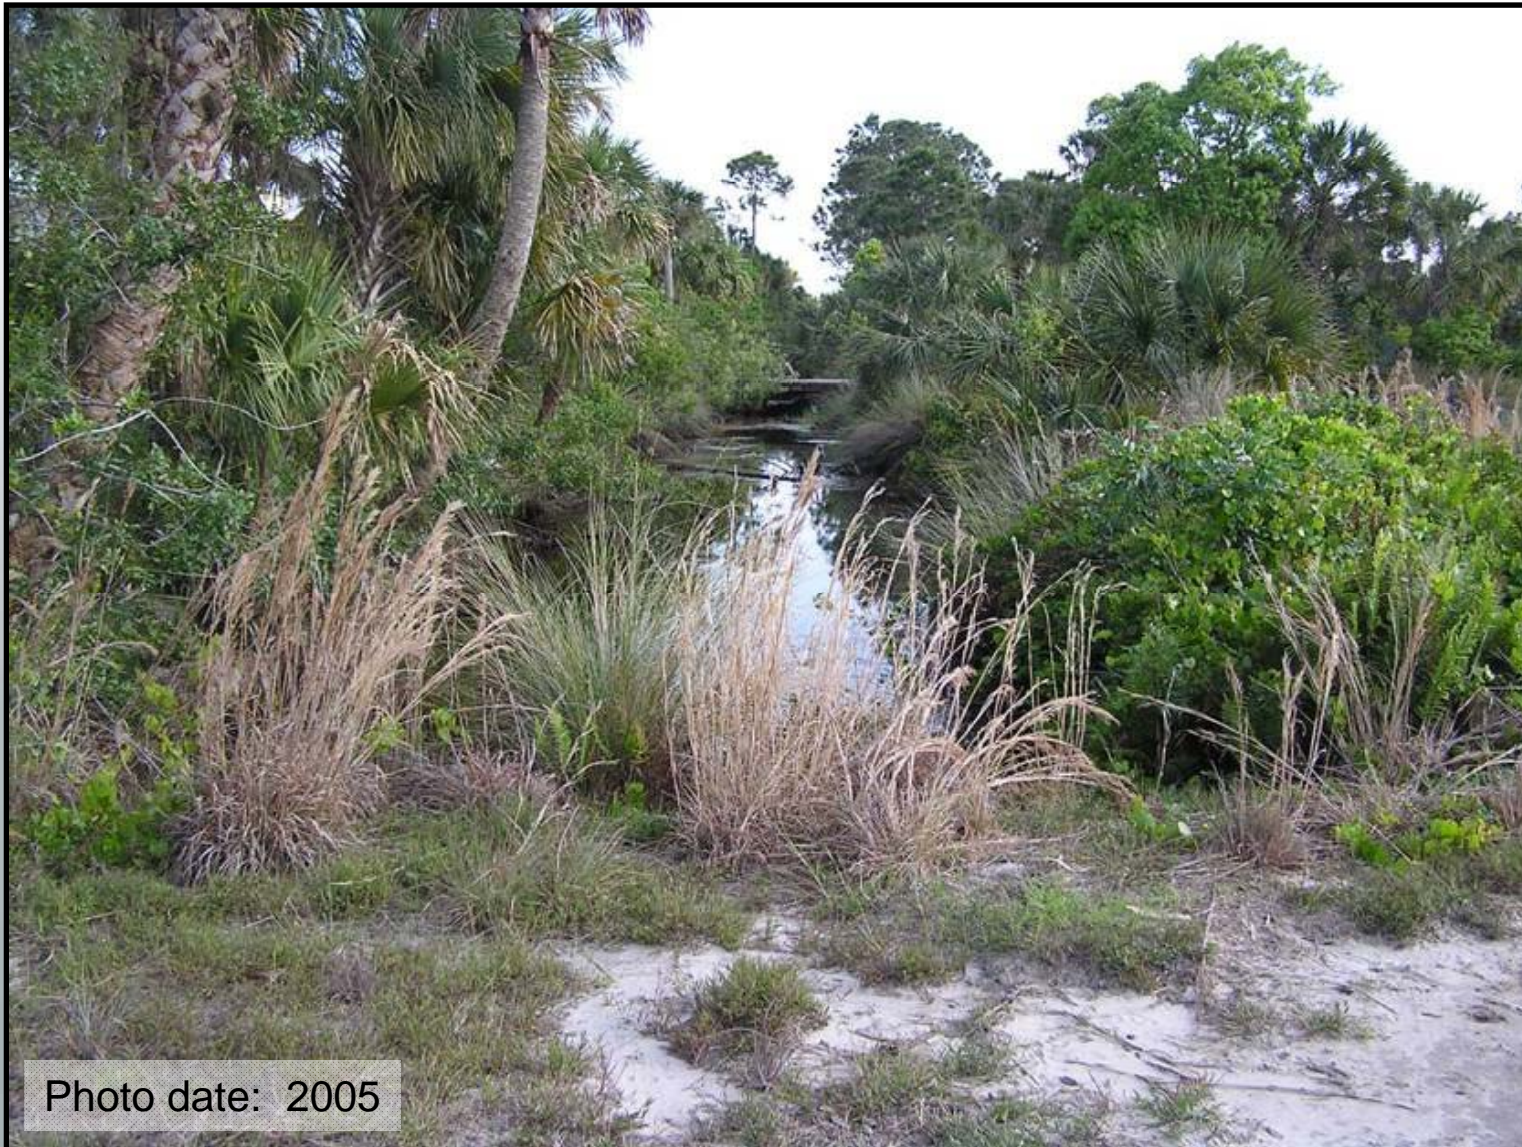
Site in Brevard County

Water Table Drawdown Impact Due to Ditching

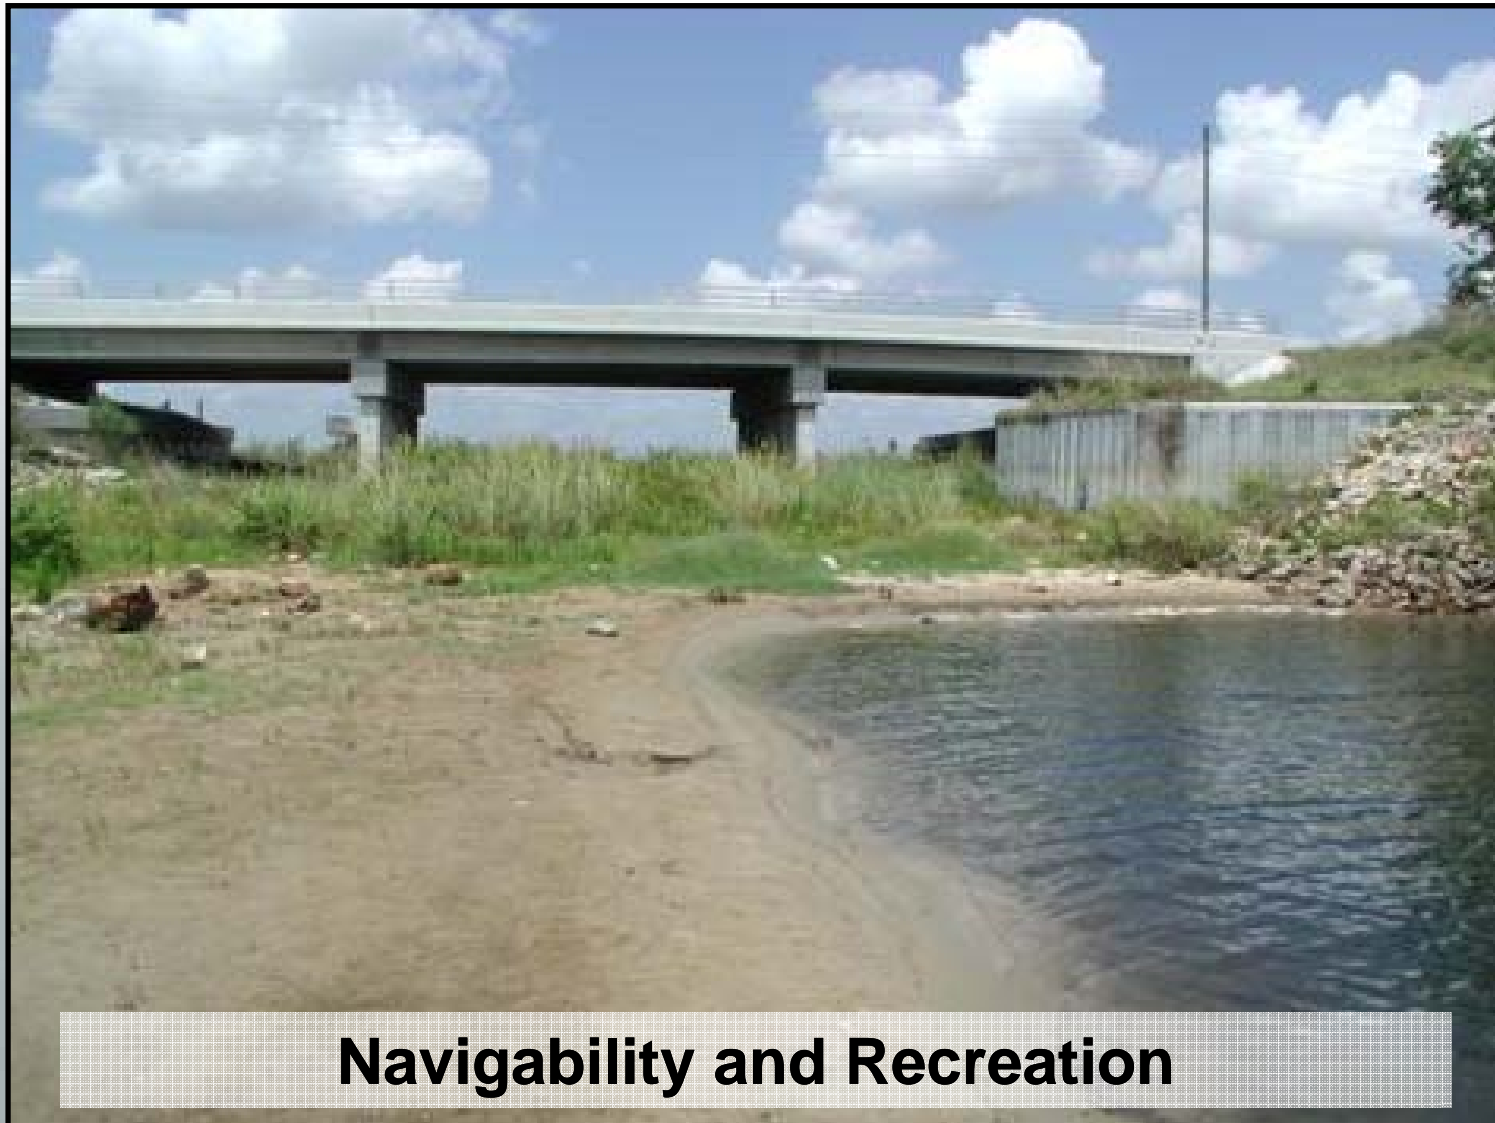
Clermont Chain of Lakes – CR 565A Bridge

Navigability and Recreation
