# ROADWAY PROJECTS WITH FOCUS ON SUBSURFACE / DRAINAGE & LITIGATION-RELATED ISSUES

## 2011 FACERS Annual Conference

- Devo Seereeram, Ph.D., P.E.  
Devo Engineering

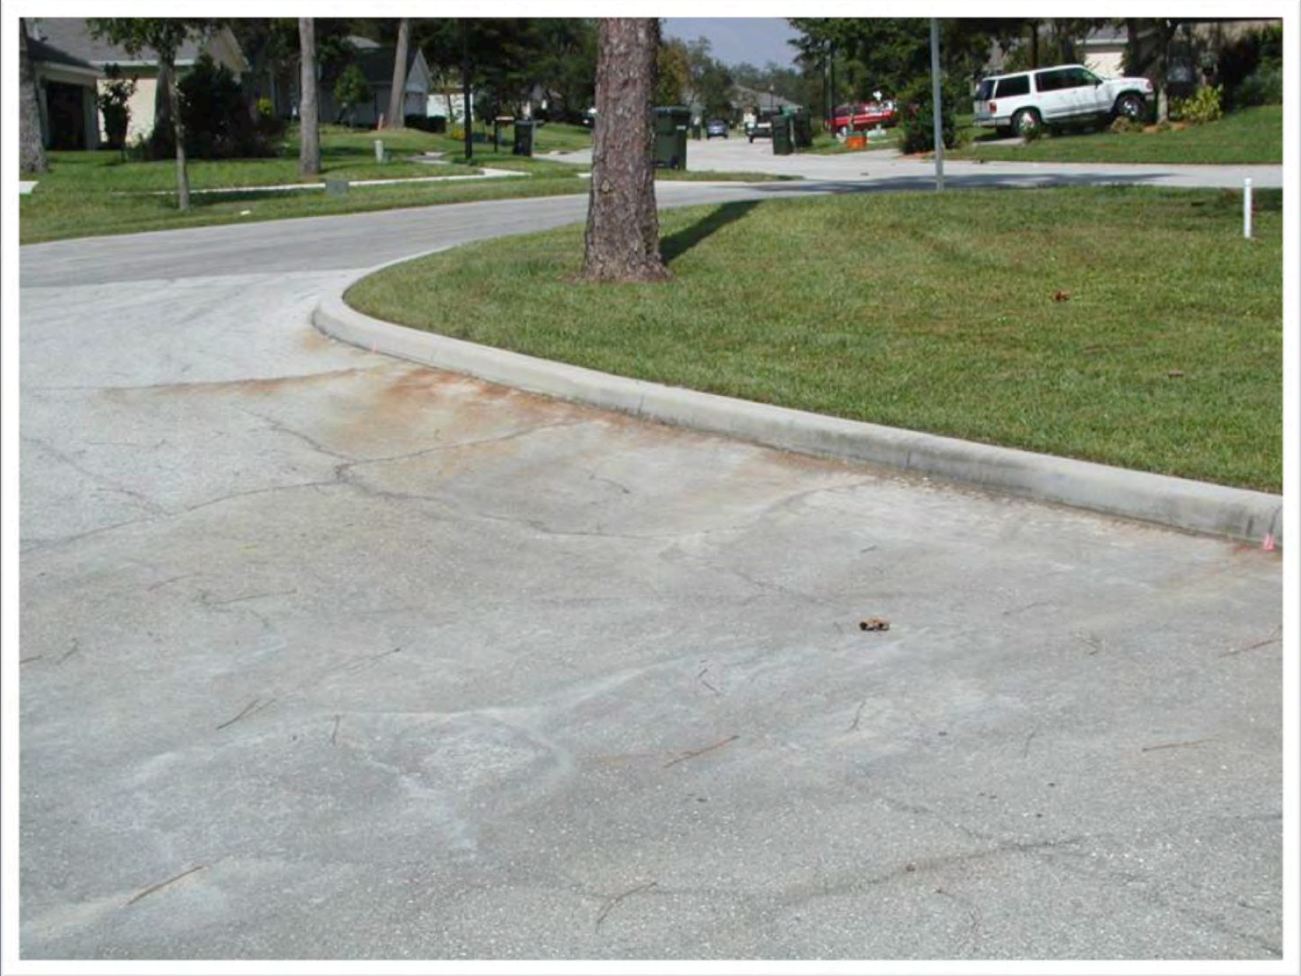
# Community Area - Reflections Subdivision in Ocoee

# Low Pavement Grades & High Groundwater

Photo date: 2000 (during drought)

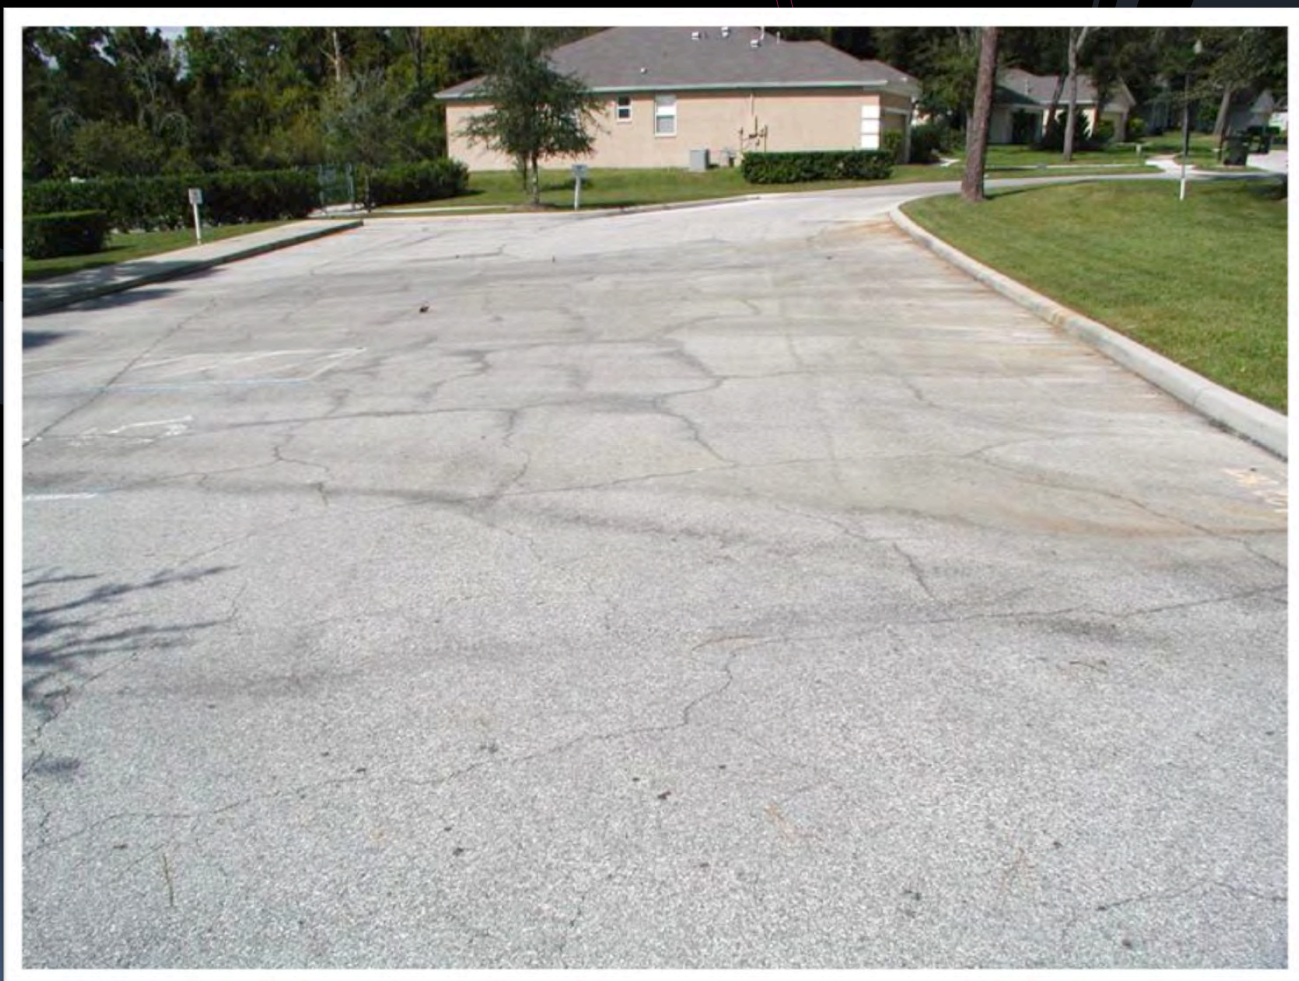
# Community Area - Reflections Subdivision in Ocoee

Photo date: 2000 (during drought)

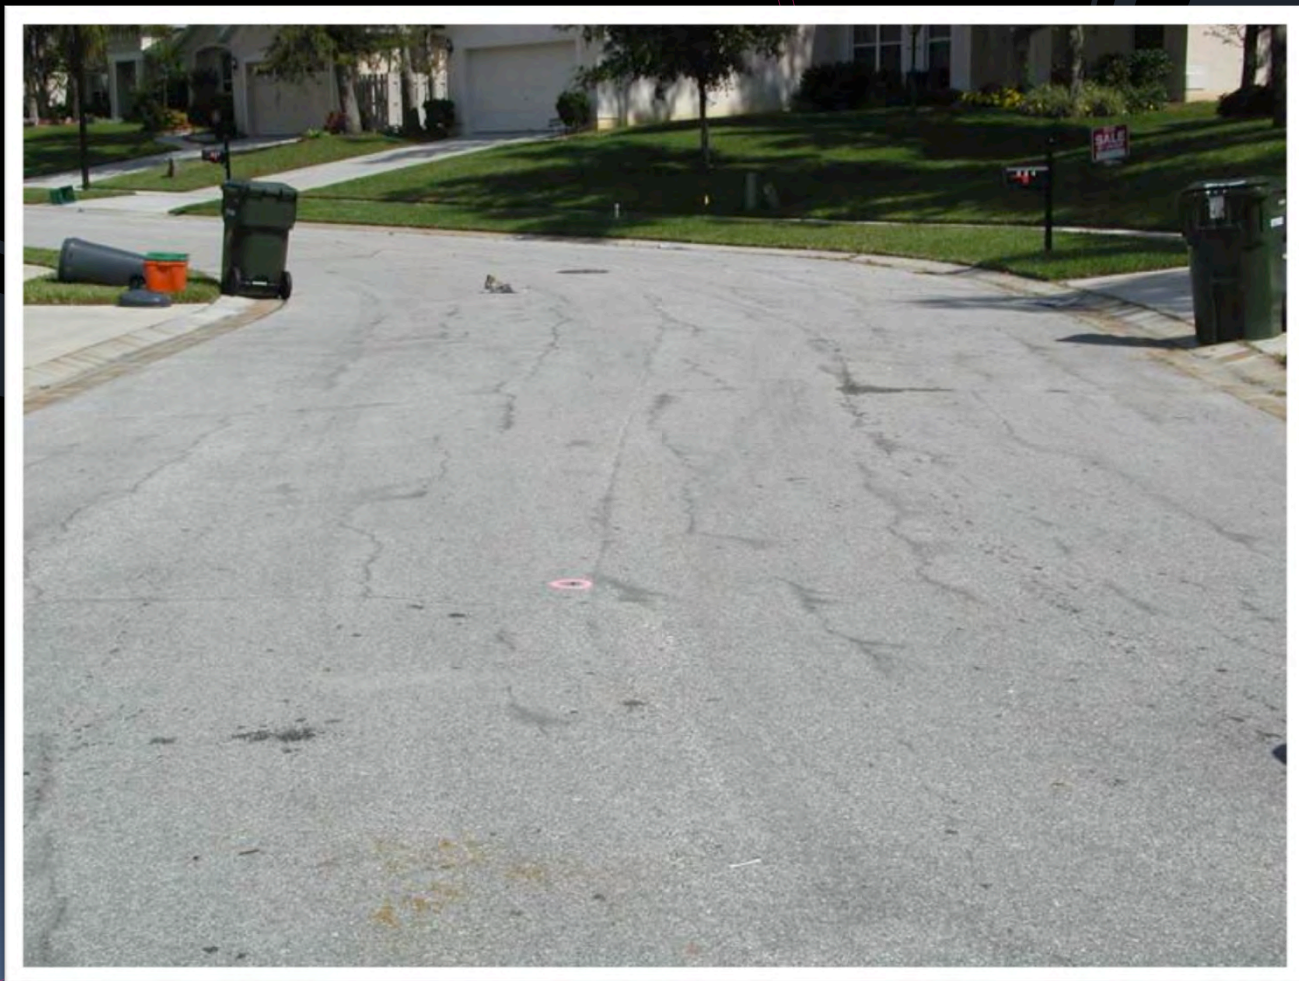
# Cool Spring Circle - Reflections Subdivision in Ocoee

Photo date: 2000 (during drought)

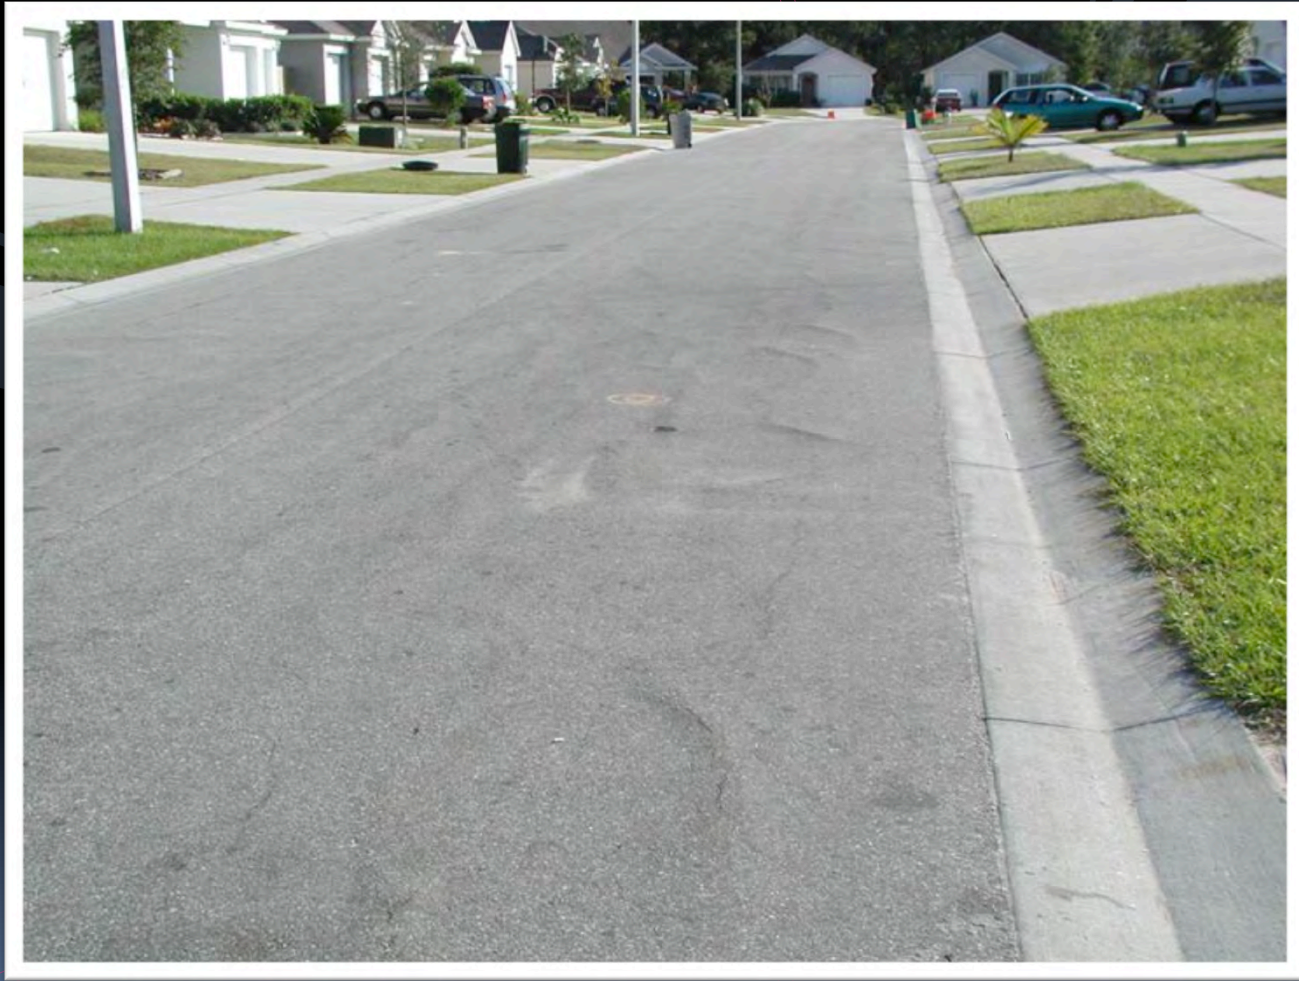
# Econ River Estates in East Orange County

Photo date: 2000 (during drought)

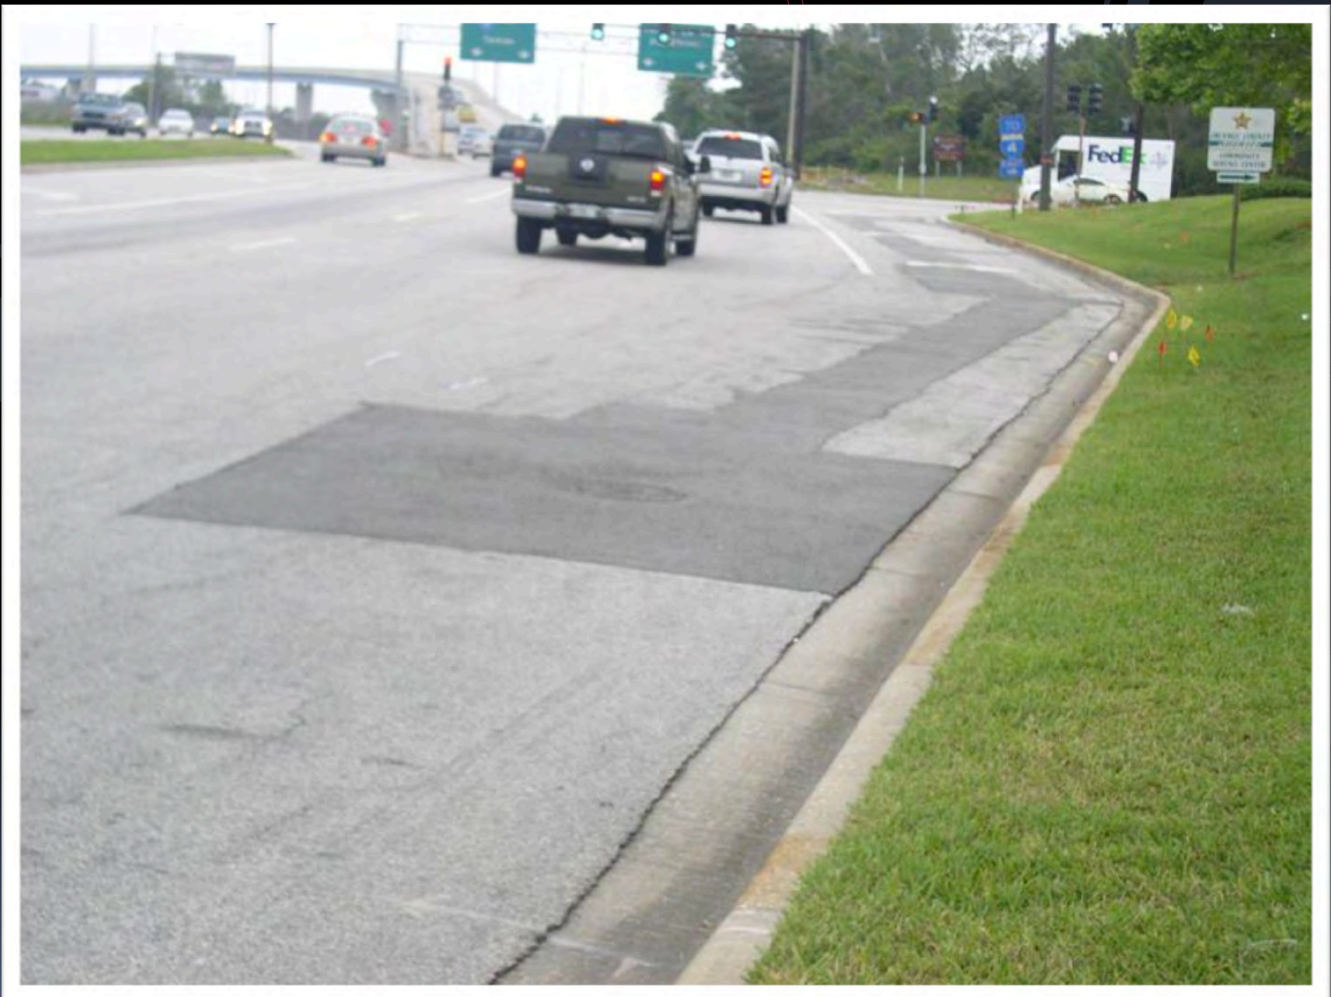
# Central Florida Parkway

# High Groundwater Artificially Raised by Over Irrigation (Main Road)

Photo date: 2005

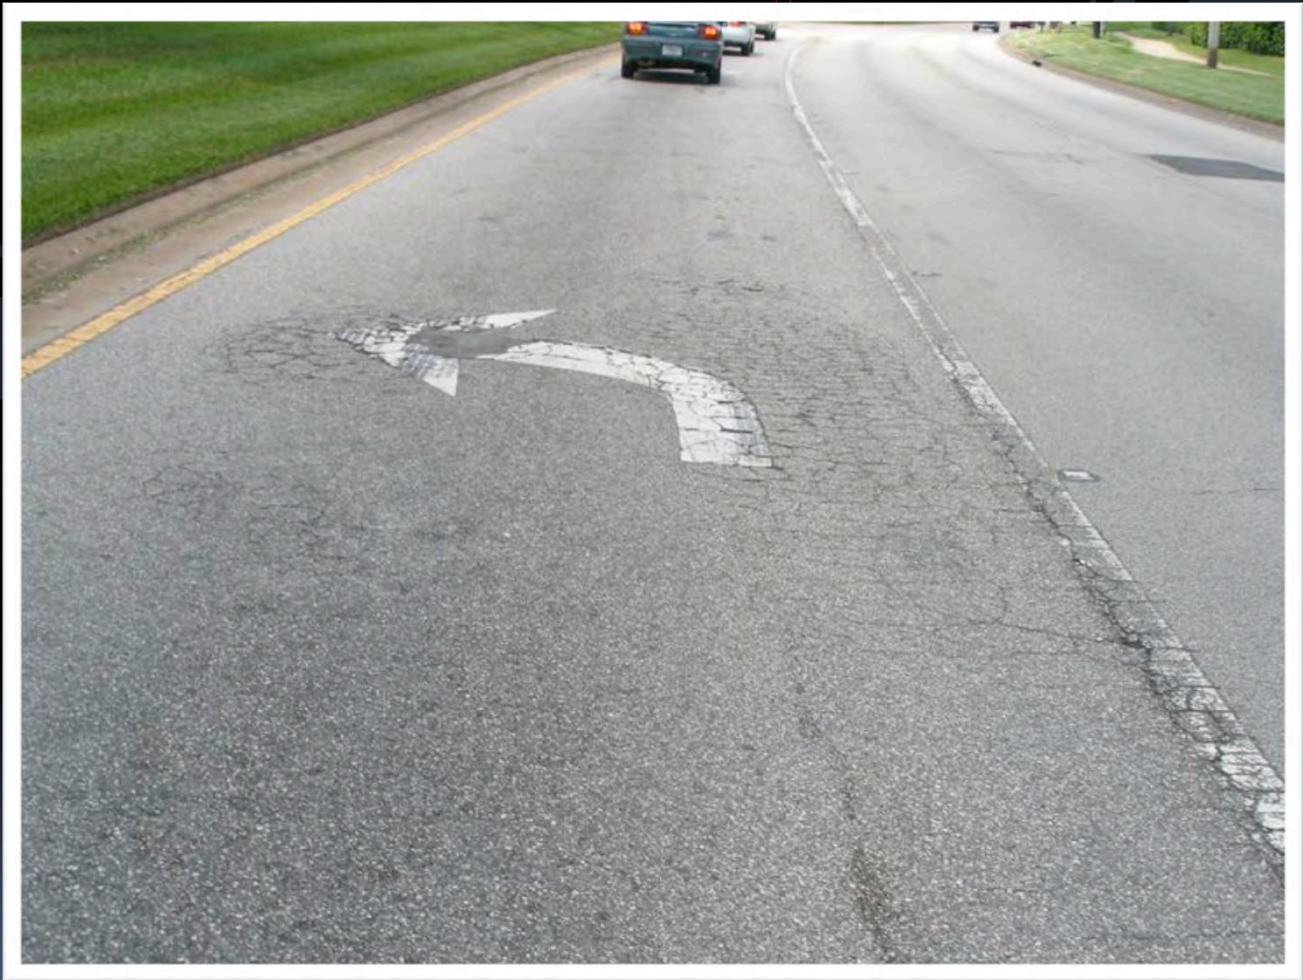
# Hiawassee Road

Photo date: 2005

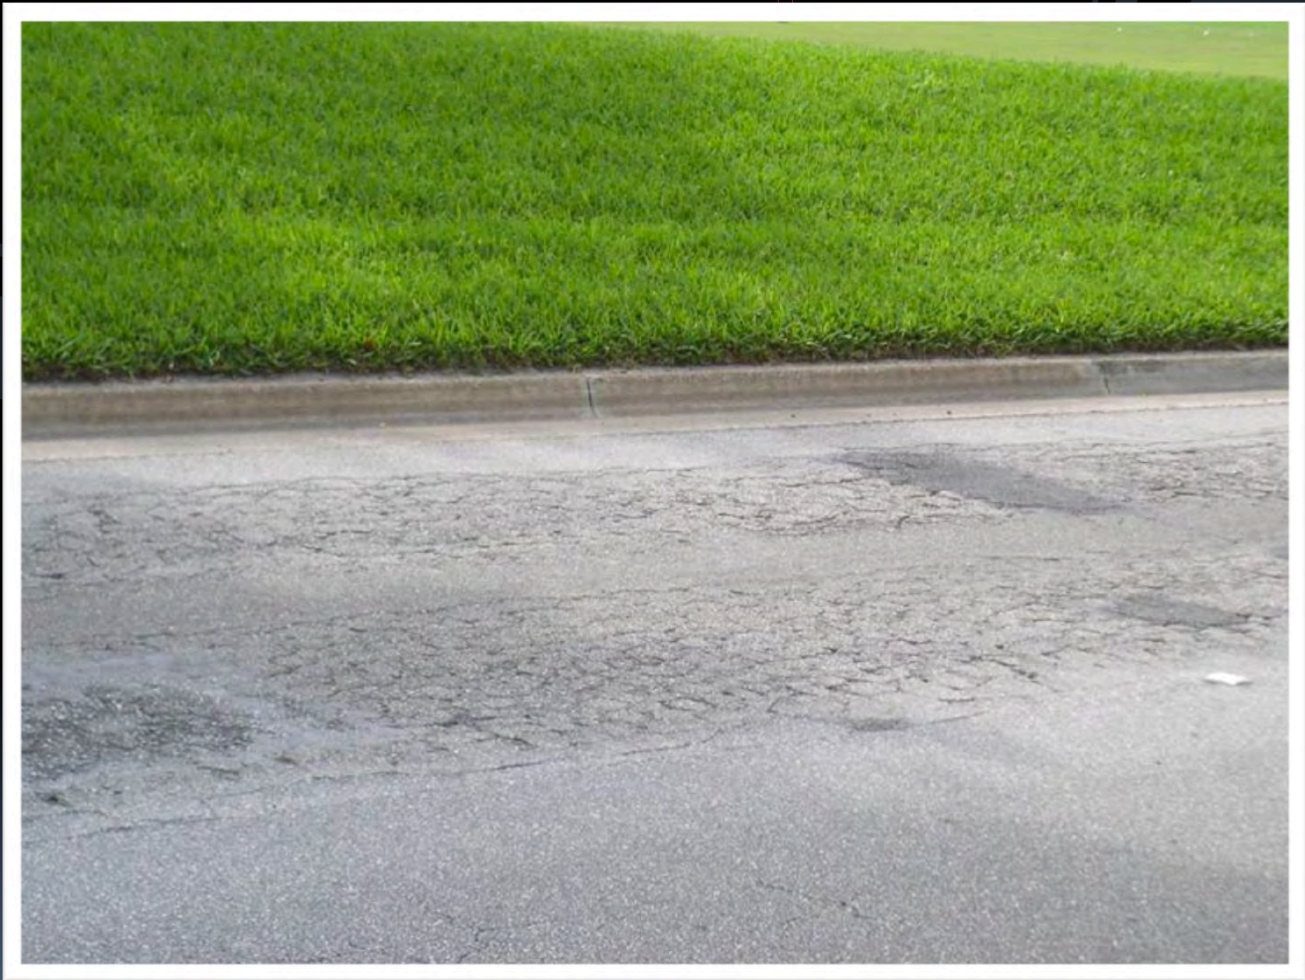
# Hiawassee Road

Photo date: 2005

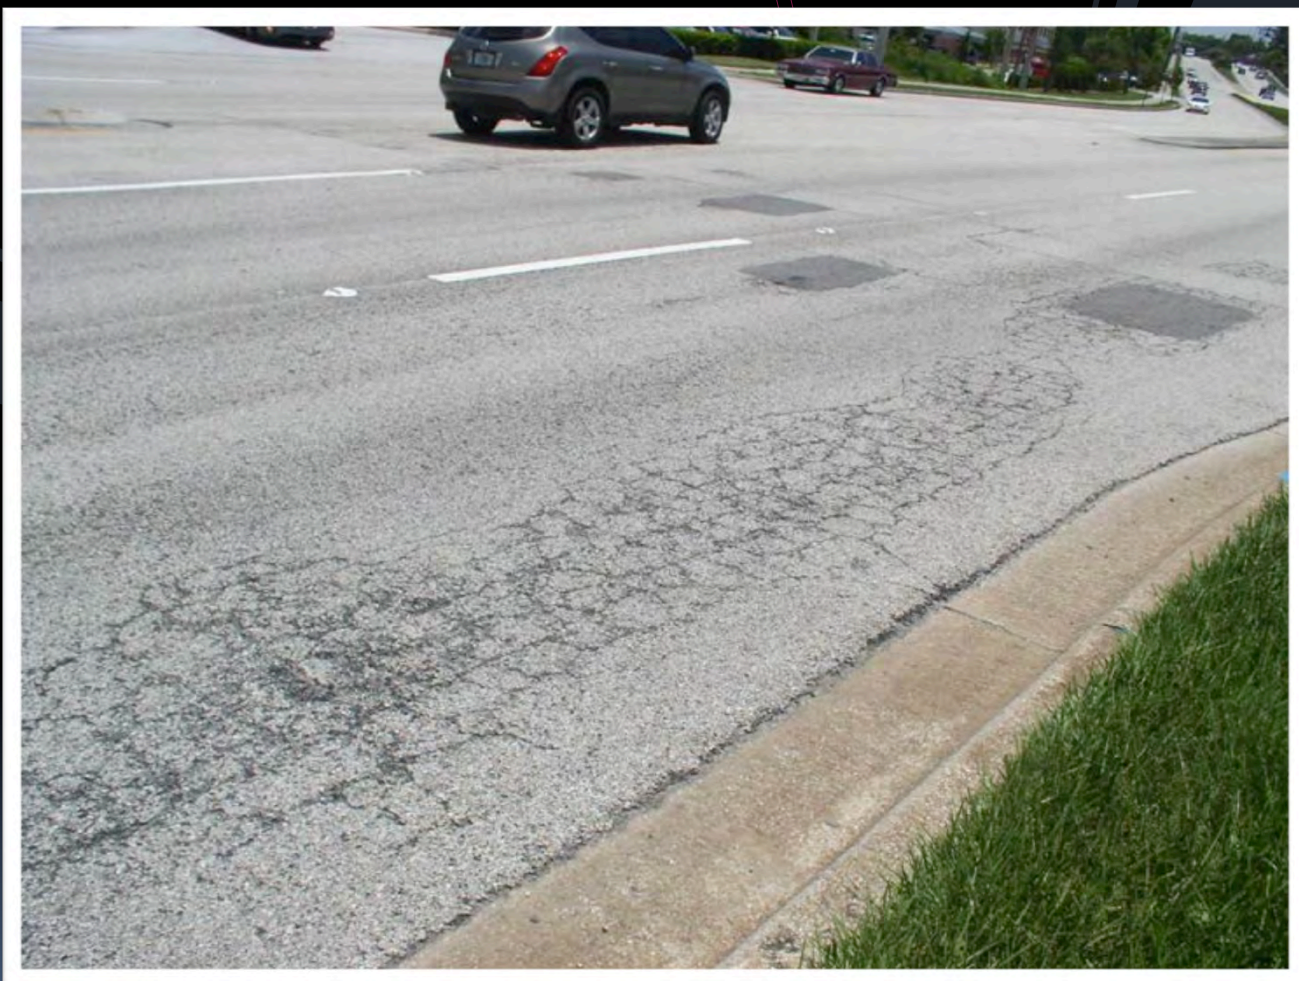
# Hiawassee Road

Photo date: 2005

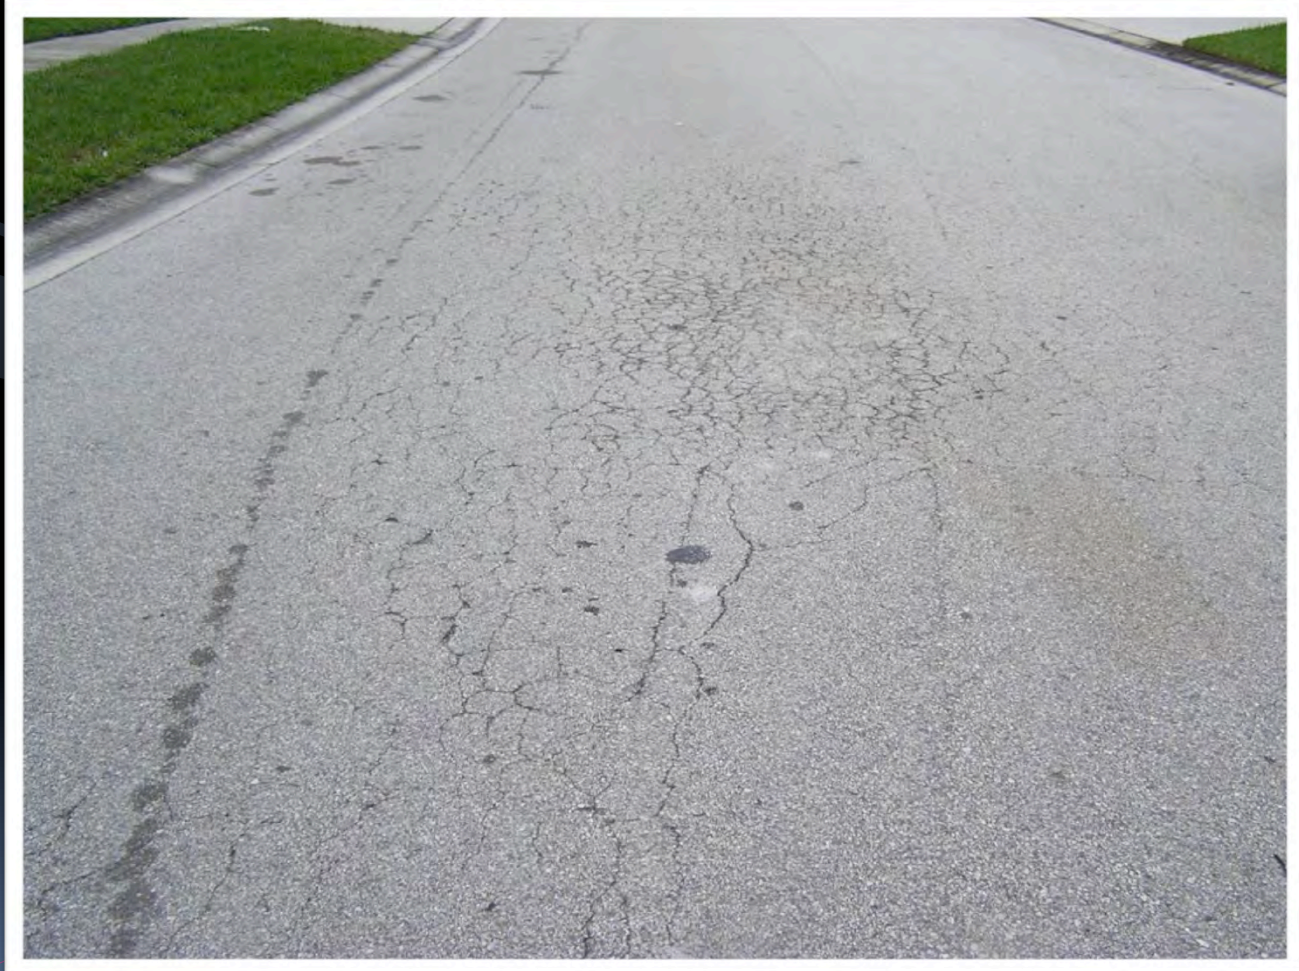
# Pond NWL and Pavement Grade Separation - Waterford Chase

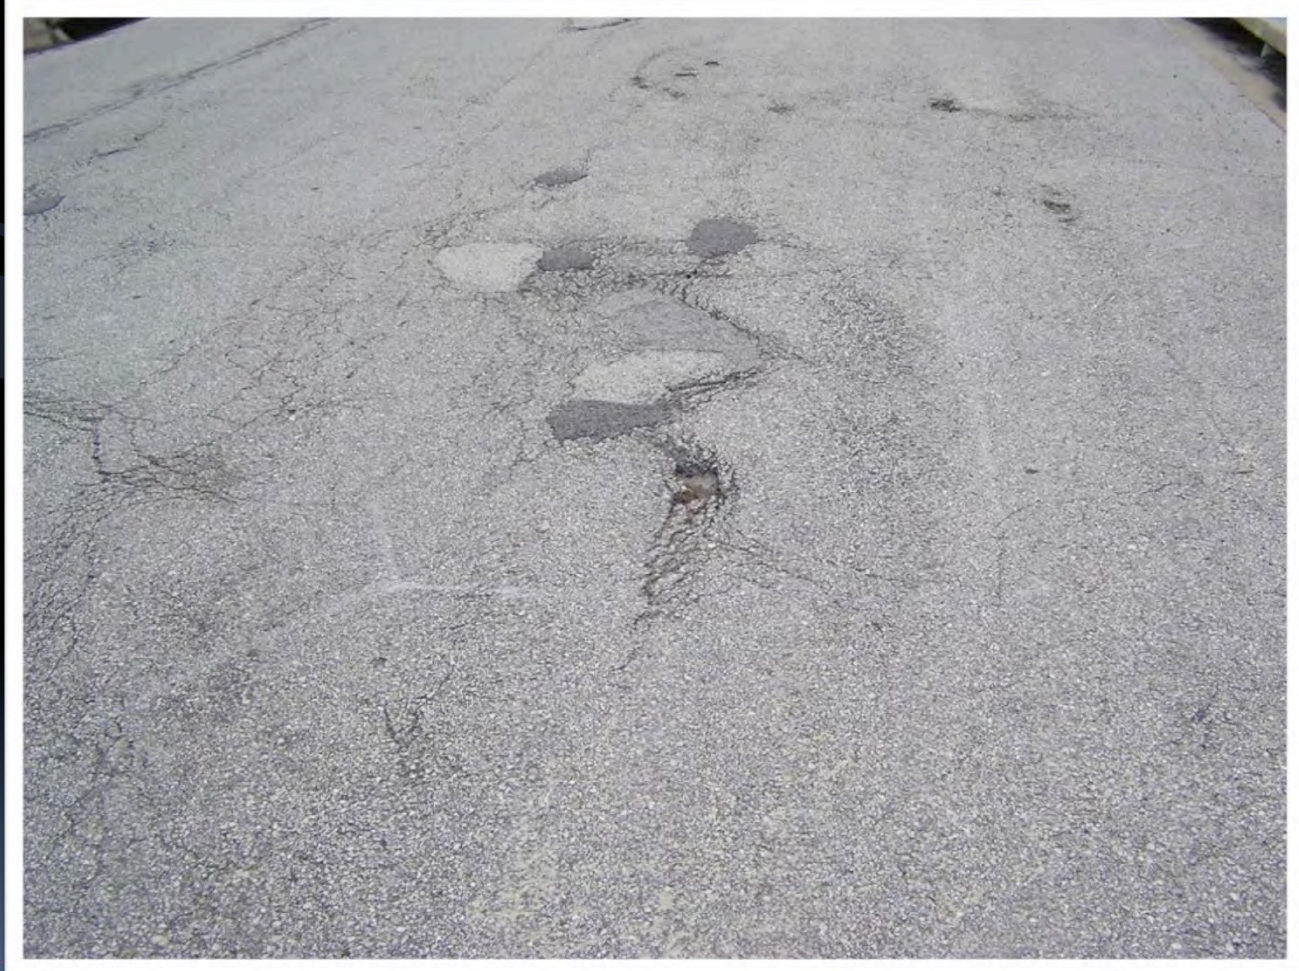
# Pond NWL and Pavement Grade Separation - Waterford Chase

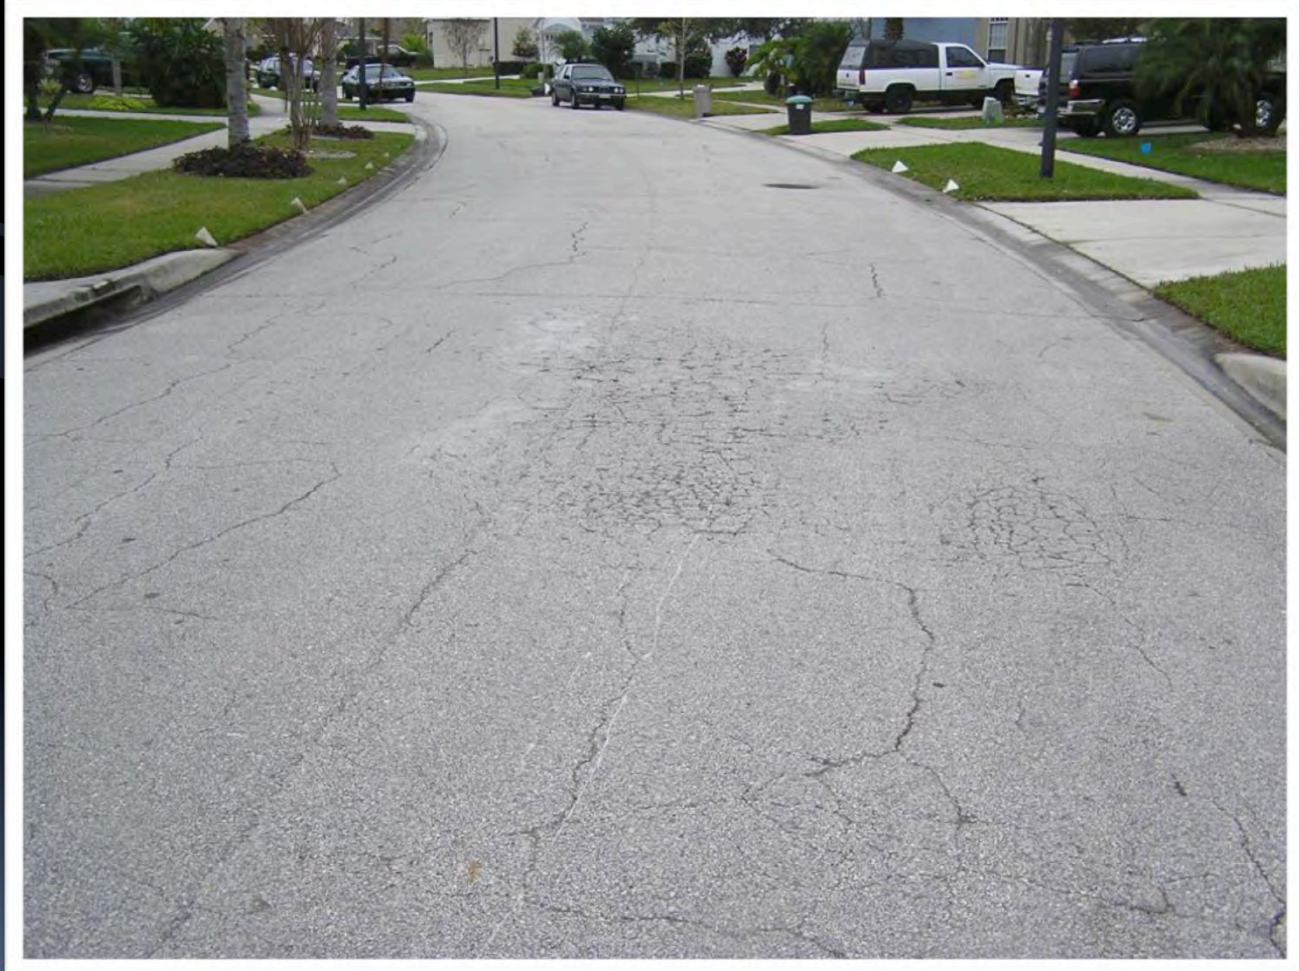
# Pond NWL and Pavement Grade Separation - Waterford Chase

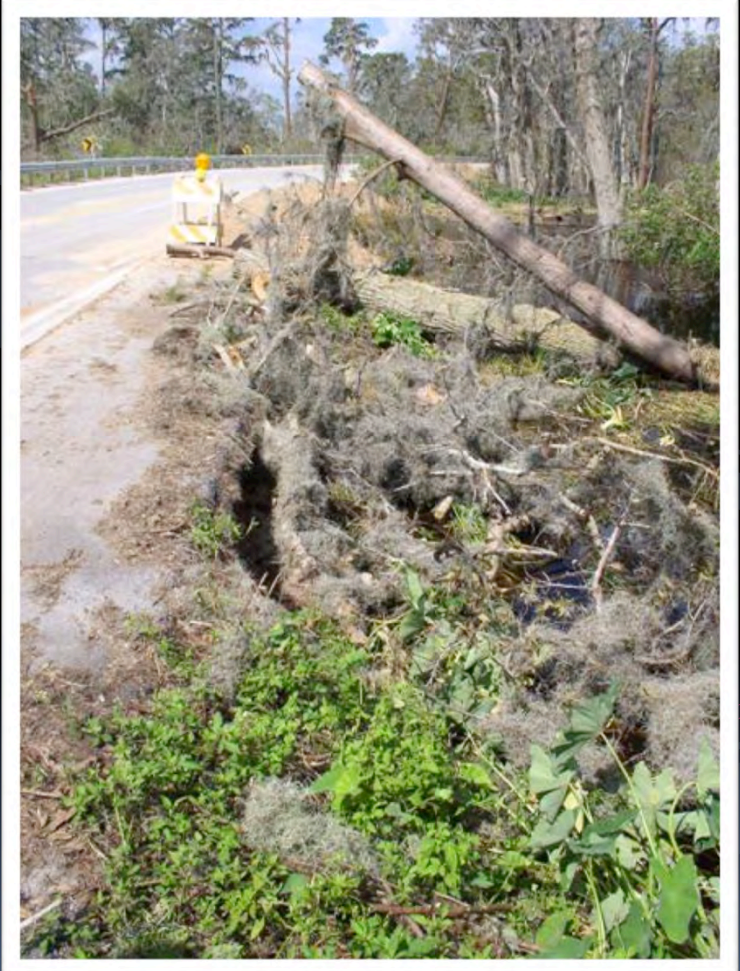
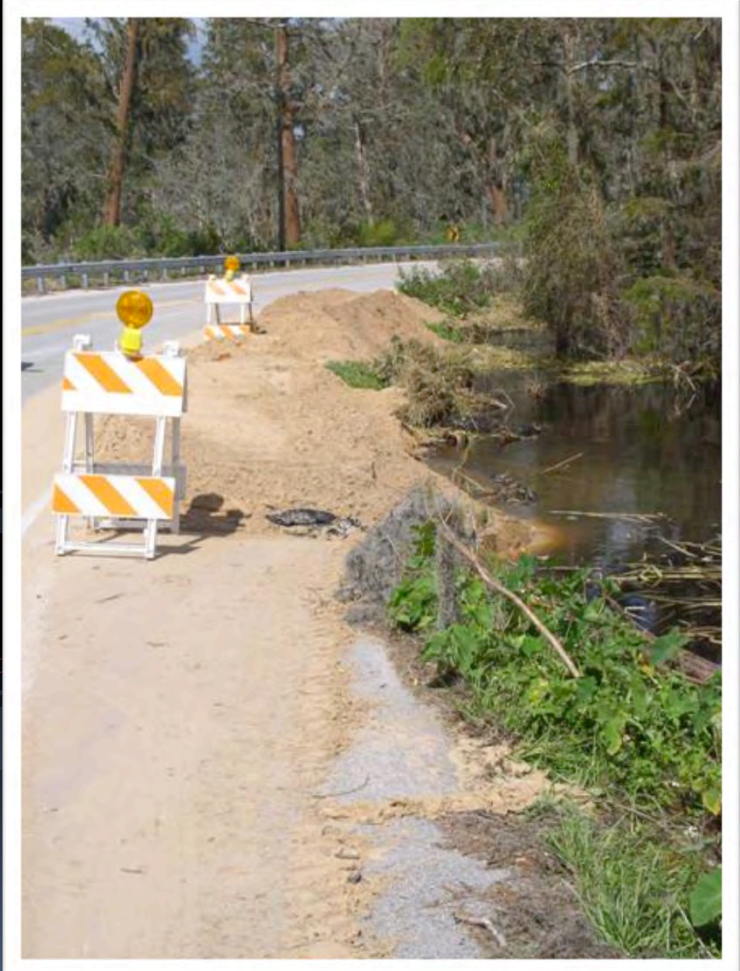
# CR 561 Clermont

# Embankment Washout Due to Storm-Induced Wave Action

Photo date: 2004 (Hurricane Jeanne)

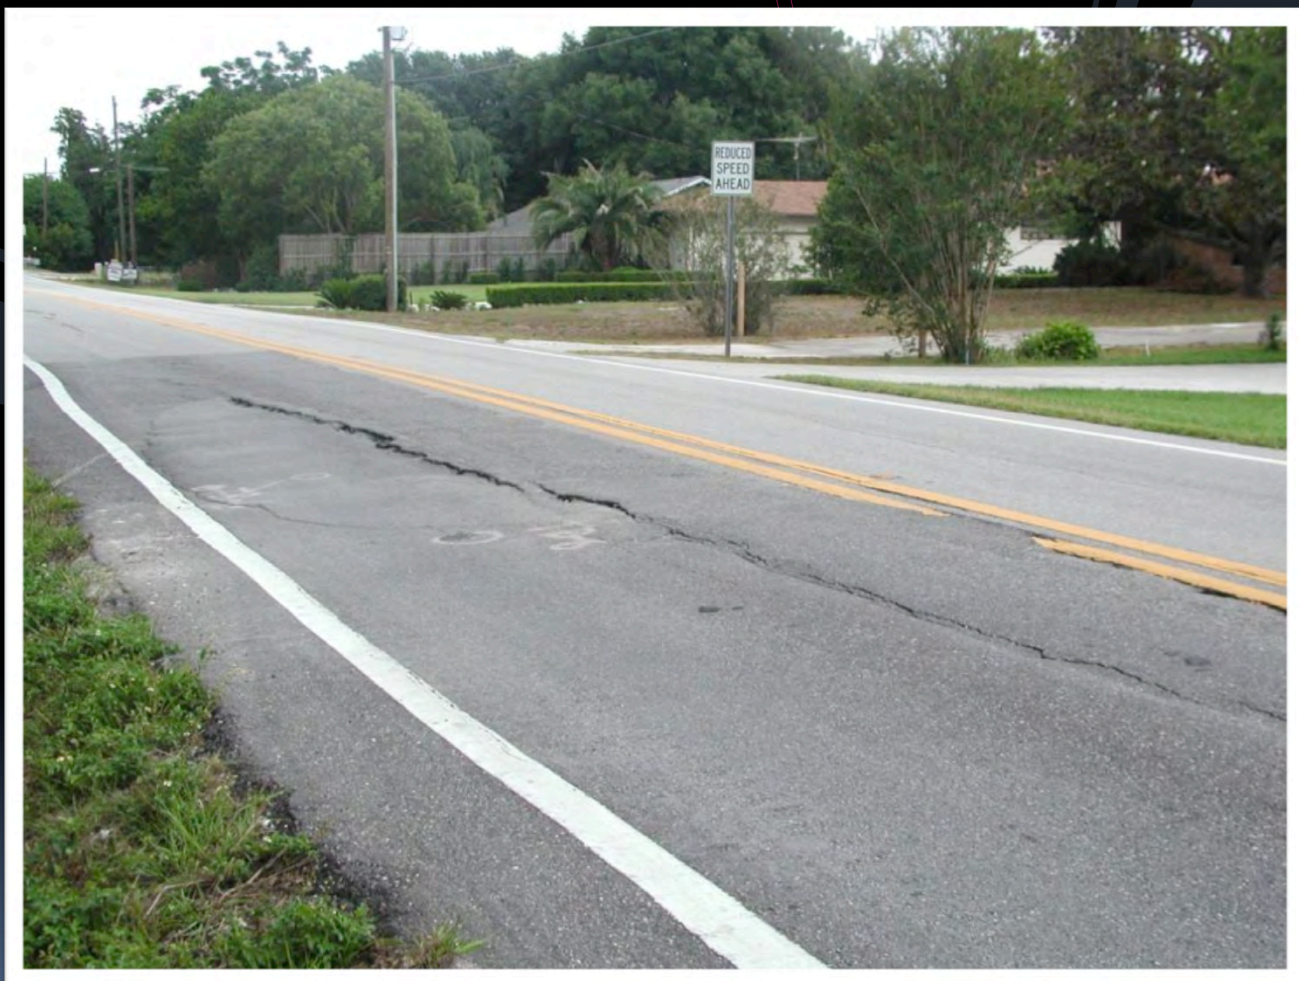
# Country Road 561

Pavement Distress

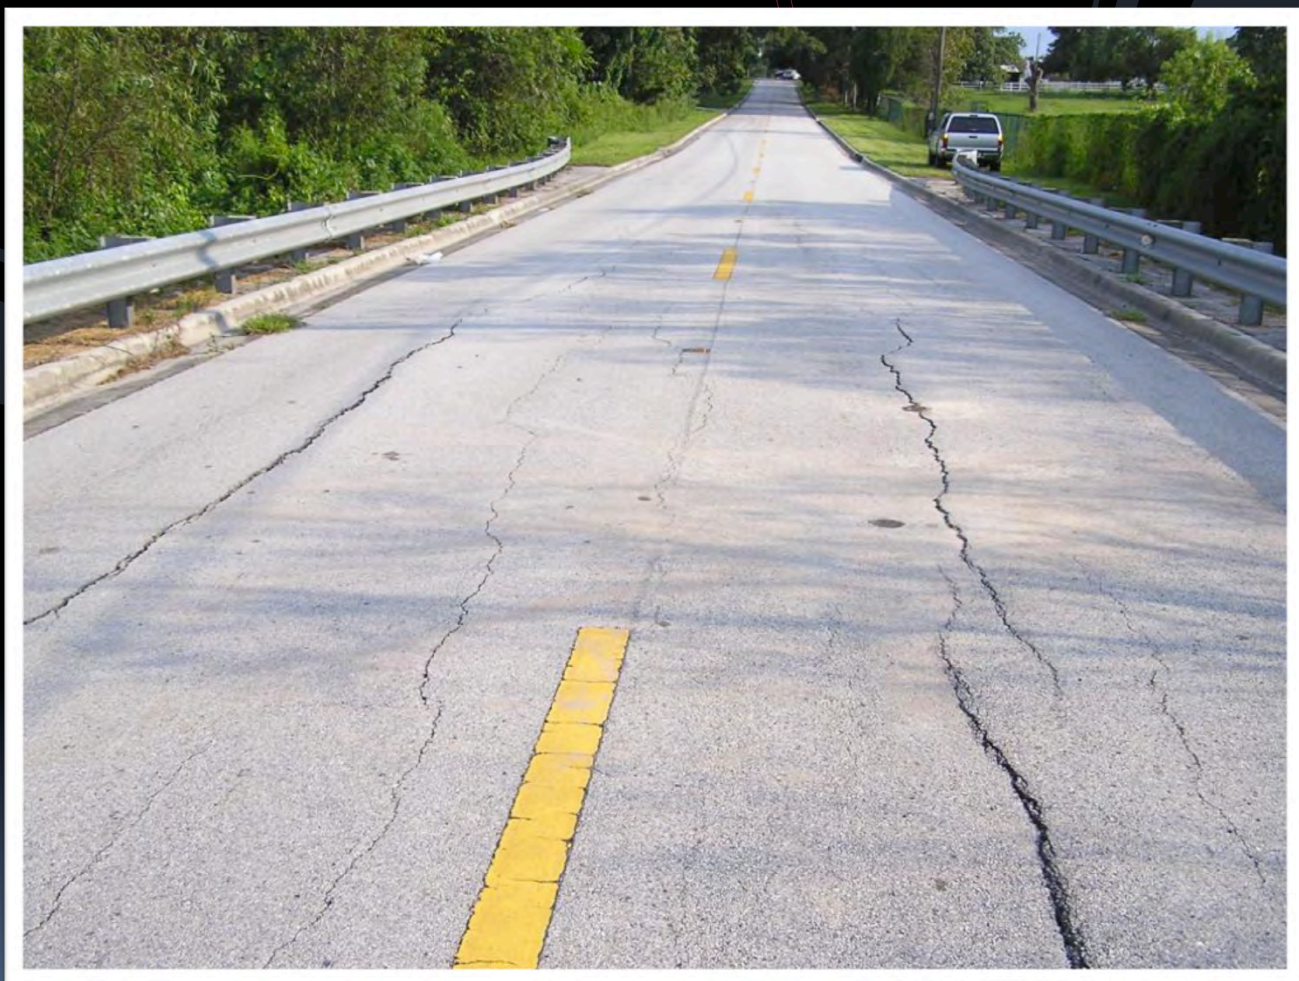
# Lake Pleasant Road

Distress Photos

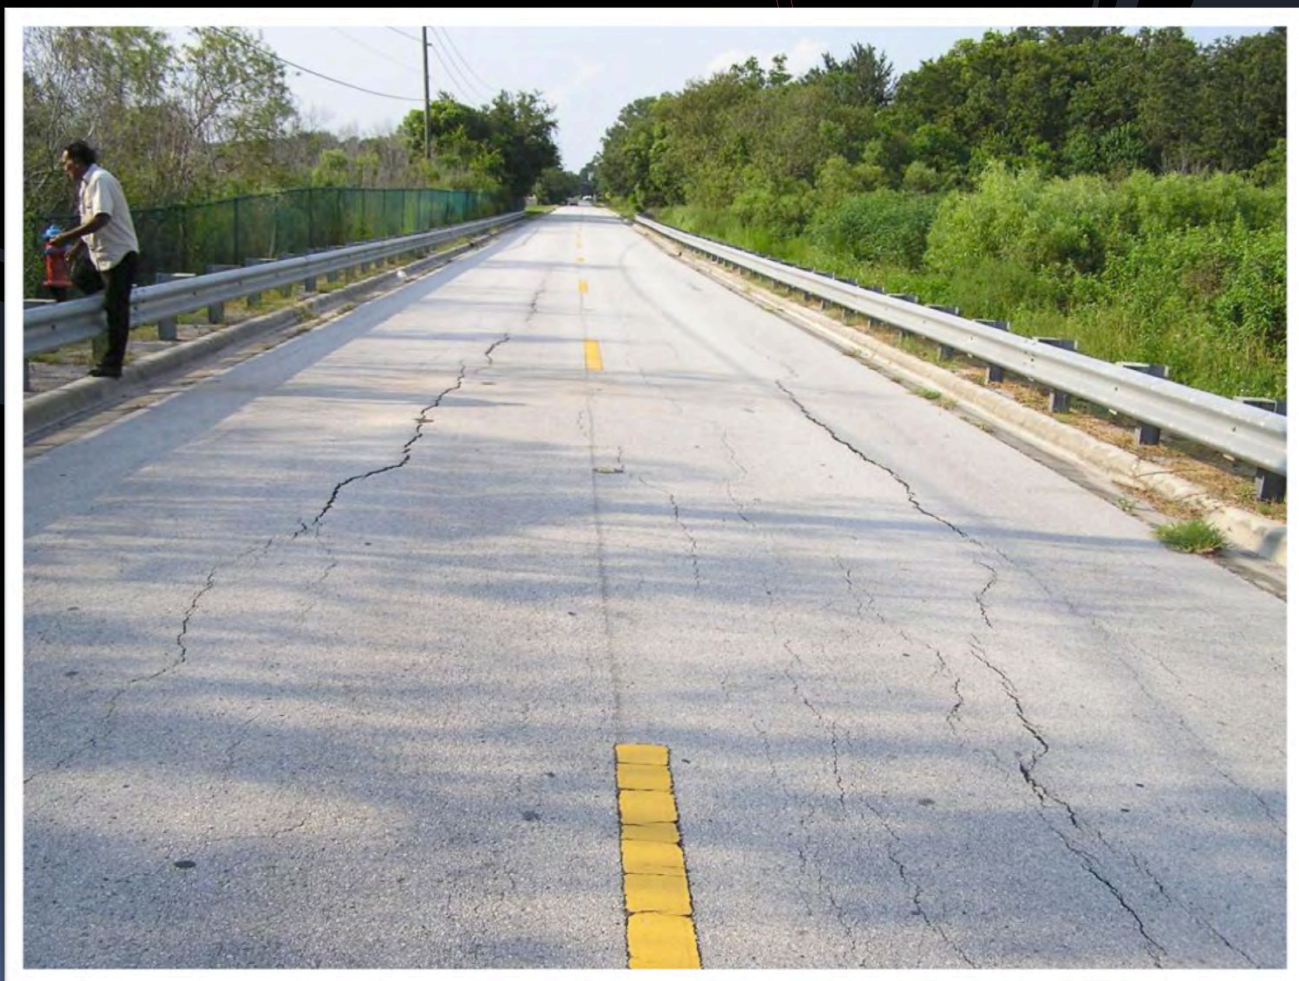
# Lake Pleasant Road

Distress Photos

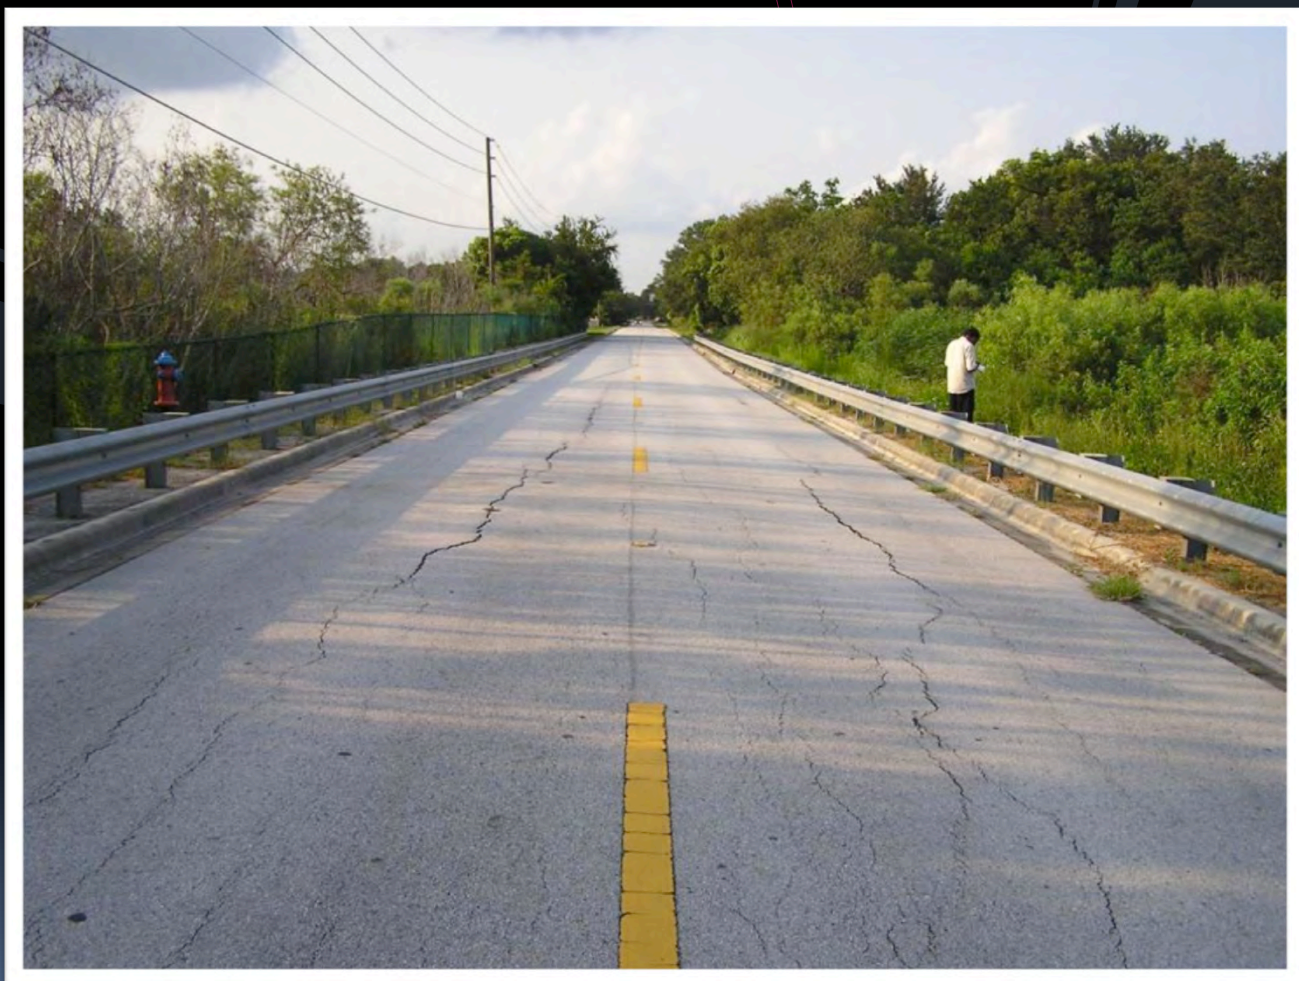
# Lake Pleasant Road

Distress Photos

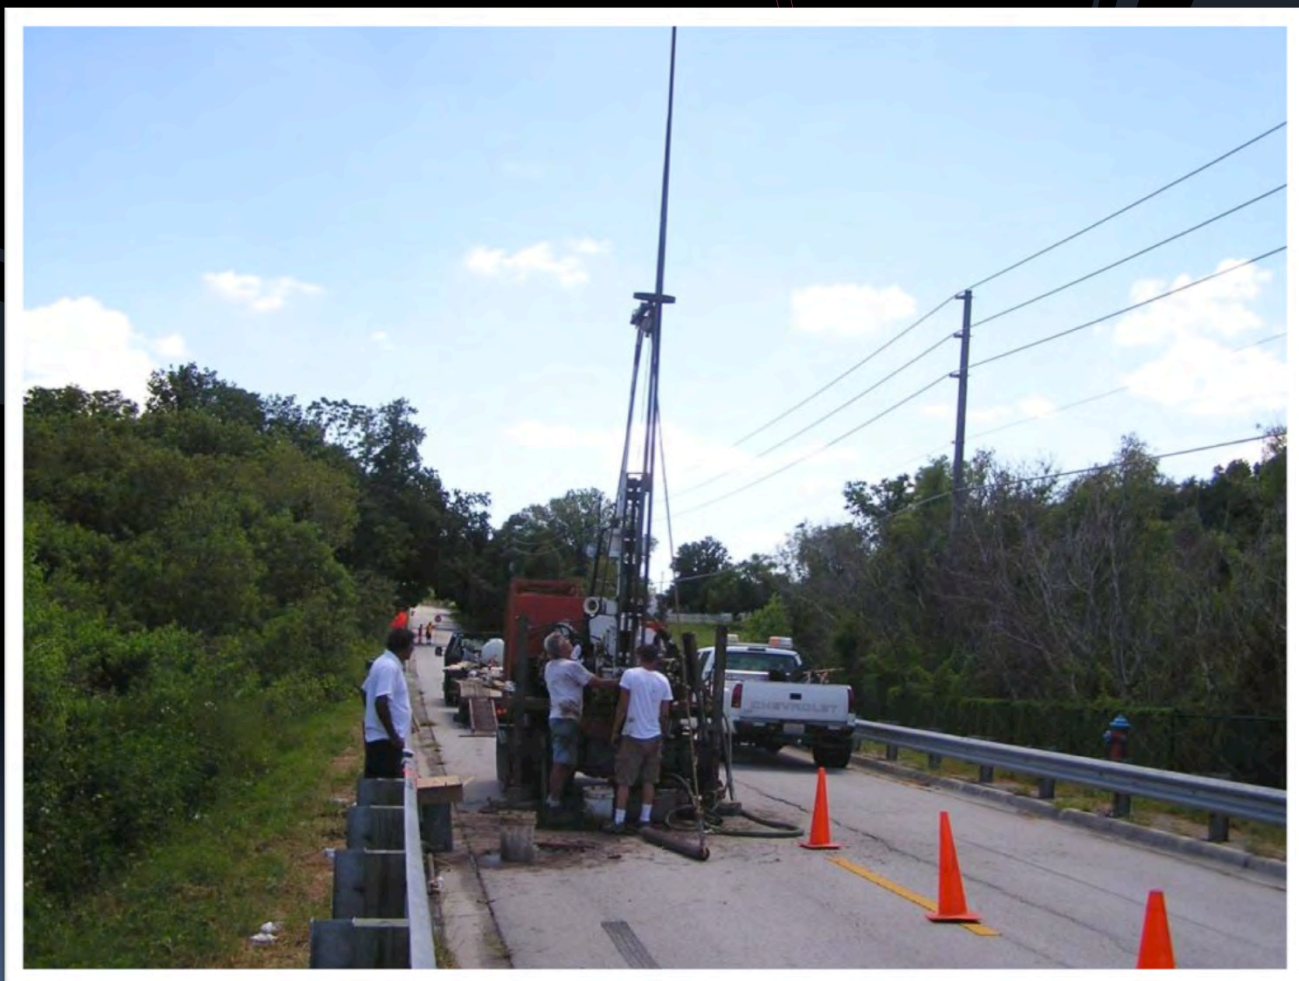
# Lake Pleasant Road

Investigation Photos

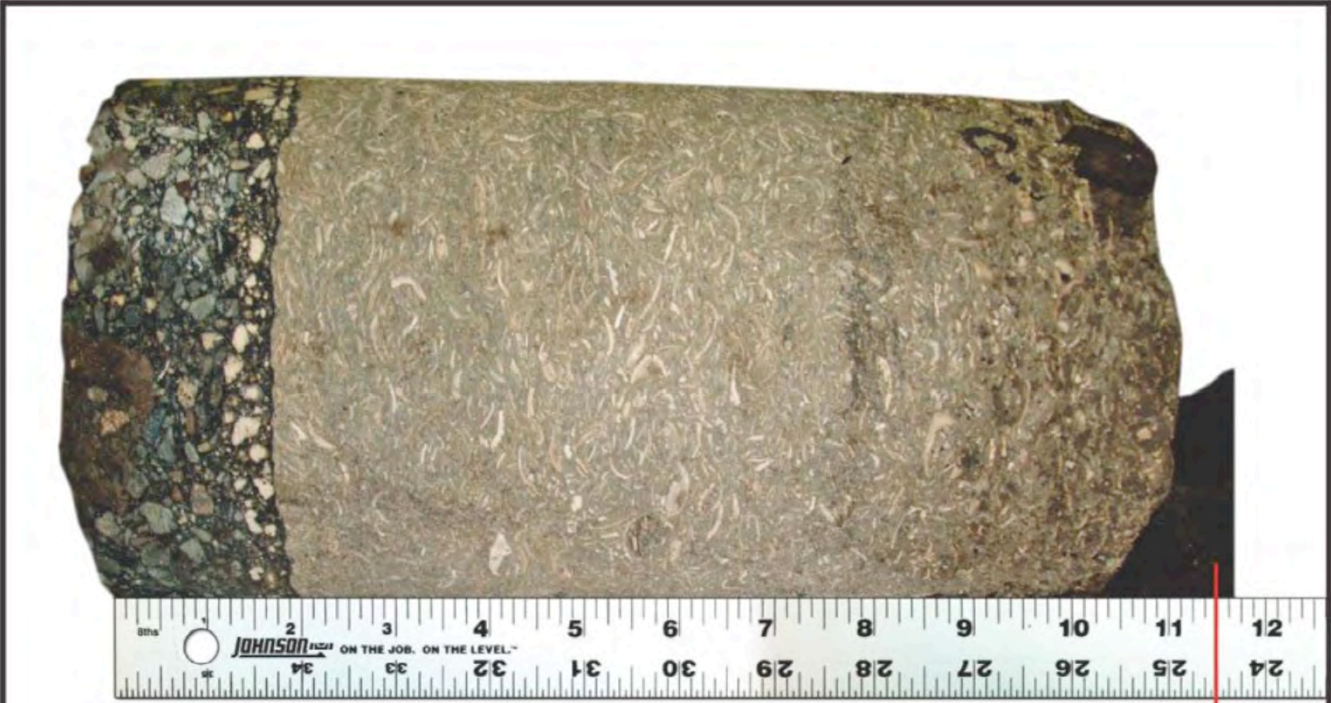
# Lake Underhill Road

# Corroding Sand-Shell-Cement Base

\* Portion of sample crumbled and unrecoverable during coring & extraction
