# ROADWAY PROJECTS WITH FOCUS ON SUBSURFACE / DRAINAGE & LITIGATION-RELATED ISSUES

## 2011 FACERS Annual Conference

- Devo Seereeram, Ph.D., P.E.  
Devo Engineering

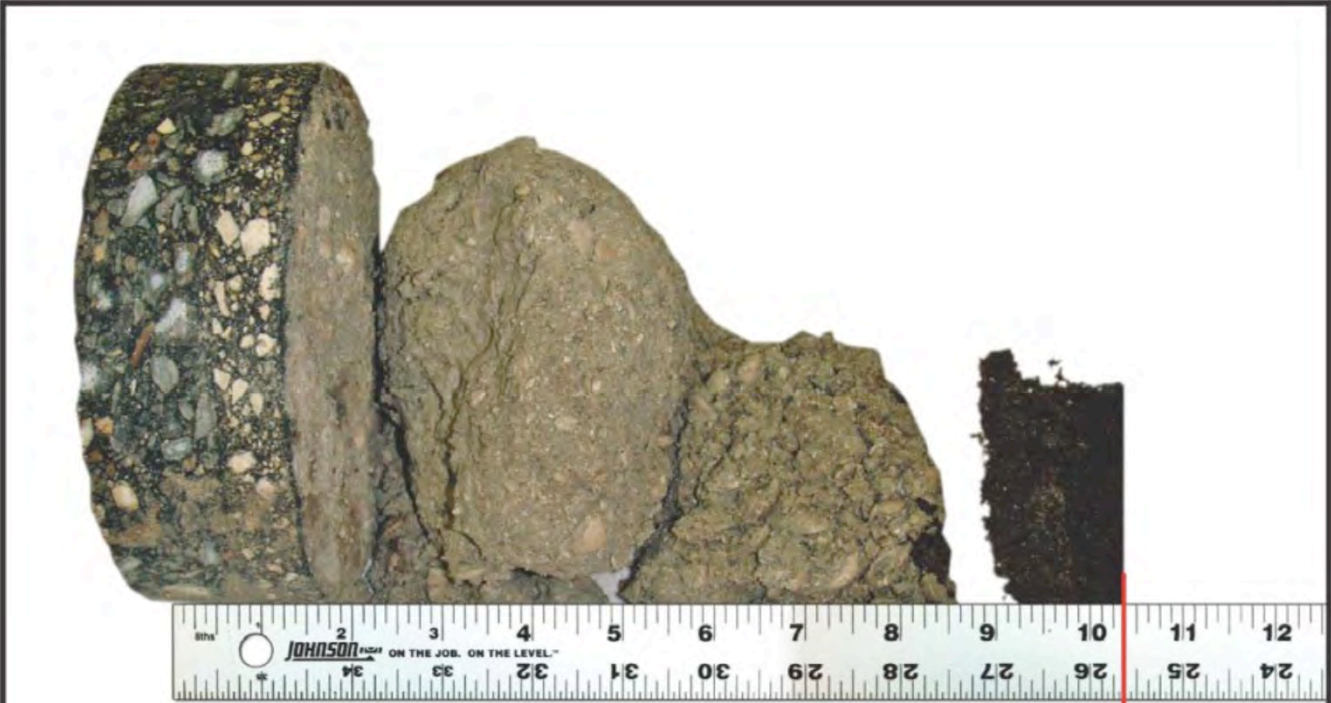
# Lake Underhill Road

# Corroding Sand-Shell-Cement Base

\* Portion of sample crumbled and unrecoverable during coring & extraction

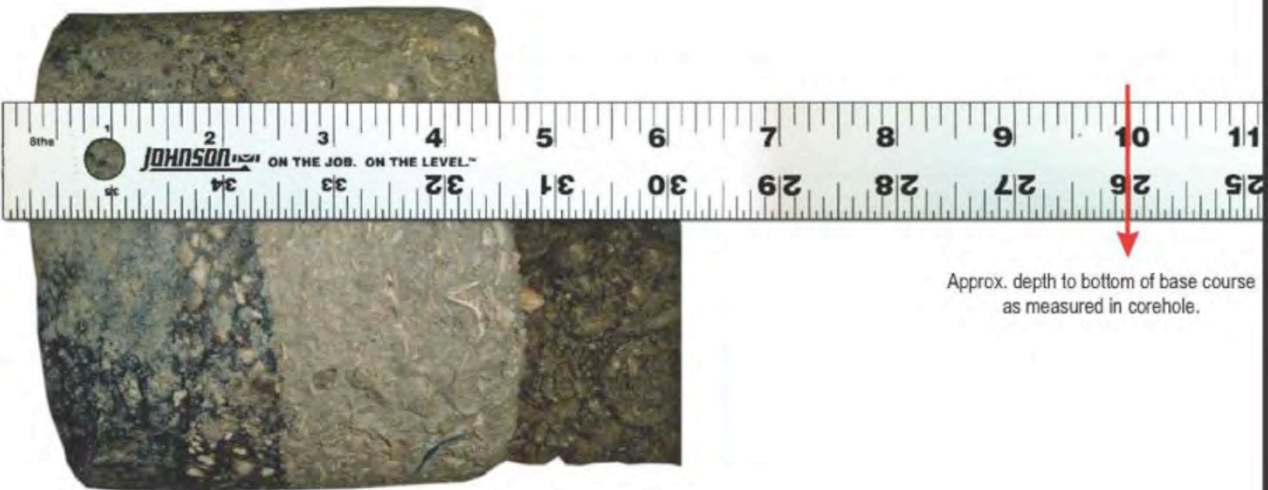
# Lake Underhill Road

\* Portion of sample crumbled and unrecoverable during coring & extraction

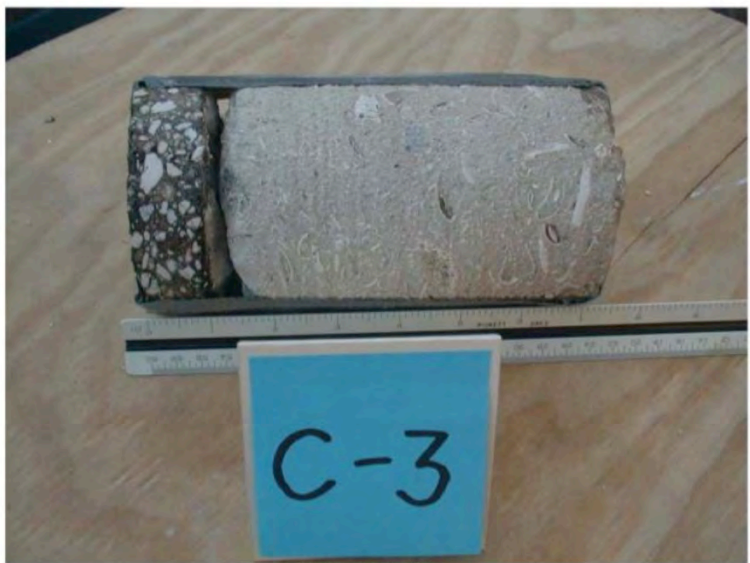
Photo 05. Core C-3

Photo 06. Core C-3

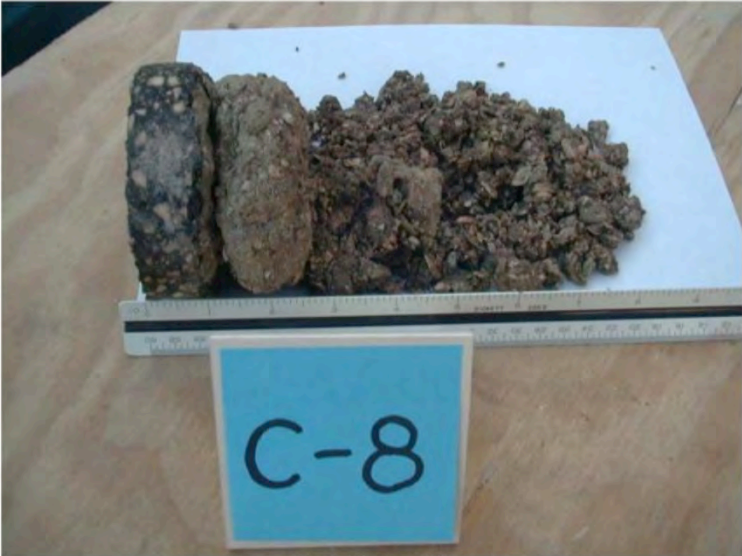
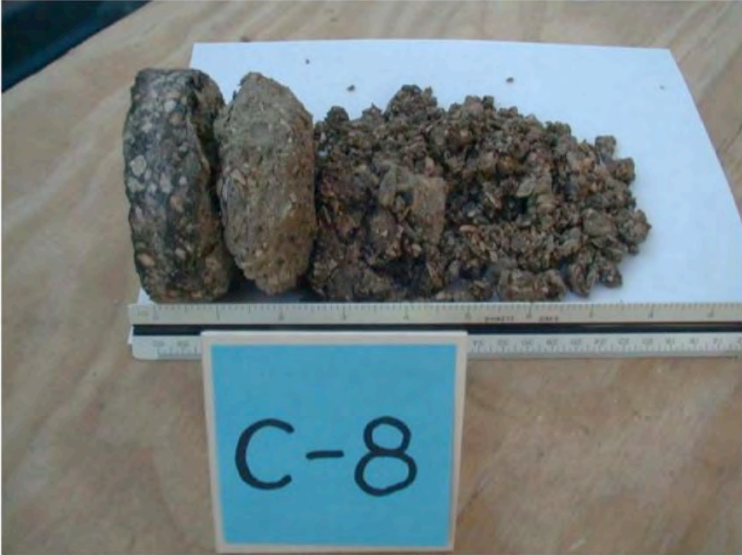
Photo 15. Core C-8

Photo 16. Core C-8

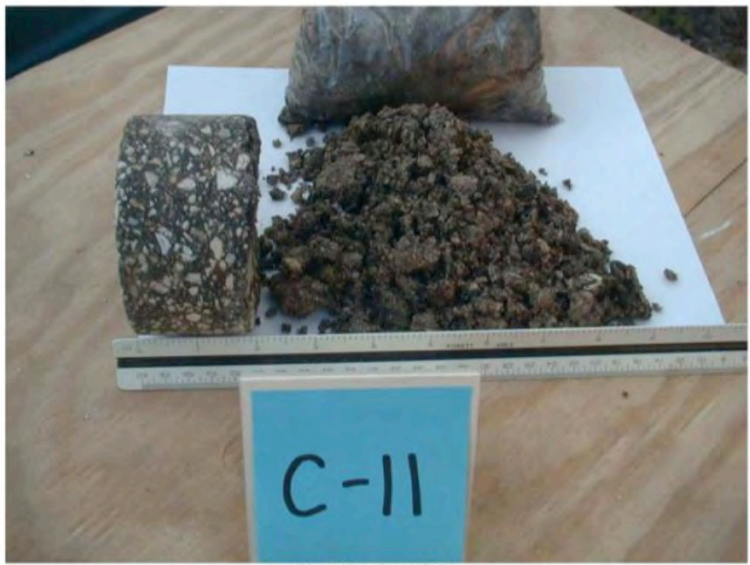
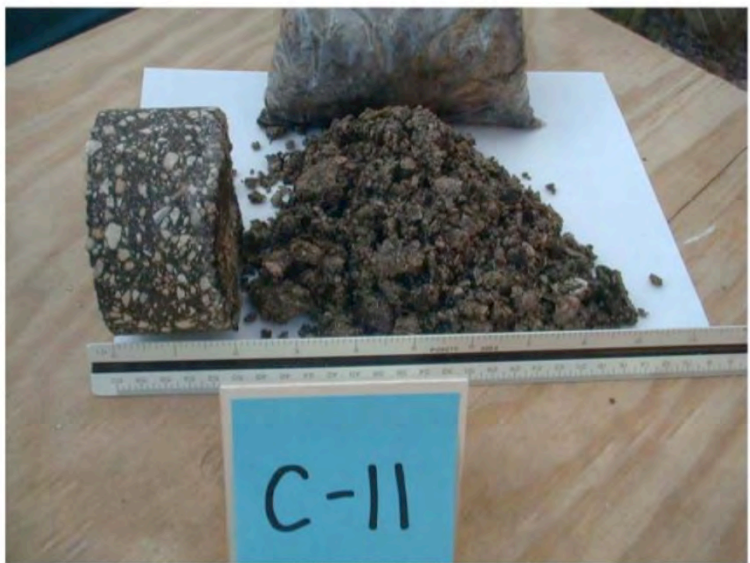
Photo 21. Core C-11

Photo 22. Core C-11

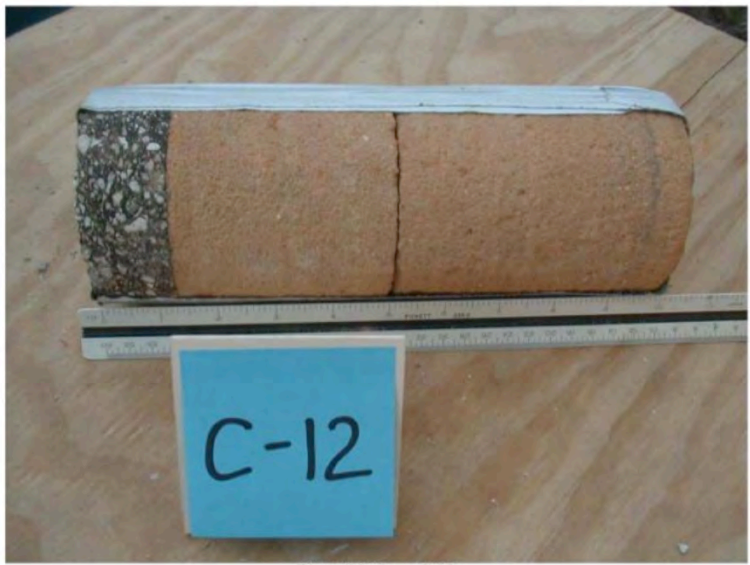
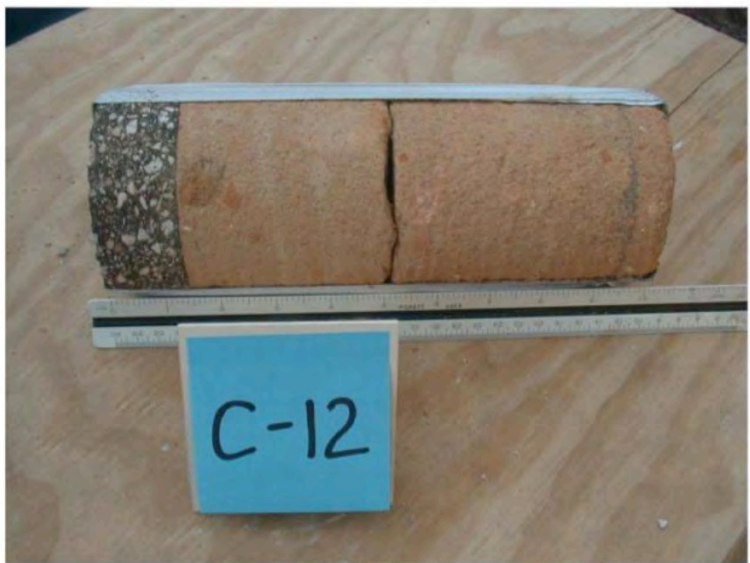
Photo 23. Core C-12

Photo 24. Core C-12

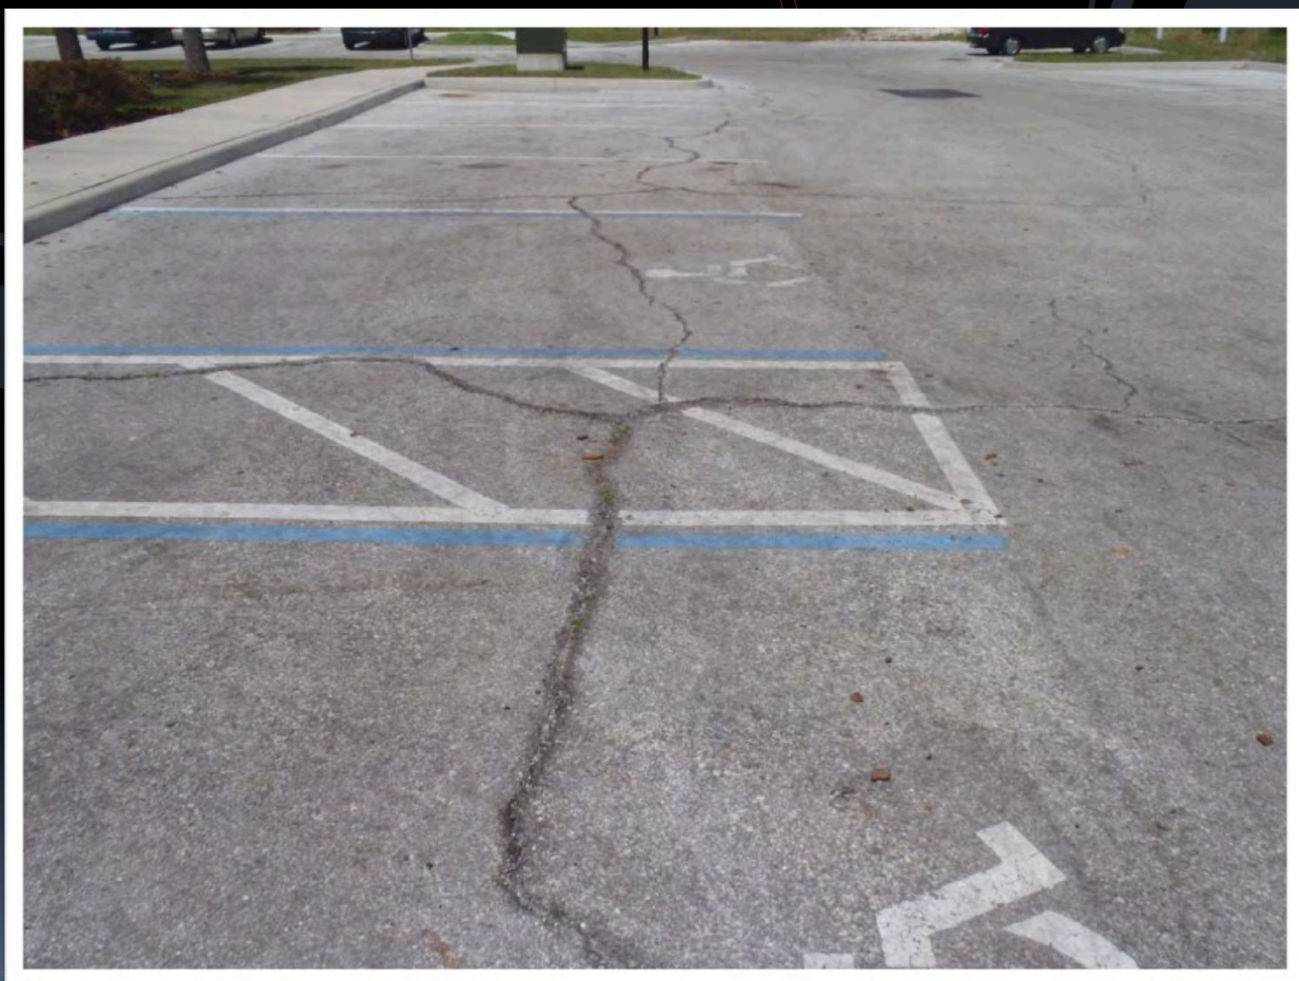
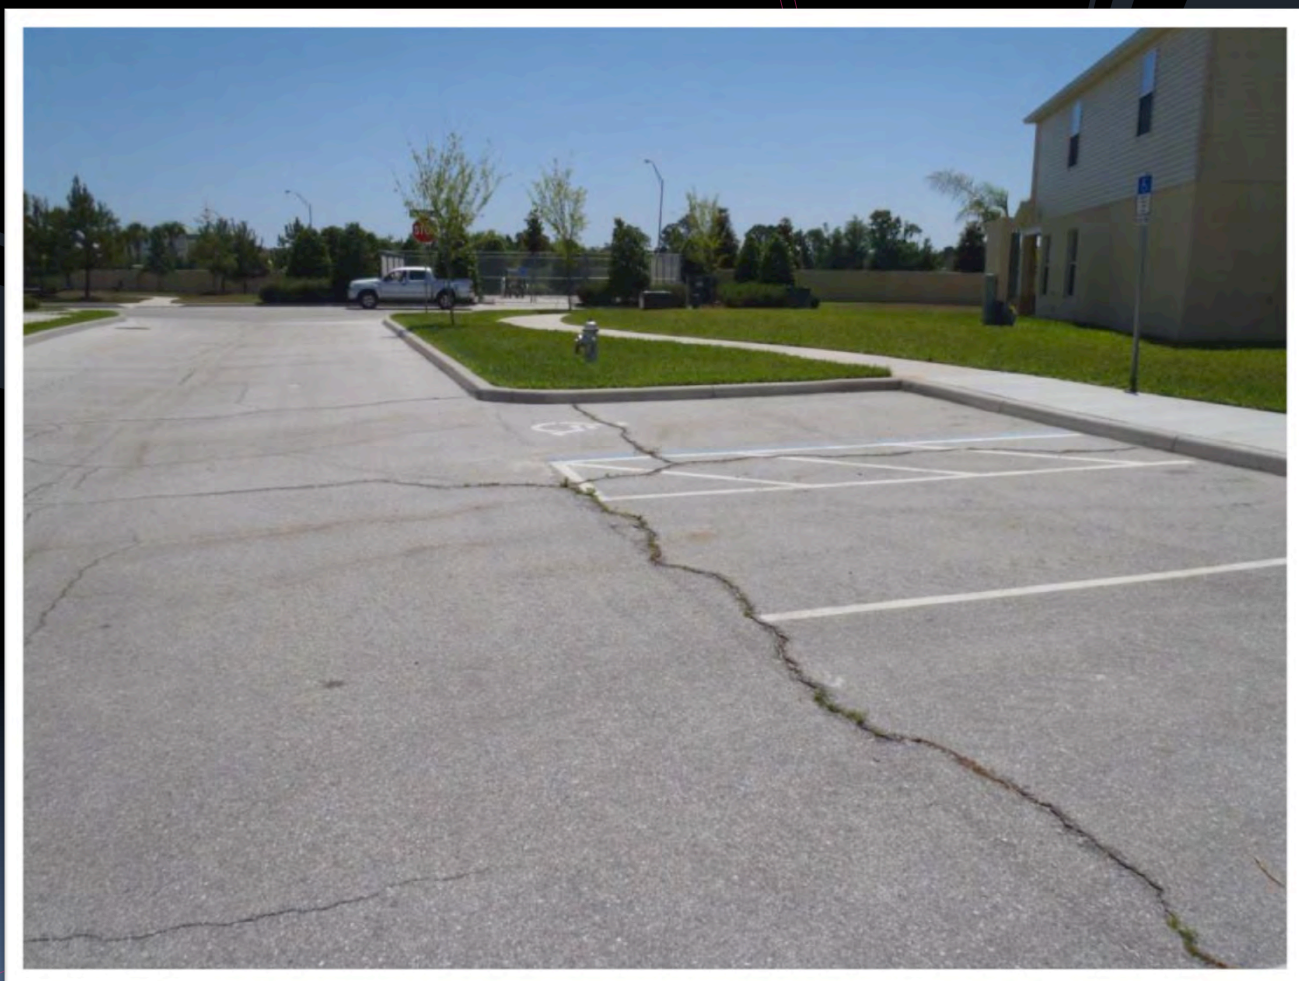
# Compass Bay

# Cracking of Soil-Cement Base

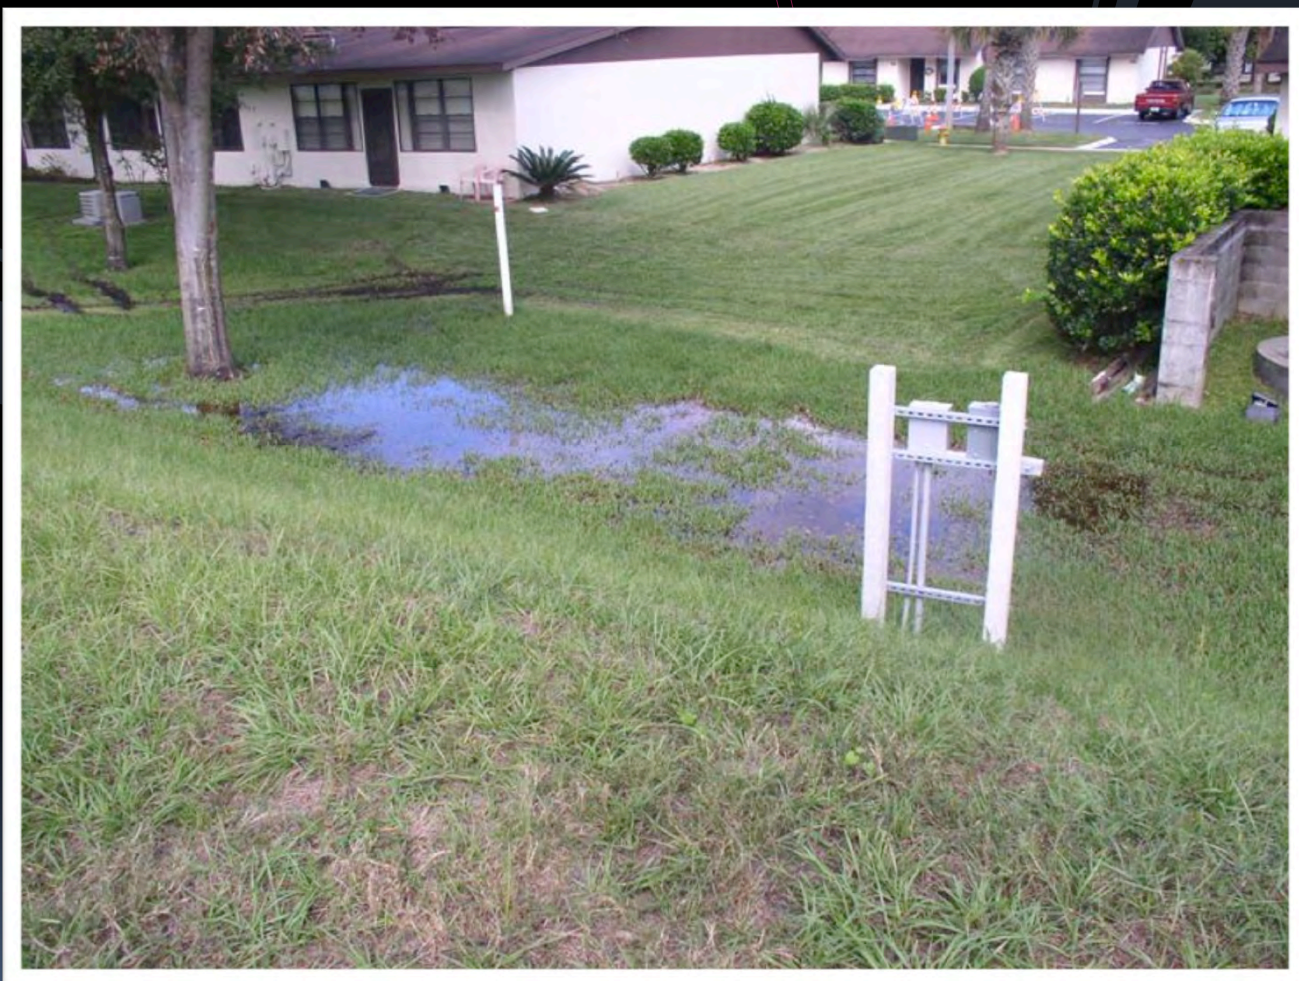
Photo date: 2002

# Seepage Through Pond Berms

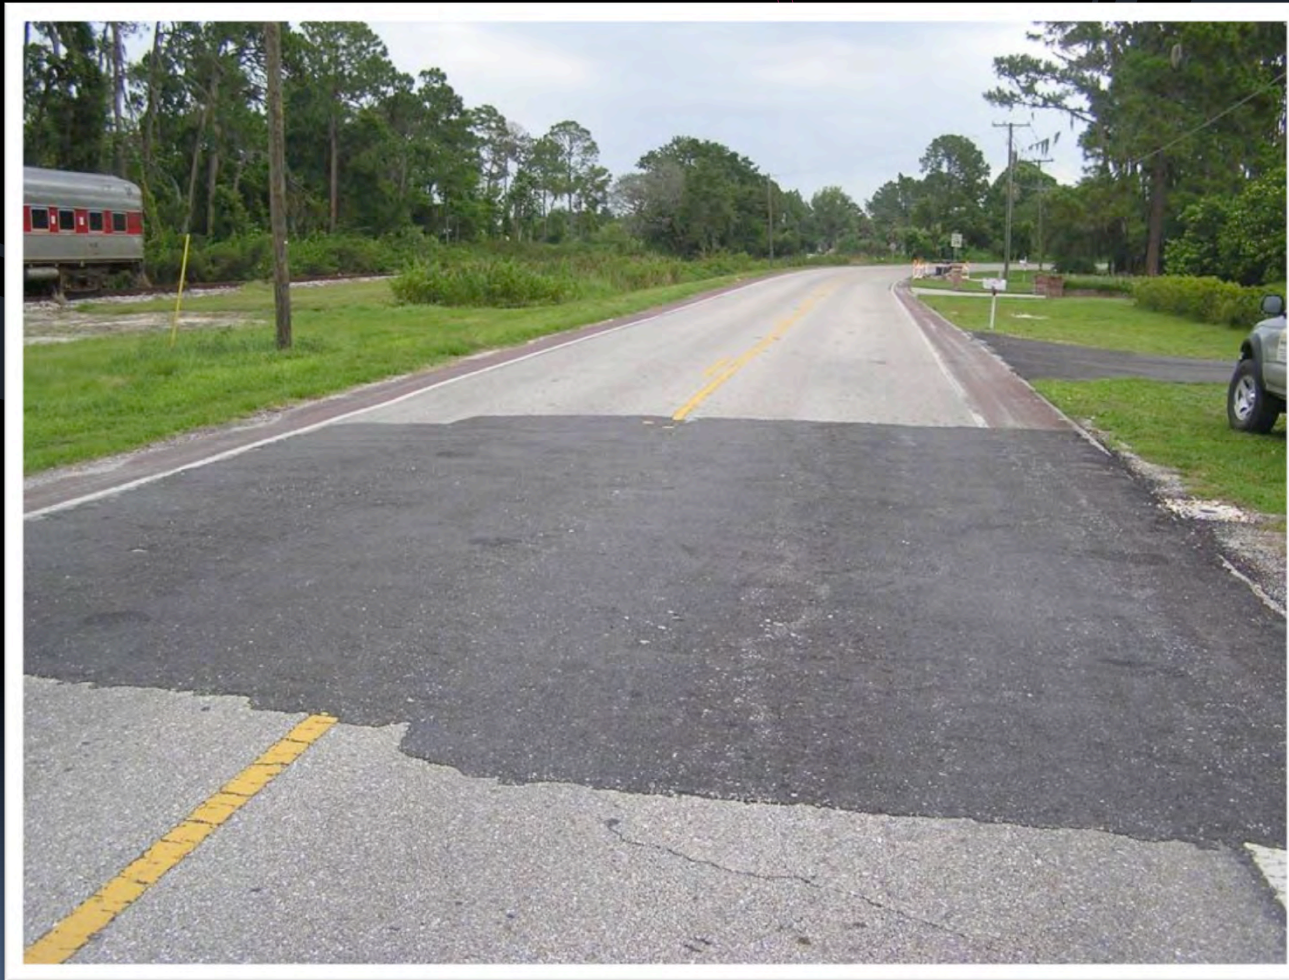
Pavement reinstated after settlement

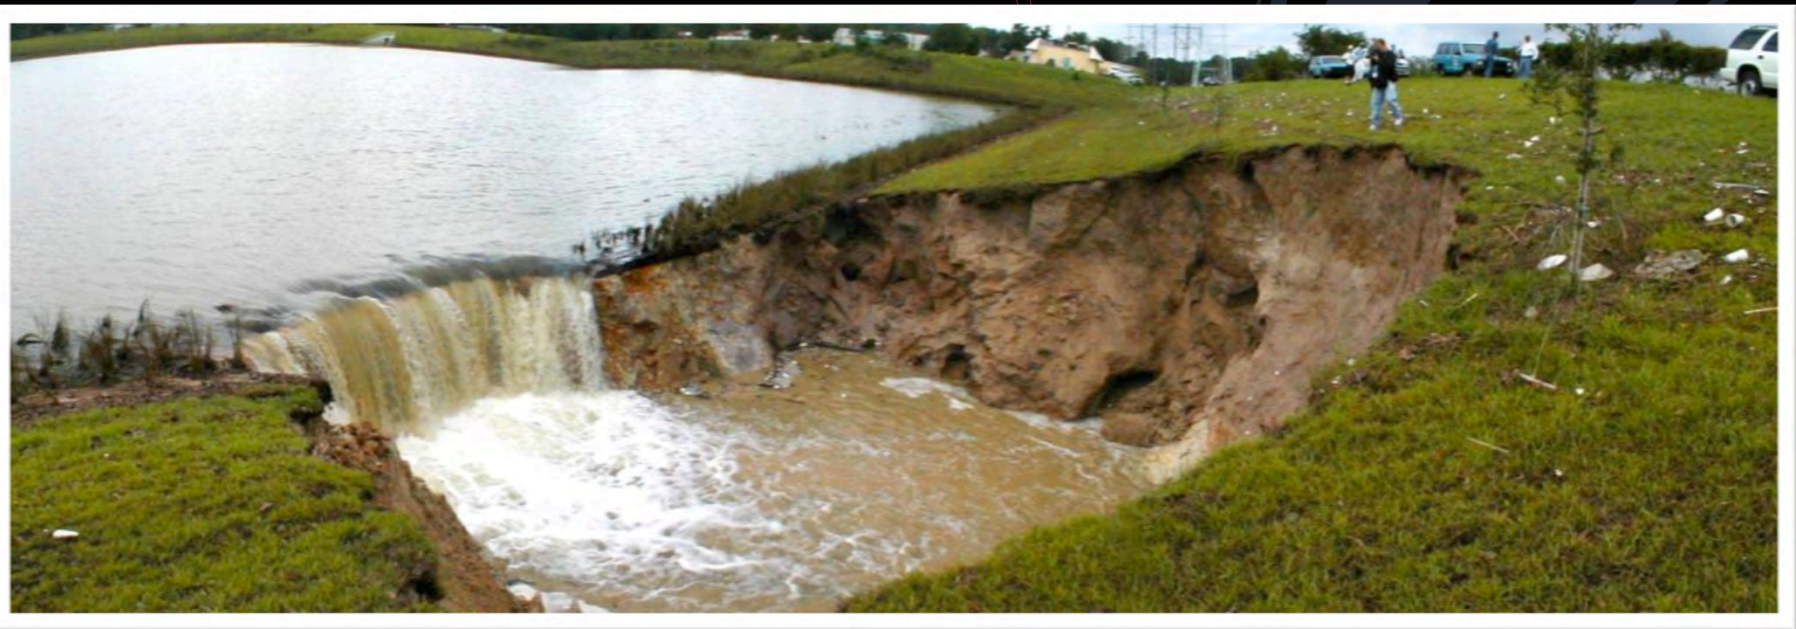
RSF sinkhole 1

# Failure of clay liner in wet pond - FSU Regional Stormwater Pond

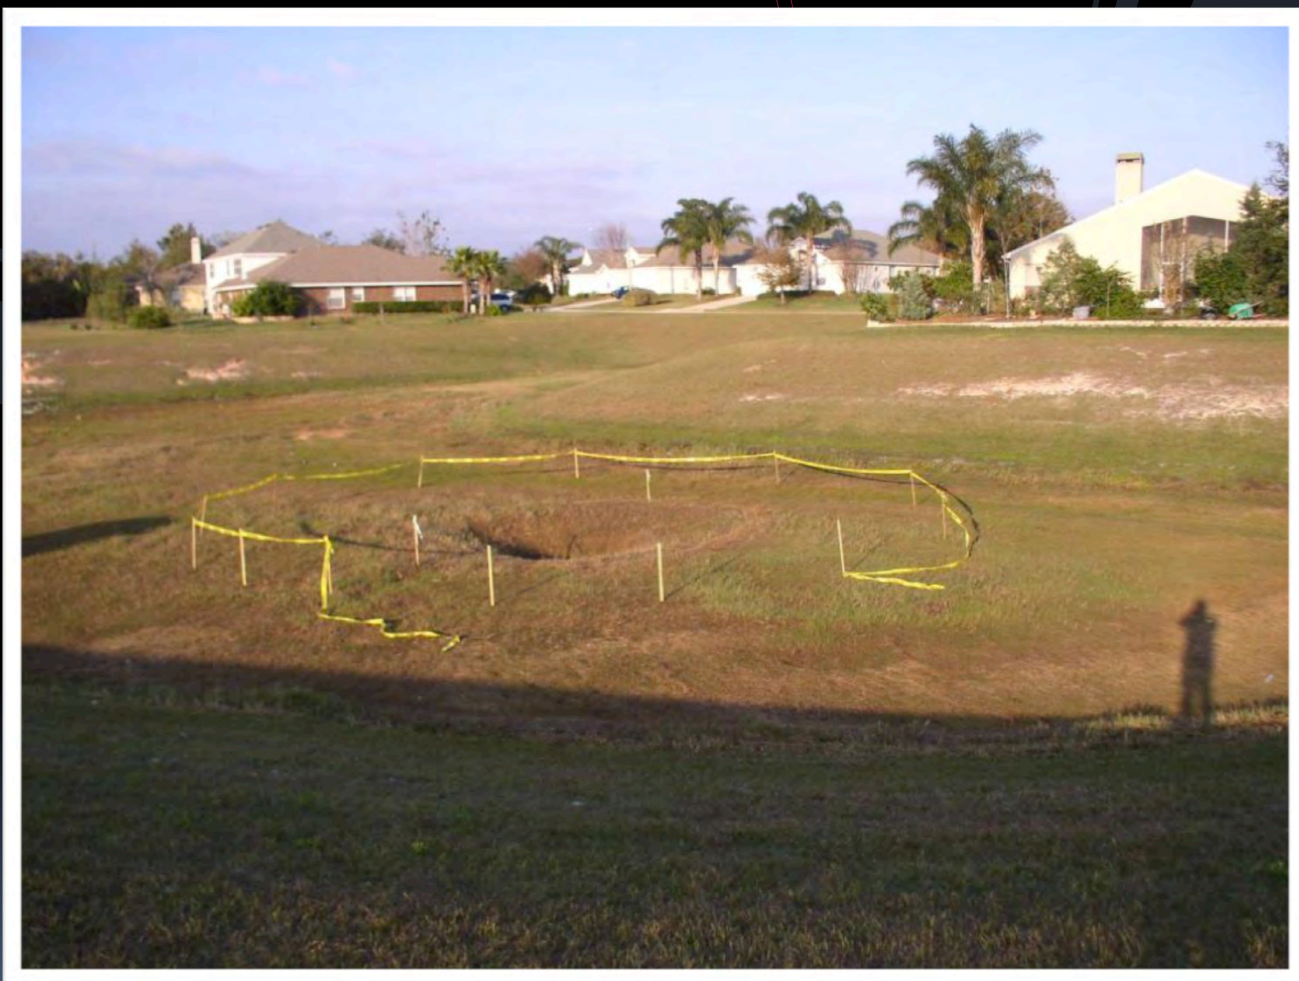
North Pond

# Sinkholes in ponds - Spring Vista Drive in Debarry

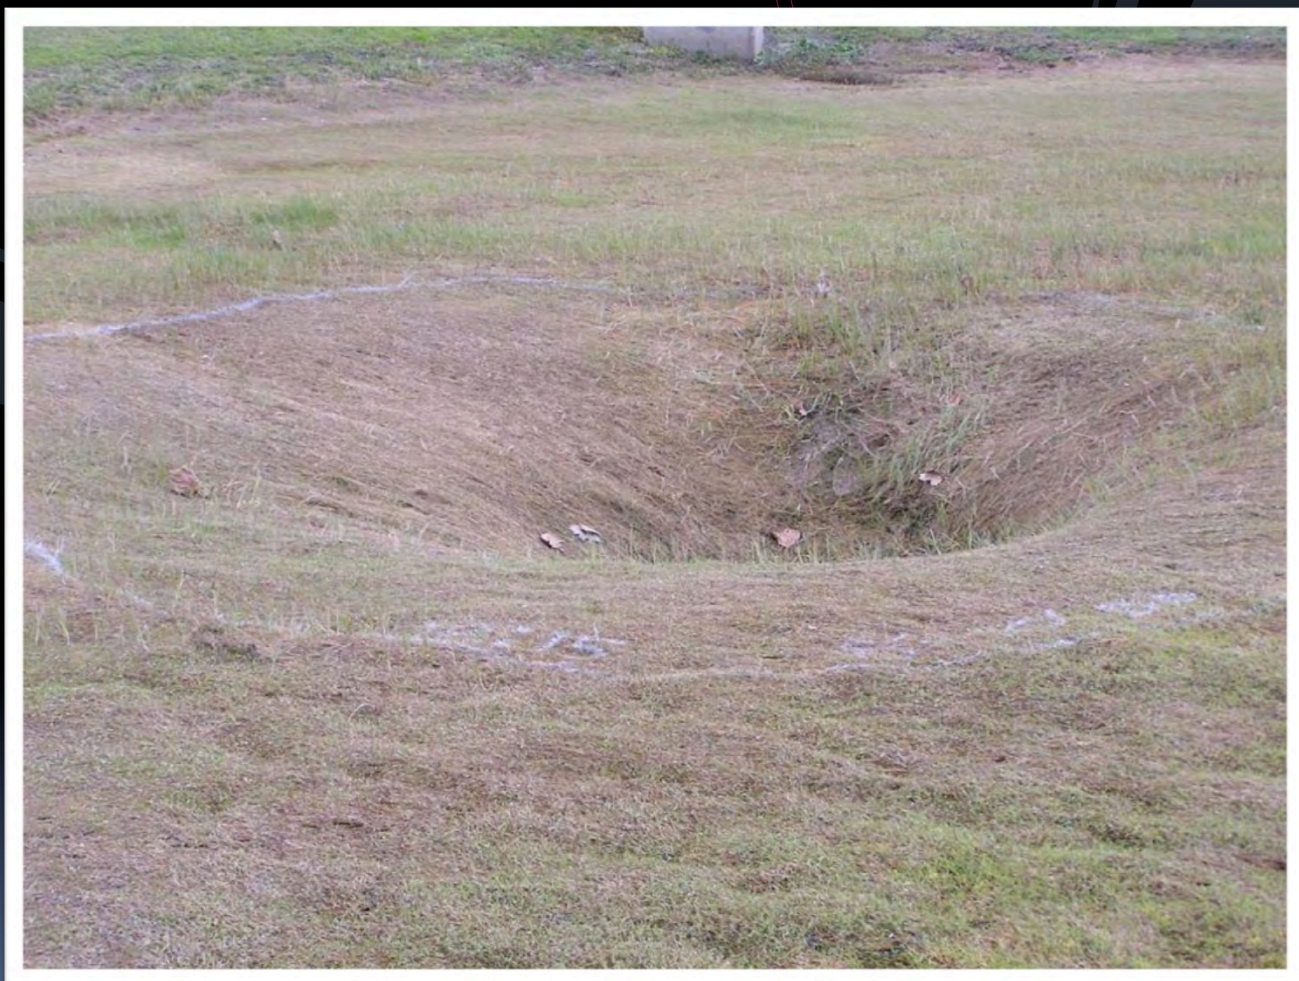
North Pond

# Sinkholes in ponds - Spring Vista Drive in Debarry

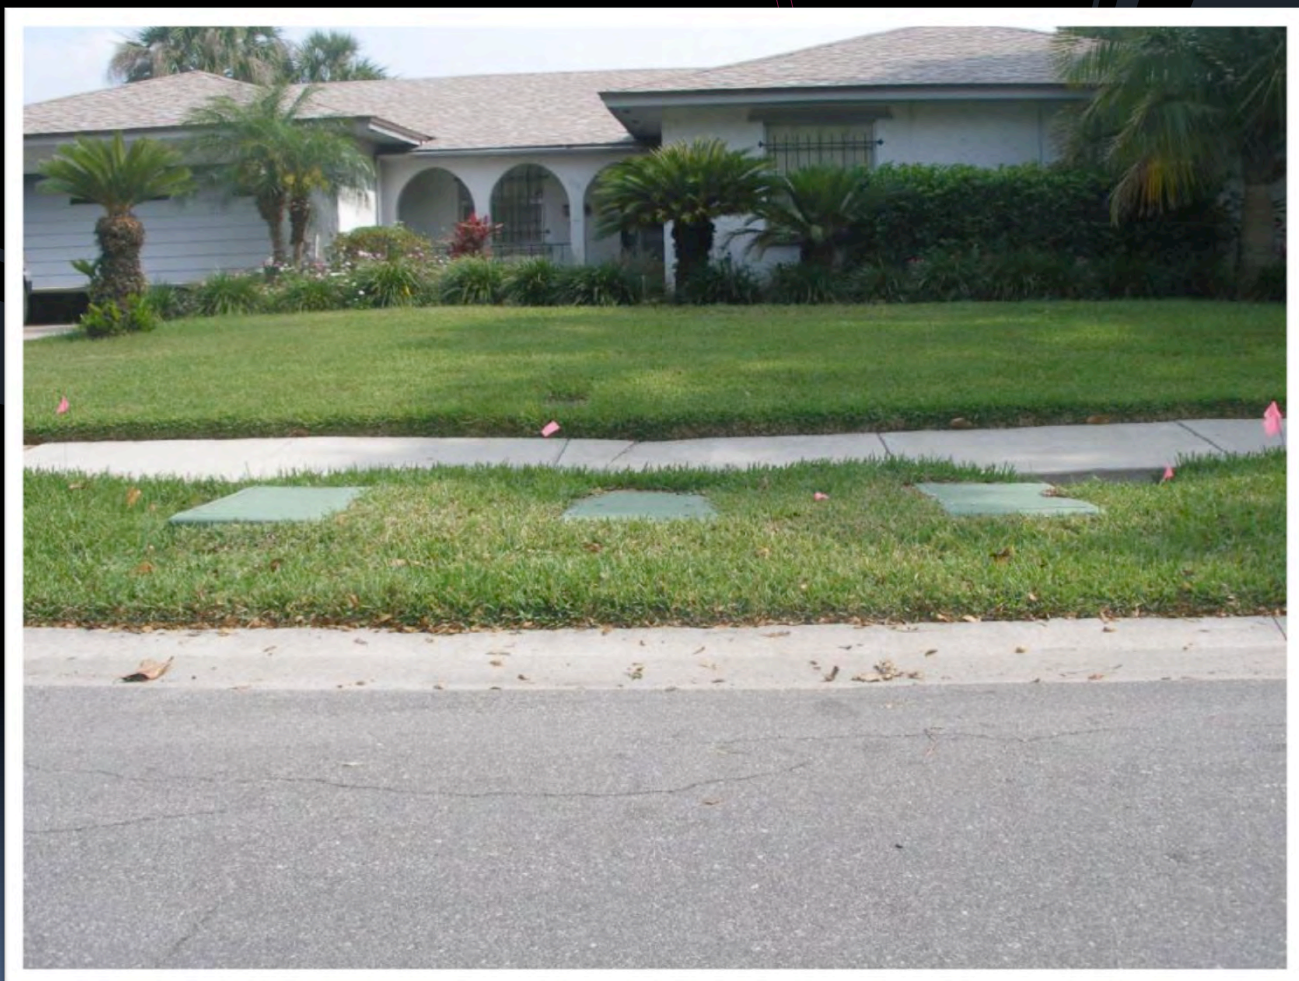
# Dumping loose fill around the sediment removal structure & hydroconsolidation of loosely placed sand backfill

# View of settlement around buried structure
